To:	Amy Driessen Alberta Transportation	From:	Leslie Cho and Carrie Murray Stantec Consulting Ltd.
File:	123315222	Date:	June 12, 2022

Reference: North Central Region, Edson, Site NC018 - Highway 764:02 Pembina River Bridge (N. of Cherhill), Spring 2022 Instrumentation Monitoring Report

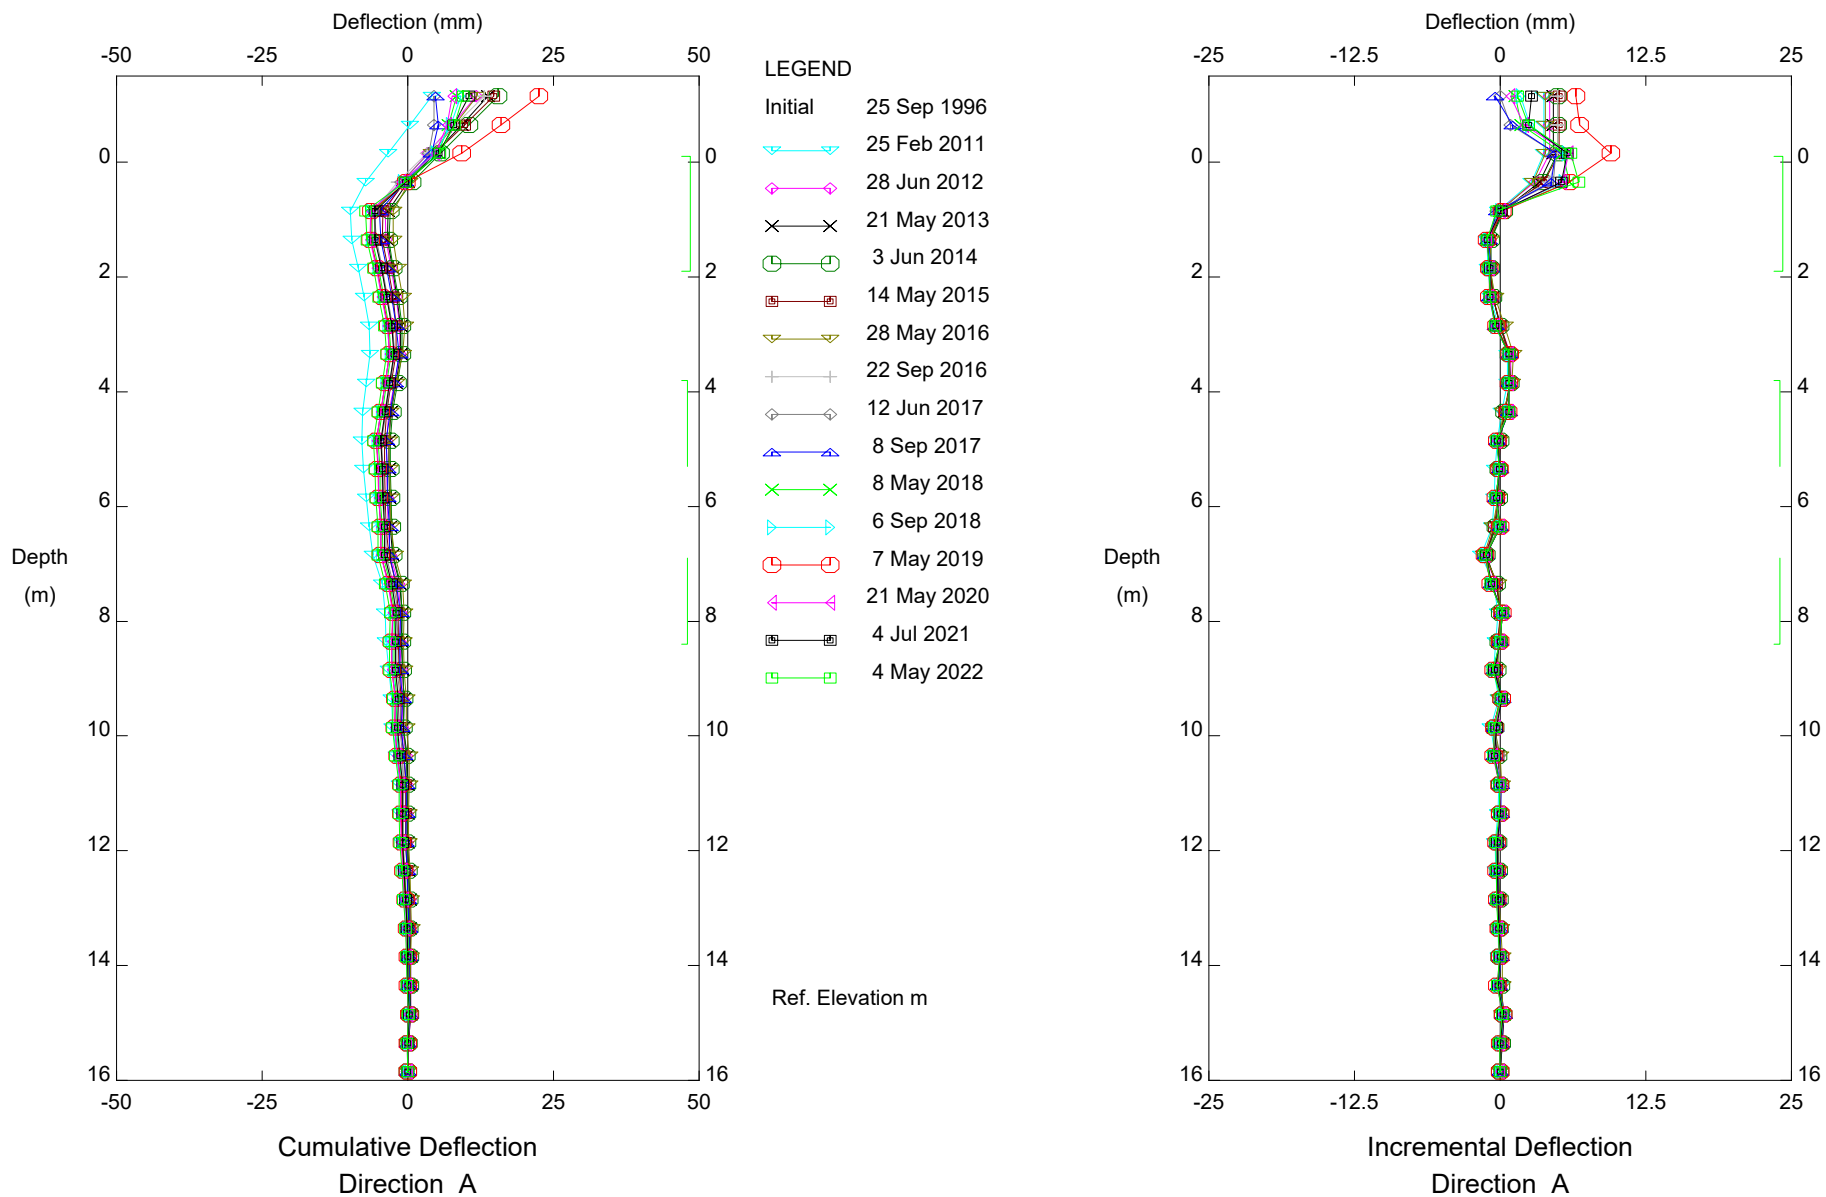
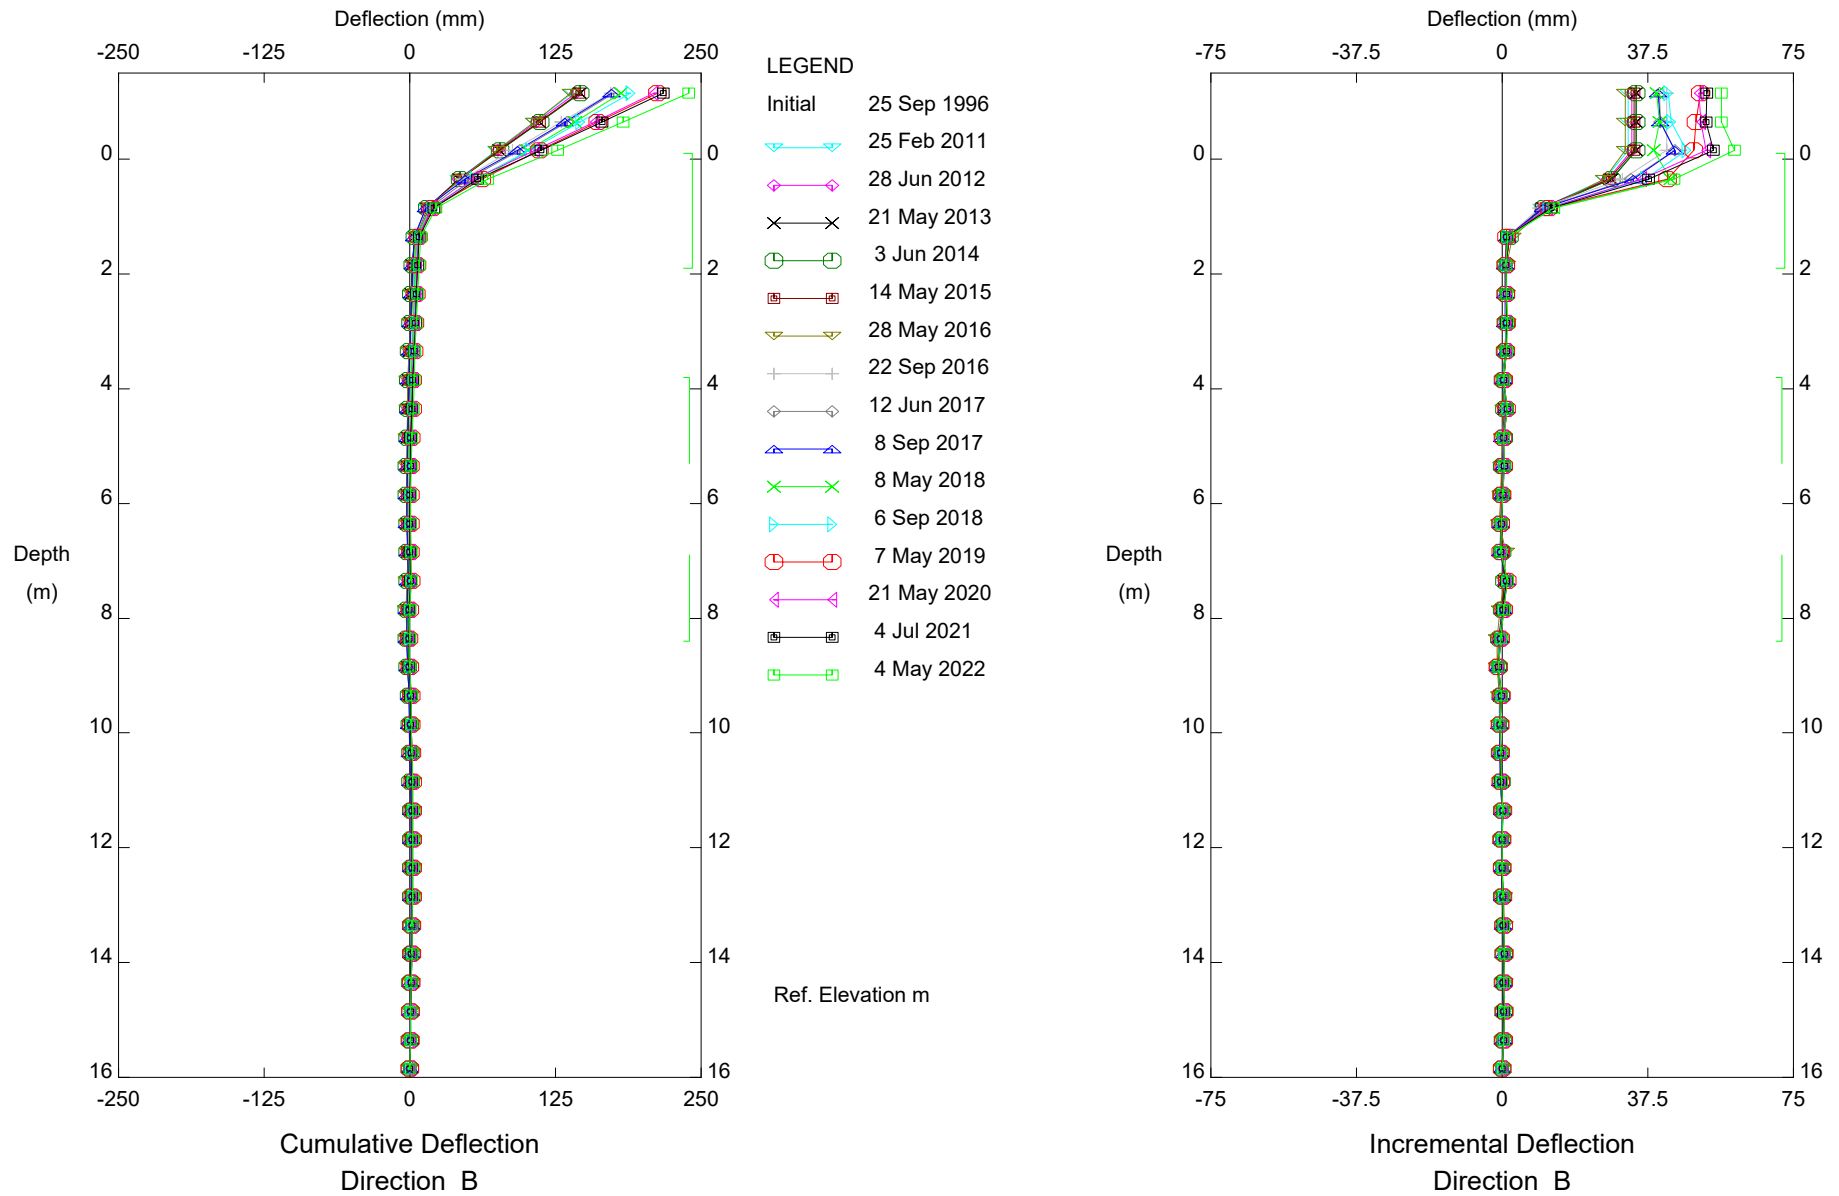
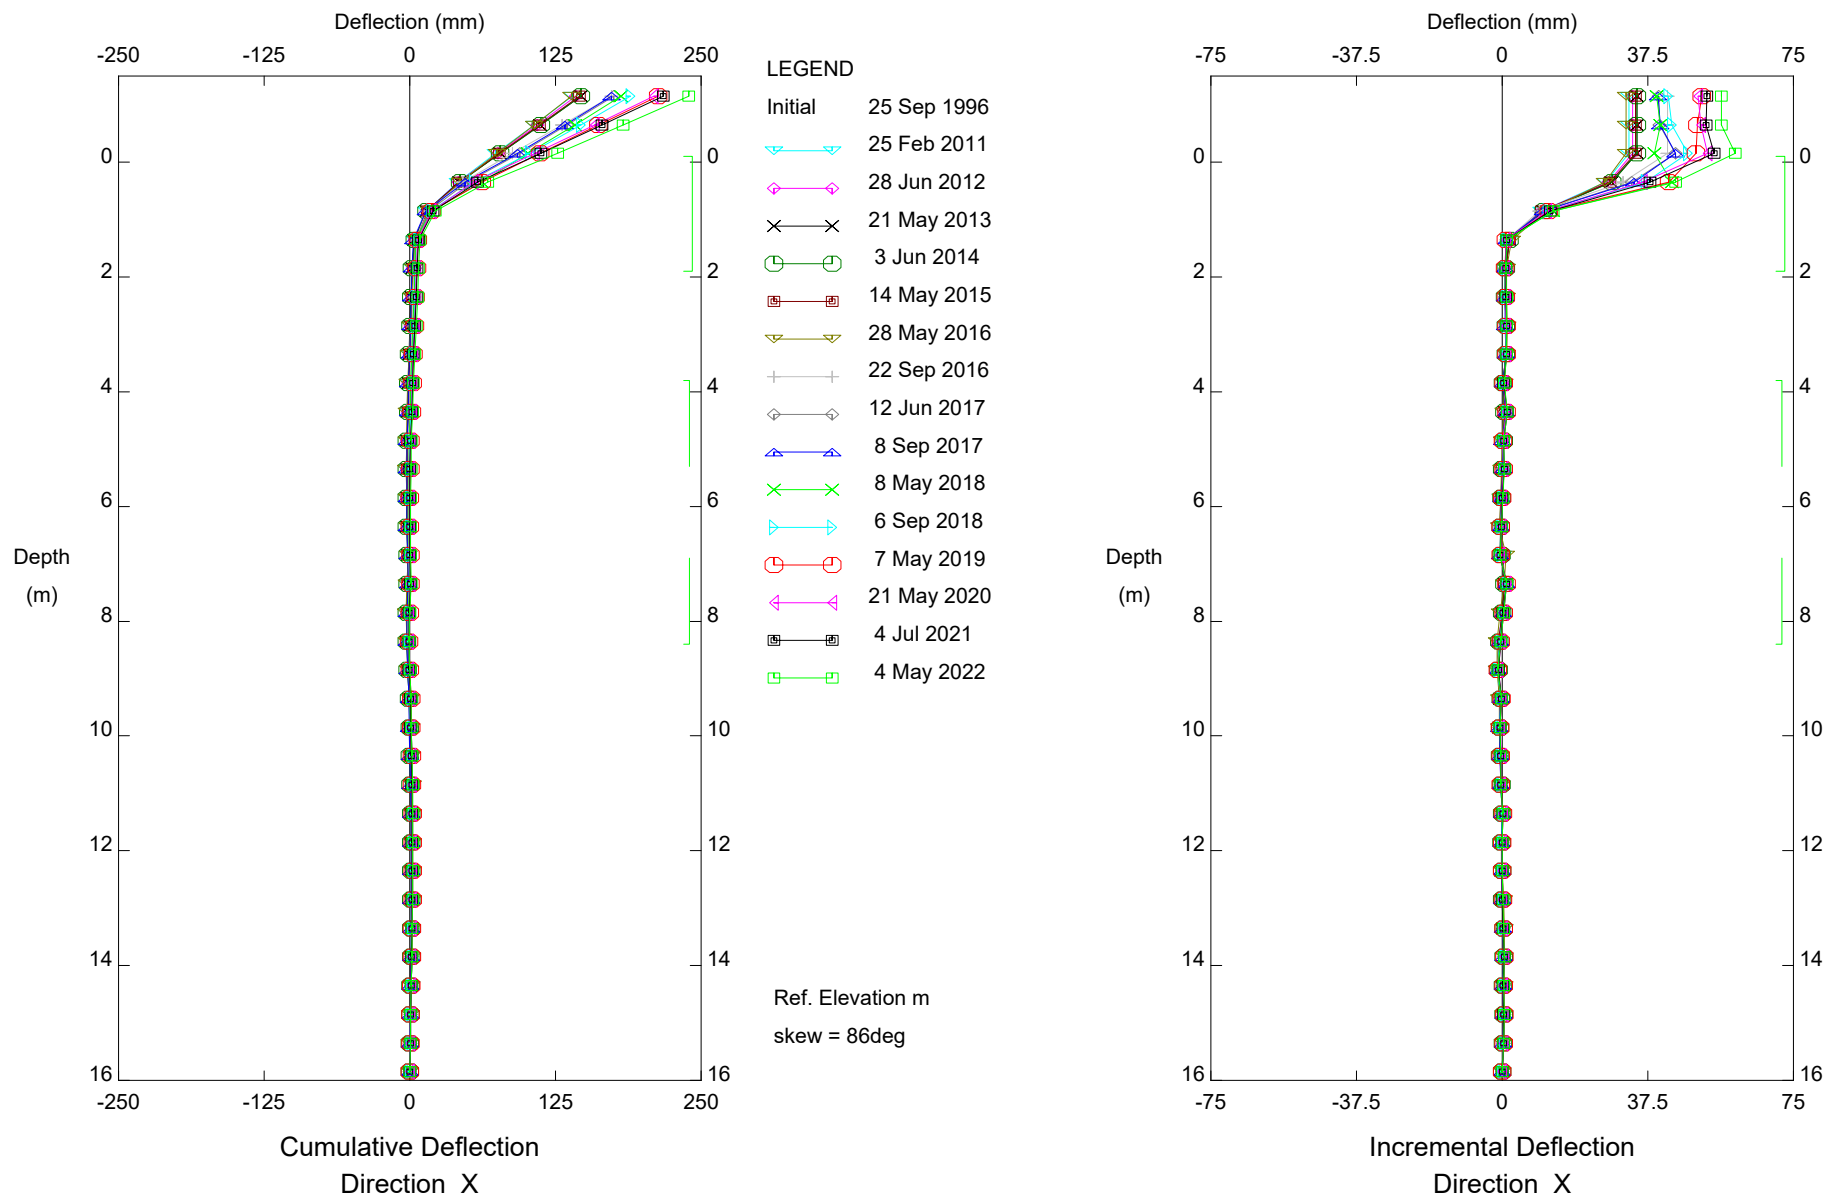
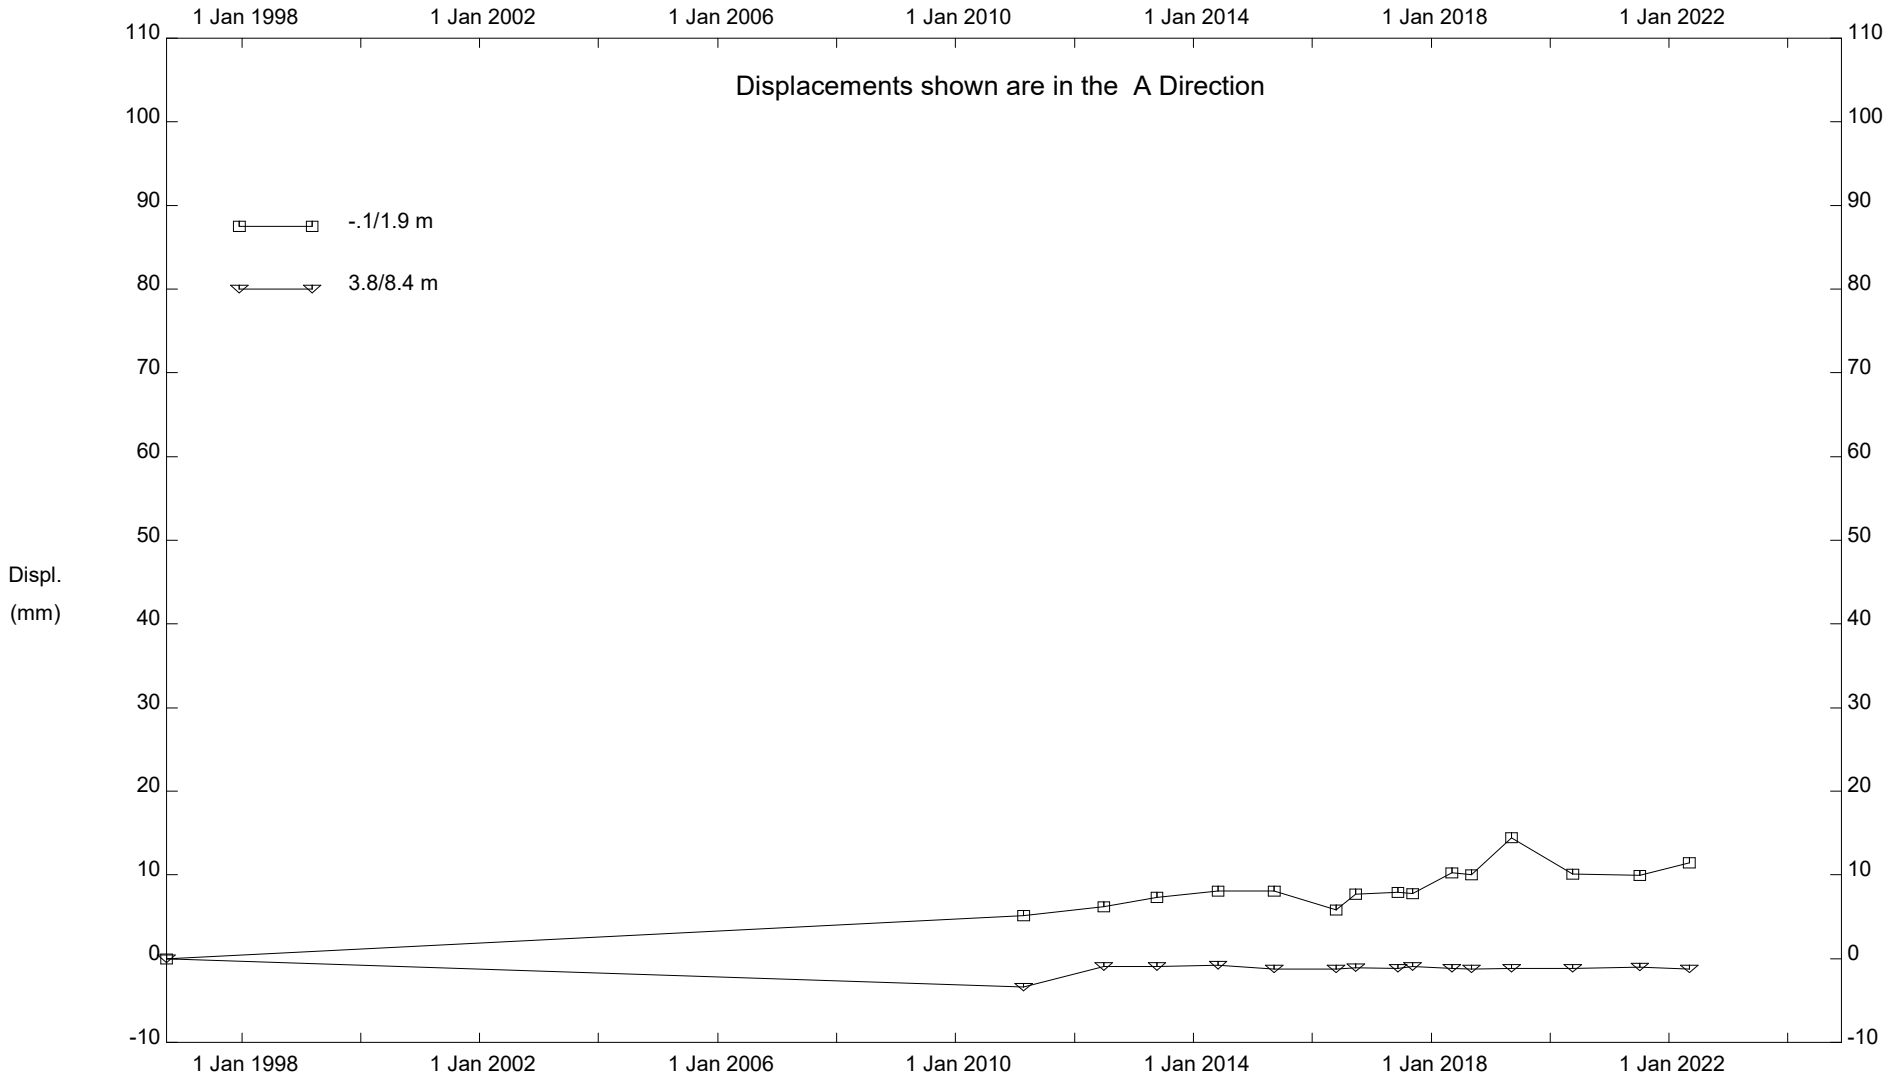
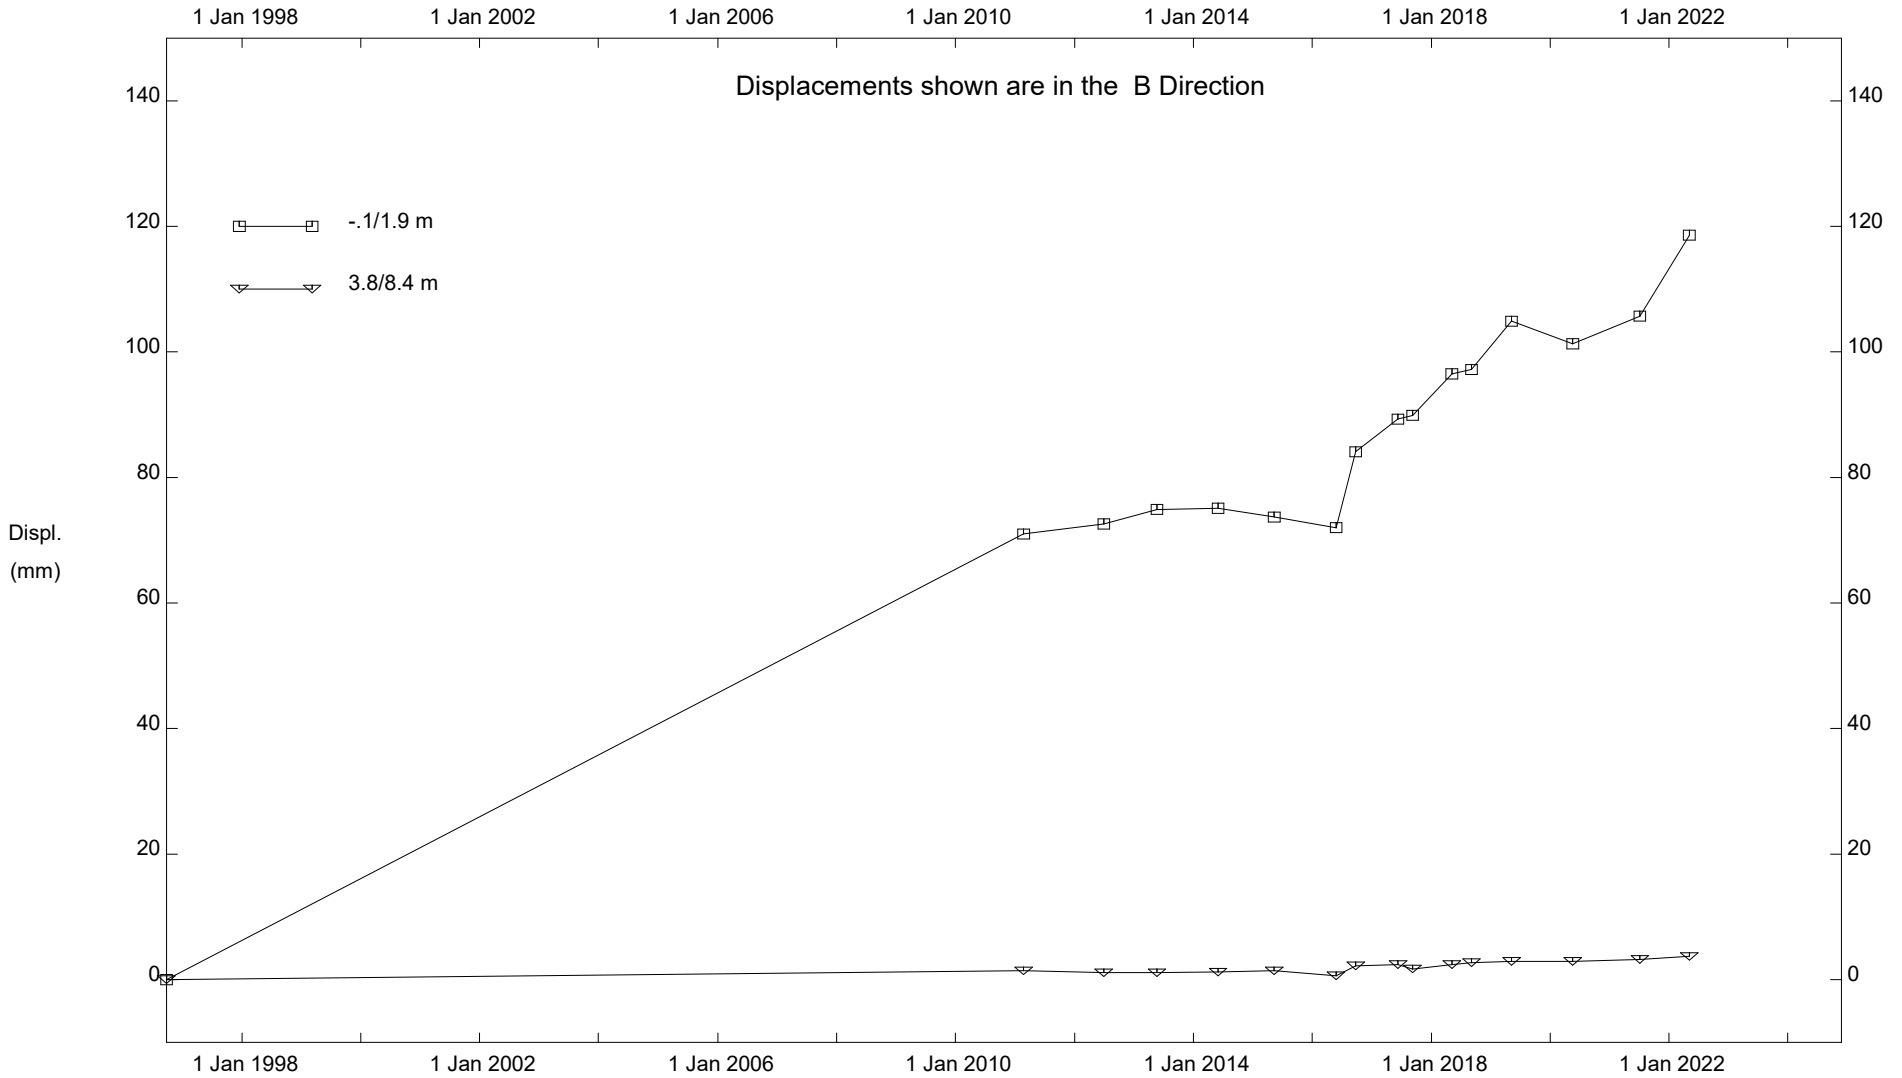
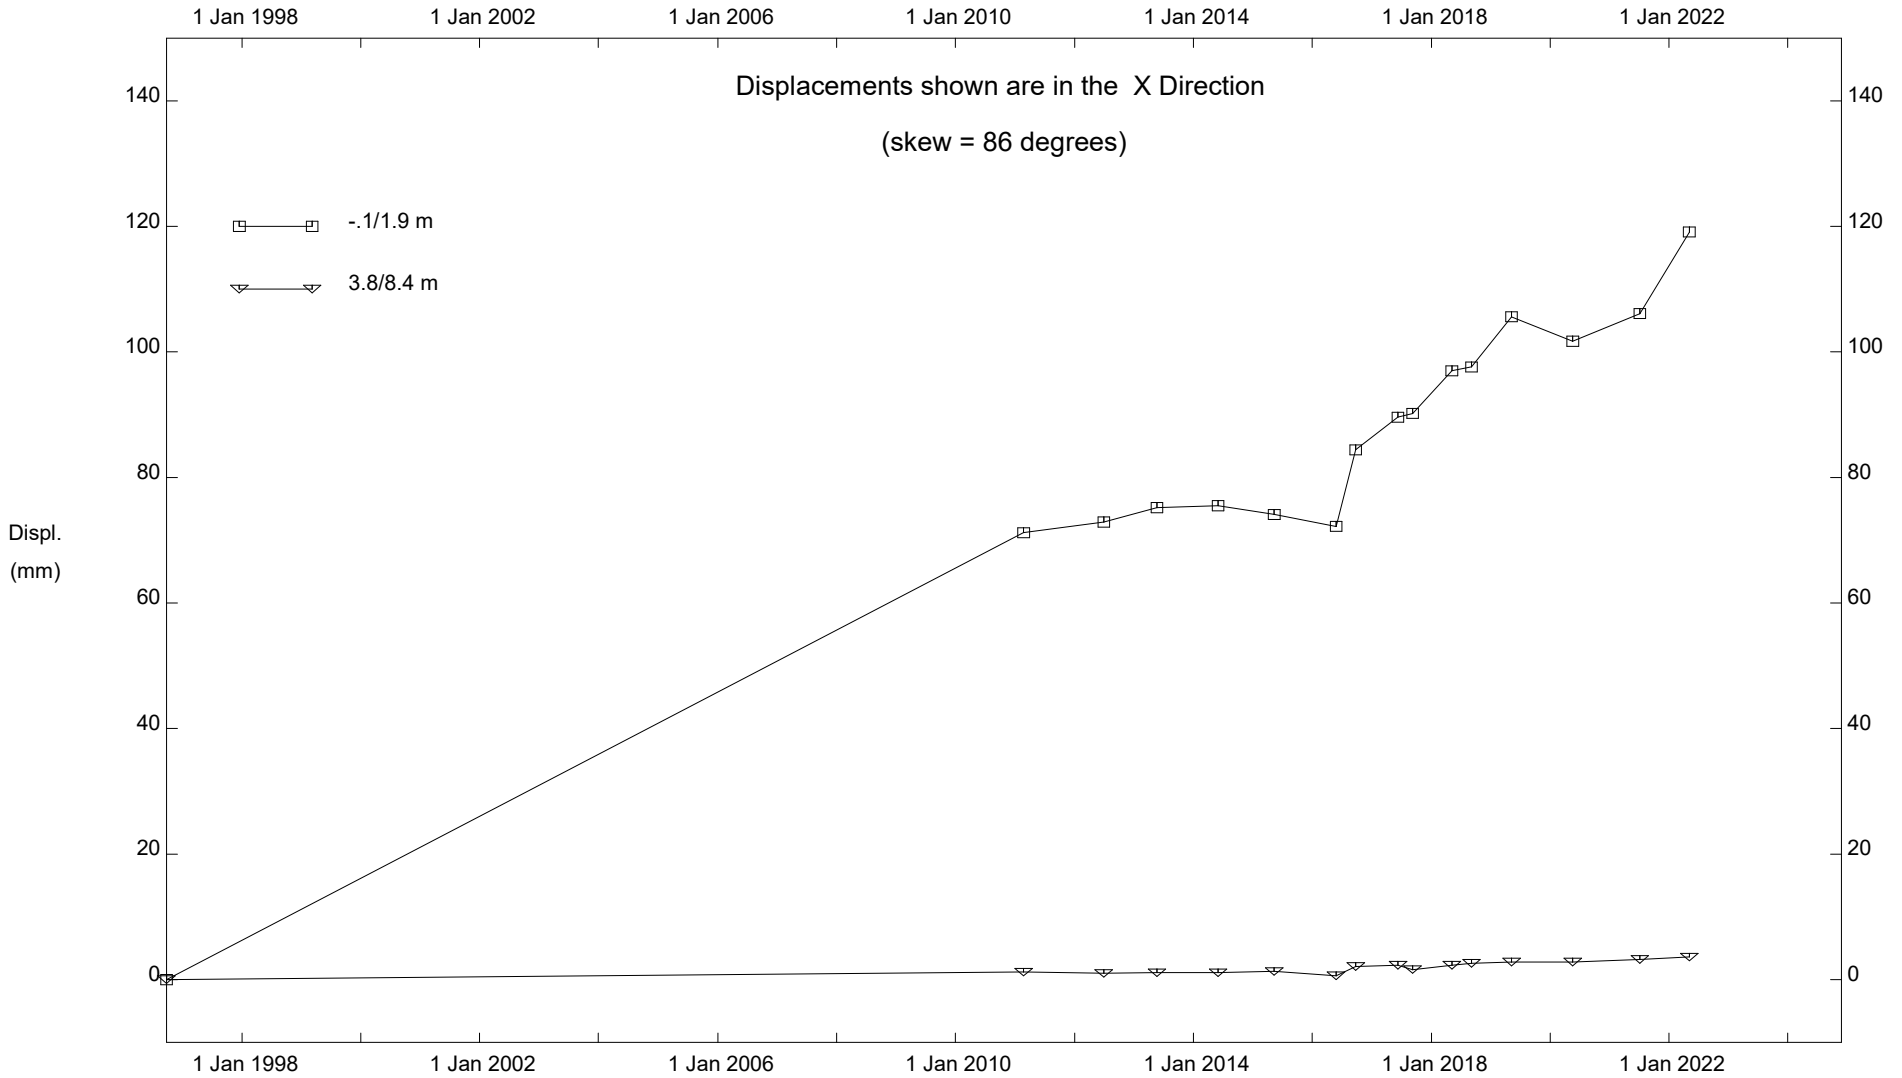
SI-24 showed a cumulative movement of about 119 mm with 5 mm/yr rate of movement within the upper 2 m. However, given that the majority of movement occurred in the B direction (i.e. perpendicular to the roadway), this movement is likely due to seasonal frost/thaw effects and lateral spreading of the road embankment. The lower shear zone is located at approximately 5 m below grade. The lower zone showed negligible movement (< 1 mm) and was similar to the previous readings since about 2011.

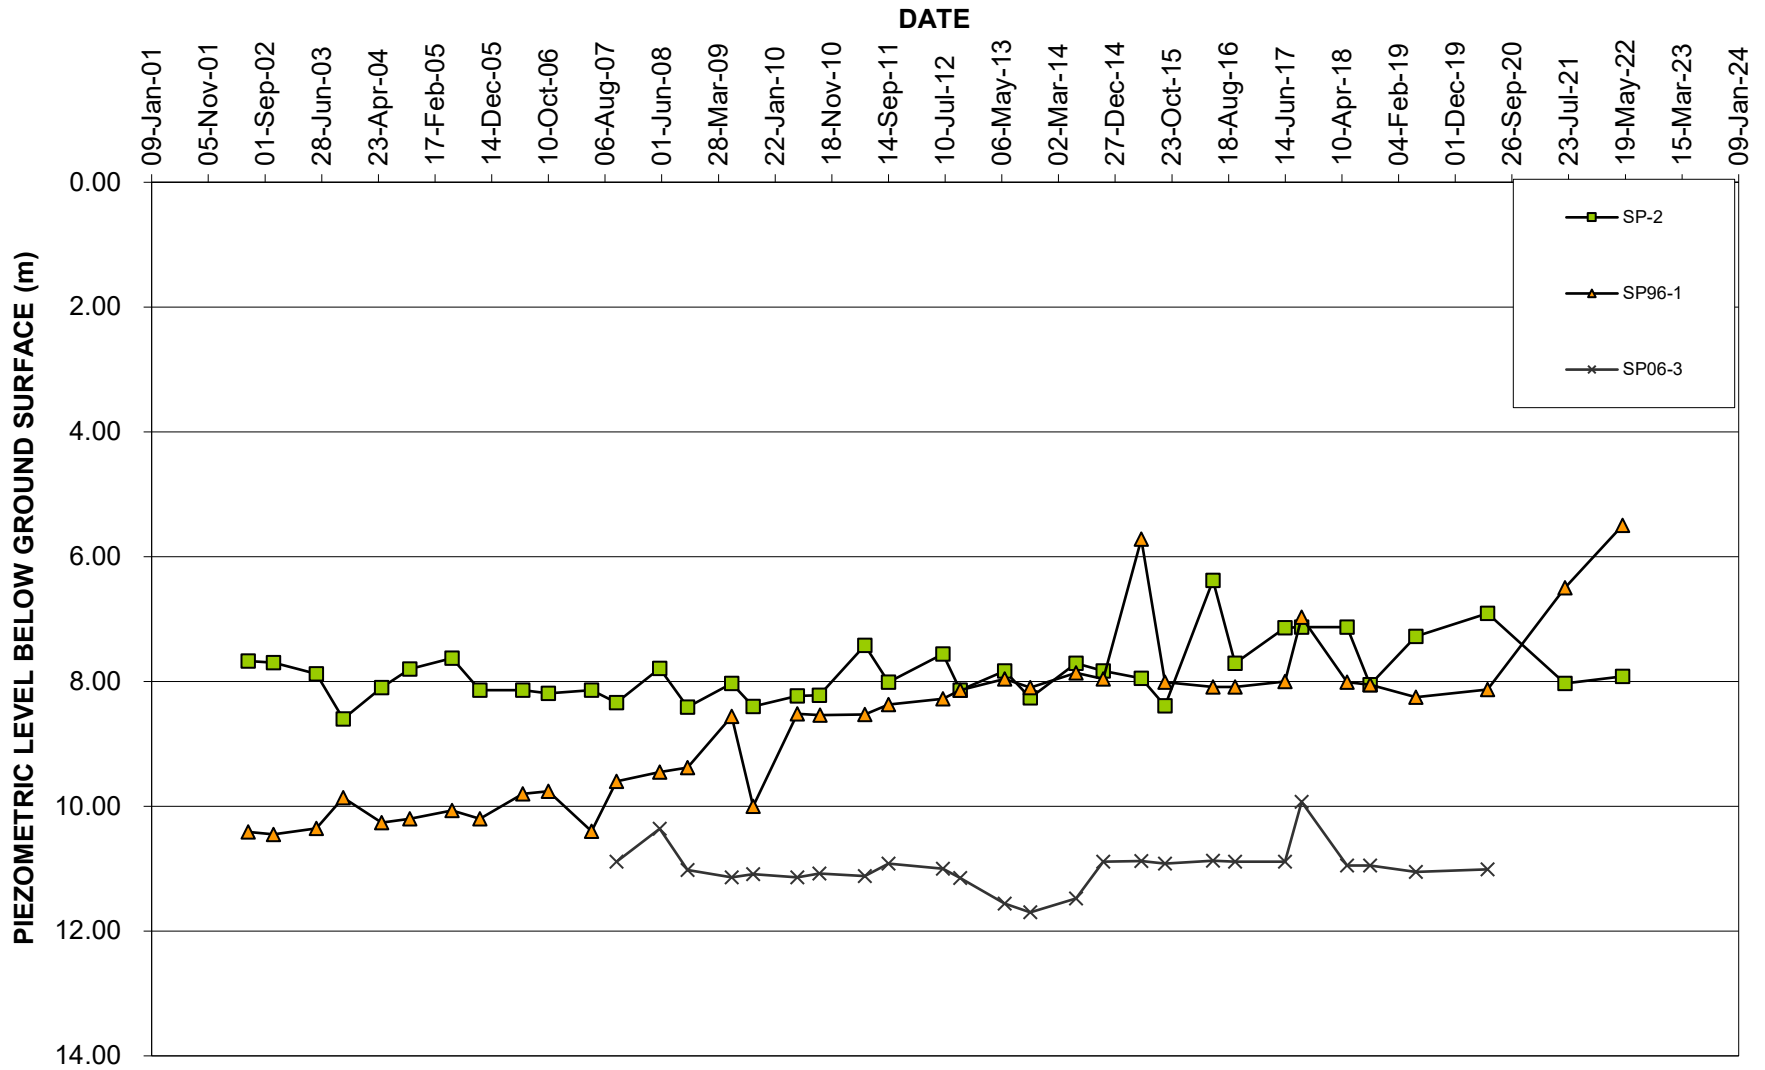
STANDPIPE PIEZOMETER DATA NC018: HWY 764:02 Pembina River Bridge

SP-2 shows signs of seasonal variations. The current reading shows an increase of 0.1 m since the Spring 2021 reading cycle.

SP96-1 shows an increase in water level by 1.0 m since the Spring 2021 reading cycle. The water level has been increasing since 2001 and is currently measuring the highest levels recorded since 2001 at 5.5 m below ground surface (bgs).
