SITE NUMBER AND NAME: NC018 – Pembina River Bridge (North of Cherhill)	LOCATION: On Highway 764, 12 km north of Cherhill	HIGHWAY: 764:02	KM: 12.052
LEGAL DESCRIPTION: NW-15-57-5-W5	NAD83 COORDINATES: UTM11U 5978069 N, 652940 E		
AVERAGE ANNUAL DAILY TRAFFIC (AADT): 410 (2022)		CONTRACTOR MAINTENANCE AREA (CMA): 509

PRIMARY SITE ISSUE: Washed out head slope at north abutment of BF9333
APPROXIMATE DIMENSIONS: 35 m wide by 13 m long
SITE BACKGROUND AND HISTORY: <u>Thurber Engineering Ltd. (Thurber, 1996) Bridge File #9333 Geotechnical Review of Proposed Rehabilitation Work:</u> <ul style="list-style-type: none"> • Field observations indicate distress at south abutment concrete face (H-piles forced out of abutment concrete). Soil under the west side of the south abutment had settled by about 300 mm. Distress to the north abutment was also observed but to a lesser extent than the south abutment. No indication of distress to the north head slope was observed although some cracking along the lower slope was noted. Settlement was observed within the north abutment fill prior to the 1996 review by Thurber. • TEC's files indicate bolts on piers have undergone shear related deformation in th

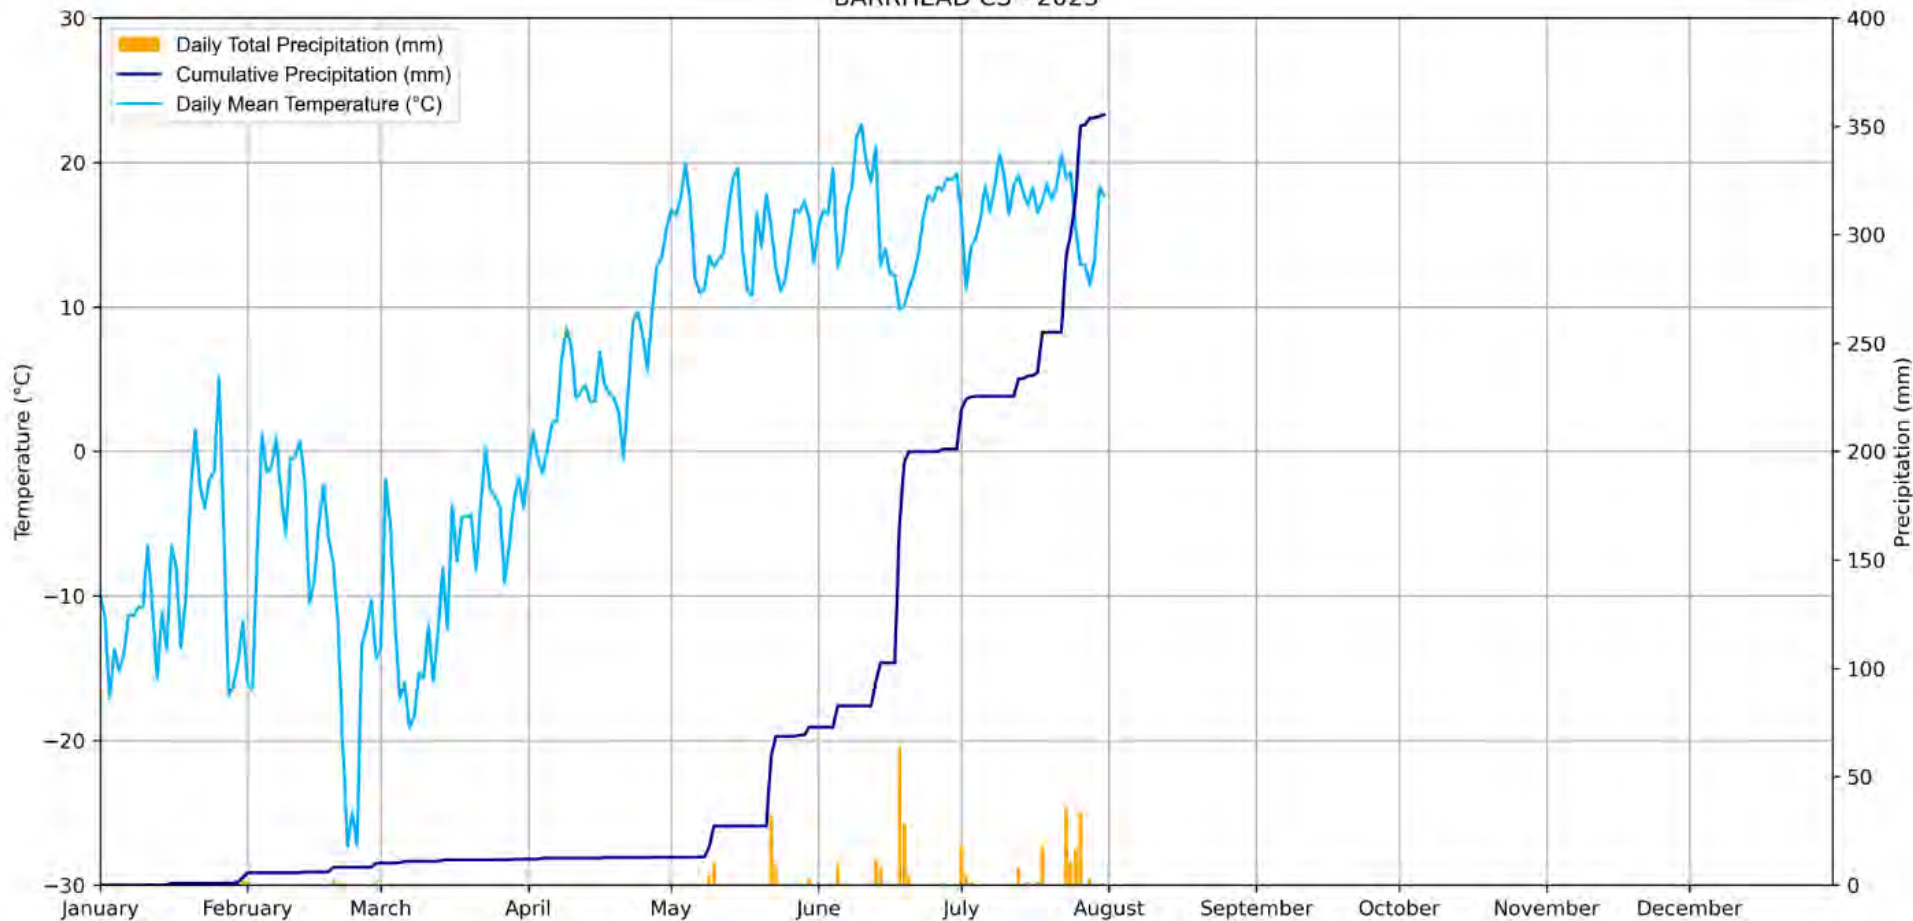
Title
 2023 Precipitation Data from Barrhead Weather Station

- Weather station data from the Barrhead CS weather station located 24 km northeast of the site indicates two significant rainfall periods in mid-June and late July (Figure 2). During this period, approximately 100 mm of rainfall was received within a few days. The cumulative precipitation for 2022 is comparable to 2023, as shown on Figure 3, however, higher intensity rainfall was experienced in 2023. Due to the rainfall received in mid-June 2023 the Pembina River water level increased by more than 3 m (Figure 4) as recorded at the Entwistle Hydrometric Station approximately 40 km southwest (upstream) from NC018. Despite comparable cumulative precipitation in 2022, river levels only risen about 1 m given the lower intensity.

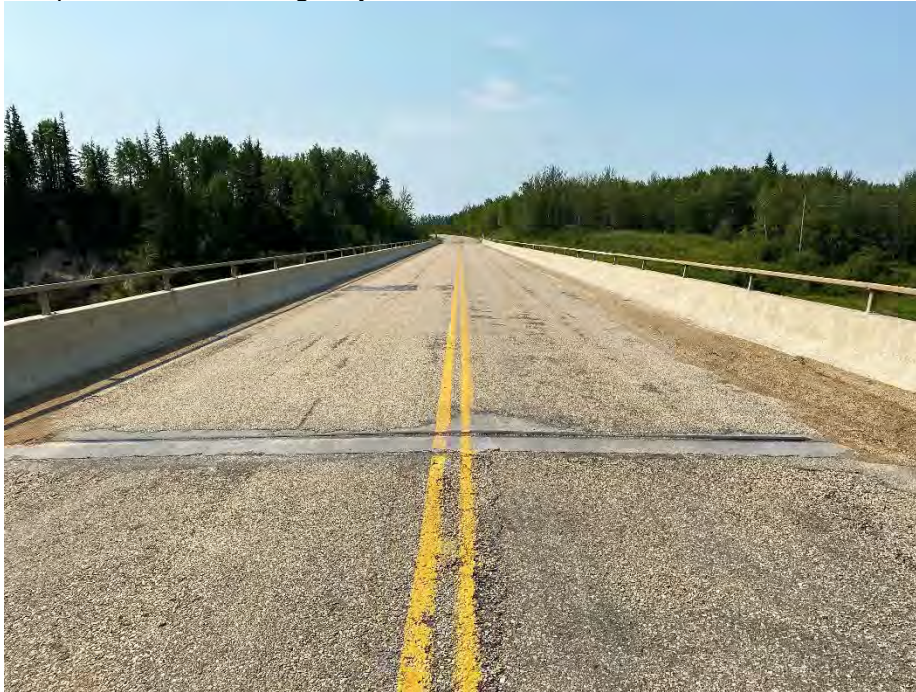
- The highway surface currently does not appear to be affected by the loss of the north embankment head slope (Photos 1 to 4).
- Significant drift accumulation was observed on the upstream side of the bridge (Photo 5). Stantec was informed that some of the drift accumulated up to the north bank of the river and was recently removed using an excavator. TEC also indicated that the remaining drift will be removed via crane in early August.

Photo 1: Highway surface at north abutment. Looking southwest.

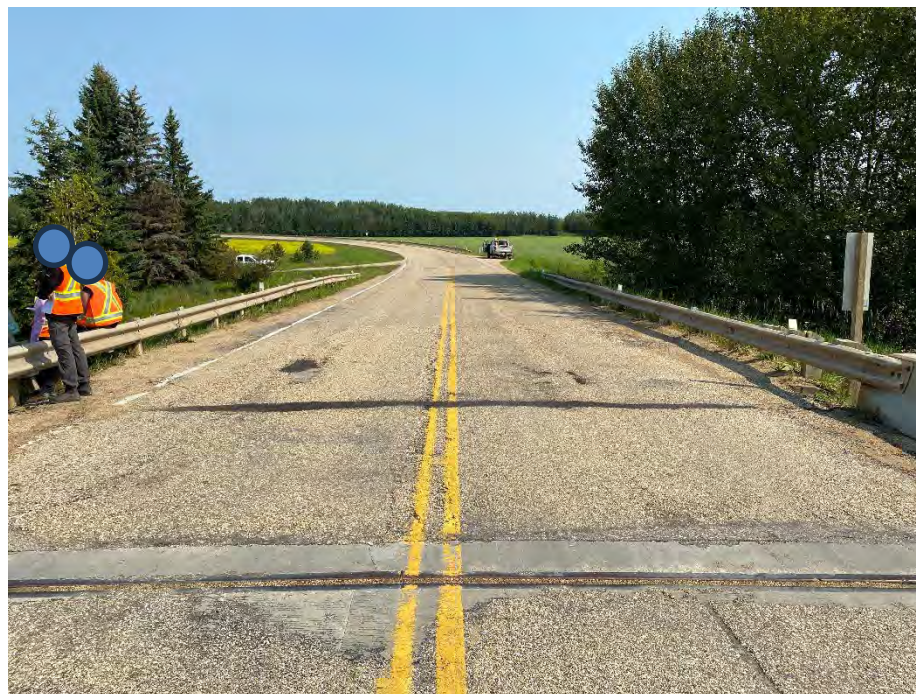
Photo 2: Highway surface at north abutment. Looking northeast.

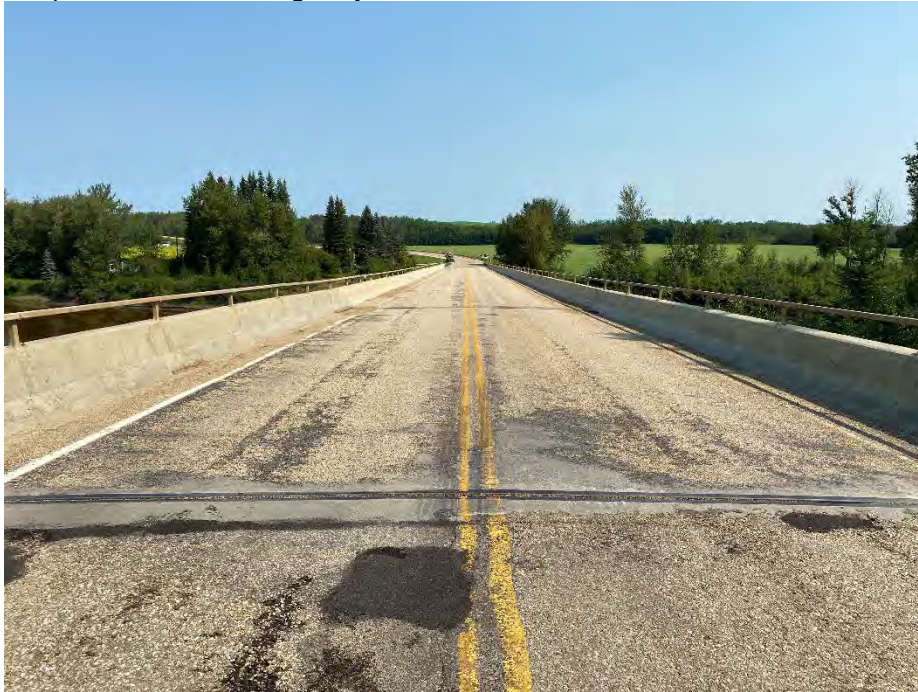
Photo 3: Highway surface at south abutment. Looking northeast.

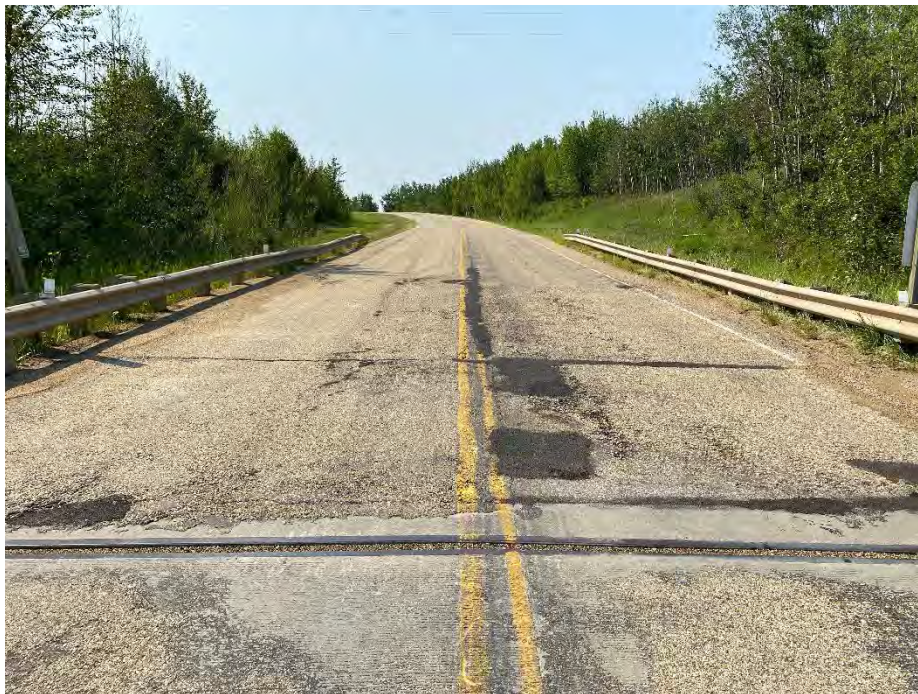
Photo 4: Highway surface at south abutment. Looking southwest.

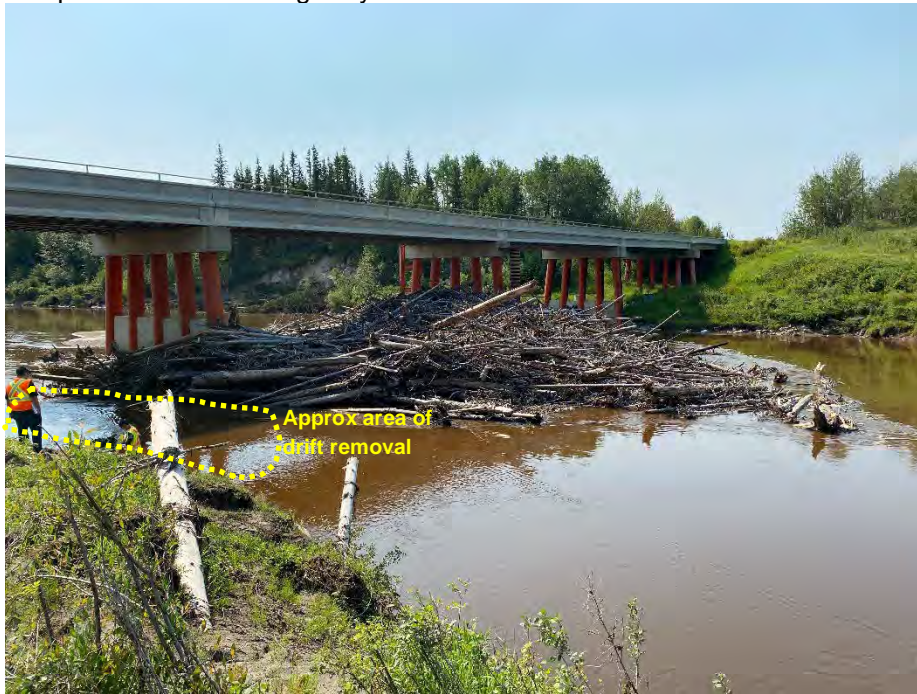
Photo 5: Drift accumulation upstream of bridge. Looking southeast.

- The accumulation of driftwood should be removed.
- A periodic subdrain cleaning program should be implemented to reduce risk of potential siltation and clogging of subdrains. The cleaning method may consist of pressure washing the insides of the subdrains and removing the dirty water and sediment from the collection points with a hydrovac. The outlet pipes to the river should be temporarily plugged until the collection points have been cleaned out to reduce migration of dirty water into the river. The outlet should also be flushed by forcing water out from the drainage galleries. The anticipated cost for subdrain cleaning is \$6,000 excluding any consulting effort.

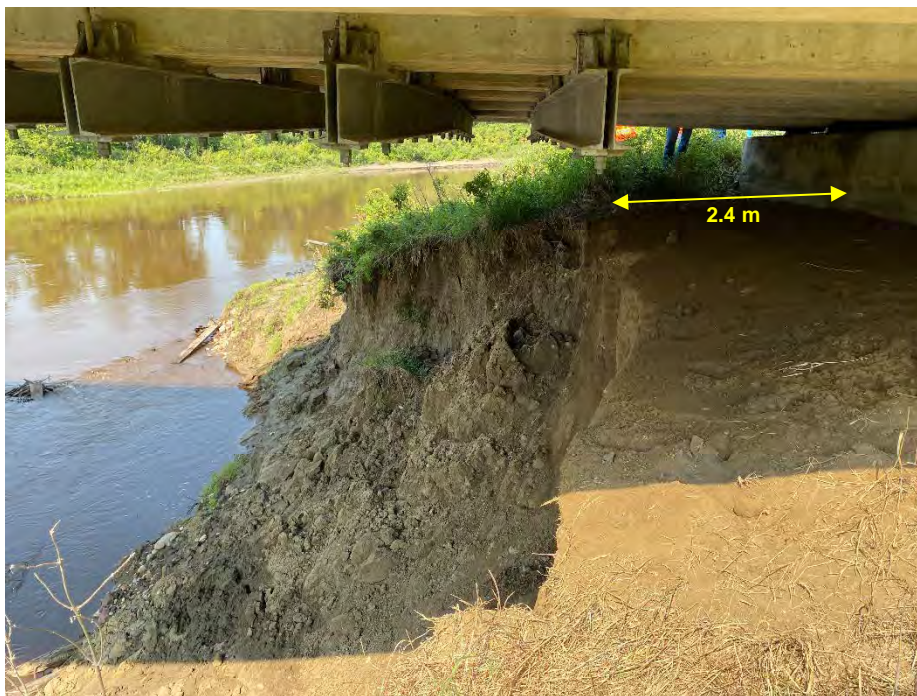
- The site is located on the meander of the Pembina River with the south abutment on the outside bank.
- Recent flooding of the Pembina River appears to have resulted in washing out of the north abutment bridge head slope.

- The current crest of the head slope is about 2.4 m away from the concrete north abutment wall (Photo 6).
- A collapsed riprap channel wrapped in geotextile was observed at the east extent of the washed out head slope (Photo 7).

Photo 6: North abutment head slope washed away. Looking northwest.

- For long-term remediation, Stantec recommends the following for high-level consideration:
 - Rebuilding the bridge head slope to its original configuration with concrete slope protection.

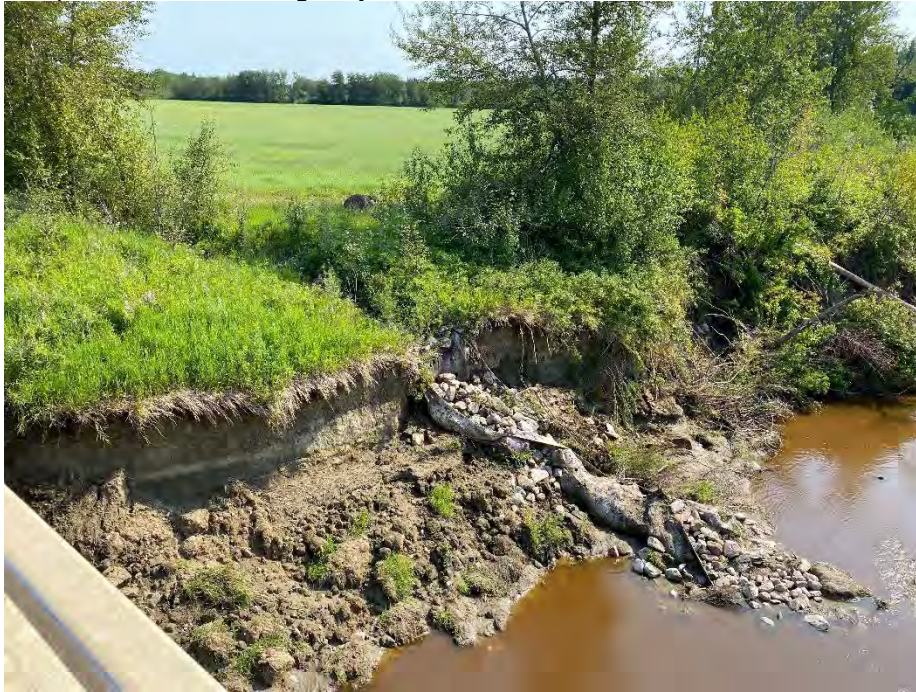
Photo 7: East extent of washout at north abutment. Note collapsed riprap channel wrapped in geotextile. Looking east.

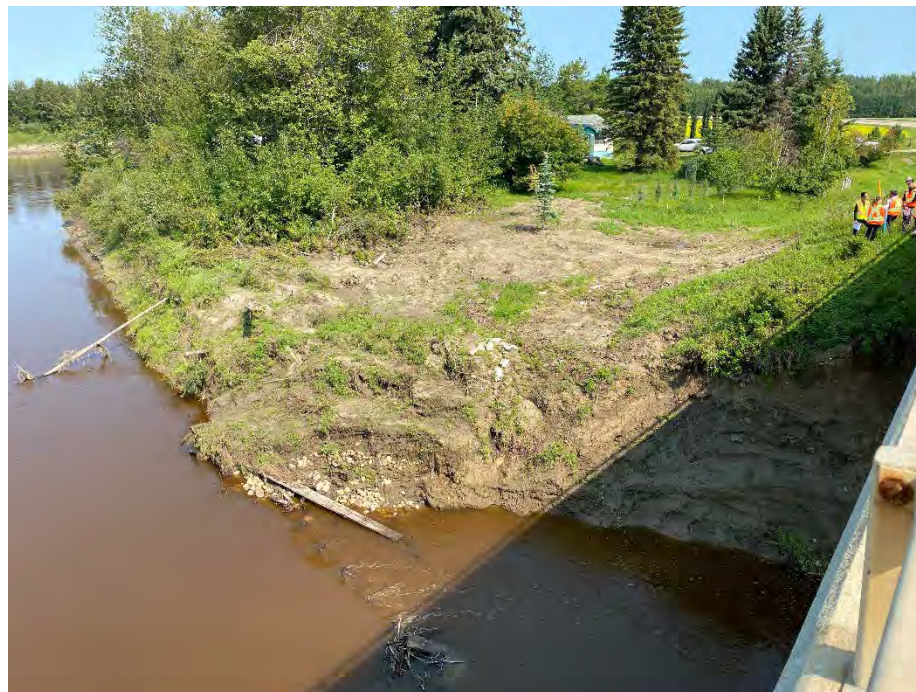
- Erosion and slumping were observed along the riverbank west of the north bridge abutment (Photo 8).
- The south abutment did not appear to be affected by recent flooding. (Photos 9 and 10). A small slump along the riverbank was observed about 15 m to 20 m west of the south abutment. It is unlikely this slump is affecting the bridge.

Photo 8: West extent of washout at north abutment. Looking north.

- The north riverbank should be regraded to remove existing erosion and slumping areas.
 - Riprap should be placed for erosion protection 20 m upstream and downstream of the north abutment up to the 1:100 year water level.

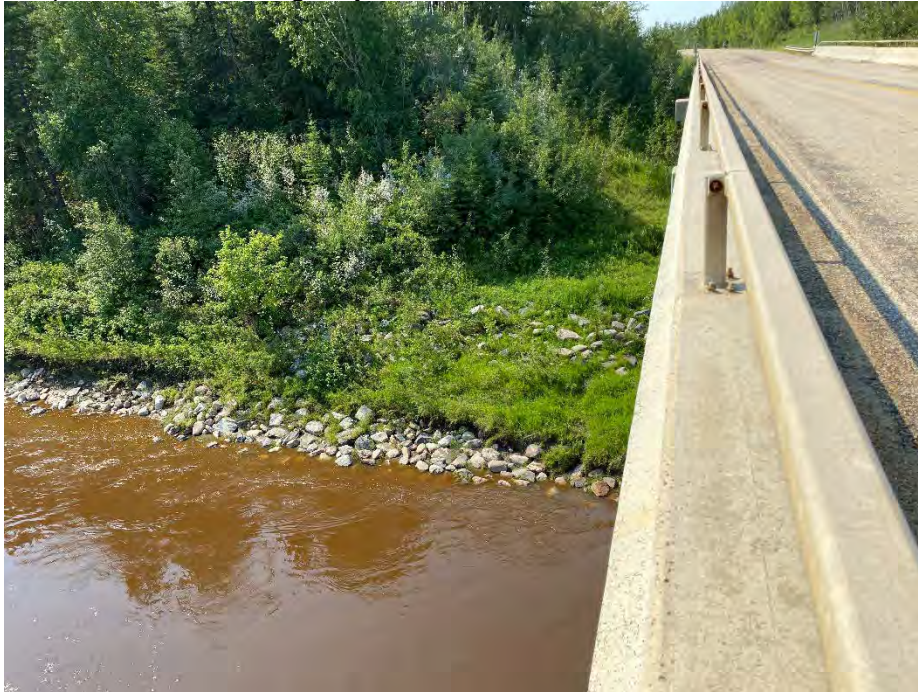
Photo 9: Downstream side of south abutment. Looking southeast.

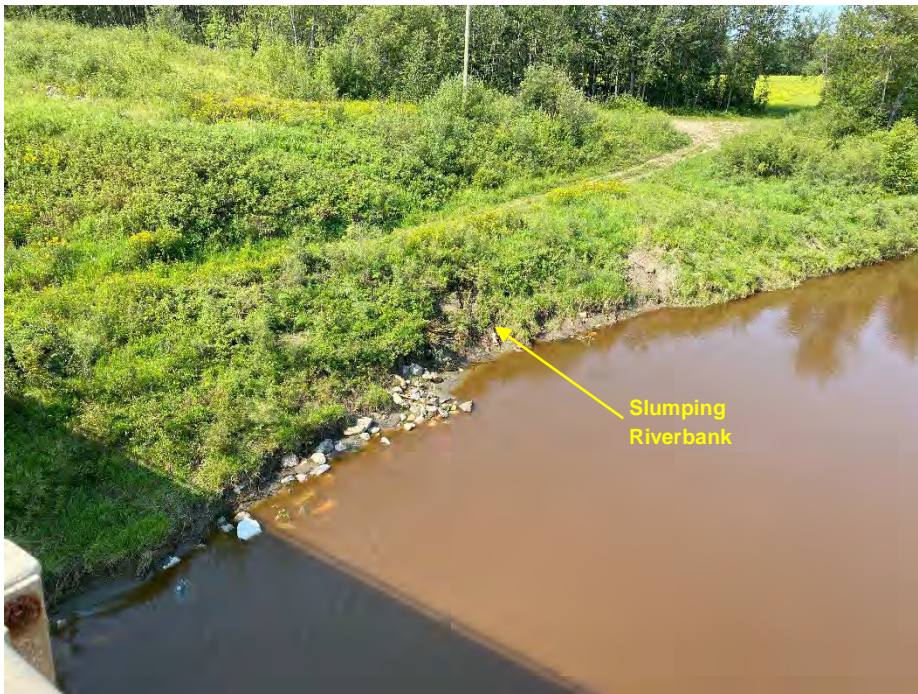
Photo 10: Upstream side of south abutment. Looking southwest.

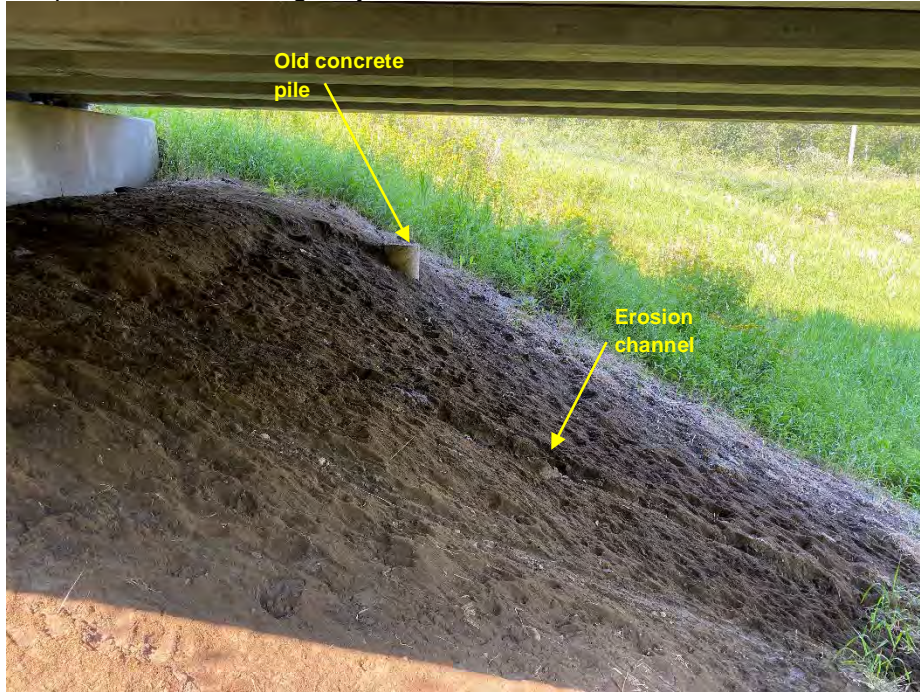
- A small erosion channel was developing along the south head slope (Photo 11). Water appears to be pooling between the head slope and drainage galleries (Photo 12).

Photo 11: South abutment head slope. Looking west.

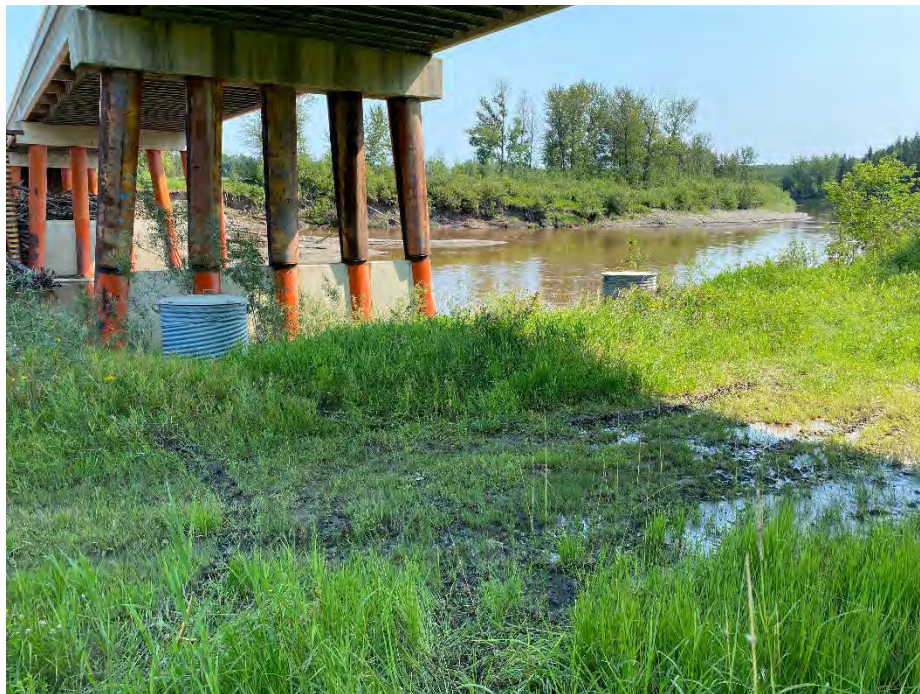
Photo 12: Saturated ground between drainage galleries and Pier 1. Looking northeast.

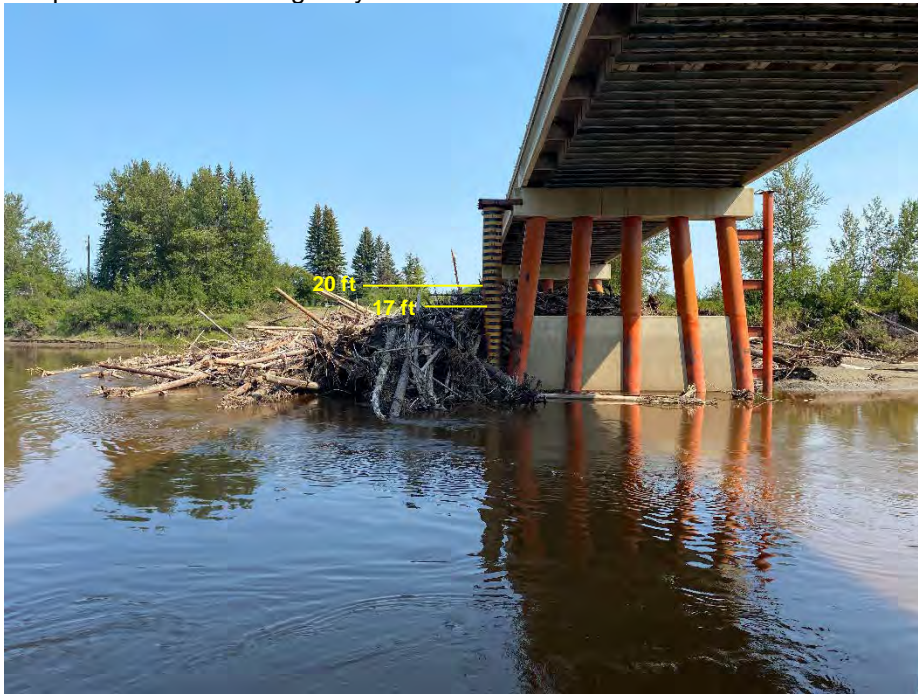
- TEC indicated on-site that the river levels were up to the 17 feet mark on the river level gauge at Pier 3 (Photo 13).
- All three drains in the west drainage gallery (collection point) were slowly trickling water. Only the east most drain was slowly draining in the east drainage gallery. Siltation within both drainage galleries was apparent.

Photo 13: Drift accumulation upstream of bridge up to about 20 ft mark. River level up to 17 ft mark during flooding. Looking northeast.
