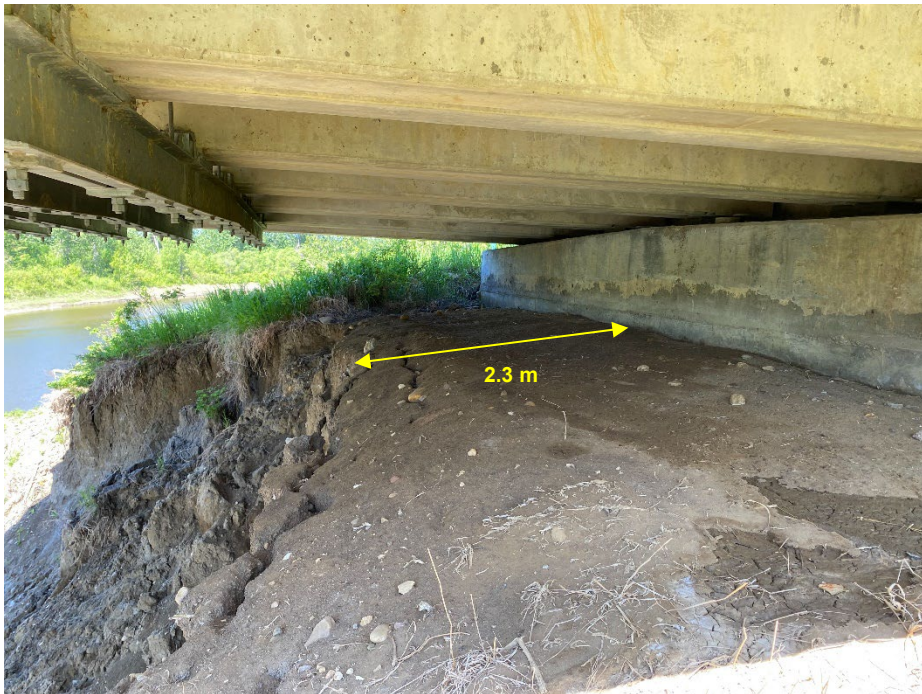
Photo 6: North abutment head slope washed away with further tension cracks. Looking northwest.

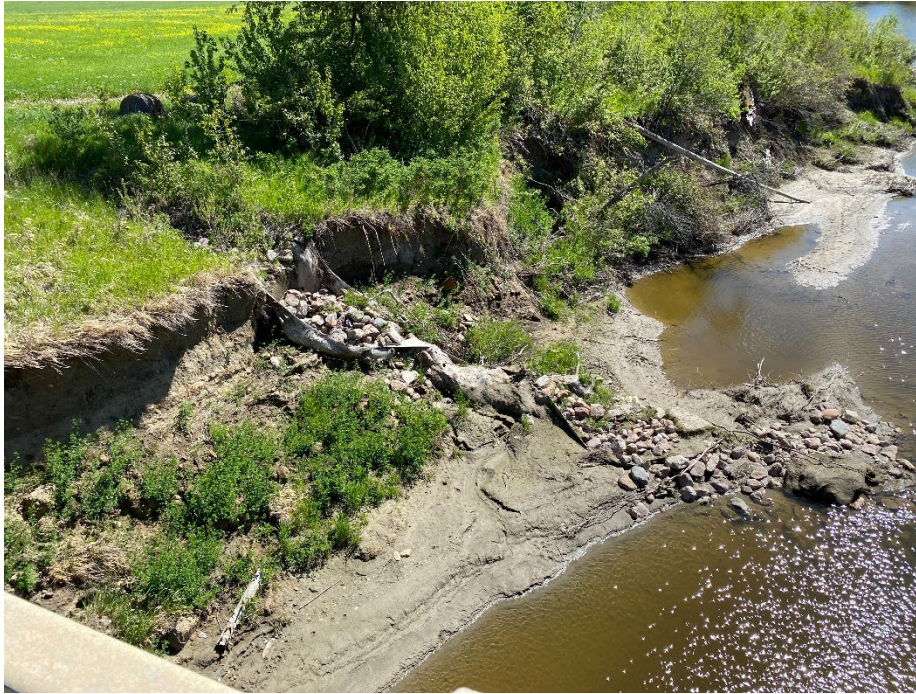
Photo 7: East extent of washout at north abutment. Note collapsed riprap channel wrapped in geotextile. Looking east.
