## GEOHAZARD RISK MANAGEMENT PROGRAM

### North Central Region – Edson / Stony Plain Area

#### 2019 Inspection Report

Site Number	Site Name	Hwy	km
NC82	Morinville Slide	642	10.2
Legal Land Description	SW 4-56-25-W4M and NW 33-55-25-W4M		
NAD 83 Coordinates	3TM 114	5963560 N	22353 E
Operational Site Instrumentation	Slope Inclinometers	0	
	Pneumatic Piezometers	0	
	Vibrating Wire Piezometers	0	
	Standpipe Piezometers	0	
Date of Last Instrumentation Readings	n/a

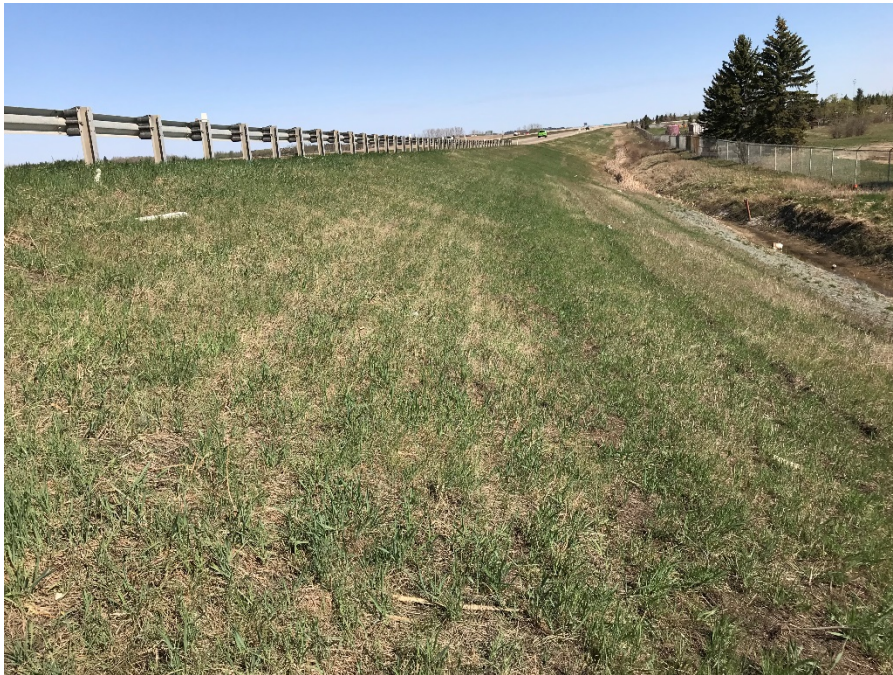
<b>Discussion</b>	<p>Both the north and south slumps were repaired in Winter 2017. No signs of slope movement were observed during this site visit as shown in Photos 1 and 2.</p> <p>Signs of minor slumping was observed in between the two previous slide areas as shown in Photo 3. The slump is located at the location of one of the test pits completed in February 2017.</p> <p>A new ground crack appears to be developing at the southern limits of the south slump as shown in Photo 4.</p> <p>Ditch drainage appeared to have improved with less water observed as shown in Photos 5 and 6.</p> <p>The highway surface appeared similar to the previous inspection. Photos 7 and 8 show the highway at the two slide repair locations.</p>
<b>Assessment</b>	<p>Slide remediation was completed in Winter 2017/Spring 2018 and appeared to have stabilized the slide at the repair locations. However, the new ground crack at the south slide suggests that additional slope movement is beginning to develop at the south limits of the old south slide. This is considered typical of embankment failures where once the initial slide mass is repaired, the slide mass begins to propagate beyond the initial repair limits. In periods of heavy precipitation, slope movement will likely increase.</p> <p>The ditch cleaning performed as part of slide remediation appears to have improved drainage.</p>

**Photo 1:** Repaired north slide. Looking north.

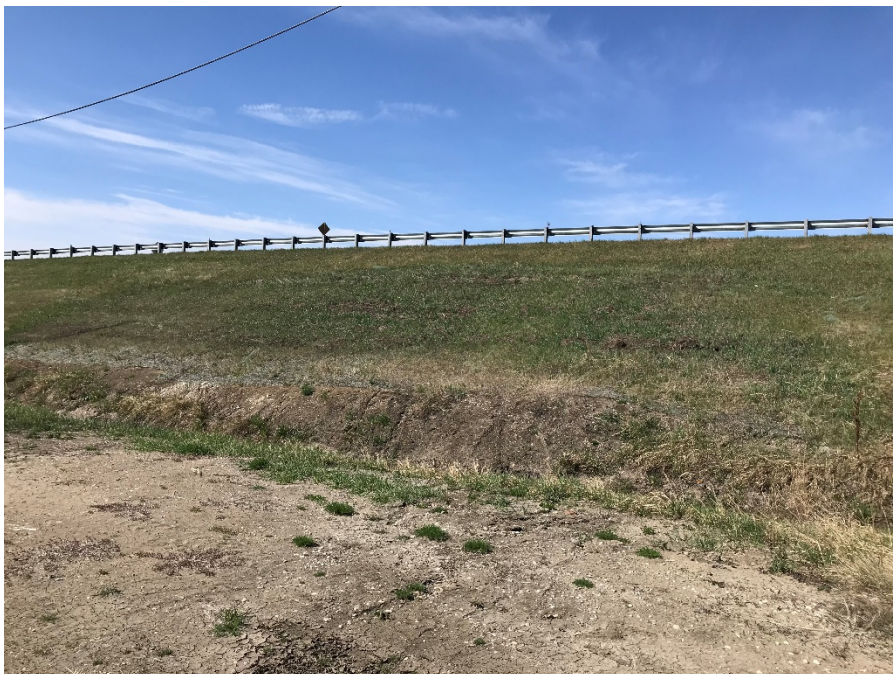
**Photo 2:** Repaired south slump. Looking west.

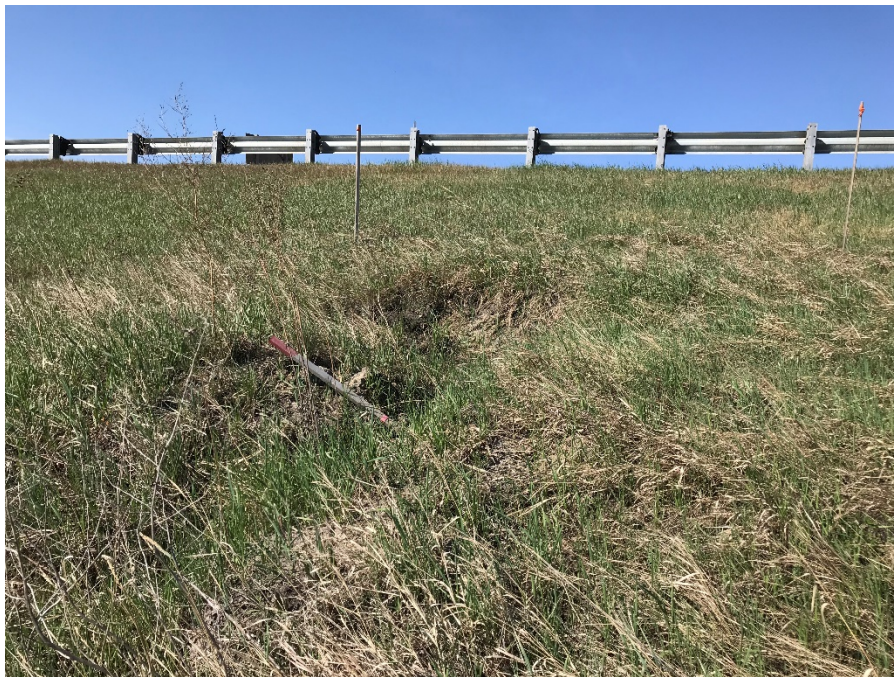
**Photo 3:** Slumping at previous test pit location. Looking west.

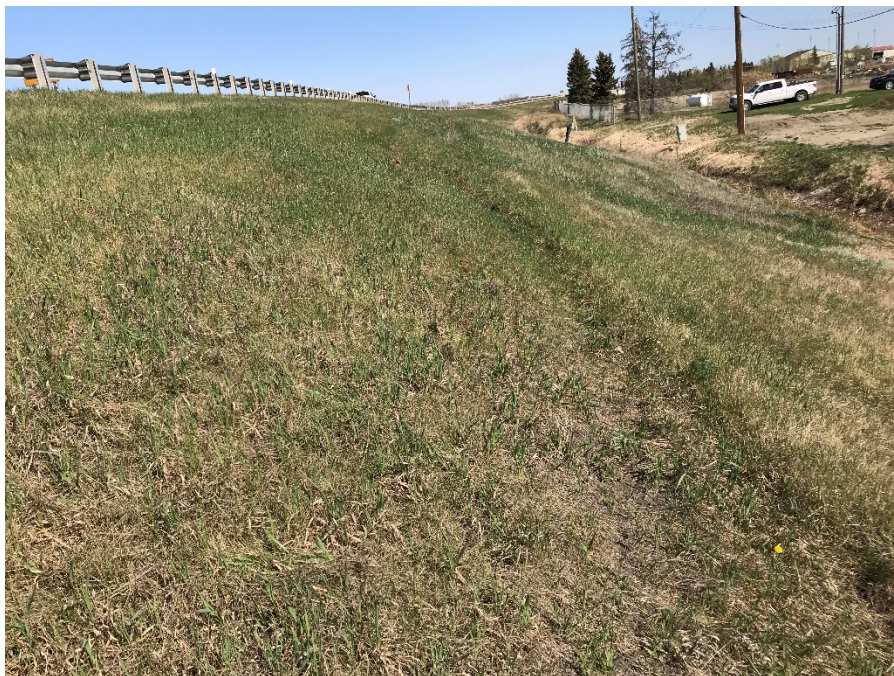
**Photo 4:** New ground crack at southern limits of south slump repair. Looking north.

<b>Recommendations</b>	<p>Short term recommendations should consist of sealing any pavement cracks to reduce surface water infiltration into the slope and pavement structure.</p> <p>The Maintenance Contract Inspector should continue to monitor the new ground cracks for retrogression towards Highway 2.</p> <p>Ditch cleaning beyond the current site may be considered to further improve ditch drainage.</p> <p>Site inspections may be reduced to bi-annual frequency.</p>
------------------------	---

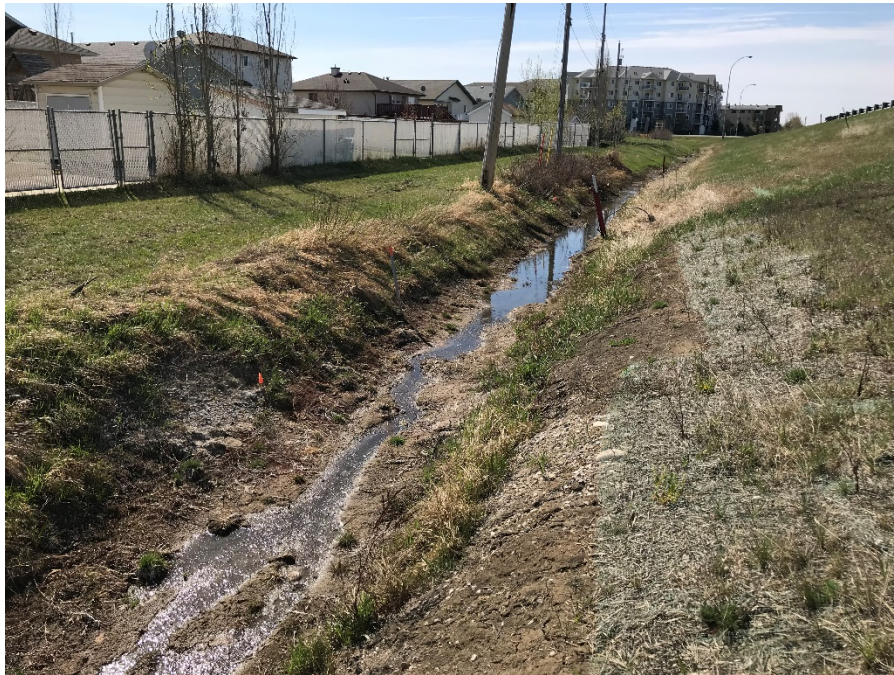
**Photo 5:** Cleaned and de-vegetated ditch. Looking south.

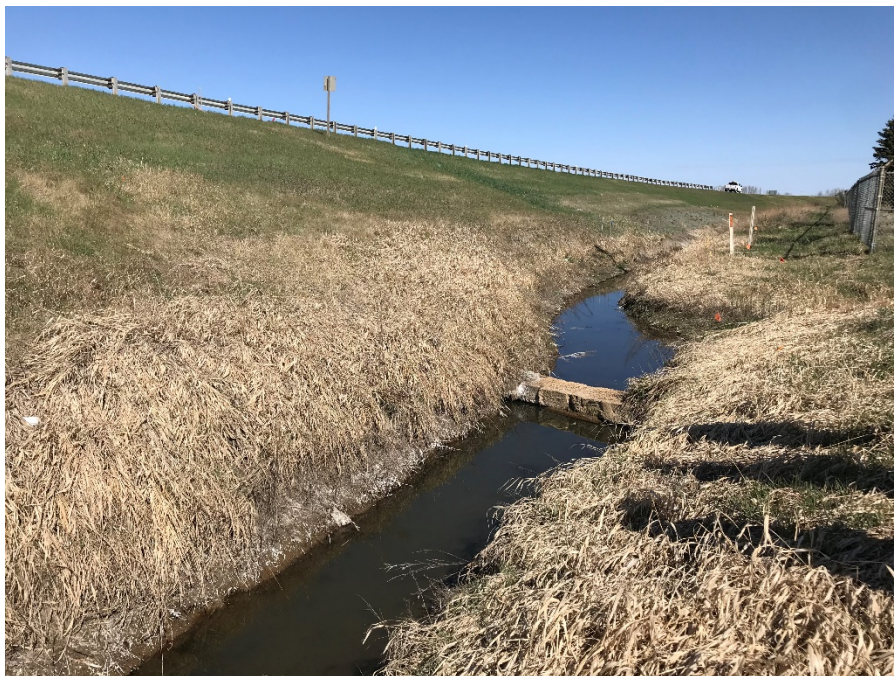
**Photo 6:** Cleaned and de-vegetated ditch. Looking north.

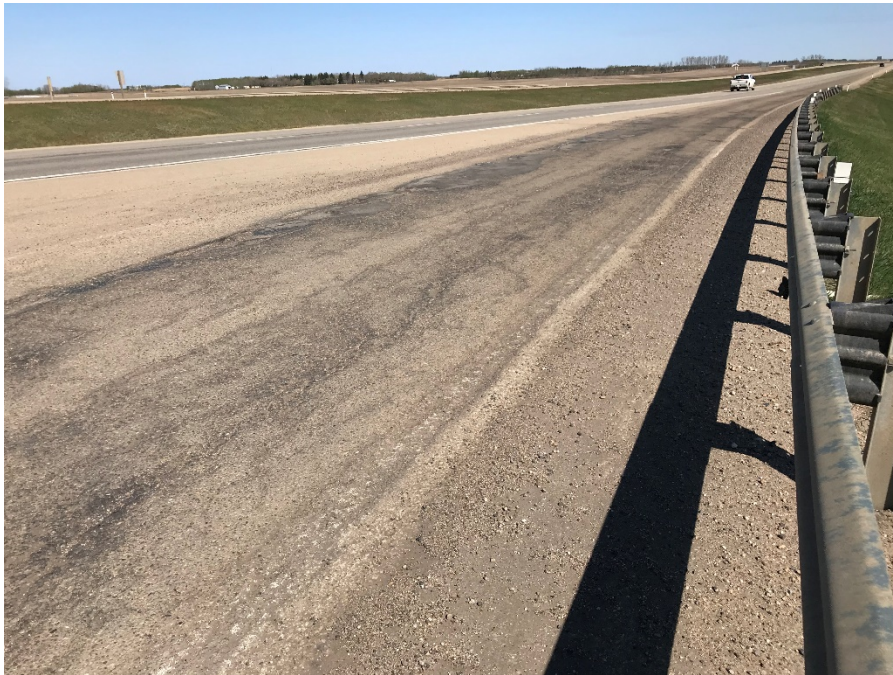
**Photo 7:** Highway 2 surface at north slide. Looking north.

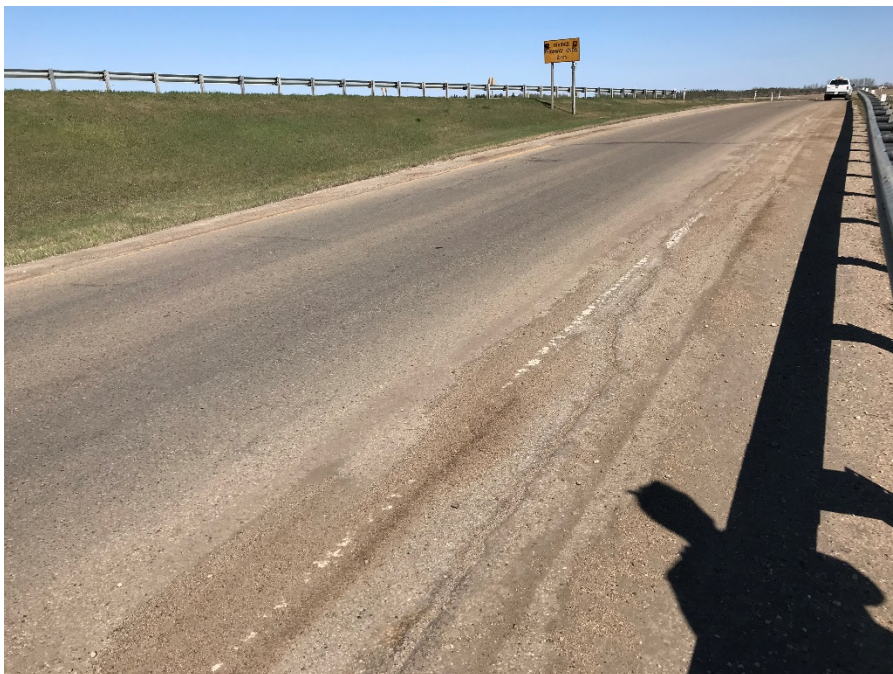
**Photo 8:** Highway 2 surface at south slide. Looking north.
