SITE NUMBER AND NAME: NC082 – Morinville Slide	HIGHWAY AND KM: 02:36 R1 km 10.187	PREVIOUS INSPECTION: May 13, 2019	CURRENT INSPECTION: June 14, 2022
LEGAL DESCRIPTION: SW 4-56-25-W4M	NAD83 COORDINATES: UTM12U 5964988N, 324786E		RISK ASSESSMENT: PF: 5 CF: 3 Total: 15
AVERAGE ANNUAL DAILY TRAFFIC (AADT): 490 (2021, Traffic from East, Turning Right)		CONTRACTOR MAINTENANCE AREA (CMA): 510

2022 Site Inspection Photos at NC082

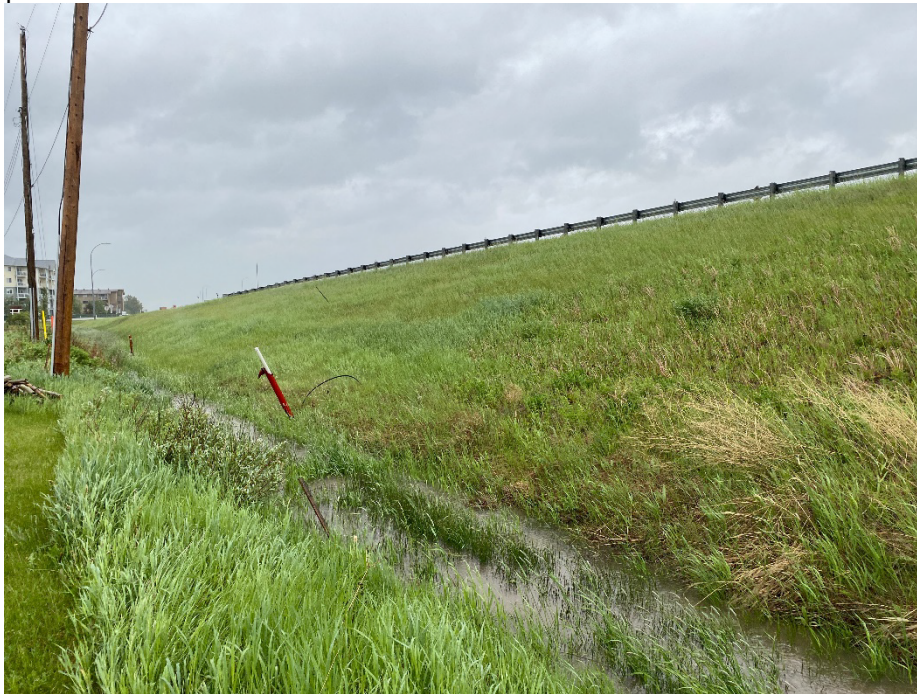
Photo 1: Repaired south slide, looking southwest.

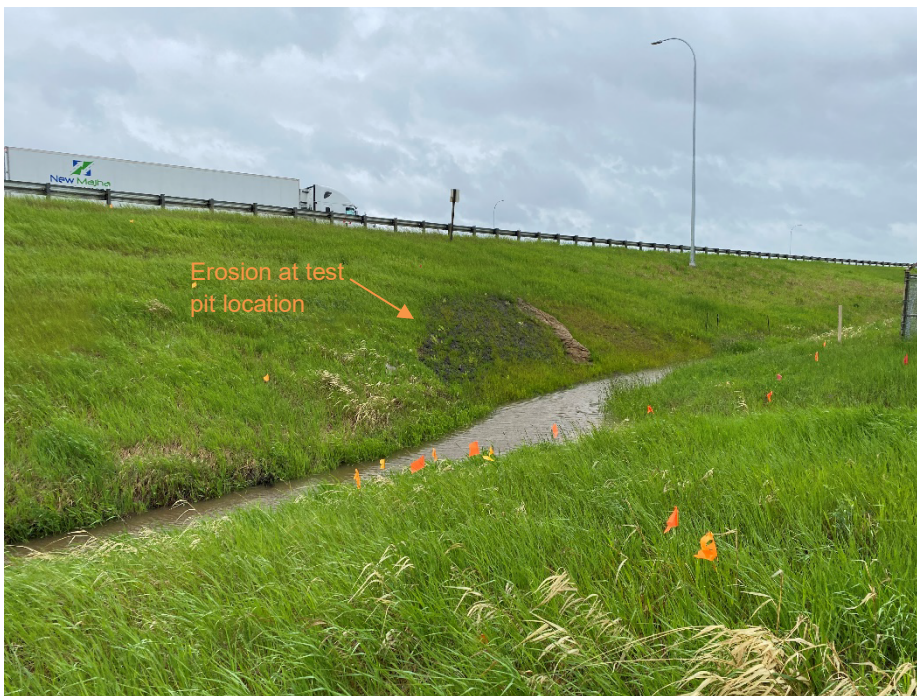
COMMENTS
<ul style="list-style-type: none"> North and south slumps were repaired in Winter 2017/Spring 2018. No signs of slope movement were observed during this site visit. Minor slumping and erosion noted at TP17-02. Erosion control matting on north side of erosion was bunched up. Previously, a new ground crack appeared to be developing at the southern limits of the south slump. The crack was not observed during the current inspection due to thick vegetative cover along the embankment. The embankment was bare of vegetation near the crest of the south slide at localized areas, possibly due to road sand. The on-ramp appeared to be recently patched. The patch date is unknown to Stantec. Transverse pavement cracking noted along on-ramp above the embankment. Longitudinal cracking along the shoulder was observed about 40 m south of the south slide. Ditch flow appeared slow. Water was approximately 450 mm deep.

Photo 2: Repaired test pit area, looking northwest.

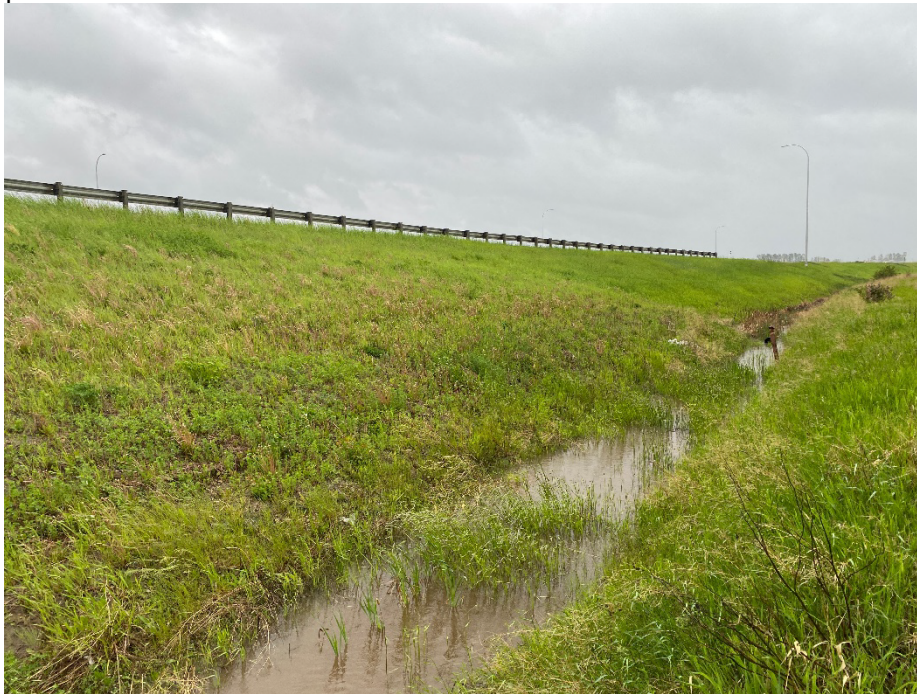
Photo 2: Repaired north slide, looking northwest.

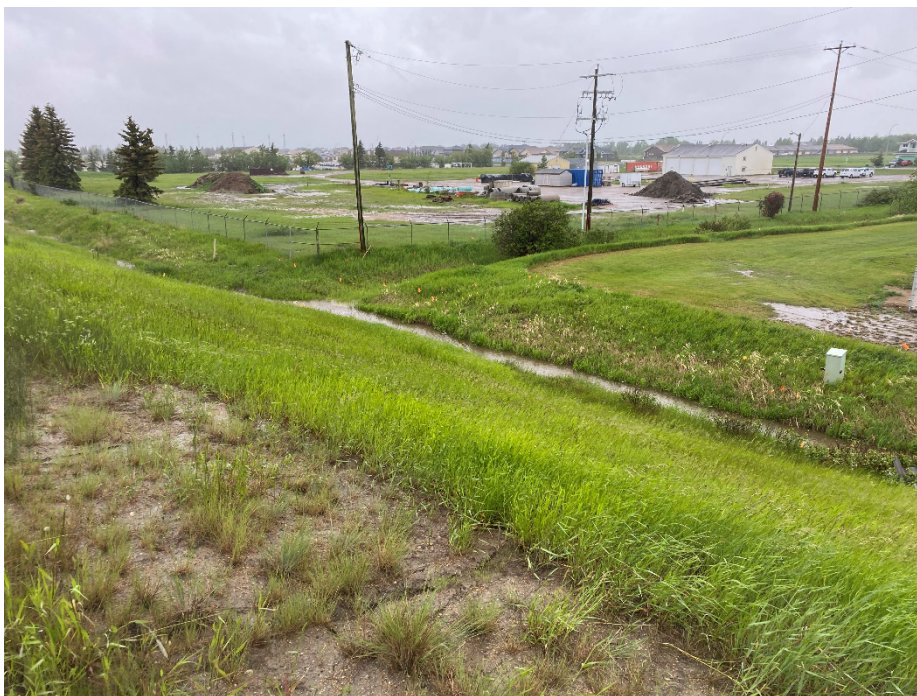
Photo 4: Road sand leading appears to be reducing vegetation at crest of embankment at south slide Facing northeast.

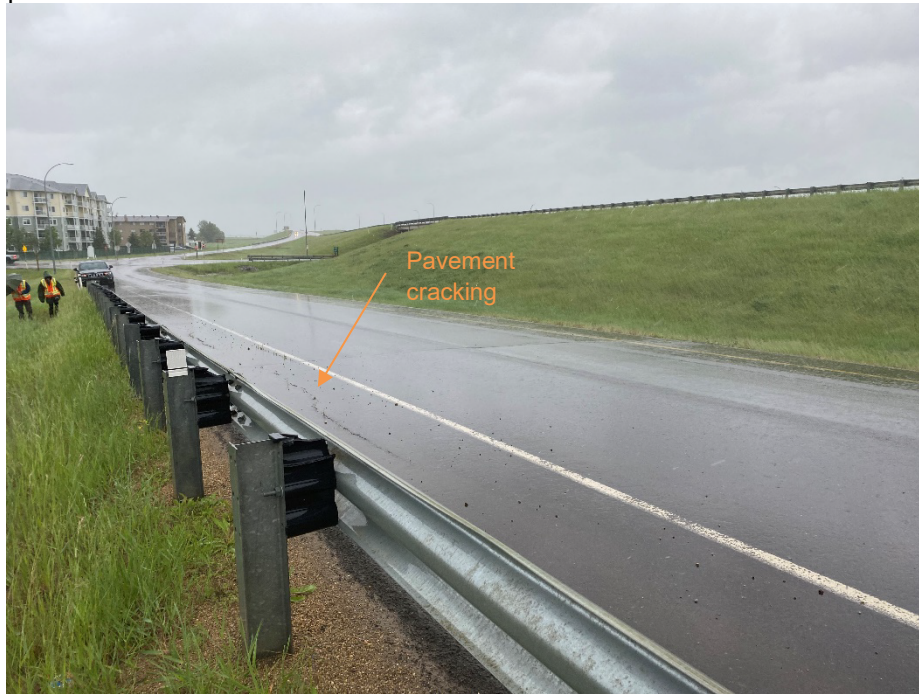
Photo 5: On-ramp to Highway 2 north bound. Cracking approx. 40 m south of south slide. Looking south.

RECOMMENDATIONS
<ul style="list-style-type: none"> Pavement cracks should be sealed to reduce surface water infiltration into the embankment. The Maintenance Contract Inspector should continue to monitor the new ground cracks for retrogression toward Highway 2.

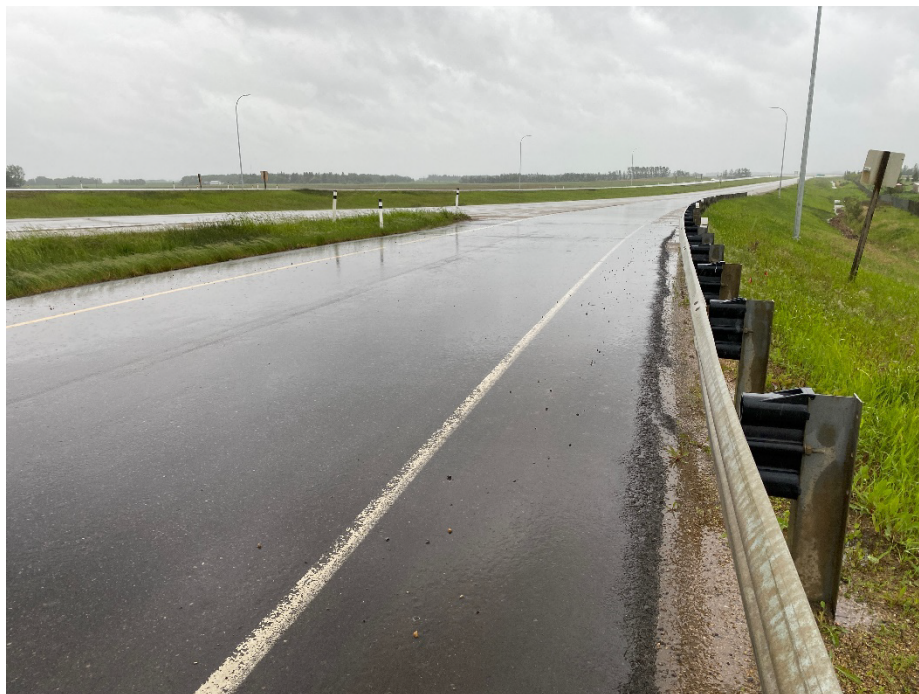
Photo 6: On-ramp to Highway 2 north bound. Looking northwest.
