**STONY PLAIN REGION
GEOHAZARD RISK ASSESSMENT
SITE INSPECTION FORM**

SITE NUMBER AND NAME: NC 2 - Pavement Cracking	HIGHWAY AND KM: Hwy 22:30, km 3.64	PREVIOUS INSPECTION DATE: June 2, 2009	INSPECTION DATE: May 20, 2010
LEGAL DESCRIPTION: SE 11-49-7-W5M	NAD 83 COORDINATES: -60737 E, 5897694 N	RISK ASSESSMENT: PF: 10 CF: 4 TOTAL: 40

North Central (Stony Plain)
Geohazard Risk Management Plan
NC-2 Wiley West Park

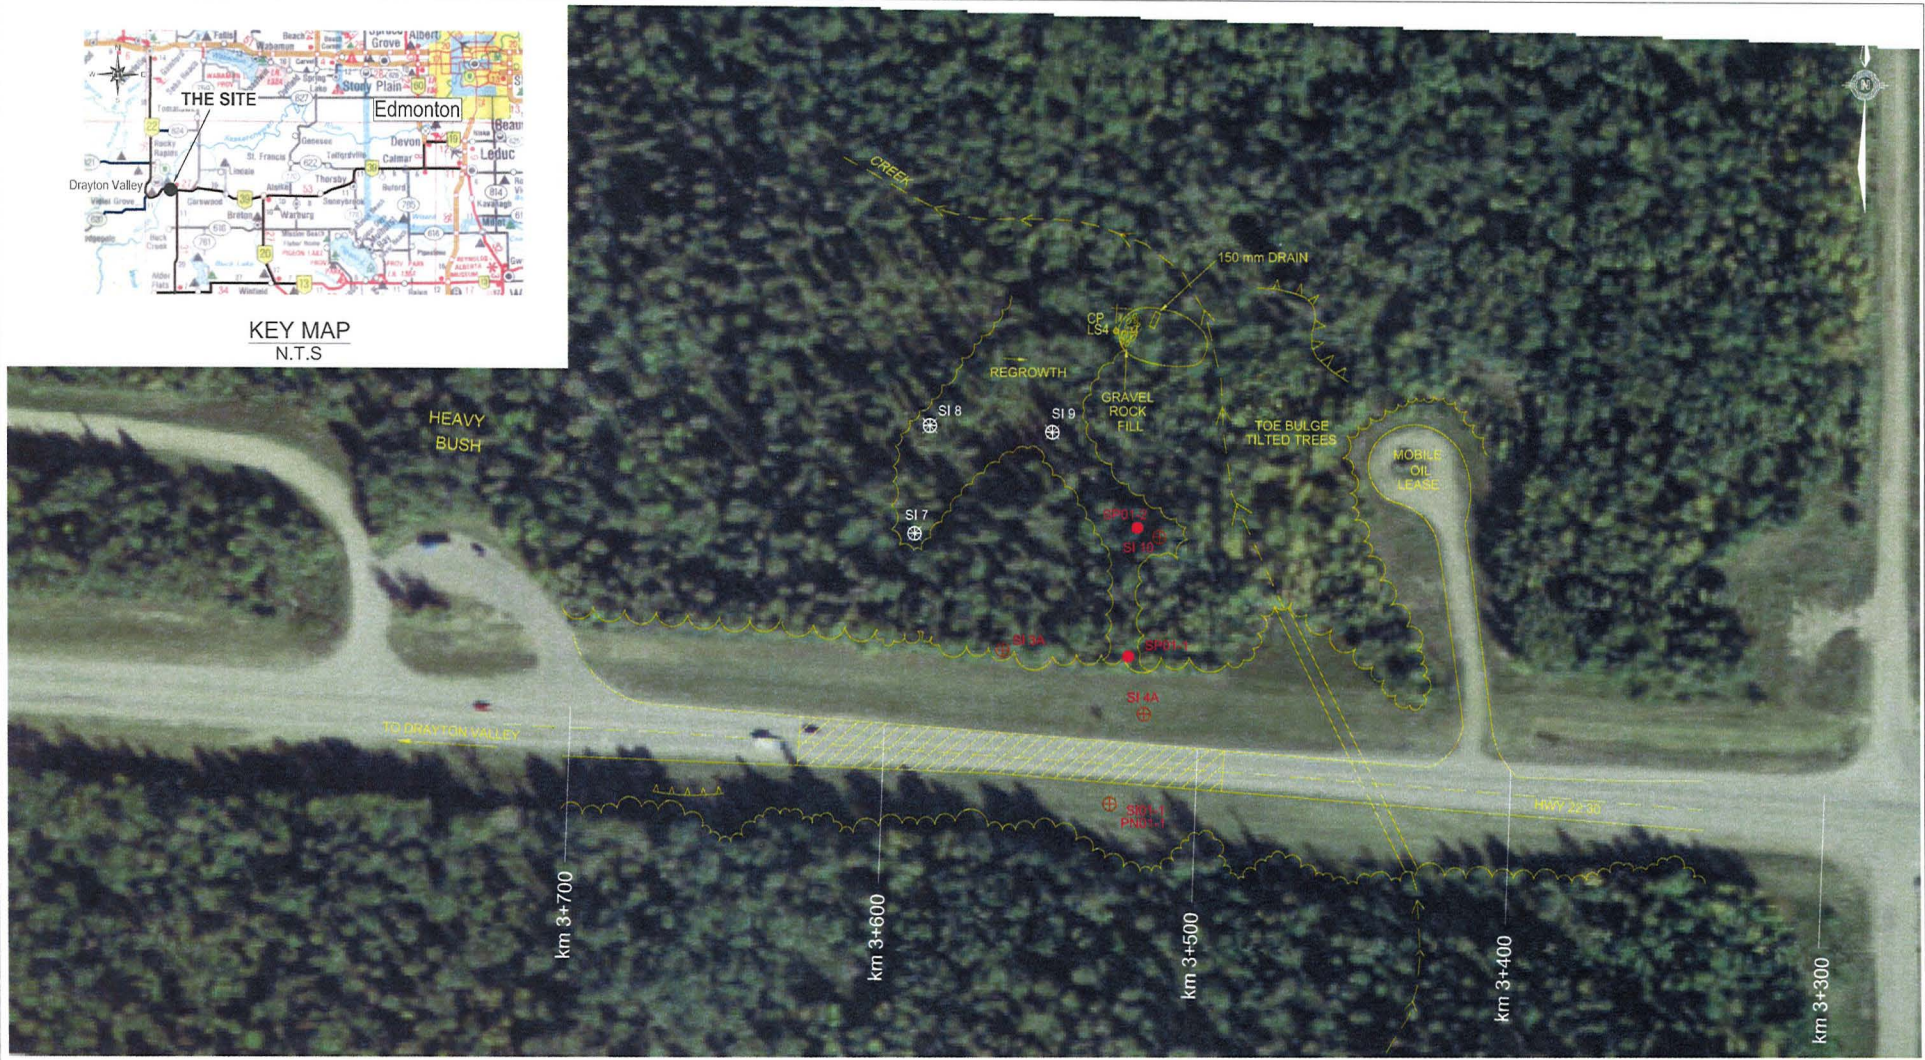
Figure NC2-1

COMMENTS:
 Location and site plan shown on Figure NC2-1.
 Site conditions shown in Photo 1.
 Risk level unchanged from 2009.

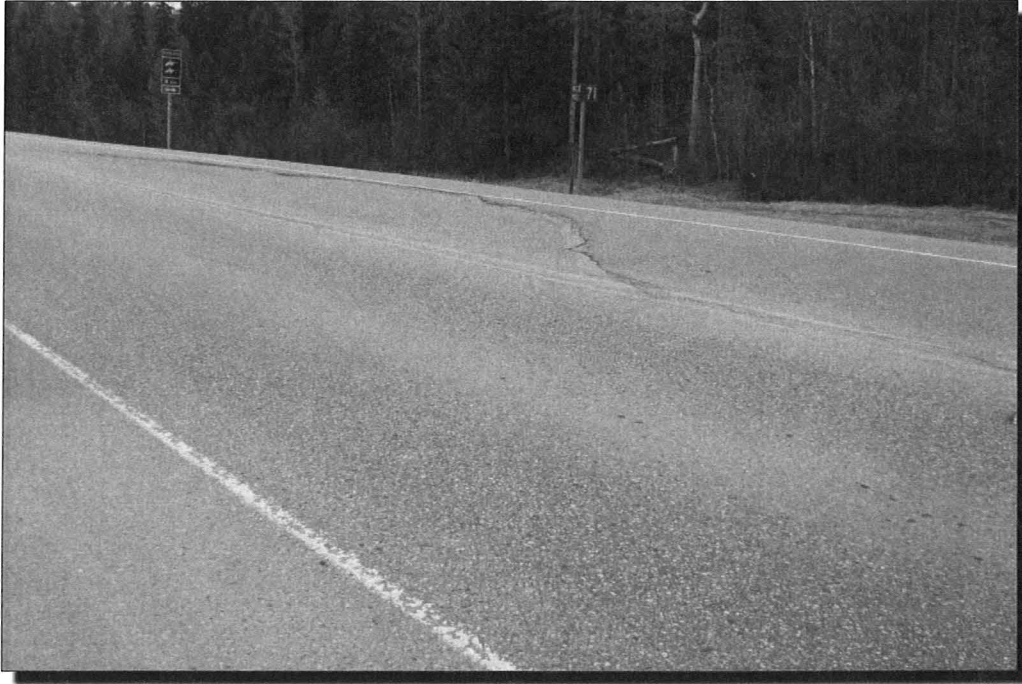
- Magnitude of crack in pavement has increased from last year. Dip in pavement has developed and is suspected to be in relation to embankment movement. Continued movement could greater deflection in the pavement surface.
- Sealant appears to have failed which may contribute to cracking of the pavement.
- Instrumentation observed near the creek, north of Hwy 22. Suspected to have been installed as part of proposed highway realignment.
- Recent tree clearing for access road in area, possible conducted as part of geotechnical assessment for proposed highway realignment.

Photo 1
Crack and dip in pavement on eastbound lane

- Pavement cracks which formed in 2004 should be sealed regularly to minimize infiltration.
- The deflection in the pavement that has developed should be monitored and may require patching if dip increases in size.

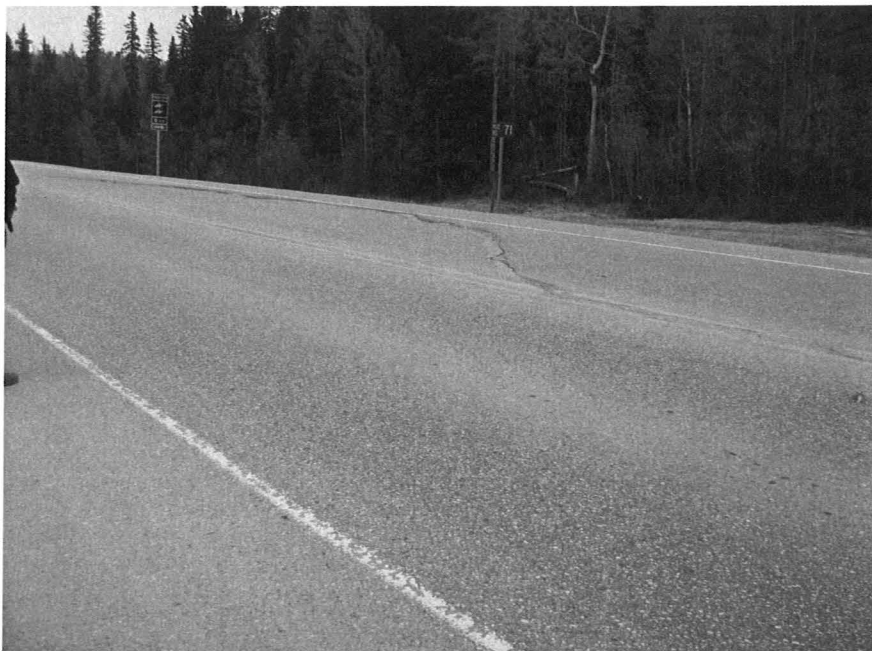
Evidence of cracking through 2004 overlay along eastbound lane

1. Locate and expose all horizontal drains near the creek with a small tracked excavator and place coarse drainage rock over the outlets. This will ensure that the drain outlets are not clogged or impeded by soil or organic debris. A proposal to conduct this work has been submitted.
2. Pavement cracks which formed in 2004 should be sealed regularly to minimize infiltration.

3. Patch the dip that has occurred due to slope movement.
4. Inspect for beaver activity.
