**STONY PLAIN REGION
GEOHAZARD RISK ASSESSMENT
SITE INSPECTION FORM**

SITE NUMBER AND NAME: NC 2 - Pavement Cracking	HIGHWAY AND KM: Hwy 22:30, km 3.64	PREVIOUS INSPECTION DATE: May 20, 2010	INSPECTION DATE: June 14, 2011
LEGAL DESCRIPTION: SE 11-49-7-W5M	NAD 83 COORDINATES: -60737 E, 5897694 N	RISK ASSESSMENT: PF: 10 CF: 4 TOTAL: 40

LAST READING DATE: May 17, 2011
PRIMARY SITE ISSUE: Landslide dating back to 1960's.
APPROXIMATE DIMENSIONS: 200 m long
DATE OF REMEDIAL ACTION: Pavement overlay in 2004.

North Central (Stony Plain)
Geohazard Risk Management Plan
NC-2 Wiley West Park

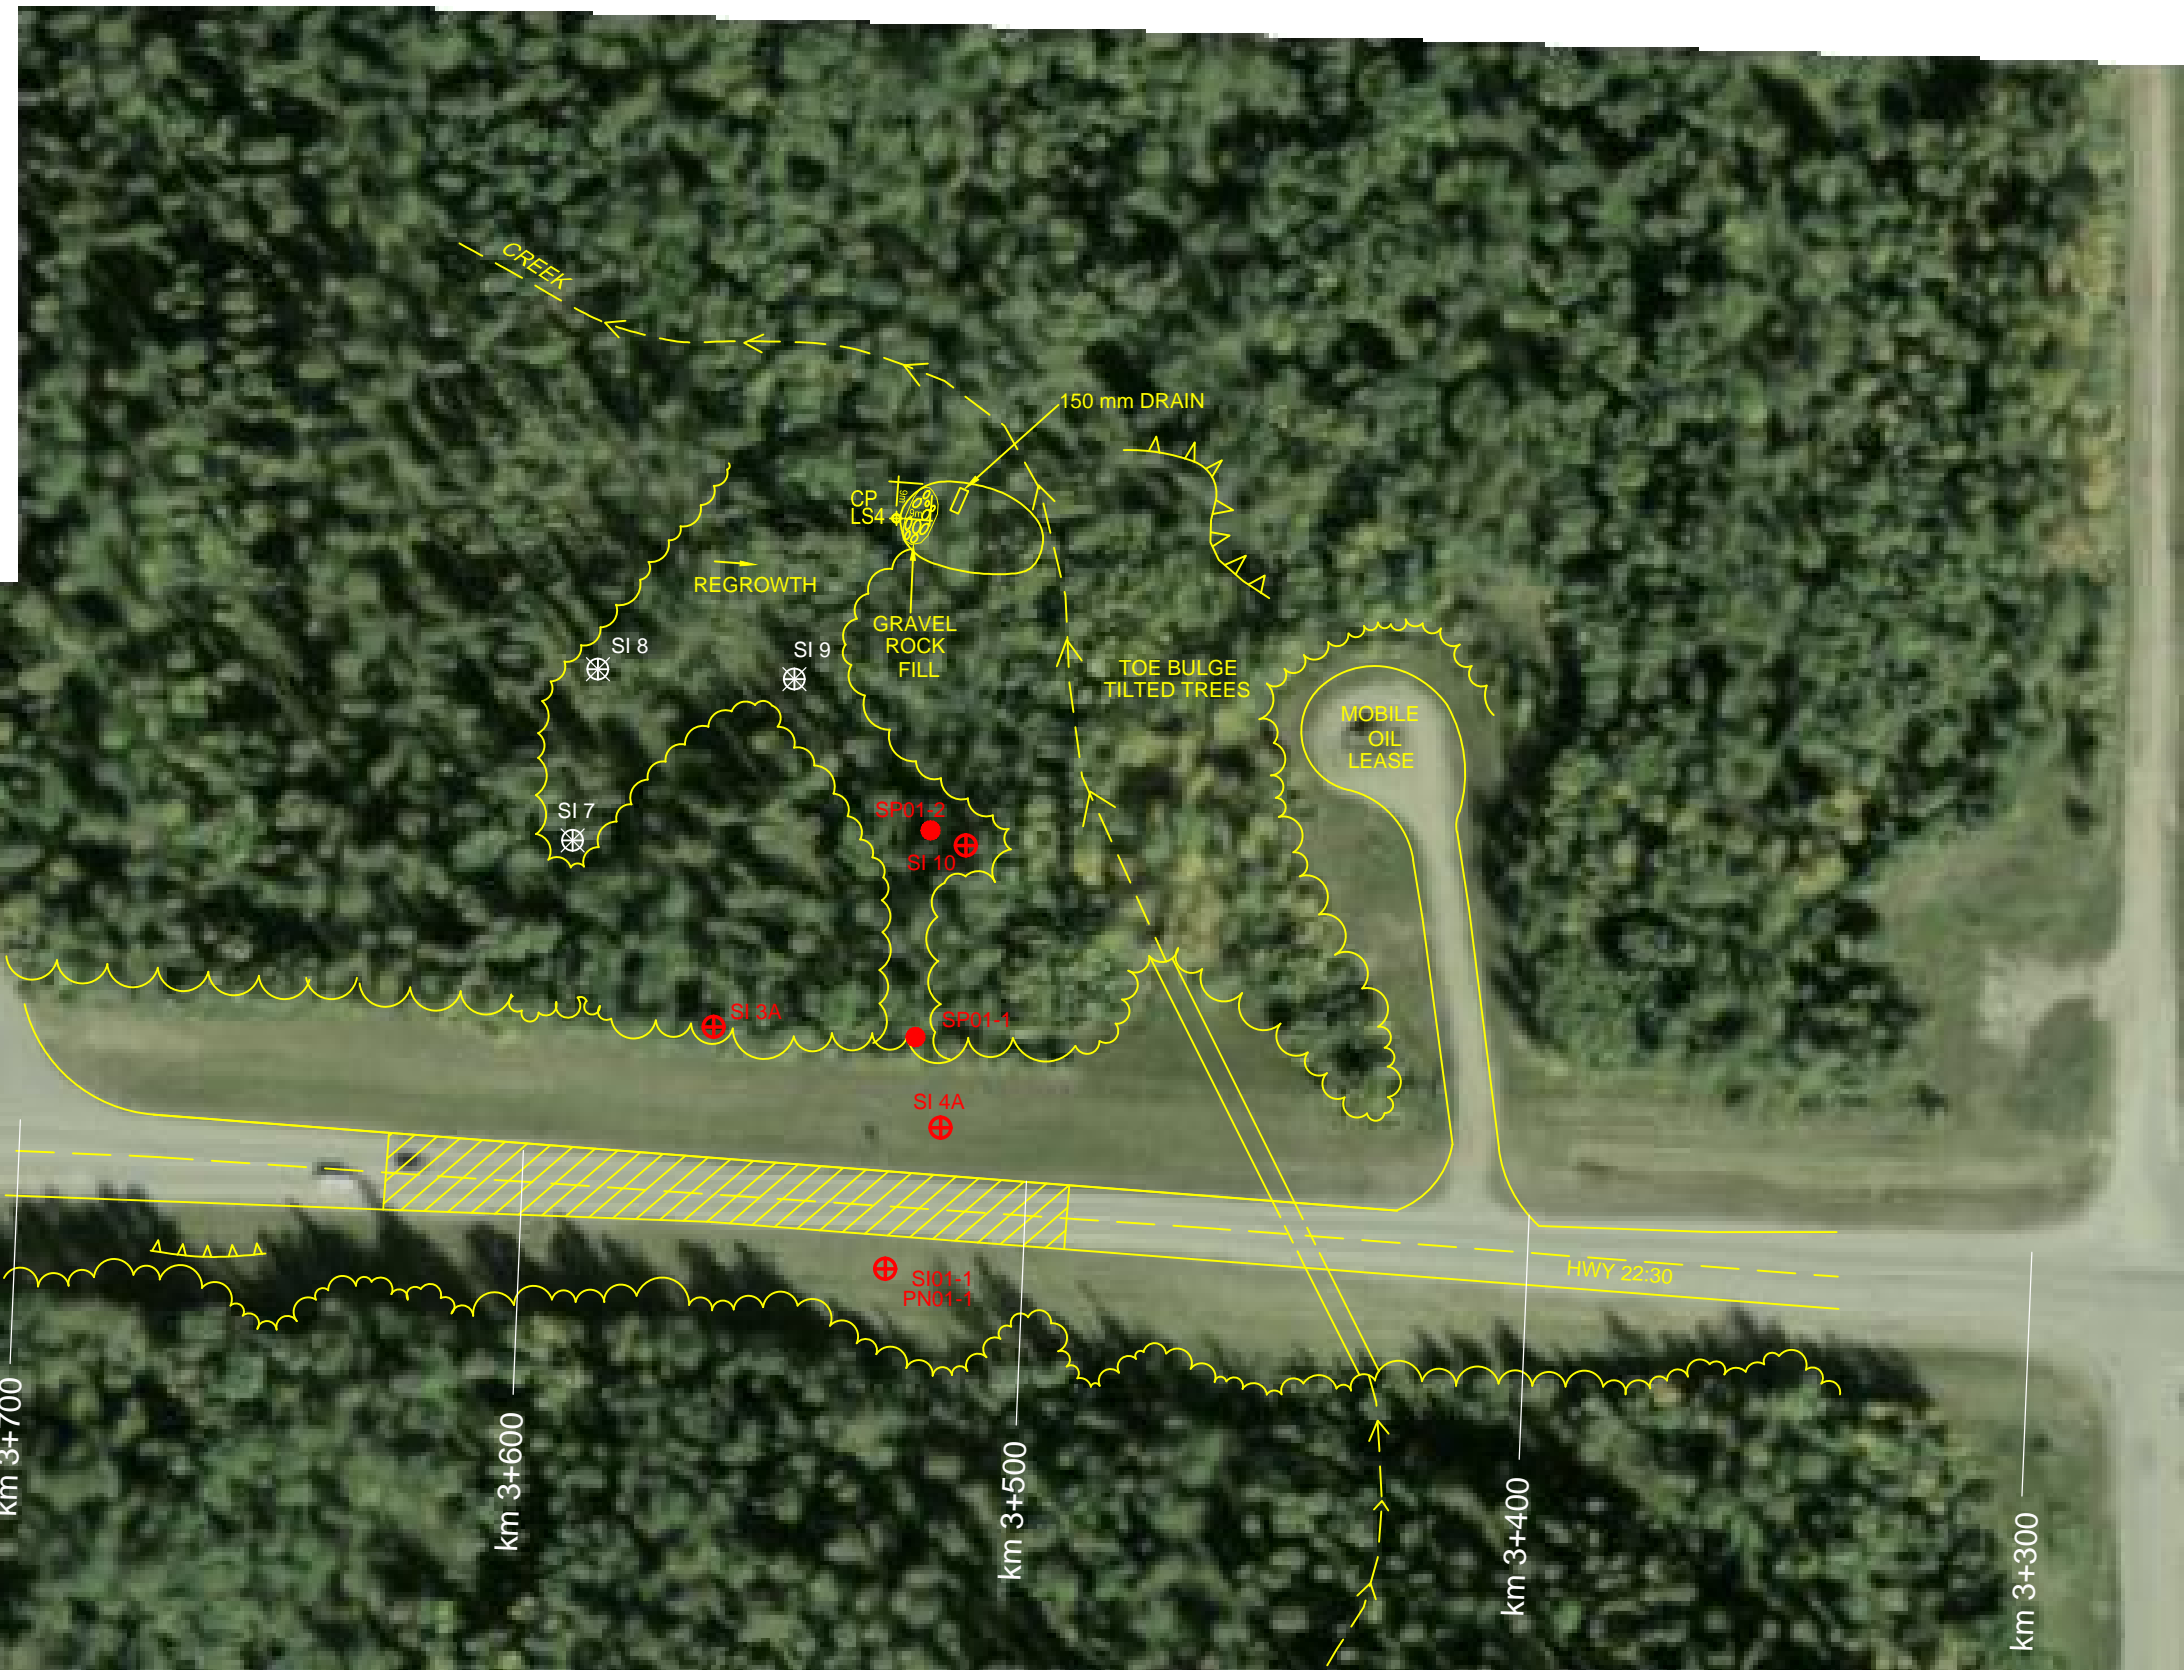
Figure NC2-1

COMMENTS: Location and site plan shown on Figure NC2-1. Site conditions shown in Photo 1. Risk level unchanged from 2010. Site recently cleared in preparation of twinning. Condition of highway unchanged from 2010 inspection.
--

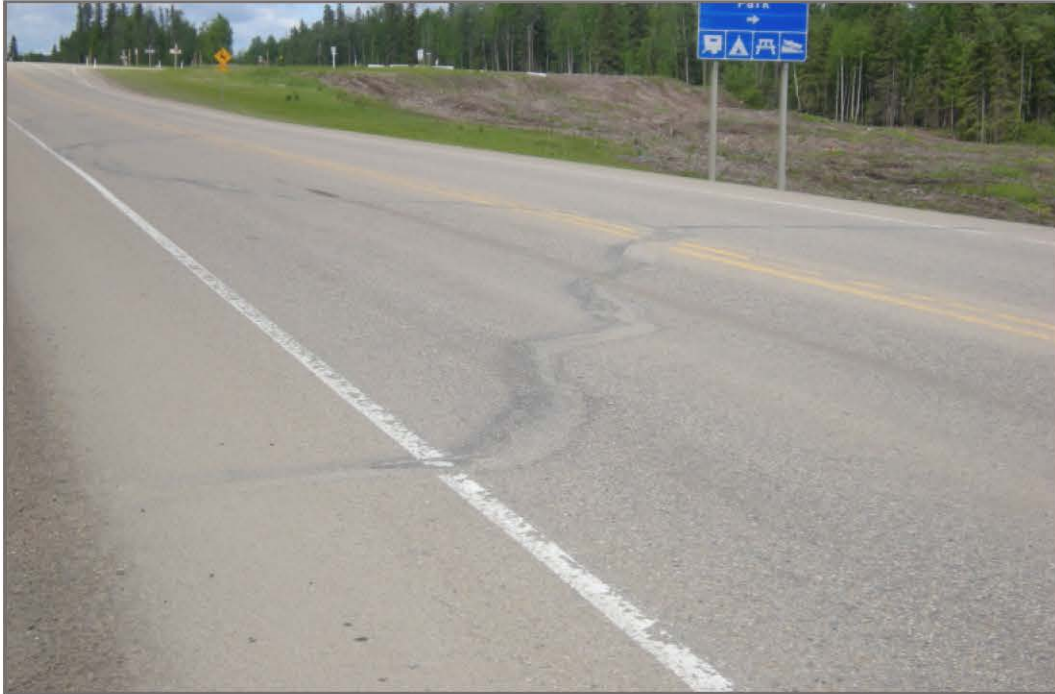
- Magnitude of crack in pavement has increased slightly from last year. Dip in pavement has developed and is suspected to be in relation to embankment movement. Continued movement could increase deflection in the pavement surface.
- Sealant appears to have failed which may contribute to cracking of the pavement.
- Instrumentation observed near the creek, north of Hwy 22. Suspected to have been installed as part of proposed highway realignment.
- Recent tree clearing for highway twinning may be contributing to increase in movement.

Photo 1: Sealed crack and dip in pavement overlay

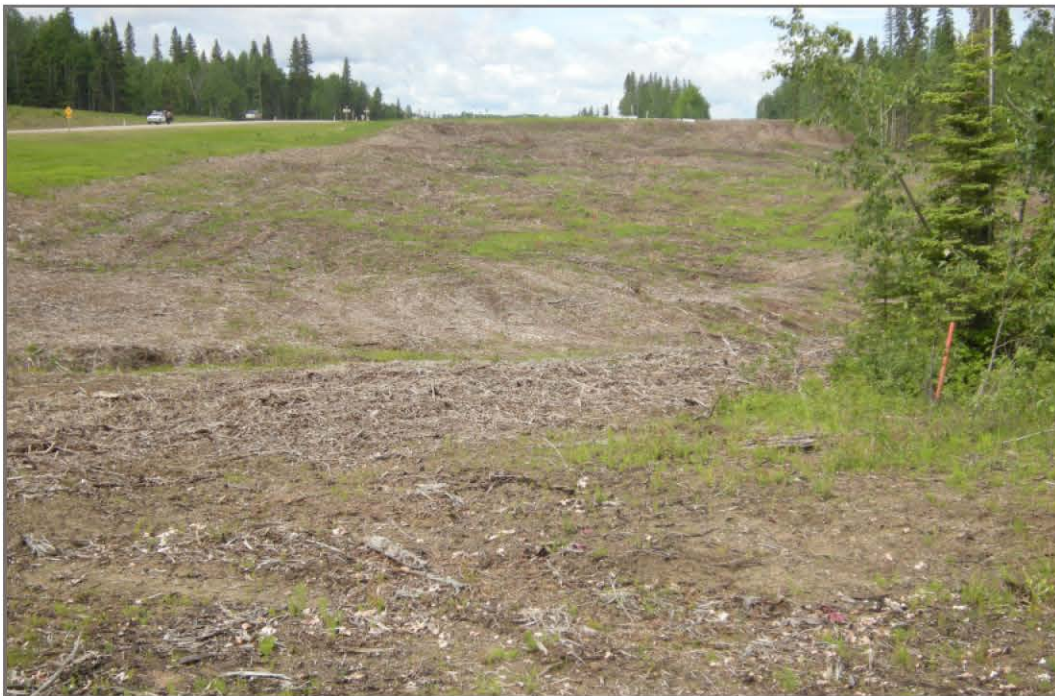
Photo 2: Site clearing in preparation of highway twinning

- A fill slope design for twinning of Hwy 22 should consider the presence of the existing slide.
- Each horizontal drain near the creek should be exposed and its outlet covered with coarse drainage rock to prevent clogging. Proposal to conduct this work has been submitted (EBA File No. PE12101119 dated May 13, 2009).
- Inoperable slope inclinometers should be replaced if pavement cracking worsens. Additional investigation may need to be conducted should slope movements or pavement deformations begin to accelerate.
- Pavement cracks which formed in 2004 should be sealed regularly to minimize infiltration.
- The deflection in the pavement that has developed should be monitored and may require patching if dip increases in size.
- The ditches and culvert inlet/outlets should be inspected for debris or beaver activity impeding water flow.

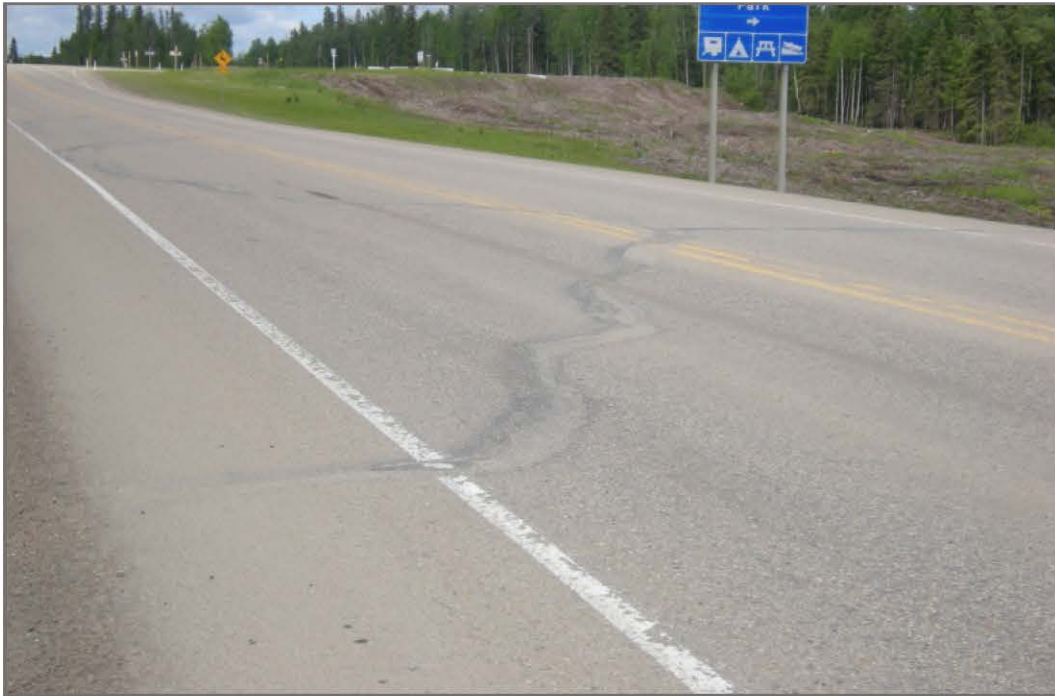
Photo 1: Sealed crack and dip in pavement overlay

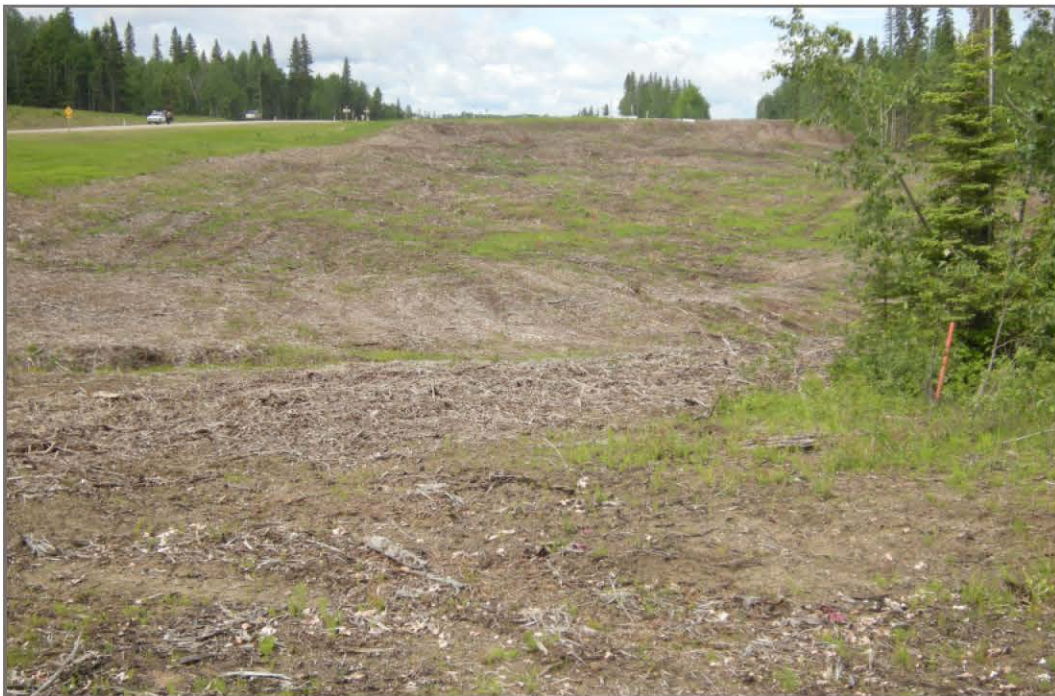
Photo 2: Site clearing in preparation of highway twinning
