THURBER ENGINEERING LTD.

October 15, 2004

File: 15-16-192

**NORTH CENTRAL REGION GEOHAZARD ASSESSMENT
HWY 39:06 SAUNDERS LAKE (MODEST CREEK) - NC5
2004 ANNUAL INSPECTION REPORT**

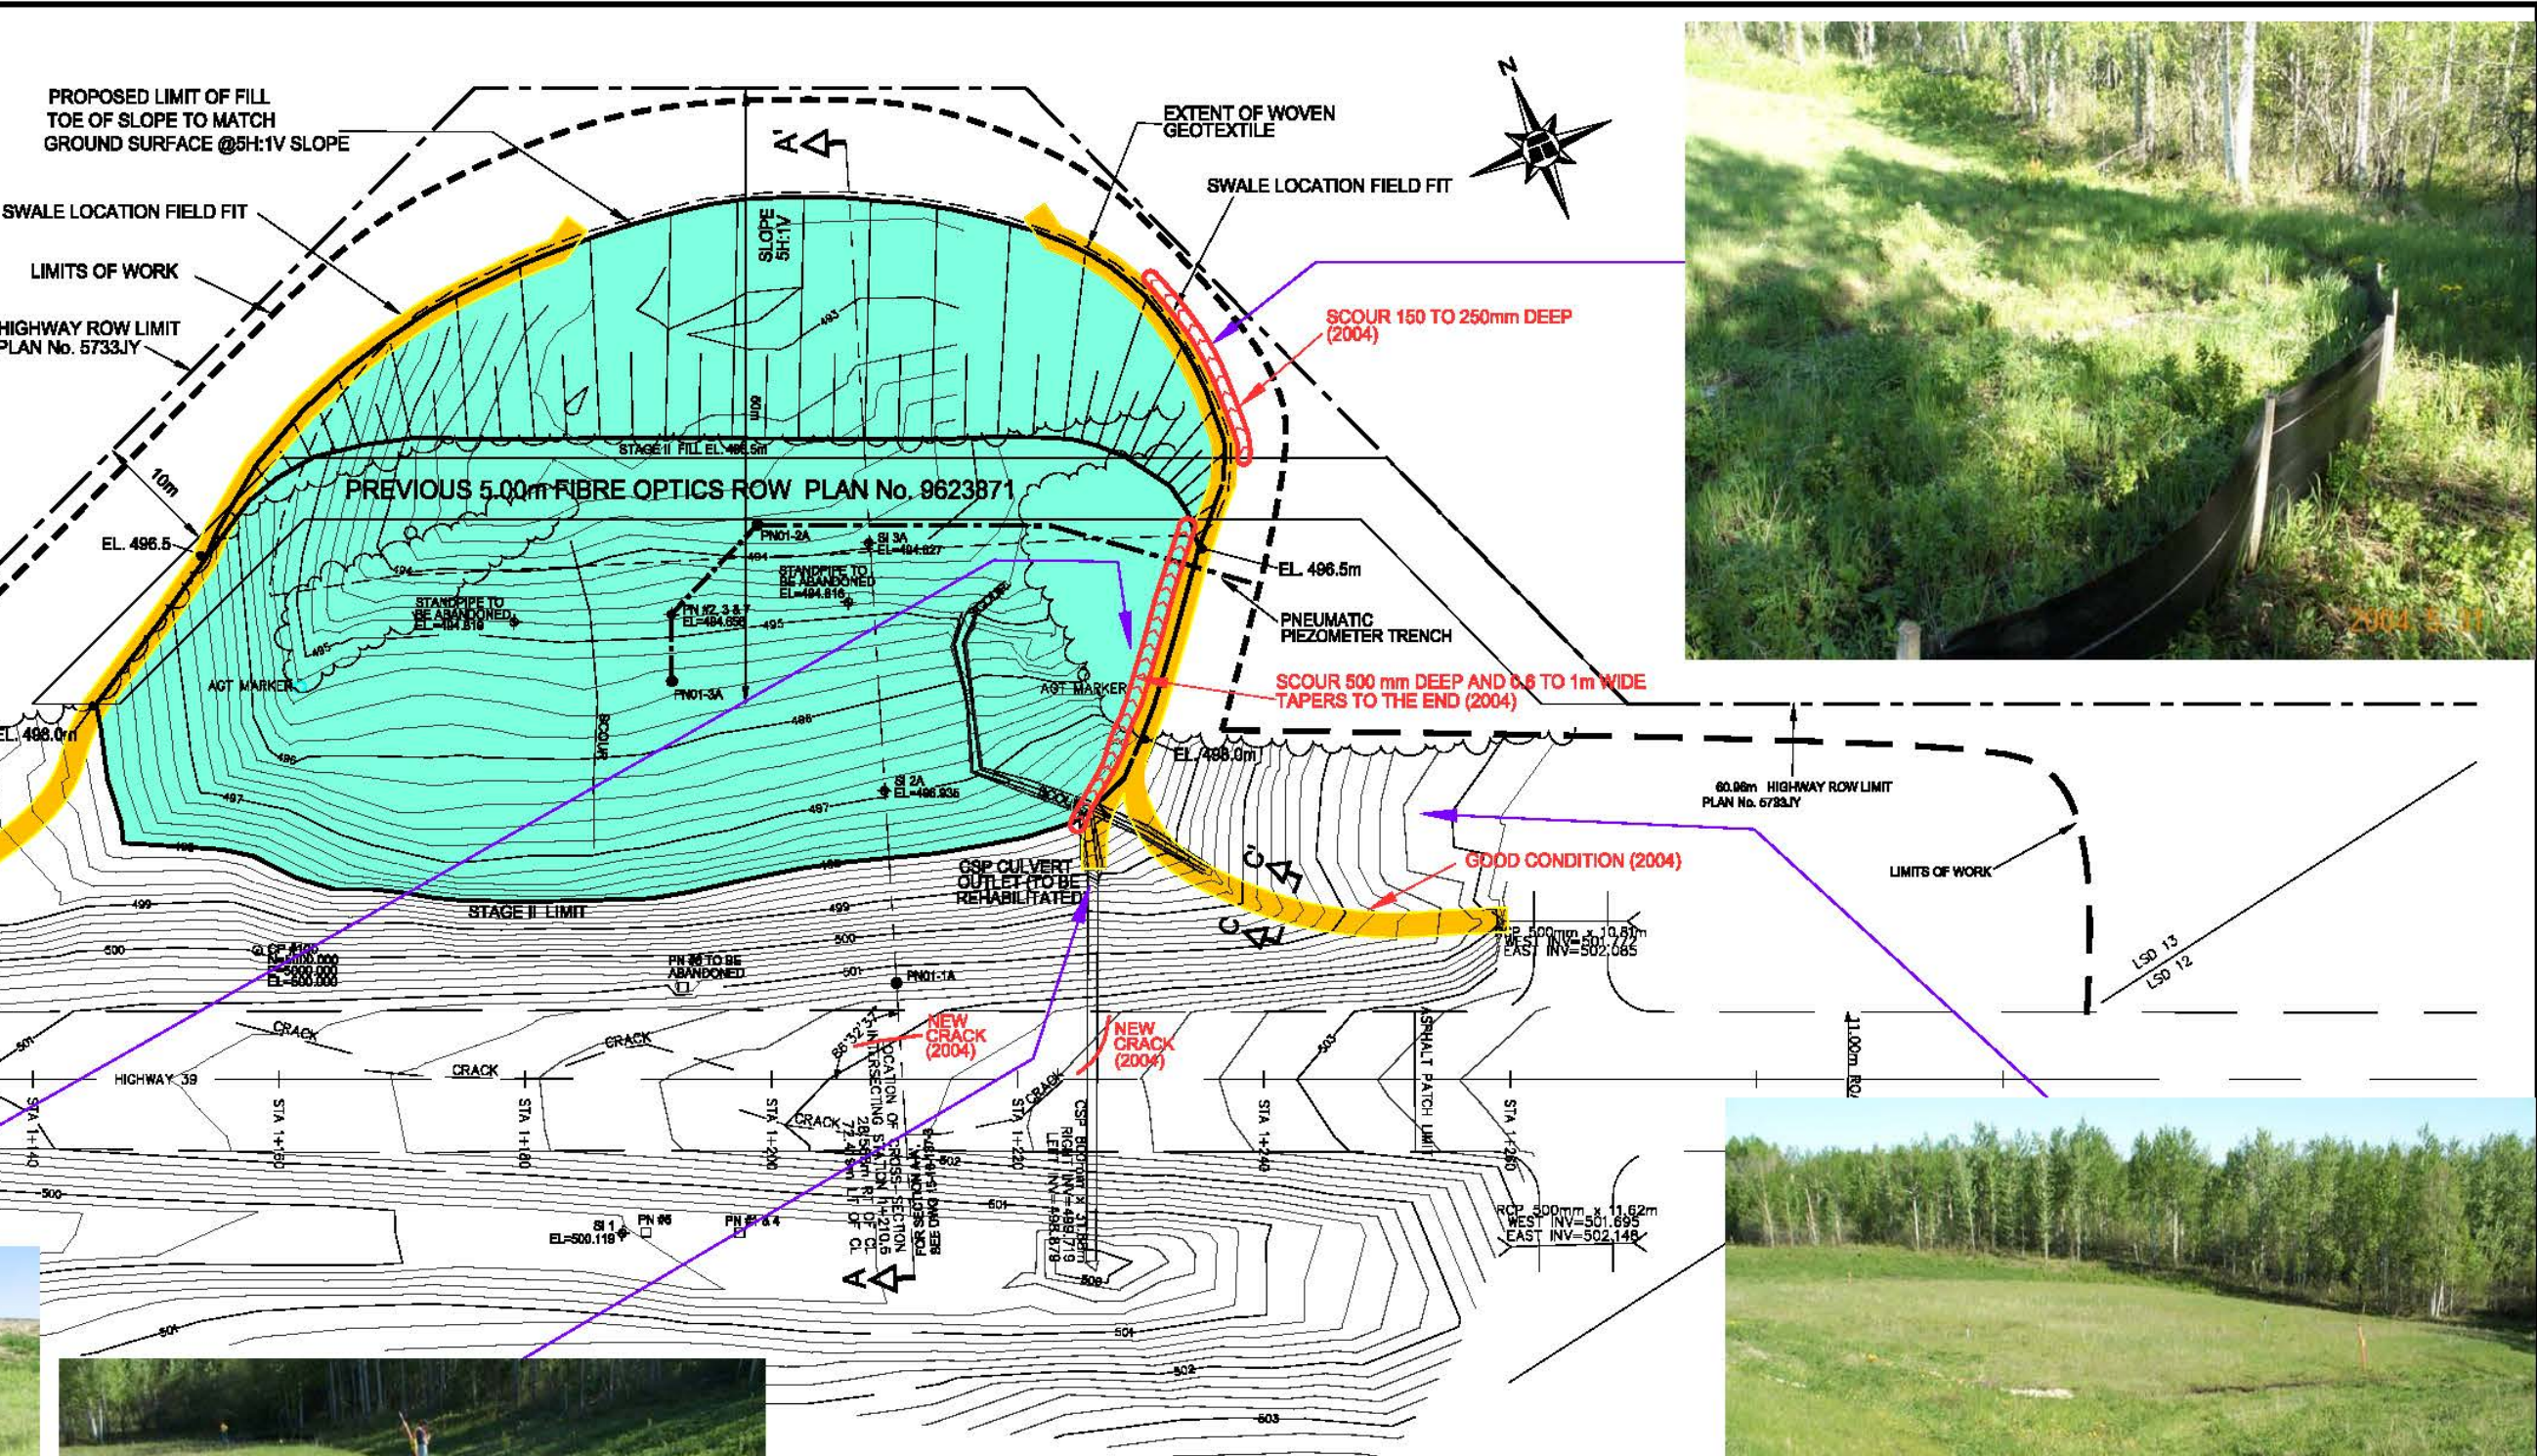
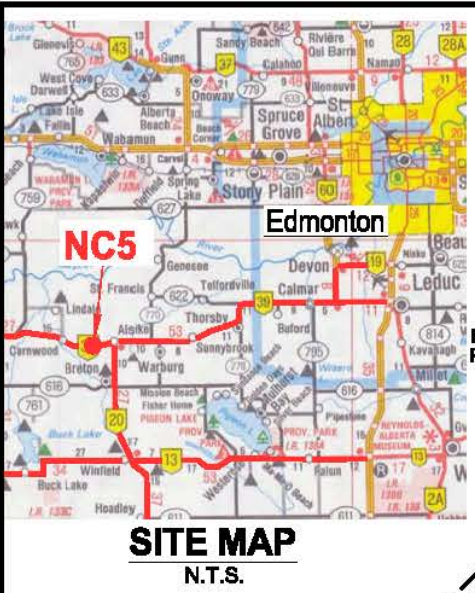
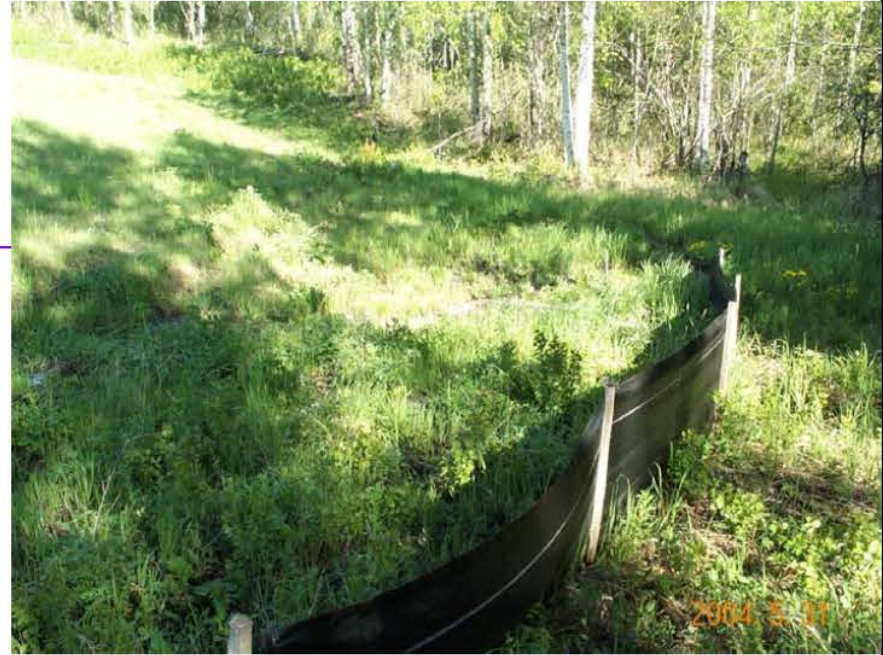
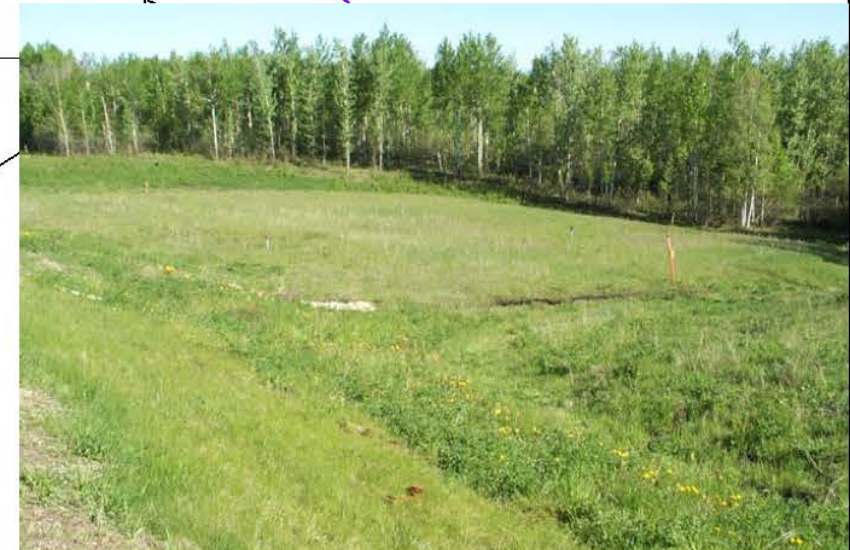
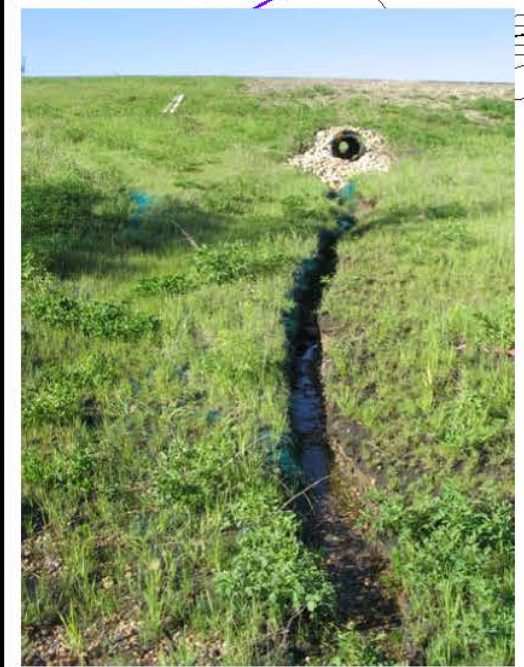
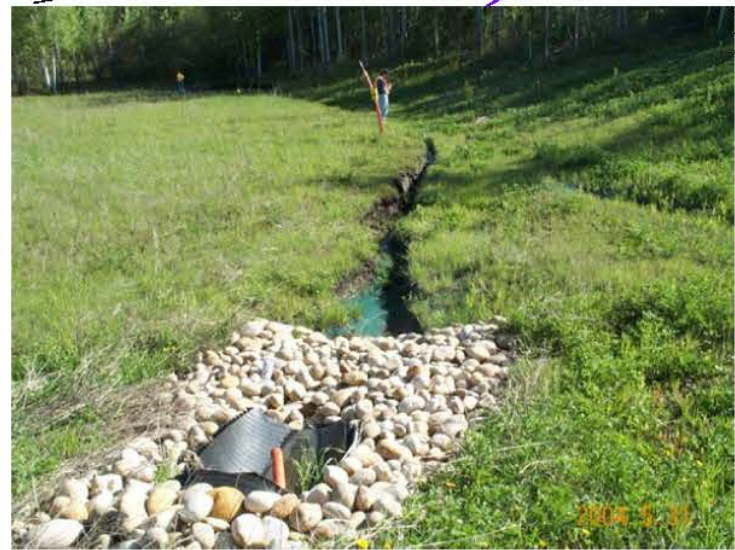
DRAWING No. **FIGURE NC5-1**

- An arc shaped cracking pattern about 70 m long was noted in the roadway surface, however the cracking was similar to what was observed last year with no noticeable change in its condition. However two small new cracks were observed on the pavement on the east end as shown in Figure NC5-1.

- The vegetation on the berm is growing well and covering the whole berm and adjacent area.
- The scour observed last year at the culvert outlet and extending about 22 m down the slope has increased in depth and width. However, no significant change was noted on the scour downstream at the toe of the berm on its east end as shown in Figure NC5-1, Section F.

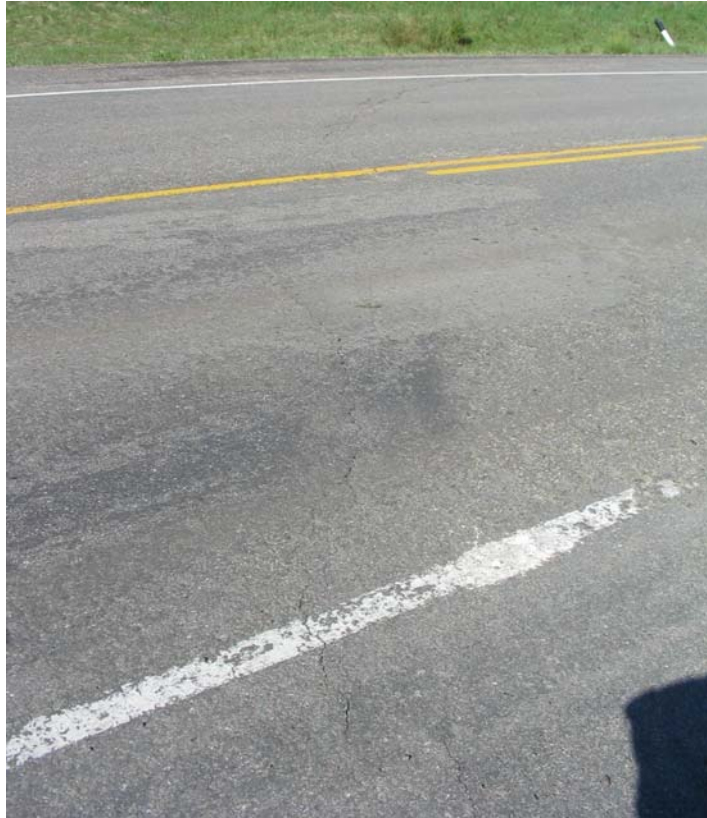
The two new cracks may be related to side slope above the berm that is still somewhat over steep. Monitoring and assessment of the crack evolution should be performed next year. Minor sideslope flattening above the berm could be carried out at a later date, if required.

Photo 1. New crack at the east flank.

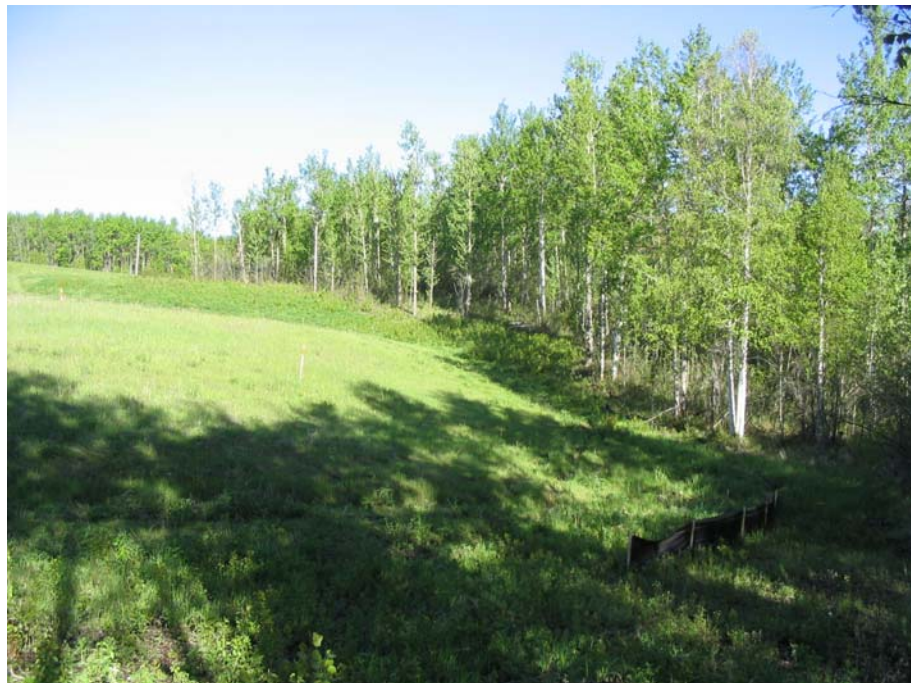
Photo 2. Toe berm vegetation cover.

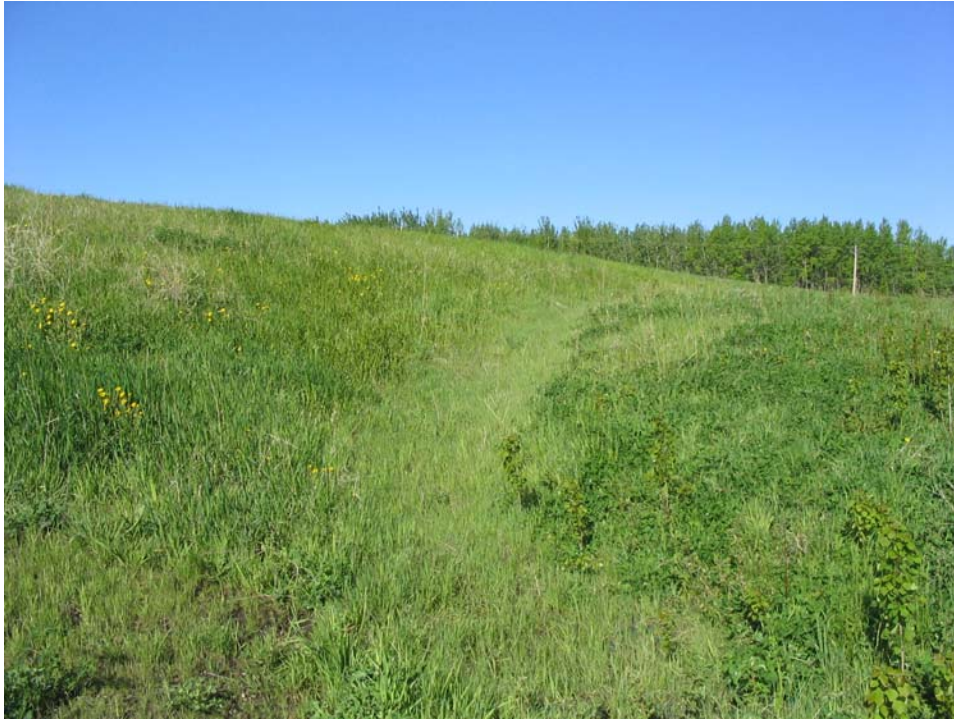
Photo 3. West swale vegetation cover

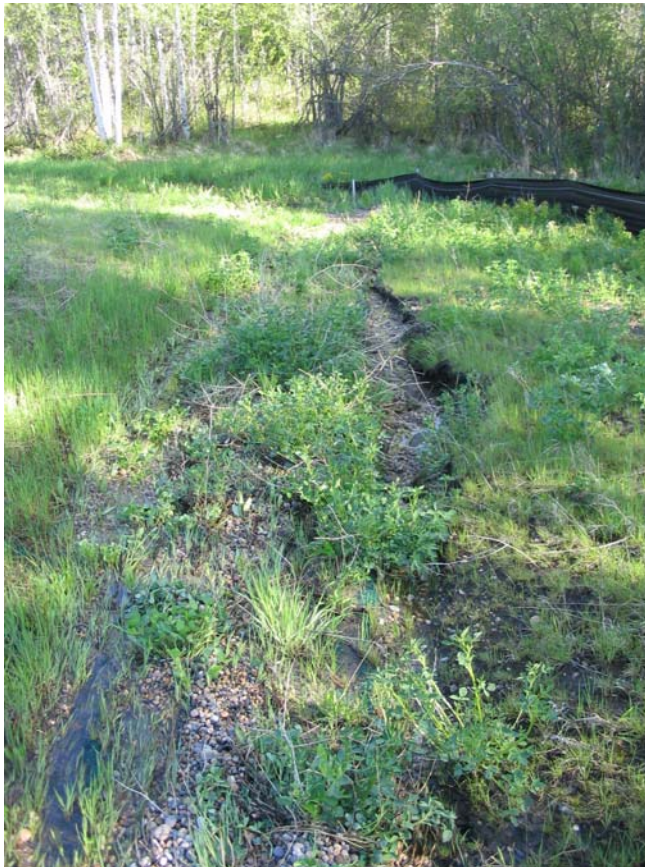
Photo 4. Toe scour.

It is recommended that the existing scours should be repaired as soon as possible to avoid additional erosion that may end up affecting the berm. The repair at the outlet of the culvert should consist of removing the riprap, cleaning the scour by removing any organic soil and loose material, backfilling with pitrun, over non-woven geotextile, and replacing the riprap extending it 5 m down slope. The repair of the erosion gully should consist of peeling back the adjacent section of soil covering, removing the existing topsoil, re-aligning and widening the existing swale, backfilling the gully with compacted clay fill, re-spreading the topsoil and seeding it, and placing another strip of soil covering (P300 from North American Green) adjacent to the existing to increase the erosion protection area. The same procedure should apply for both affected areas, i.e., immediately downstream of the culvert outlet and at the toe of the berm. The soil covering should be placed as per Alberta Transportation Design Guidelines for Erosion and Sediment Control for Highways manual.
