December 5, 2005

File: 15-85-11

**NORTH CENTRAL REGION GEOHAZARD ASSESSMENT  
HWY 39:06 SAUNDERS LAKE (MODEST CREEK) – NC5  
2005 ANNUAL INSPECTION REPORT**

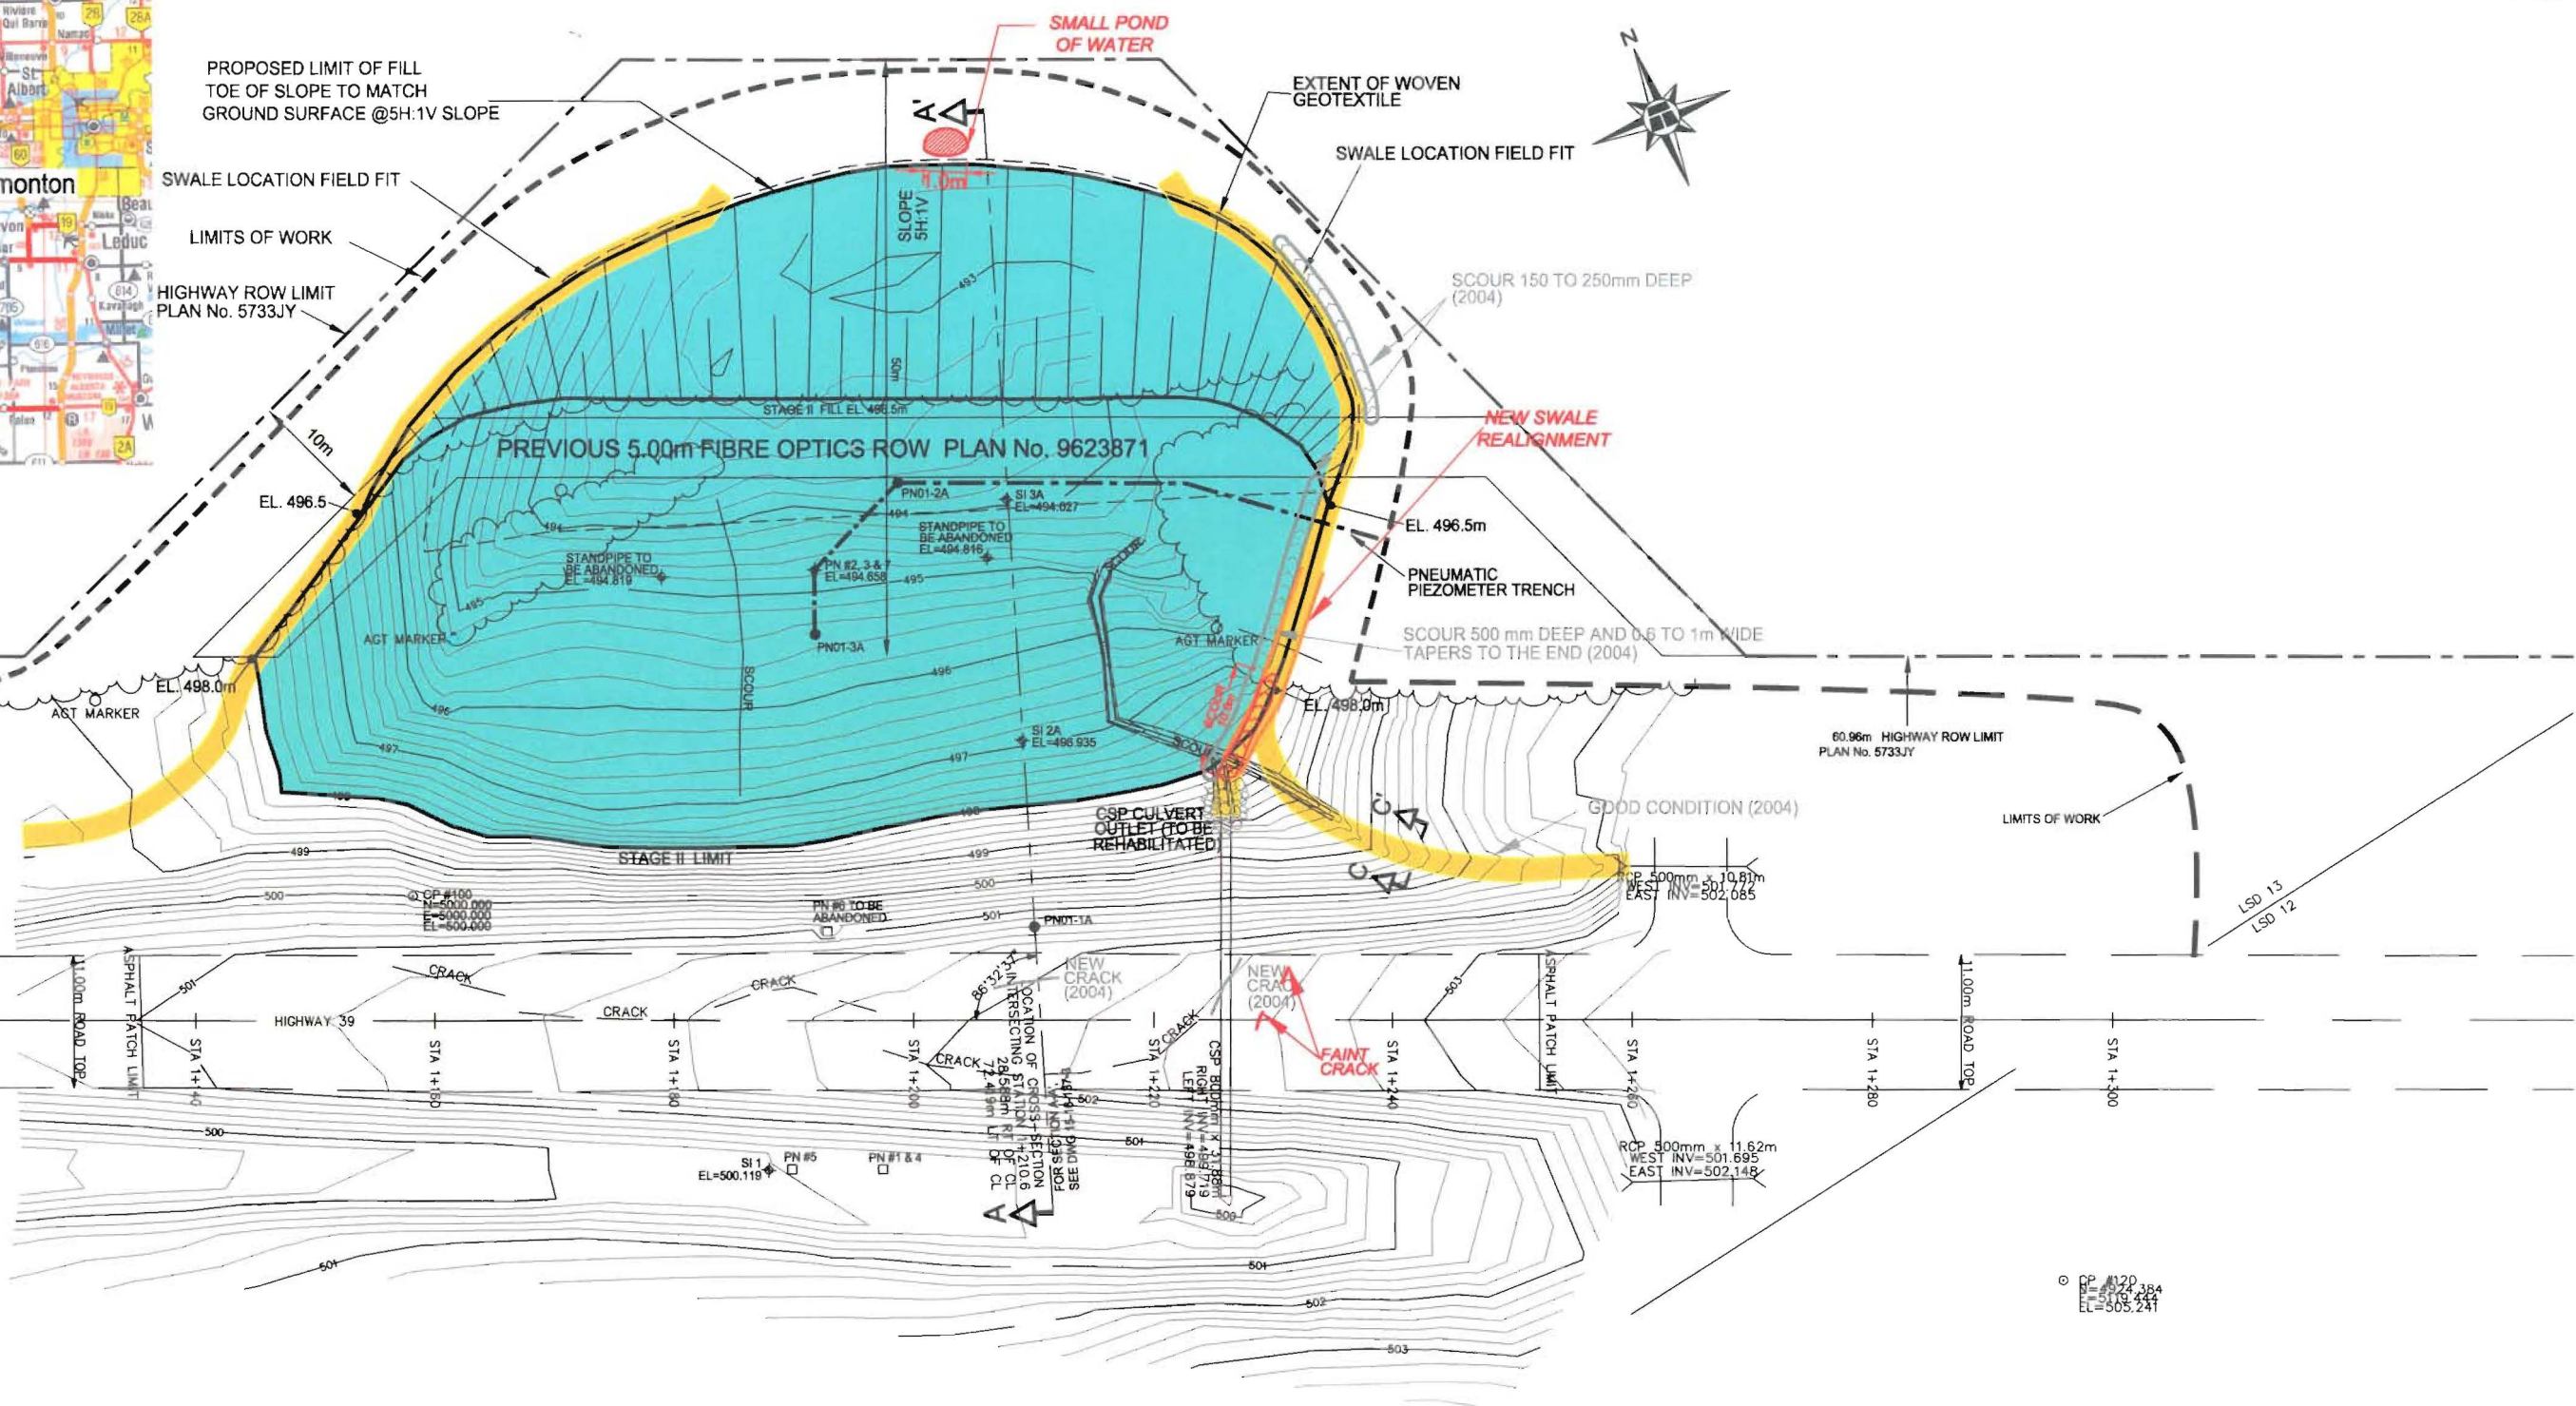
ENGINEER:	RVC	DRAWN:	GV	APPROVED:
DATE:	MAY, 2005	SCALE:	1:600	DRAWING No.
				FIGURE NC5-1

The changes in condition since last year are shown on the attached site sketch plan Figure NC5-1 in Section F of the binder. A cross section through the toe berm is also provided in Figure NC5-2. Selected photographs taken during the visit are also attached at the end of this letter.

The pavement crack pattern was the same as observed last year, with the exception of two faint cracks at the east side of the west bound lane as shown in the drawing.

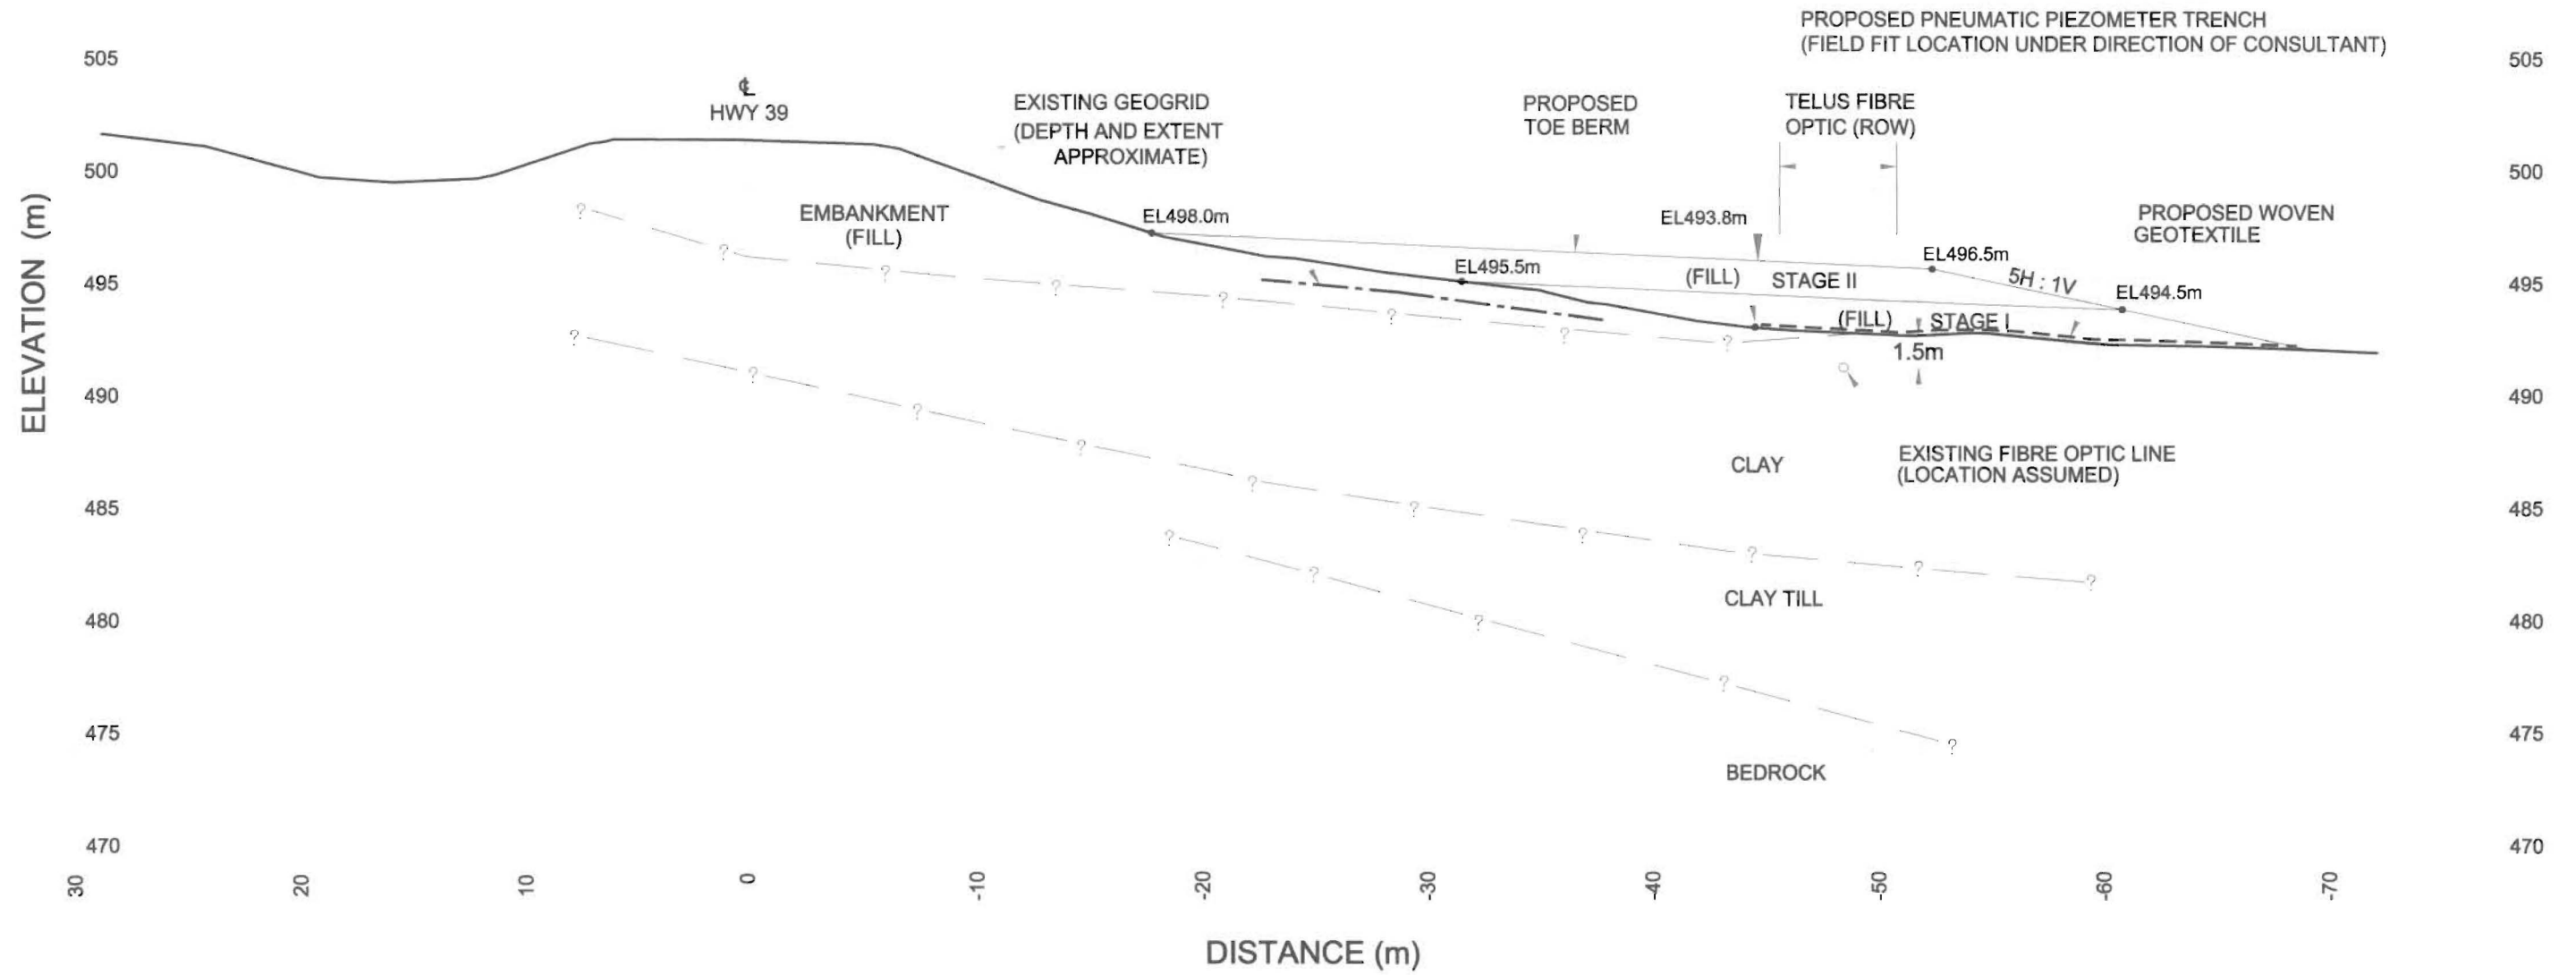
ENGINEER:	RVC	DRAWN:	ZD	APPROVED:
DATE:	MAY 2005	SCALE:	1:600	DRAWING NO.:
				FIGURE NC5-2

The existing berm appears to be performing very well and no slide activity was observed in this site. The SI reading has also confirmed that no movement is occurring on this site.

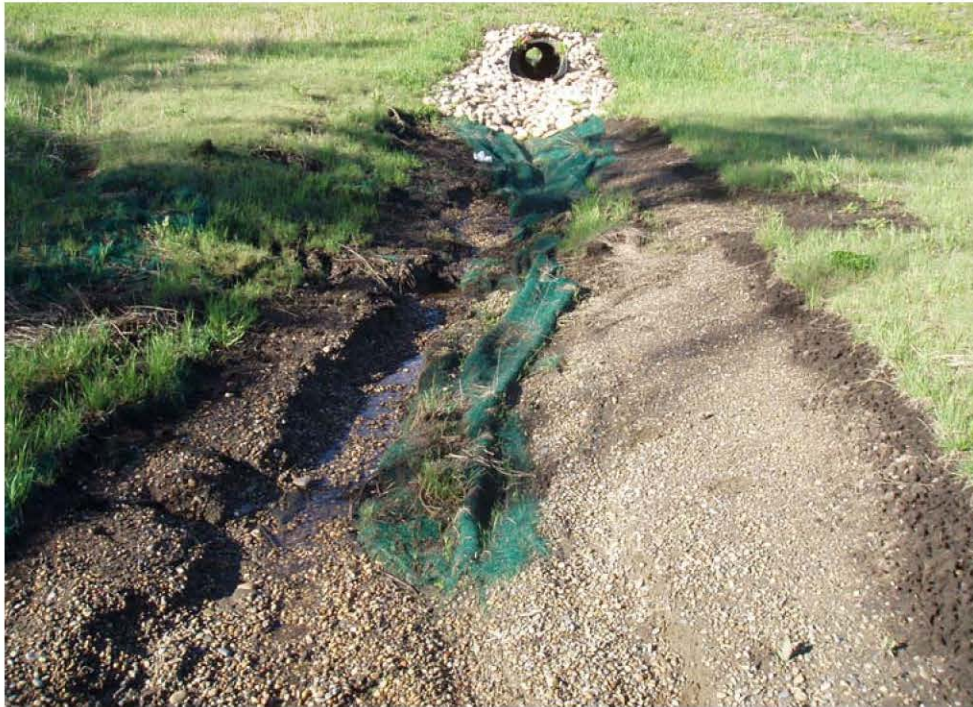
In general the site is performing well. The maintenance crew has repaired the main erosion along the culvert outlet swale and has also realigned the swale which is now performing much better. However, a minor scour is still occurring at the culvert outlet immediately after the riprap end treatment.

Photo 1. Culvert outlet scour

- The existing scour (Photo 1) at the culvert outlet location should be repaired as soon as possible to avoid becoming bigger and more expensive to repair. It is our understanding the Mr. Wilf Cousineau is planning to extend the existing riprap apron (riprap over non-woven geotextile) until it covers the affected area. In addition, the soil covering should be extended to cover the entire new re-aligned swale, after it is topsoiled and seeded. These measures should provide the necessary protection against future erosion at the outlet location.

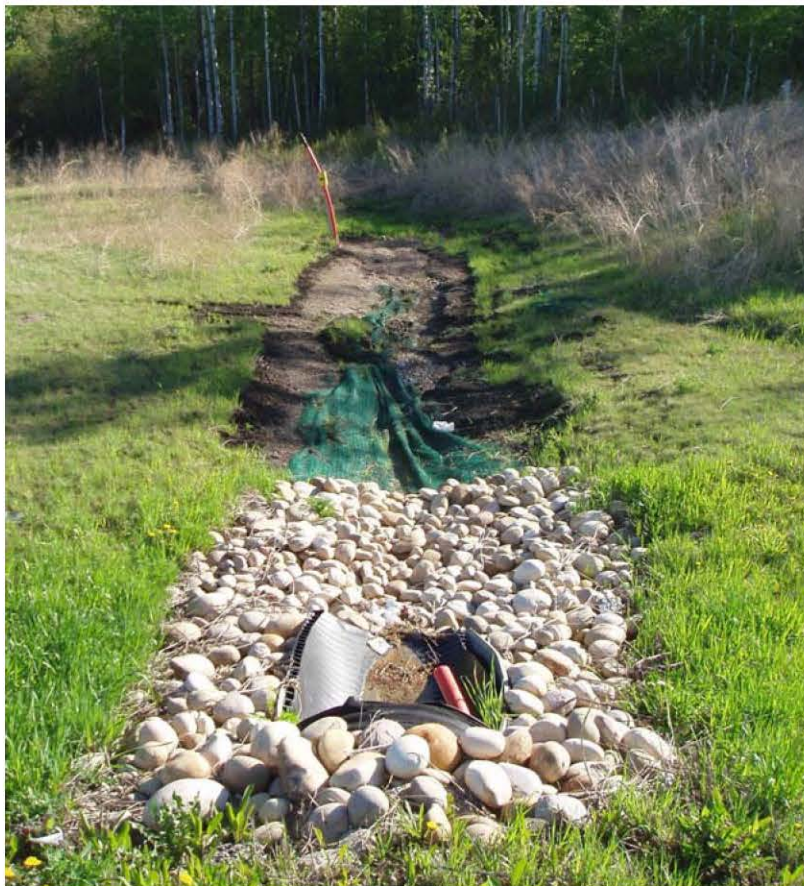
Photo 2. New swale realignment

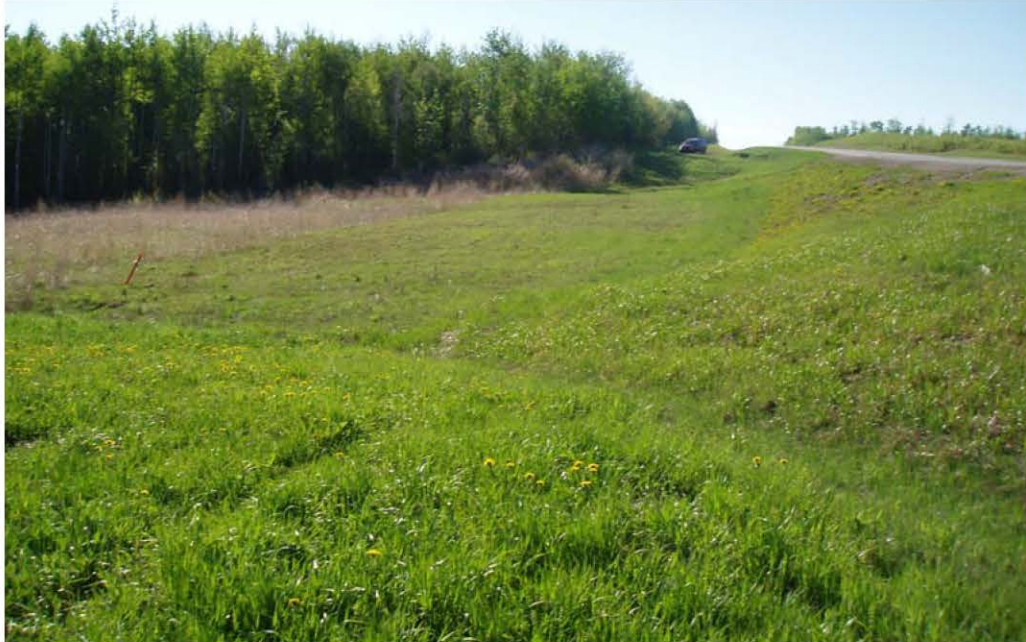
The vegetation has filled in very well through the soil covering along the swales especially on the west swale.

Photo 3 – Berm and west swale looking east.

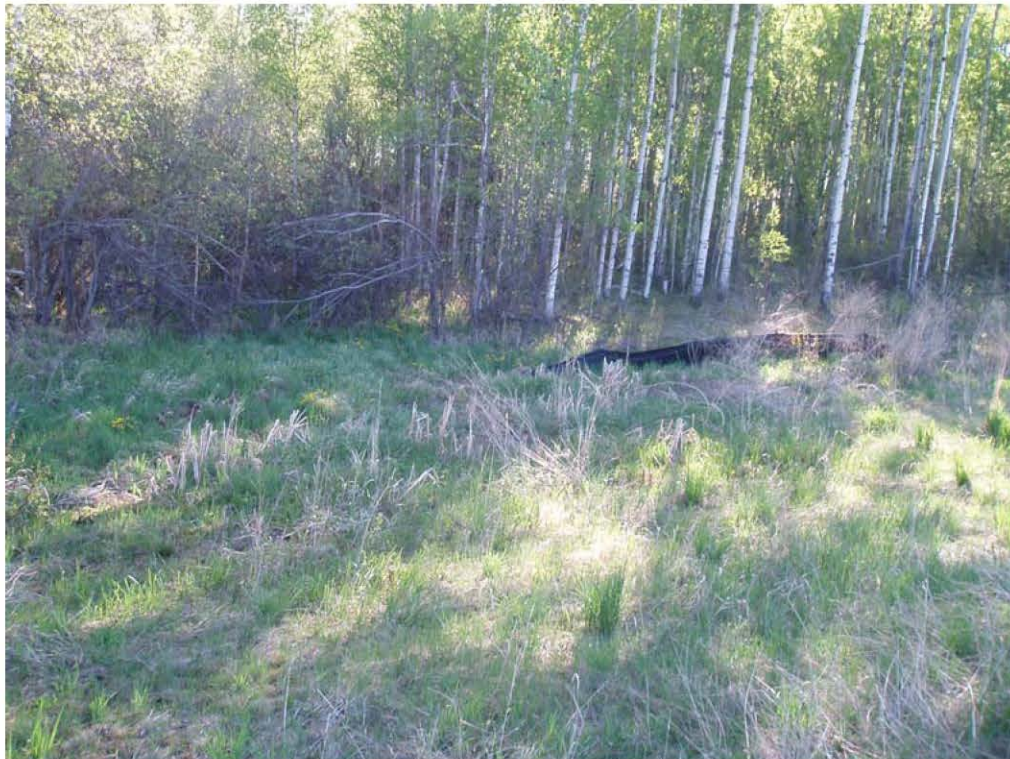
A small pond of water about 1 m diameter was observed accumulating at the north toe of the berm.

Photo 4 – View of the berm's toe area

- The existing silt fence at the toe of the berm should be removed (Photo 4).
- Slope Inclinometer SI01-2A (Photo 5) is located in a strategic position which would allow the early detection of future slope movement. Therefore, it is recommended that the stick up of this SI be repaired. Due to the shallow depth of the damaged section it is expected that the repair of this SI should be relatively inexpensive.

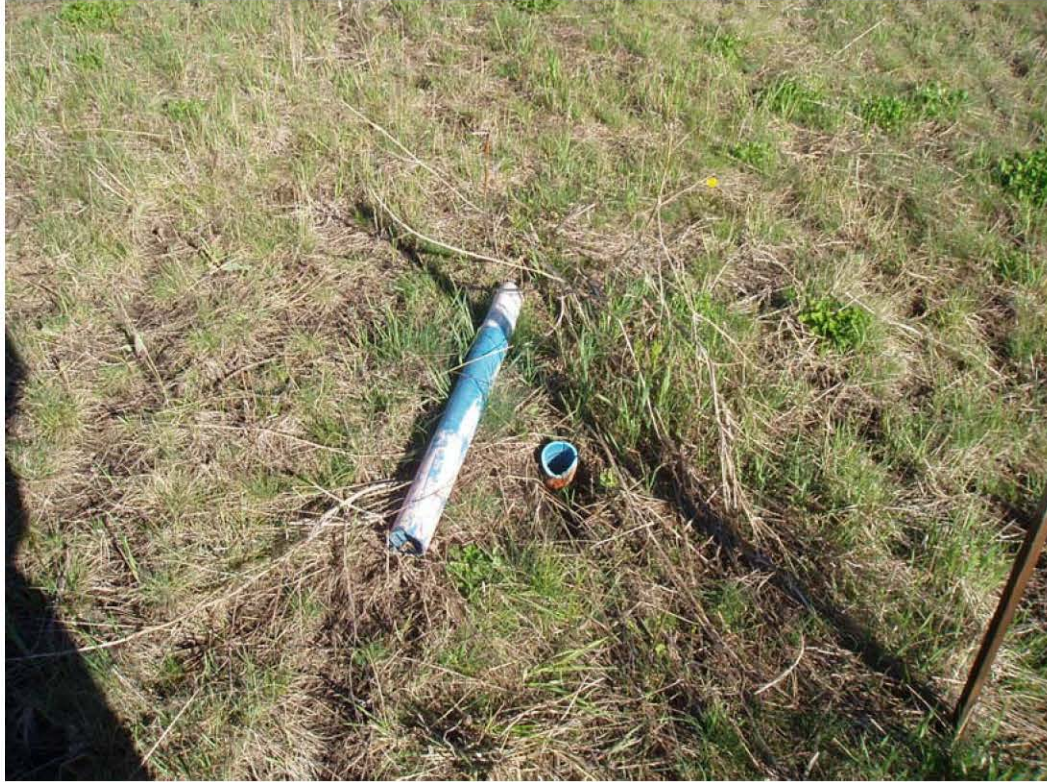
The stick up section of Slope Inclinator SI01-2A was broken by a lawnmower or quad and is bent approximately 0.75 cm below ground surface.

Photo 4 – SI01-2A – Stick up broken and pipe is bent at 0.75m depth.
