**STONY PLAIN REGION  
GEOHAZARD RISK ASSESSMENT  
SITE INSPECTION FORM**

<b>SITE NUMBER AND NAME:</b> NC 19 – Pavement Cracking (Site B)	<b>HIGHWAY AND KM:</b> Hwy 39:06, km 5.6	<b>PREVIOUS INSPECTION DATE:</b> June 2, 2009	<b>INSPECTION DATE:</b> May 20, 2010
<b>LEGAL DESCRIPTION:</b> SE 11-49-6-W5M	<b>NAD 83 COORDINATES:</b> -50736 E, 5897872 N	<b>RISK ASSESSMENT:</b> PF: 3    CF: 2 <b>TOTAL: 6</b>

**NC-19 HWY 39:06 SITE B**

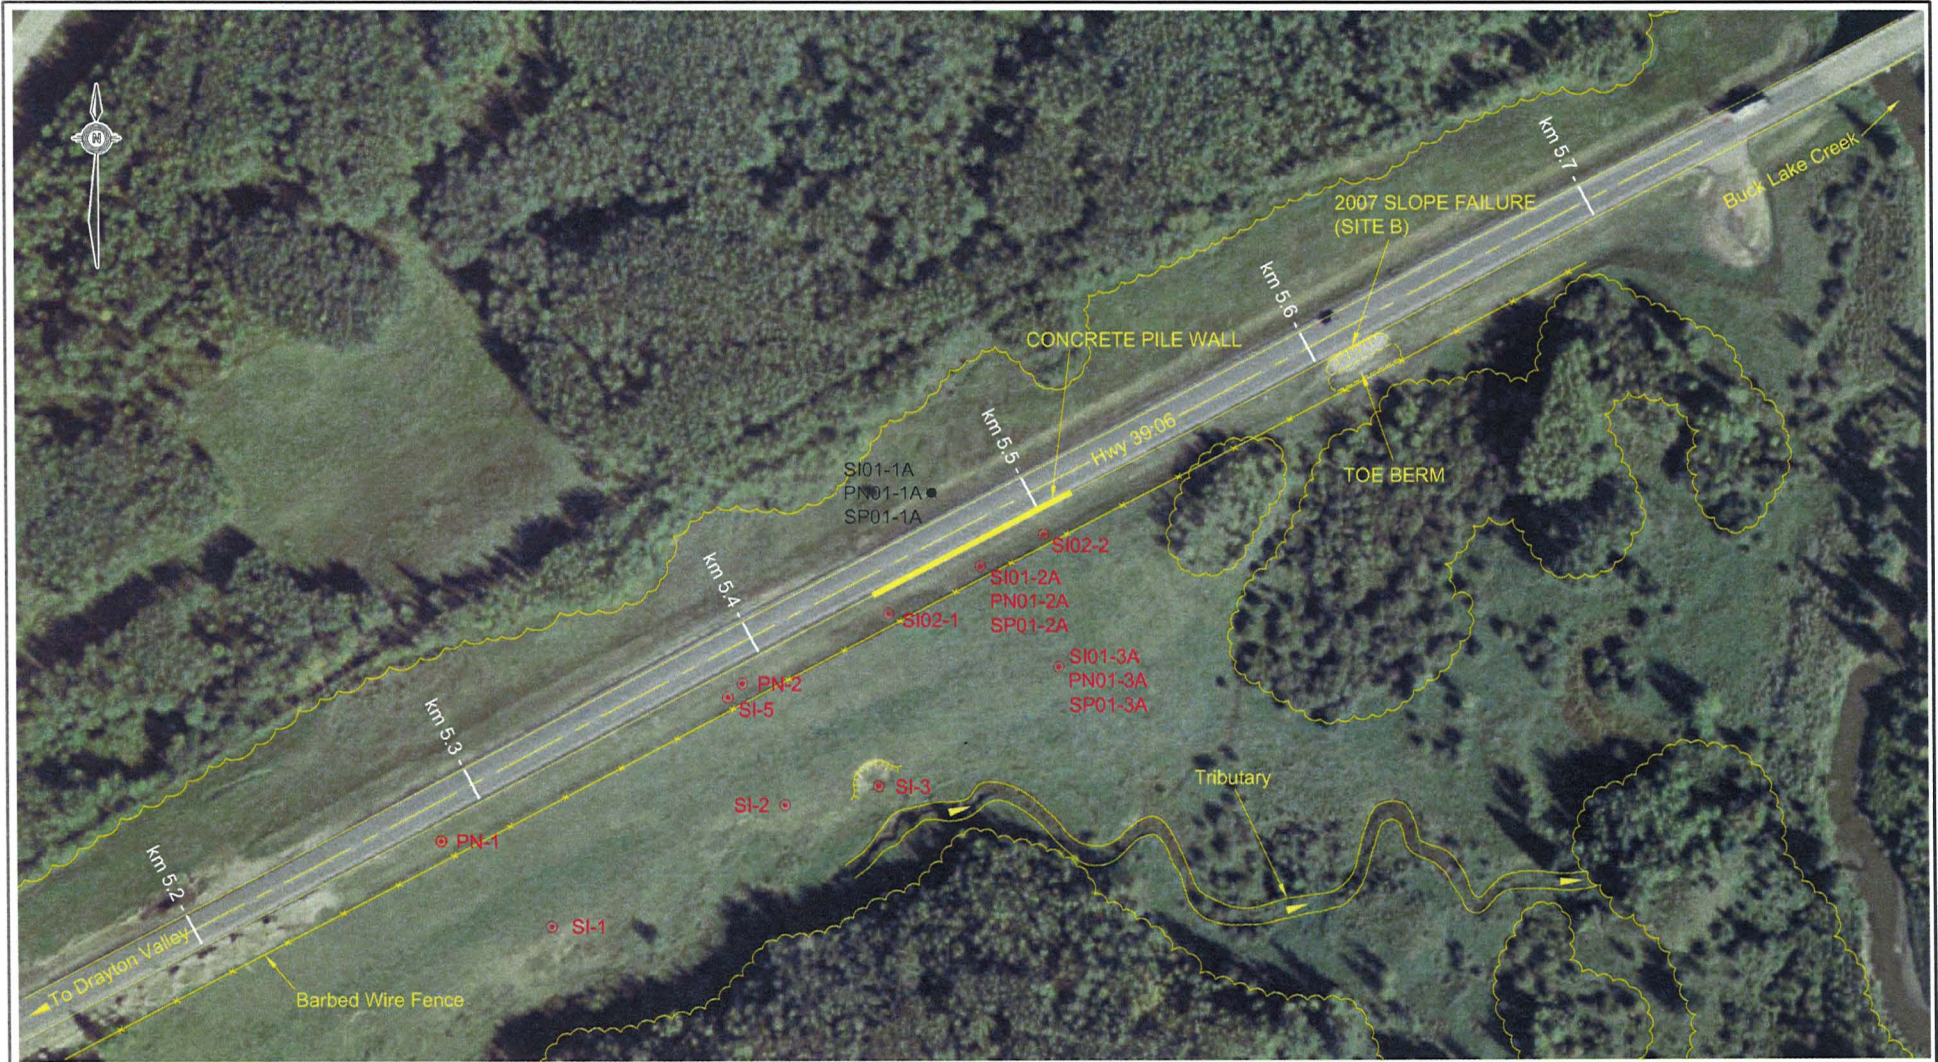
Figure NC-19

**COMMENTS:**  
 Location and site plan shown on Figure NC-19.  
 Site conditions shown in Photos 1 to 2.  
 Risk level unchanged from 2009.

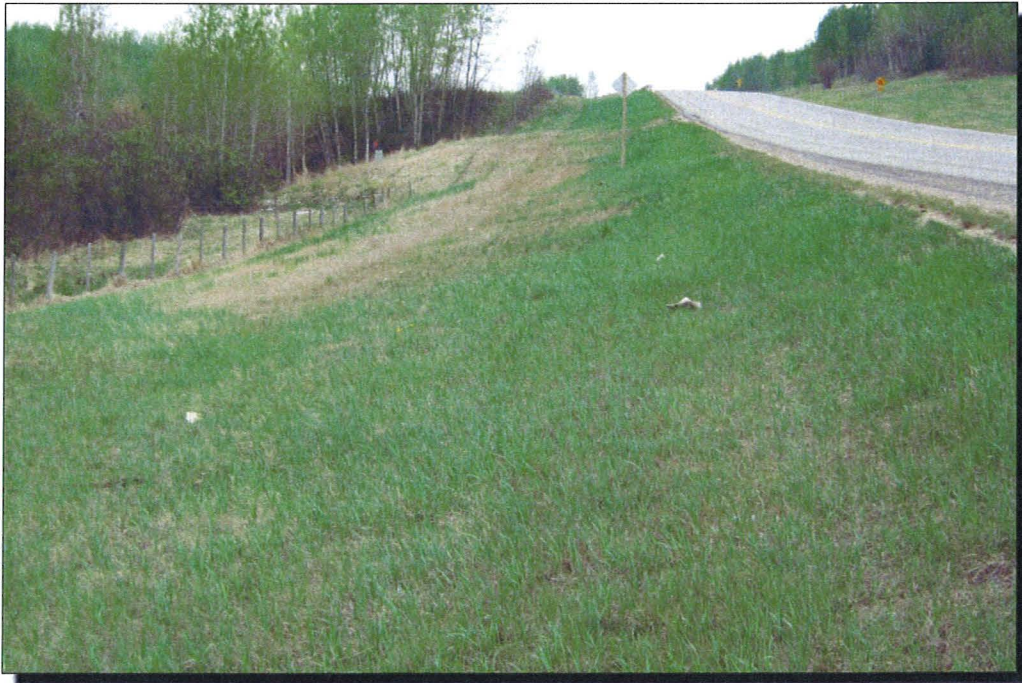
**Photo 1**  
Toe berm site (Site B) located upslope just behind road sign

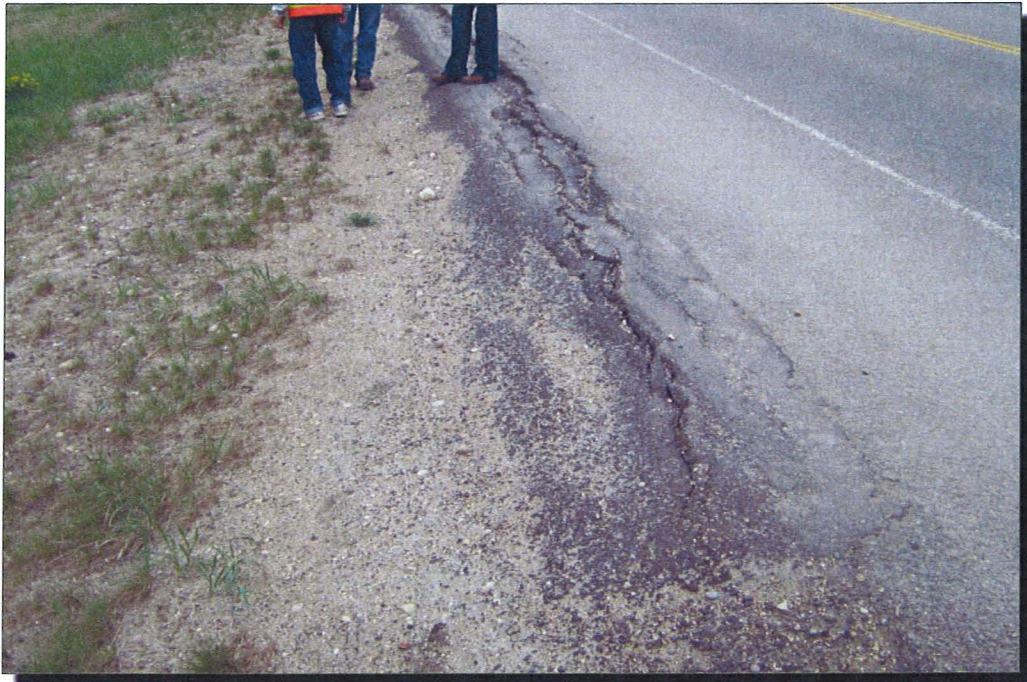
ITEM	CONDITION EXISTS		DESCRIPTION AND LOCATION	NOTICABLE CHANGE FROM LAST INSPECTION	
	YES	NO		YES	NO
Pavement Distress	X		Settlement and cracking present at pavement edge of eastbound lane at km 5.6	X	
Slope Movement		X			
Erosion		X			
Seepage		X			
Culvert Distress		X

**Photo 2**  
Cracking at edge of pavement at Site B

- Cracks along the shoulder of the km 5.6 embankment slope should be patched.
- Topsoil and seed or hydroseed top of embankment along km 5.6 where vegetation coverage is poor.
- Continue to monitor km 5.6 after asphalt is patched to assess if settlement along the shoulder continues. This should be done after periods of heavy rainfall.
- If cracking along the pavement continues or accelerates and expands after maintenance conducted at km 5.6, the upslope drainage measures of deep gravel sub-drain not constructed in 2007 should be implemented at an estimated \$100,000 to \$300,000, including engineering cost.
- The uneven portion of the ditch north of the highway should be graded to prevent water from ponding.

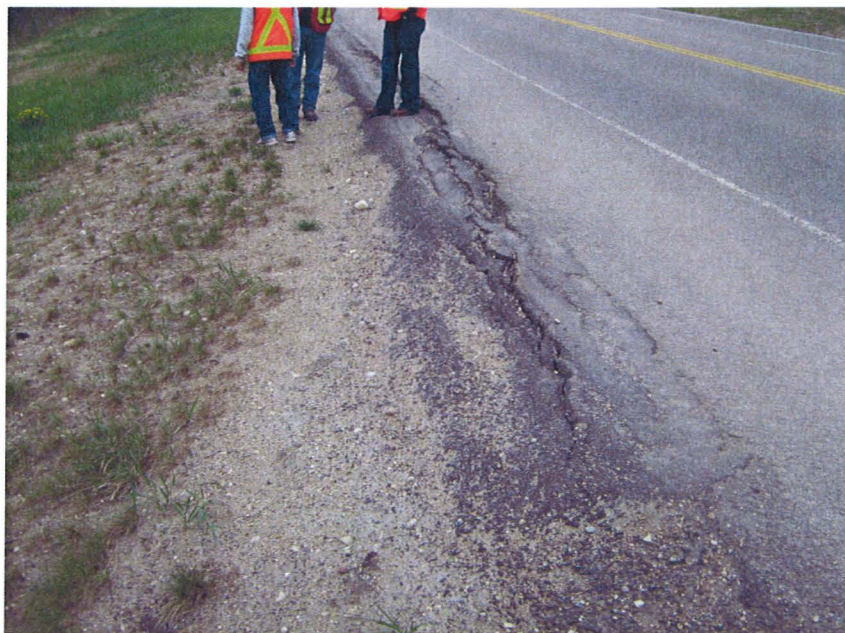
Cracking along eastbound lane and top of repaired area.  
Poor vegetation growth along top of embankment.

1. Cracks along the shoulder of the km 5.6 embankment slope should be sealed to reduce water infiltration.
2. Topsoil and seed should be applied to the top of the embankment along km 5.6 where vegetation coverage is poor.

3. If cracking along the pavement continues after maintenance conducted at km 5.6, the upslope drainage measures consisting of deep gravel sub-drain (not constructed in 2007) should be implemented.
4. The uneven portion of the ditch north of the highway should be graded to prevent water from ponding.
