**ALBERTA TRANSPORTATION
INSTRUMENTATION MONITORING RESULTS
SPRING 2010**

NORTH CENTRAL (STONY PLAIN) REGION

SITE NC19: HWY 39:06 BUCK LAKE CREEK

SLOPE INCLINOMETER SUMMARY

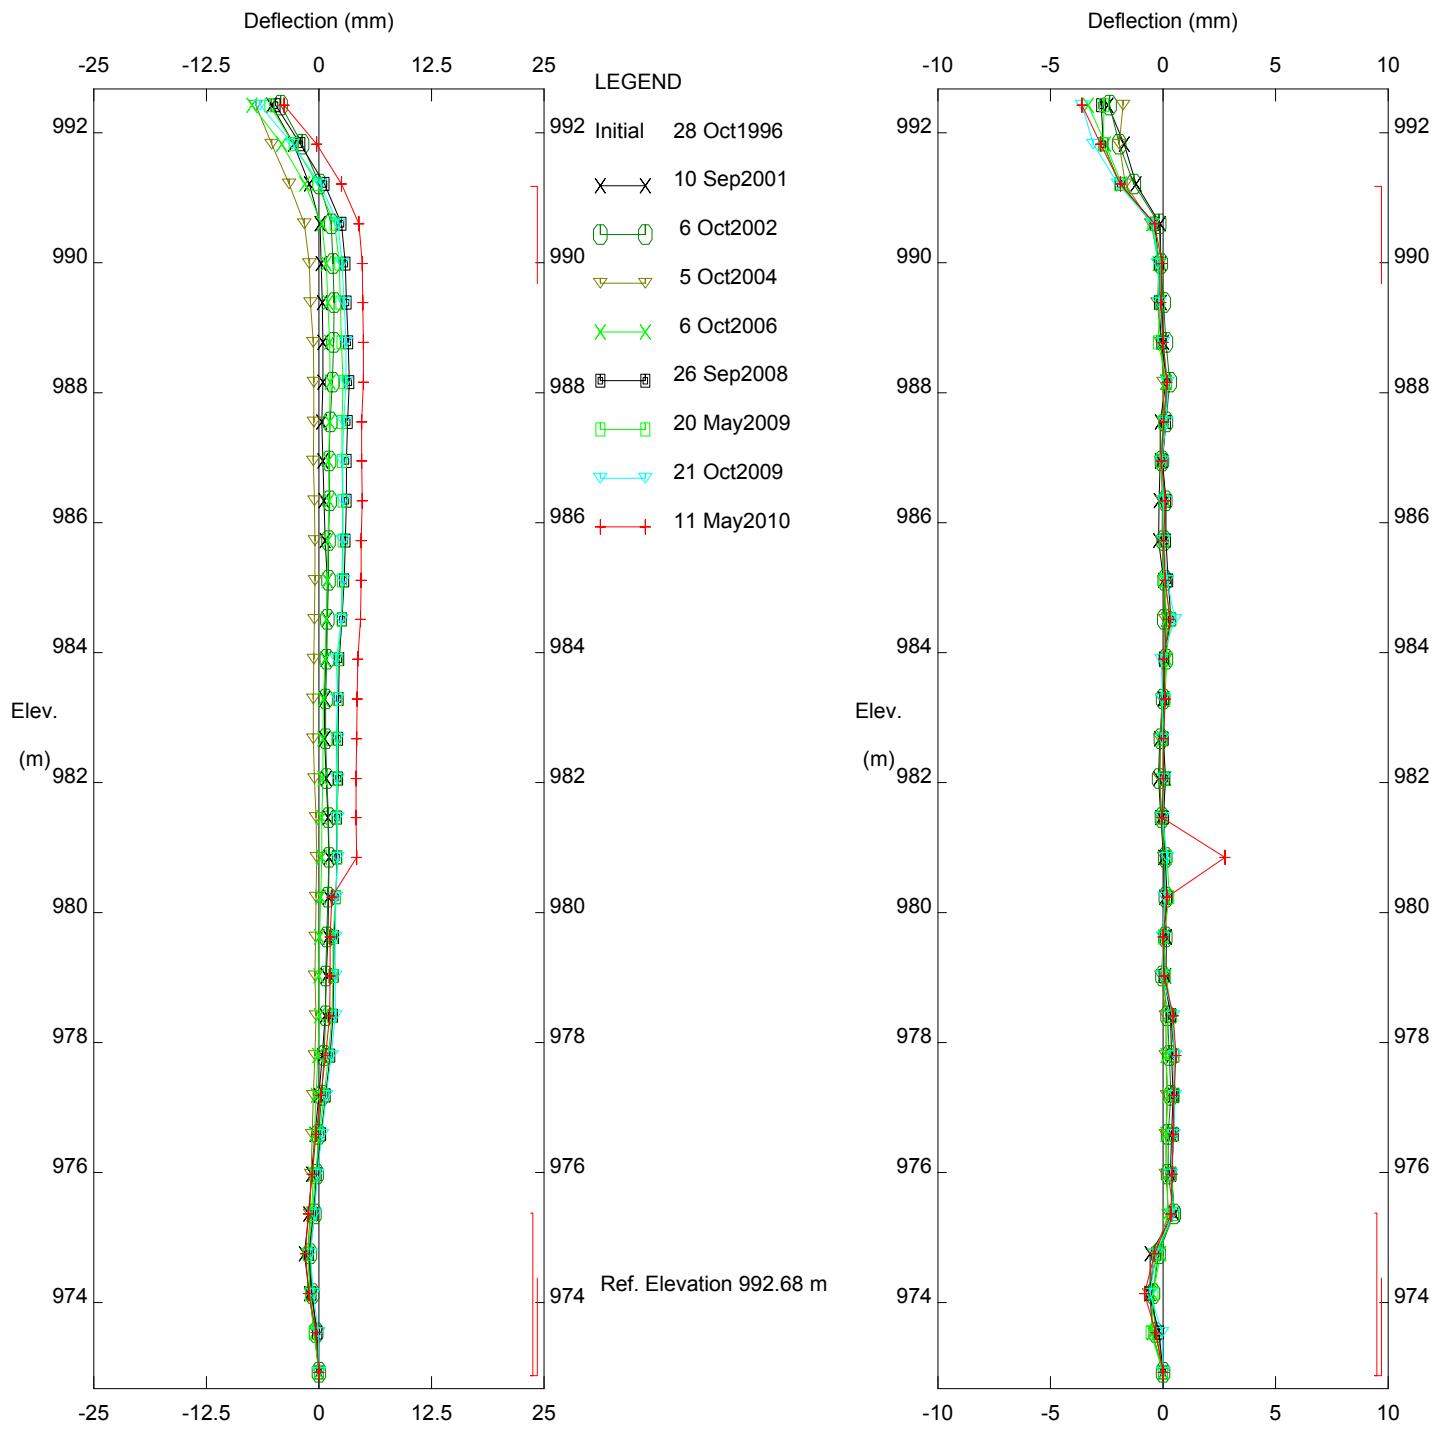
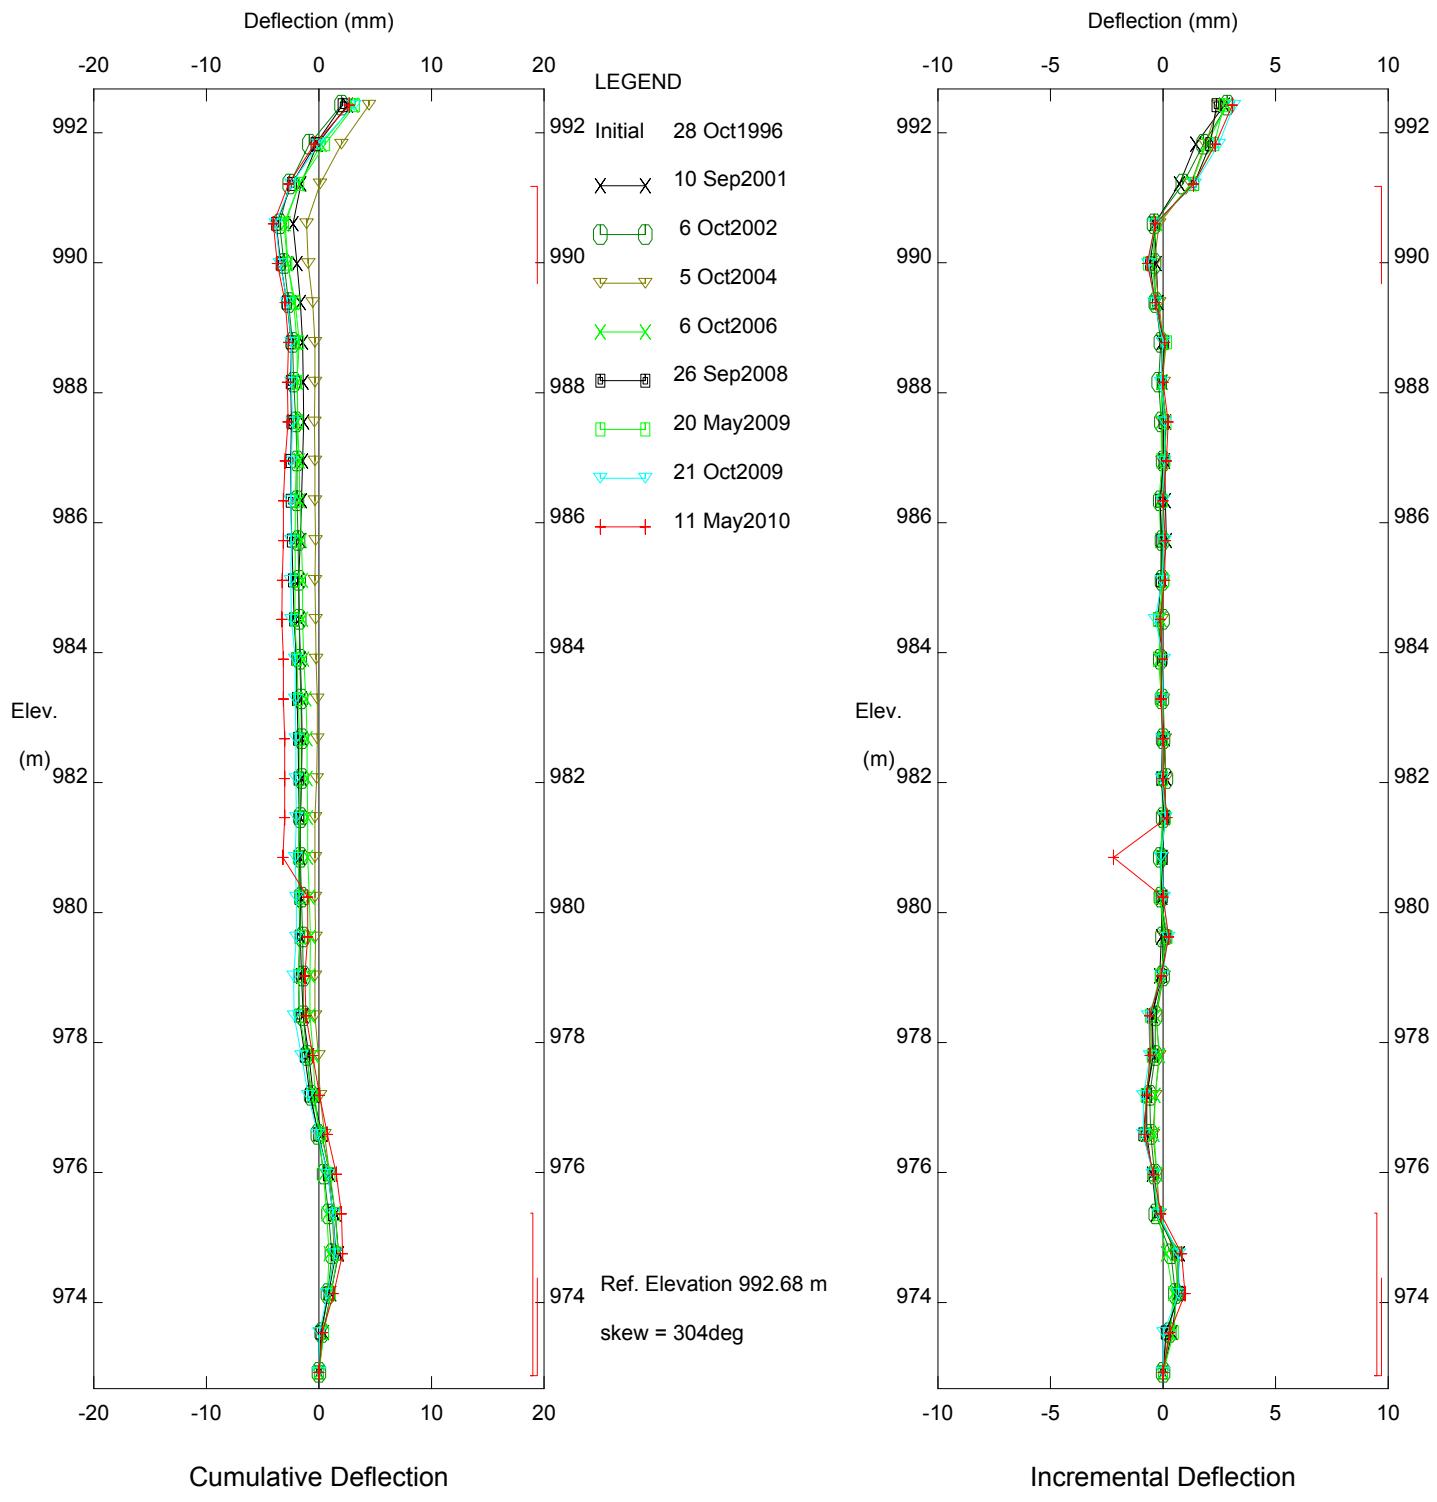
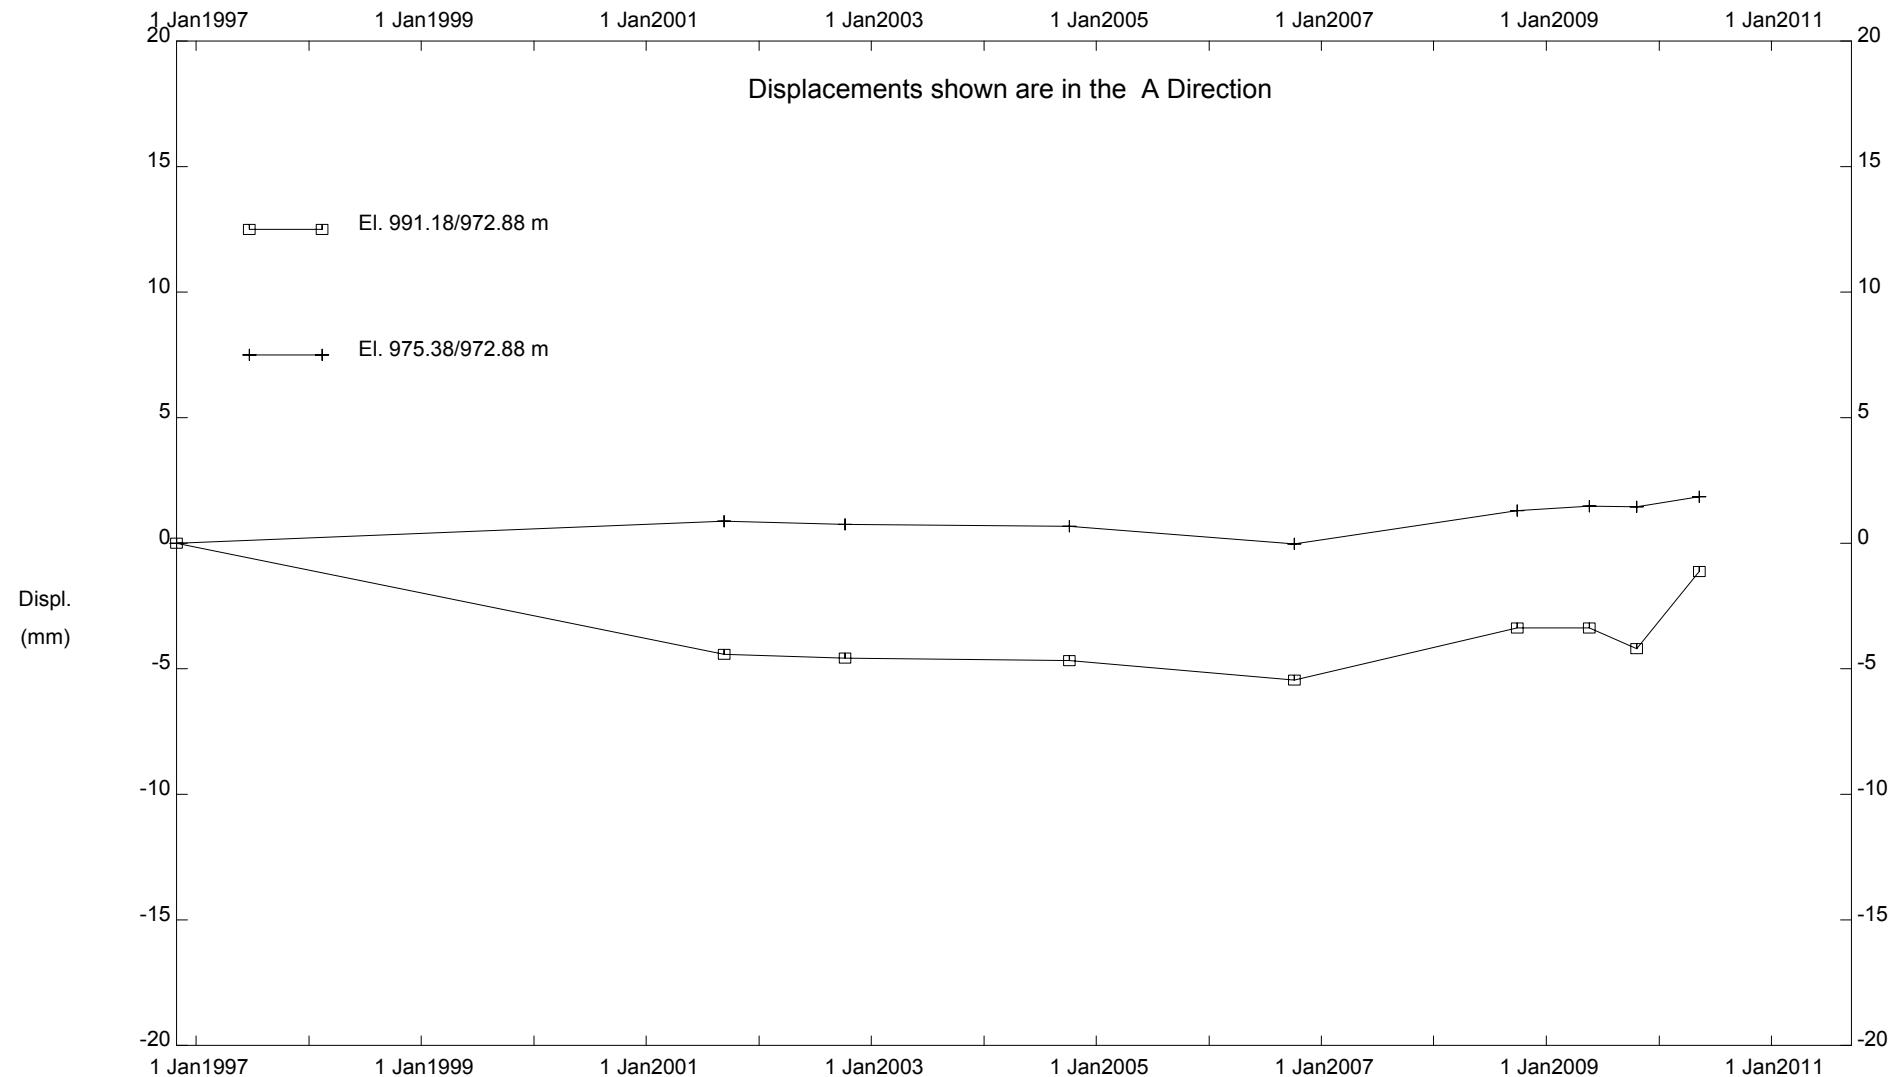
NC19, Inclinometer SI-2

In general, there is no appreciable change in the rates of movement since the fall 2009 monitoring period. SI-2 shows a deceleration in movement of <1 mm/yr at two shear zones in the upper 5 meters of the casing while SI01-2A and SI01-3A show a deceleration of <1mm/yr in a single zone in the upper 5 meters. The remaining two SI's (SI-1 and SI-5,) indicate rates of movement that are too small to be distinguished from instrument reading error. The performance of the 12 metre deep tangent pile wall installed in 2002 shows negligible movement as indicated by SI monitoring data from SI02-1 and SI02-2.

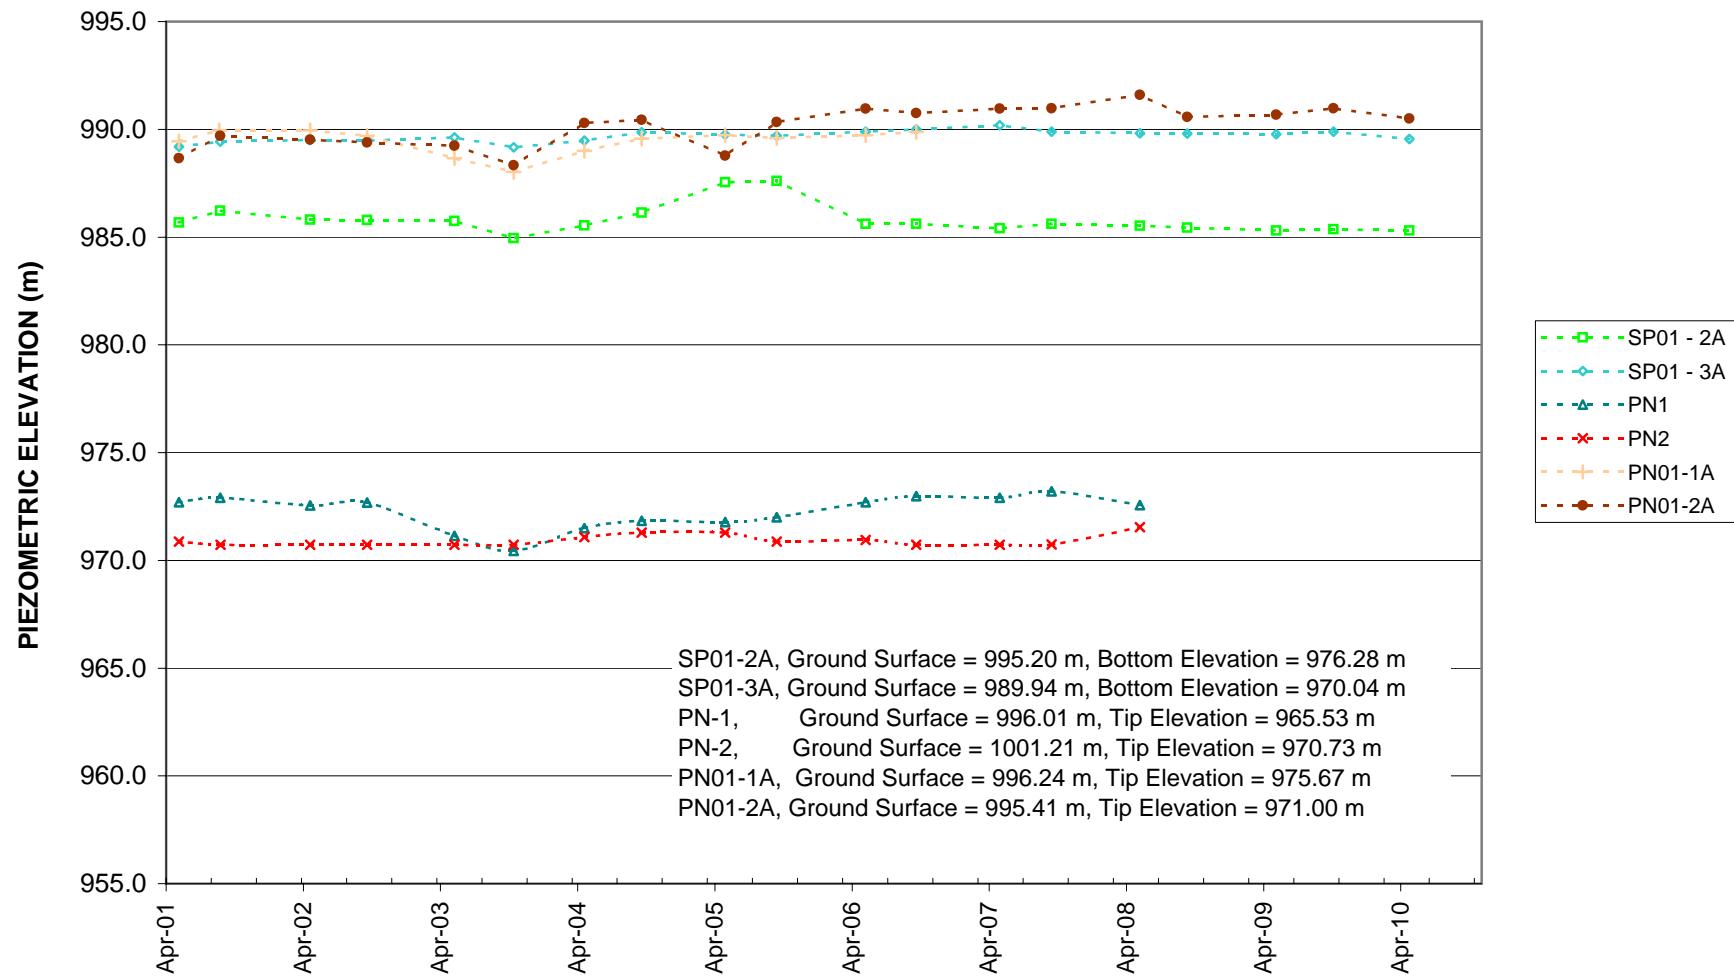
STANDPIPE / PNEUMATIC PIEZOMETERS PLOT

PN01-2A showed a decrease of pore water pressure equal to approximately 0.47 m of head. SI01-2A and SP01-3A also showed a decrease in water level of 0.1 and 0.35 m of head respectively.
