**STONY PLAIN REGION
GEOHAZARD RISK ASSESSMENT
SITE INSPECTION FORM**

SITE NUMBER AND NAME: NC 19 – Pavement Cracking (Site B)	HIGHWAY AND KM: Hwy 39:06, km 5.6	PREVIOUS INSPECTION DATE: May 20, 2010	INSPECTION DATE: June 14, 2011
LEGAL DESCRIPTION: SE 11-49-6-W5M	NAD 83 COORDINATES: -50736 E, 5897872 N	RISK ASSESSMENT: PF: 3 CF: 2 TOTAL: 6

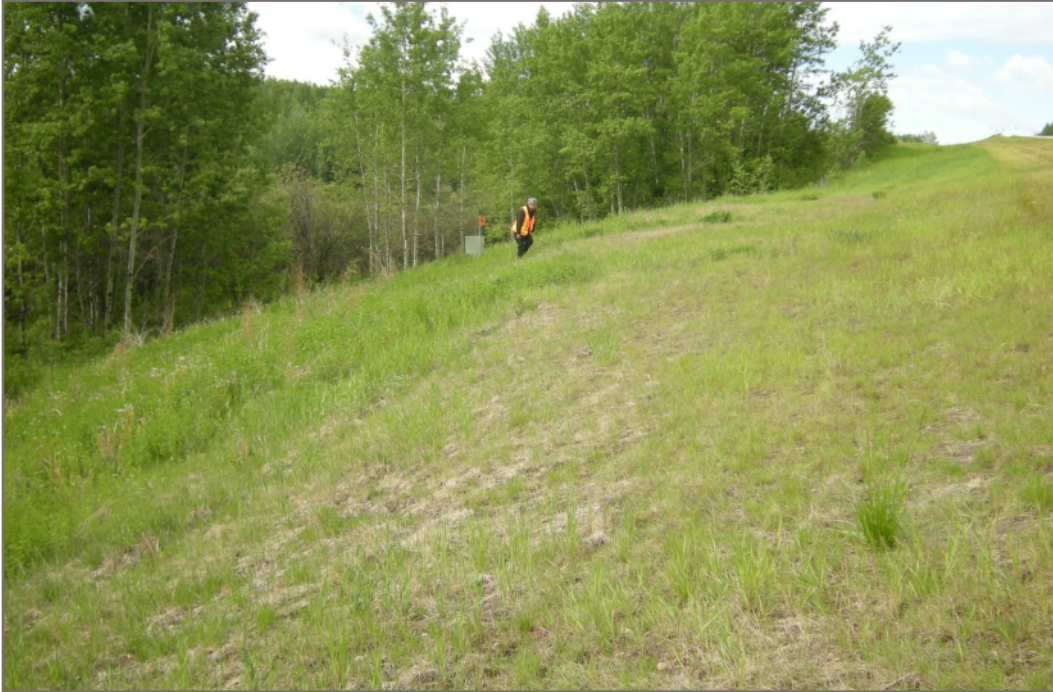
- Cracking was evident along a utility trench approximately 1.5 m north of the barb wire fence at Site A. The cracking followed the pile wall along a straight line.
- The embankment slope failure at km 5.6 (Site B) was repaired in fall of 2007 using a toe berm and installation of gravel drainage layer with perforated pipe wrapped in a geotextile filter.
- Pavement deflection, about 0.3 m from the edge of pavement at Site B, was measured to be about 65 mm in width. There appears to be little change in the crack width compared to the 2010 site visit.
- Perforated pipes at the base of the Site B toe berm appeared to be dry. The north ditch was also relatively dry.

Photo 1: Toe berm (Site B)

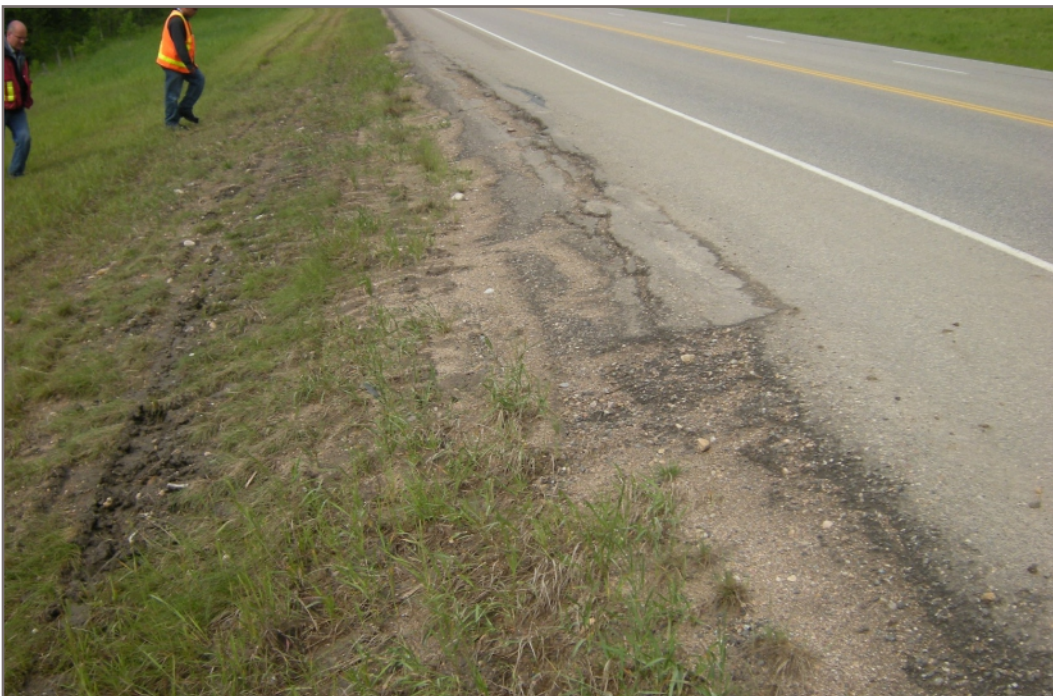
ITEM	CONDITION EXISTS		DESCRIPTION AND LOCATION	NOTICABLE CHANGE FROM LAST INSPECTION	
	YES	NO		YES	NO
Pavement Distress	X		Settlement and cracking present at pavement edge of eastbound lane at km 5.6 Small increase in movement from 2010	X	
Slope Movement		X			
Erosion		X			
Seepage		X			
Culvert Distress		X

Photo 2: Cracking at edge of pavement at Site B

- Cracks along the shoulder of the km 5.6 embankment slope should be patched.
- Topsoil and seed or hydroseed top of embankment along km 5.6 where vegetation coverage is poor.
- Continue to monitor km 5.6 after asphalt is patched to assess if settlement along the shoulder continues. This should be done after periods of heavy rainfall.
- If cracking along the pavement continues or accelerates and expands after maintenance conducted at km 5.6, the upslope drainage measures of deep gravel sub-drain not constructed in 2007 should be implemented at an estimated \$100,000 to \$300,000, including engineering cost.
- The uneven portion of the ditch north of the highway should be graded to prevent water from ponding.
