November 25, 2005

File: 15-85-11

**NORTH CENTRAL REGION GEOHAZARD ASSESSMENT CALL OUT  
NC38 HWY 47:06 EMBARRAS CREEK  
2005 ANNUAL INSPECTION REPORT**

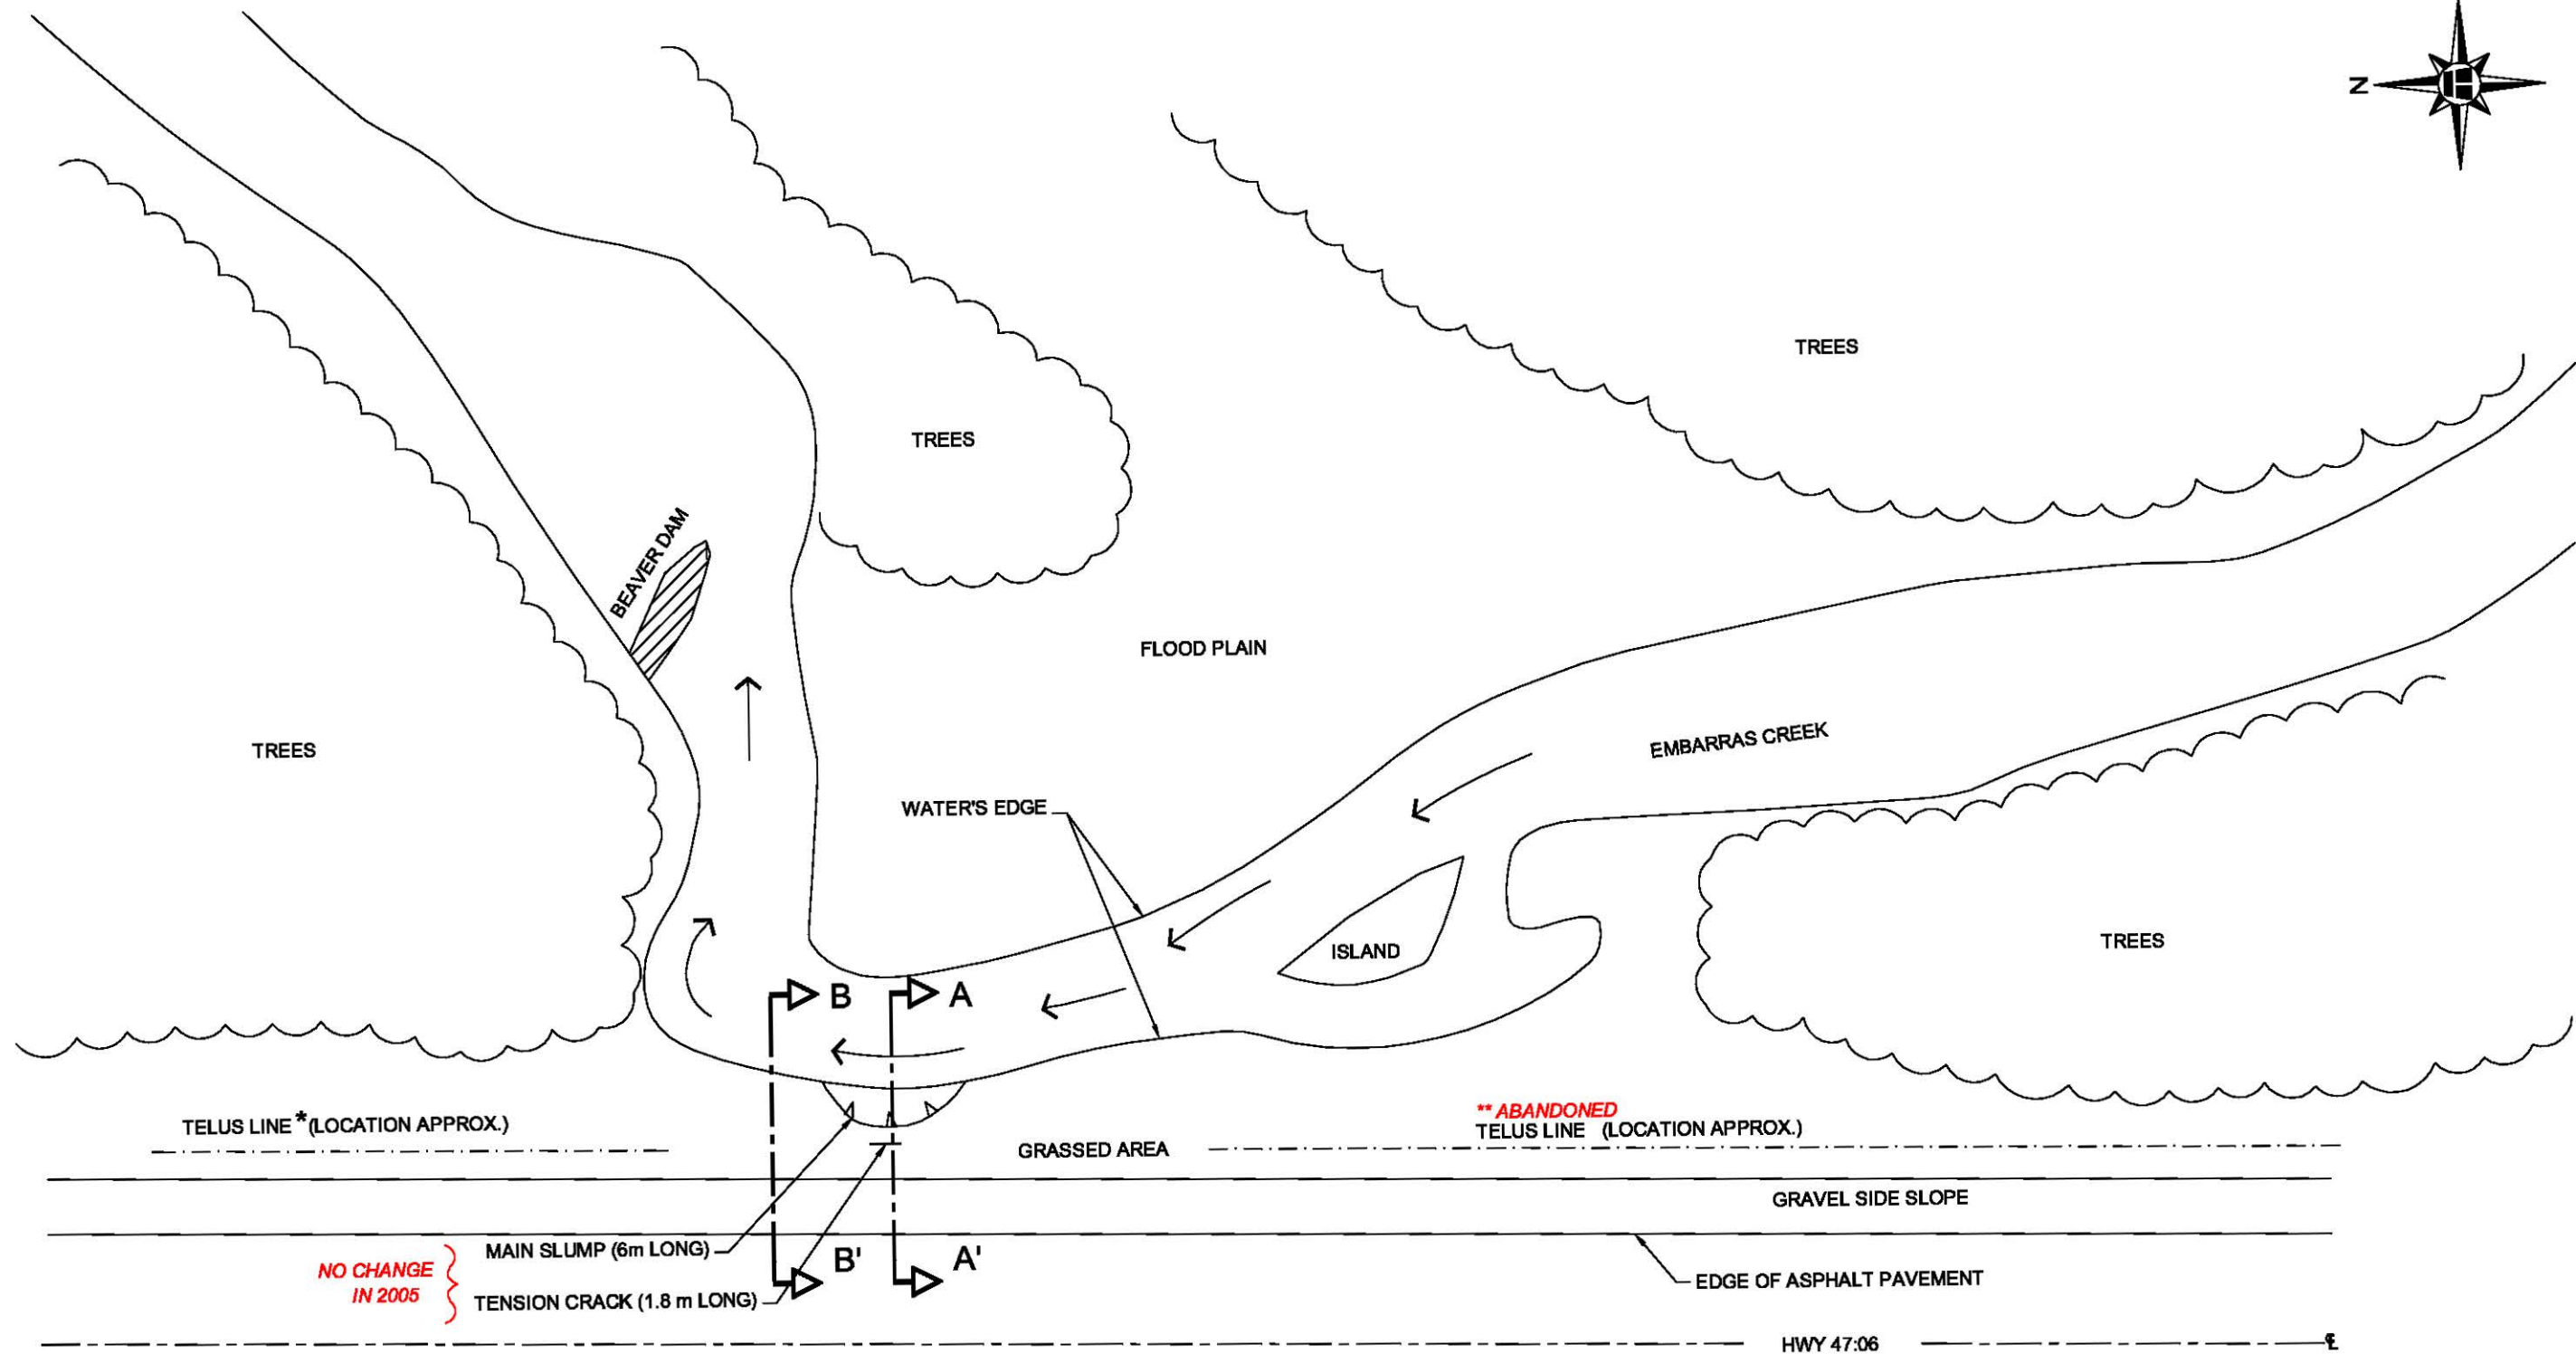
**FIGURE NC38-1**

The roadway surface, side slope and adjacent creek bank at the site were inspected during the site reconnaissance. Features observed at the site are shown on the site plan, Figure NC38-1 (Appendix F), and selected photographs taken during the site visit are attached. In addition, cross-sections through the

The erosion noted on the creek bank and the condition of the main slump and tension crack observed during the initial call out undertaken by Thurber in June of 2004 have not changed significantly since that time.

As noted in the 2004 call out assessment, the tension crack observed between the slump and the highway is linear and appears coincident with the abandoned Telus line, located between the highway surface and the top of bank as shown on the site plan. The Telus line had been abandoned in place since the last site visit, and a new surface line was present at the time of the site reconnaissance.

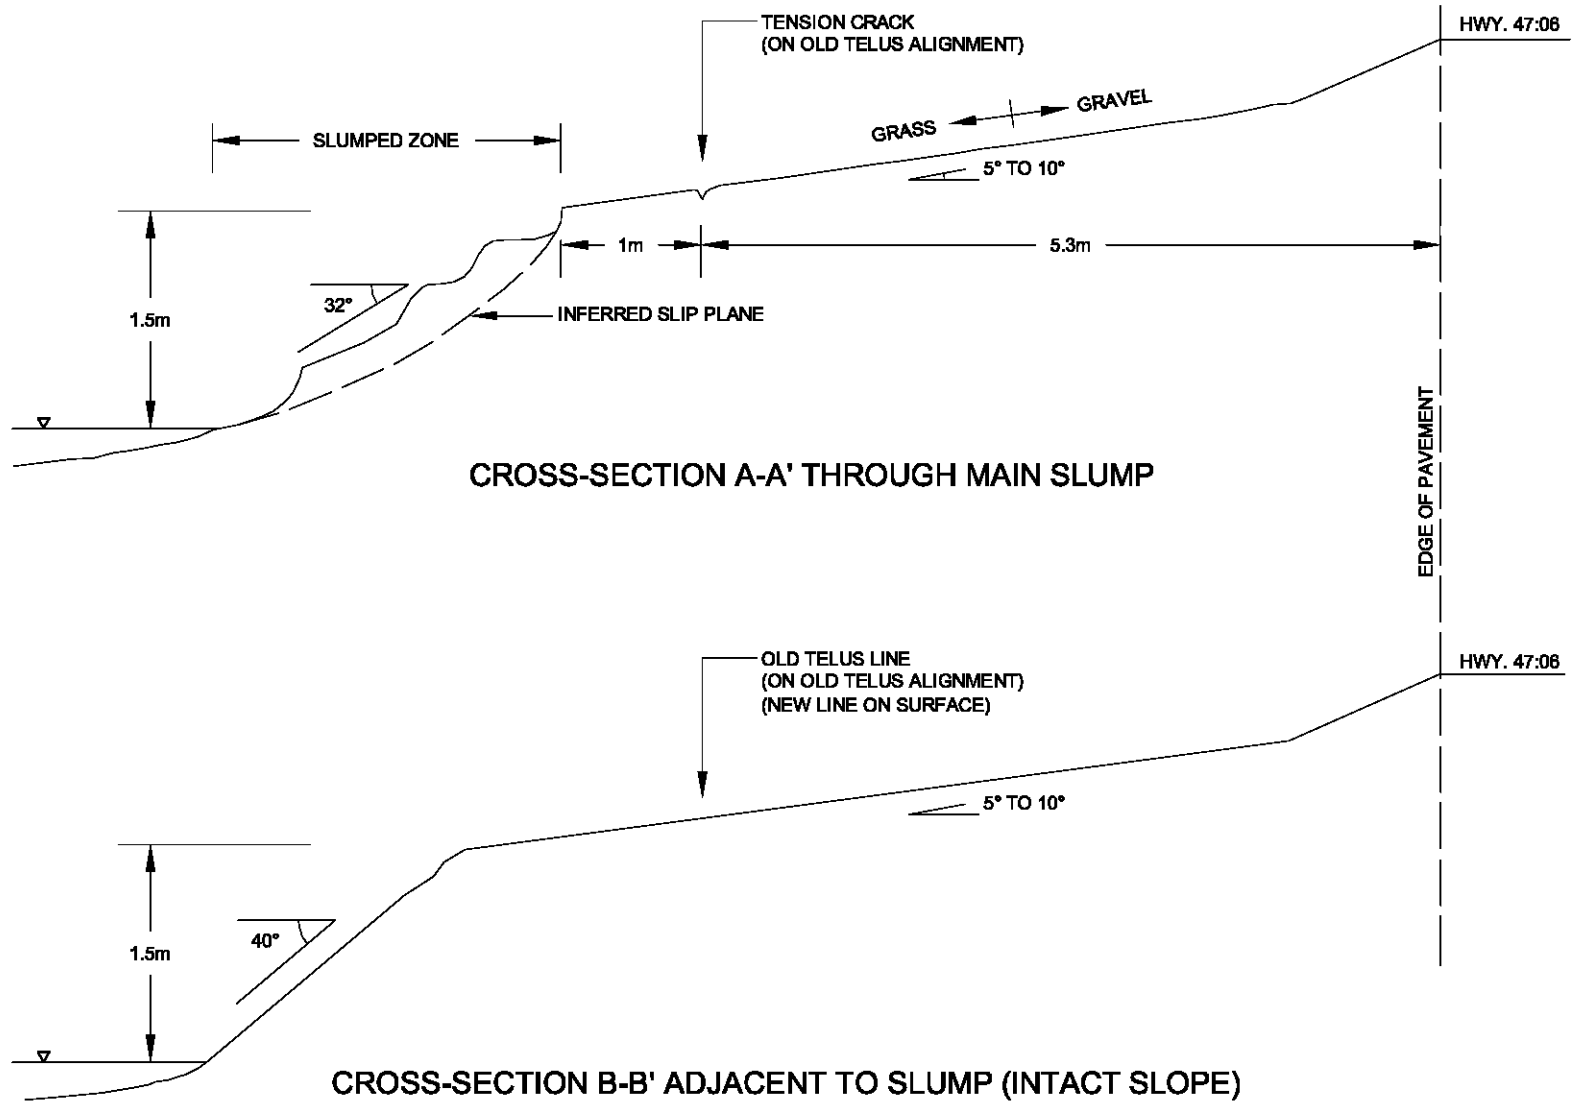
**FIGURE NC38-2**

stream bank slope are presented on Figure NC38-2. Cross-Section A-A' provides an approximate slope profile through the slump area, and Cross-Section B-B' shows the typical slope configuration away from the slump area.

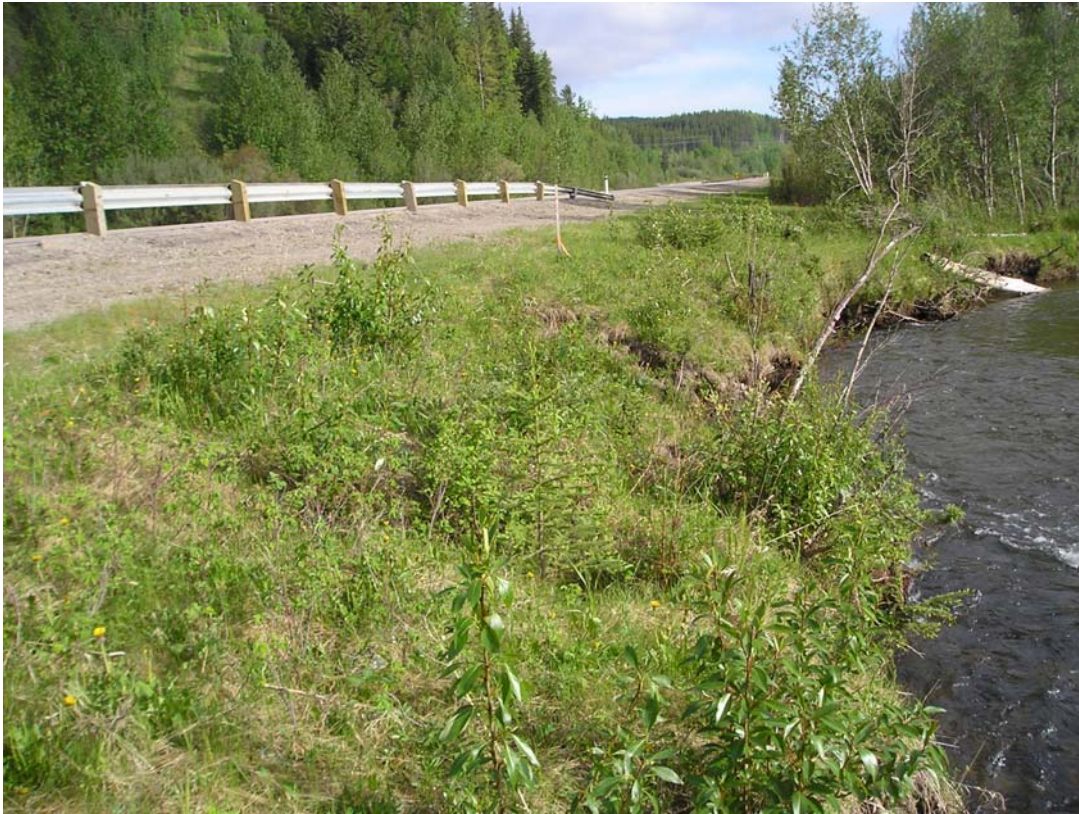
Photo 1 - Looking north along west bank.

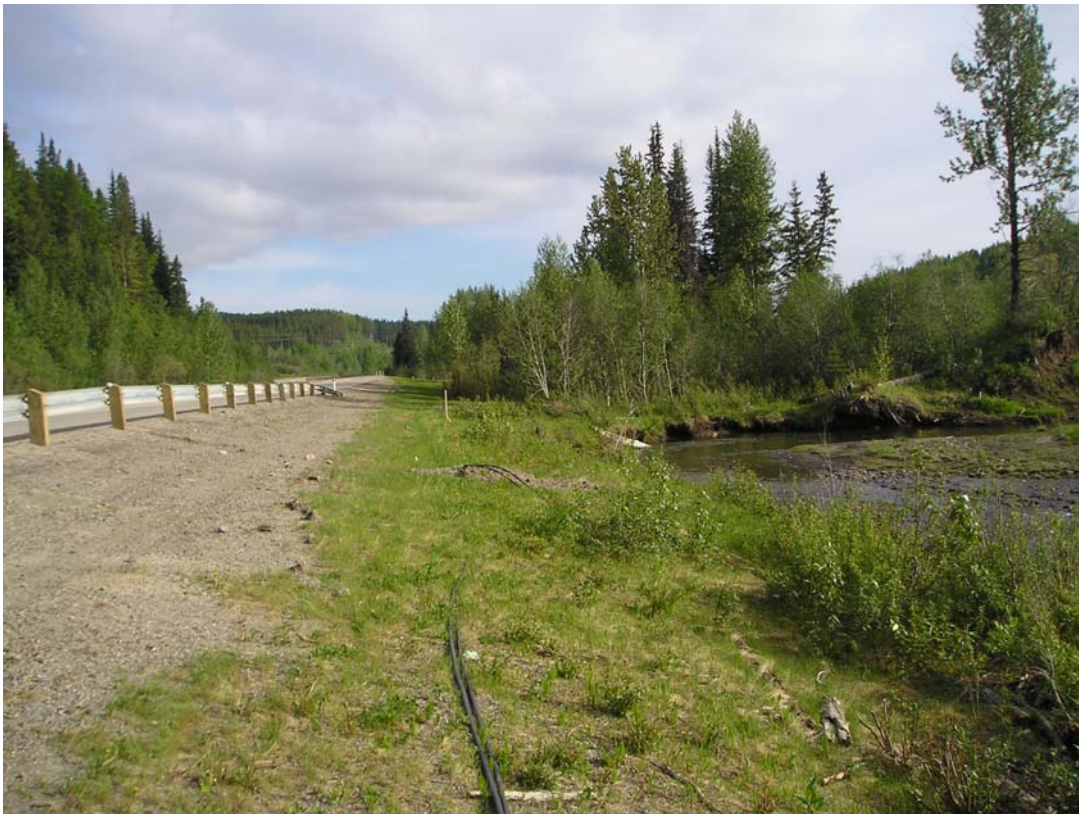
Photo 2 – Looking north along Telus alignment.

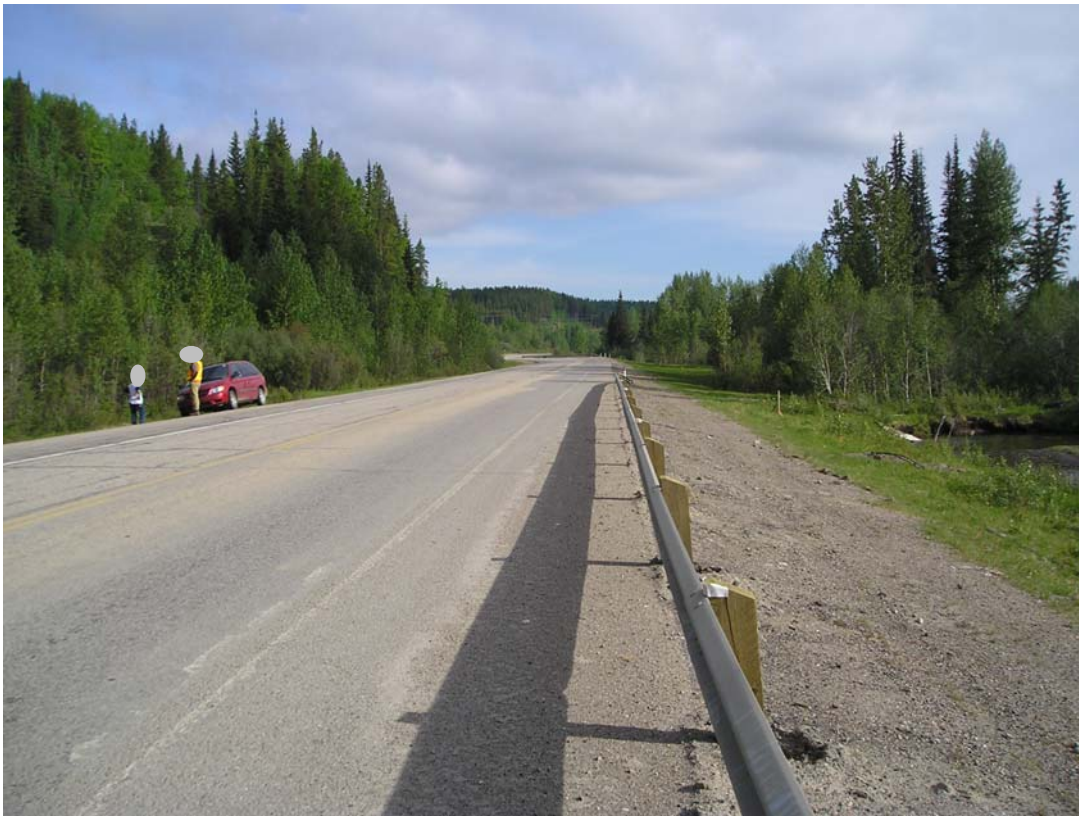
Photo 3 – Looking north along edge of pavement.
