THURBER ENGINEERING LTD.

August 1, 2006

**NORTH CENTRAL REGION – STONY PLAIN AREA
GEOHAZARD ASSESSMENT CALL-OUT, (CE 142-06)
NC 56: WEST DITCH EROSION ALONG HWY 60:02**

FIGURE NC56-1 SITE PLAN
NC56: HWY 60:02 WEST DITCH EROSION
NORTH CENTRAL REGION - STONY PLAIN AREA GEOHAZARD ASSESSMENT
DATE: JULY 2006
THURBER PROJECT #15-85-49

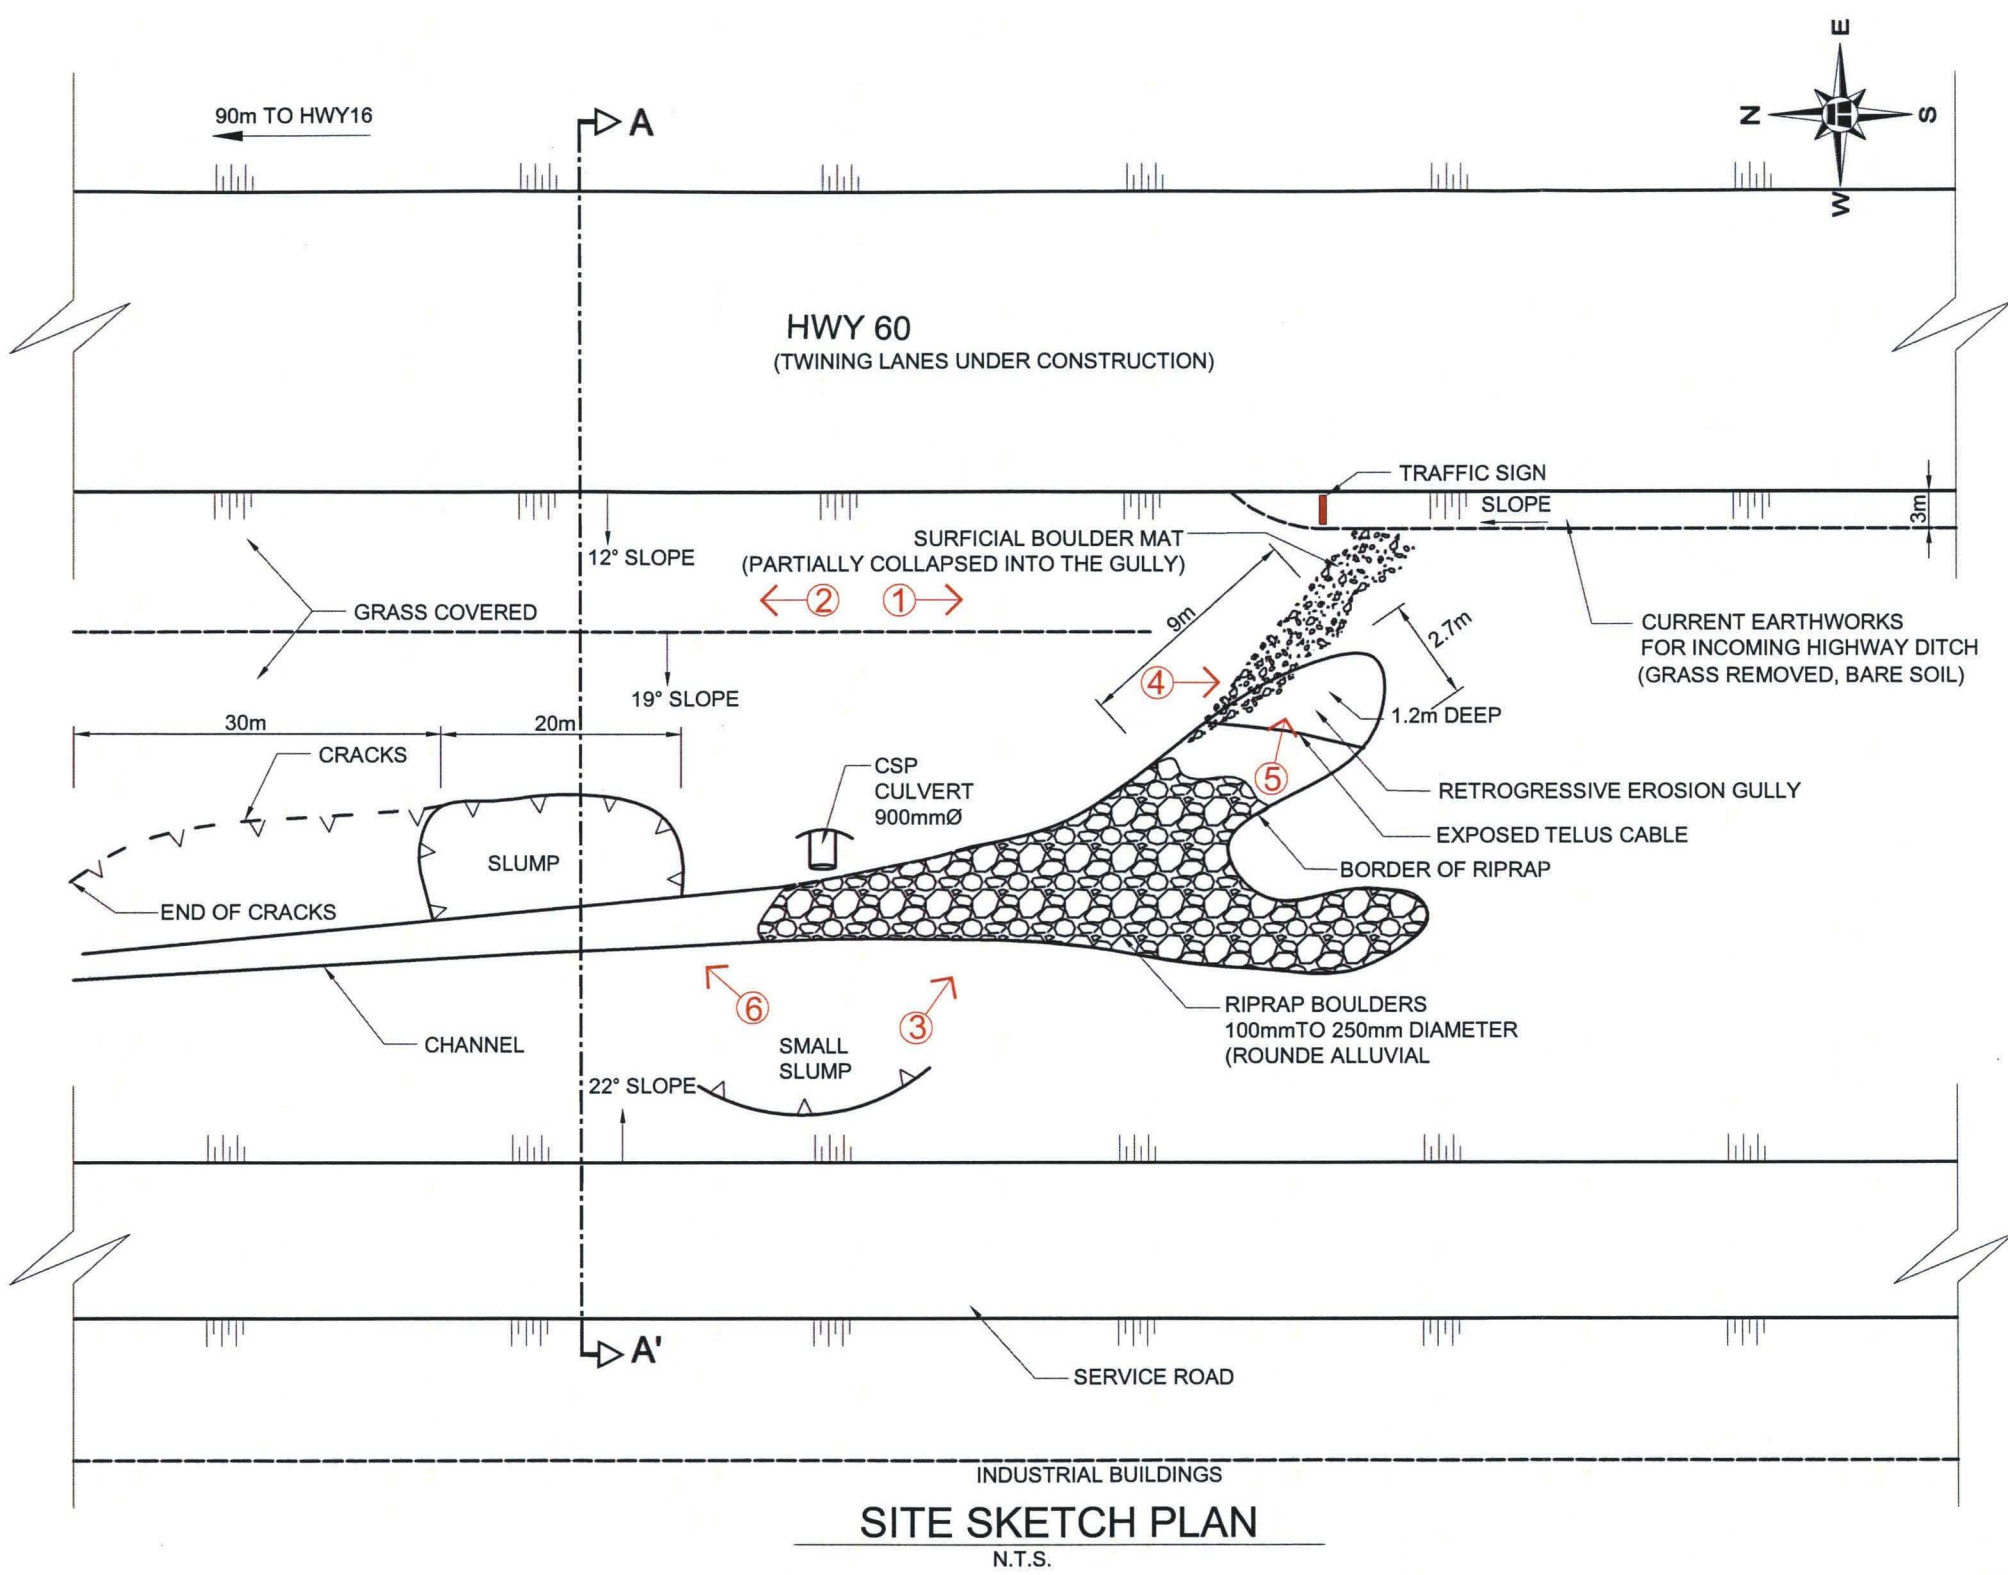
The erosion gully located on the west ditch of Highway 60:02 is the result of insufficient erosion protection in the transition turn of a ditch formerly constructed to join two segments of the west ditch that had a misalignment of about 6 m and a height difference of about 2 m. The thin boulder layer placed at the bottom of the ditch to prevent soil erosion proved insufficient and the incoming water flow from the south quickly eroded the soil along the transition turn that joins the two segments of the ditch. This erosion is retrogressive, advancing to the southeast, towards the direction of the incoming flow.

In the short term, the ground surface at the erosion gully location should be stripped and all loose or disturbed material removed. The disturbed riprap should also be removed and salvaged if possible. The gully should be backfilled with packed clay. A new ditch with a smoother alignment should be excavated through the new fill to smoothly transfer the flow from the upper level highway ditch to the lower level highway ditch. The ditch should be cut with a flat bottom and sloped sides and lined with Class 1 riprap placed over non-woven geotextile. A suggested ditch cross-section is shown on Figure NC56-1. Care will need to be taken to avoid damaging the Telus cable that crosses the eroded ditch section.

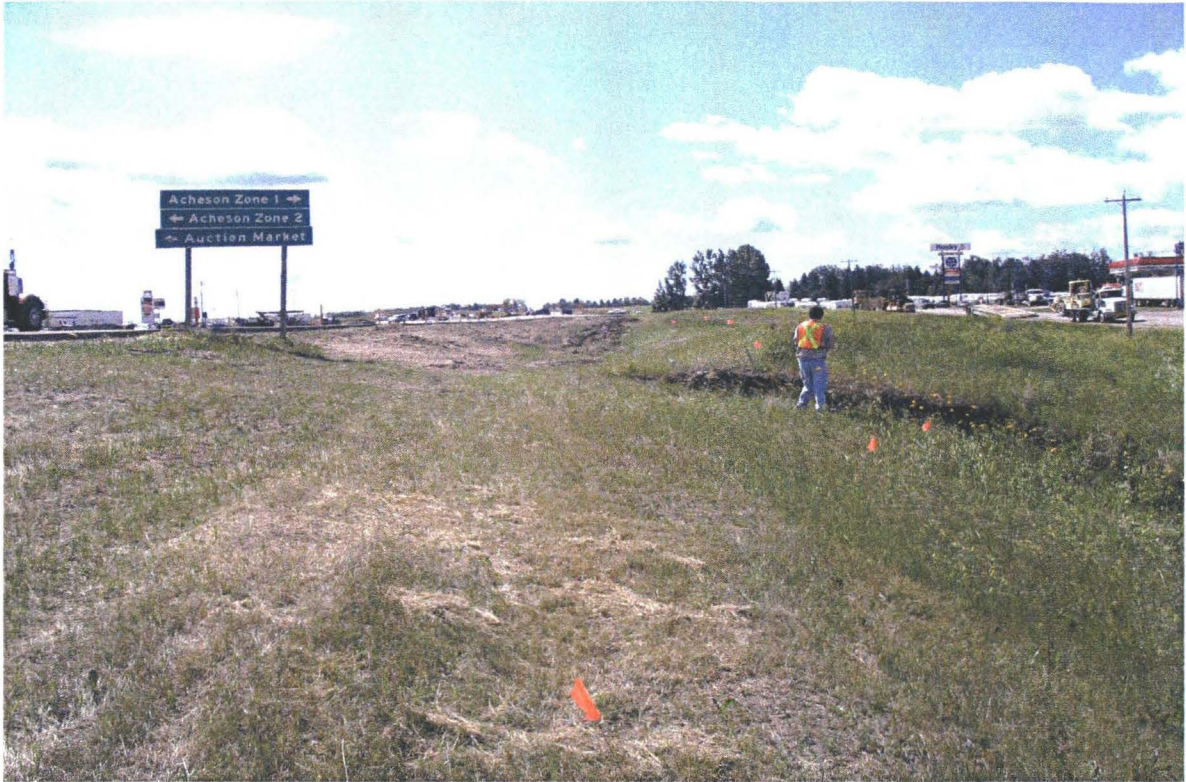
An existing ditch located west of Hwy 60:02 has experienced soil erosion problems since 2002. A Telus telephone cable is currently exposed as its soil cover has been eroded. The erosion rate apparently has been increasing lately, prompting a callout request.

PHOTO 1: Looking south at the location of ditch erosion. Grading associated with the construction of a turning lane is visible further to the south.

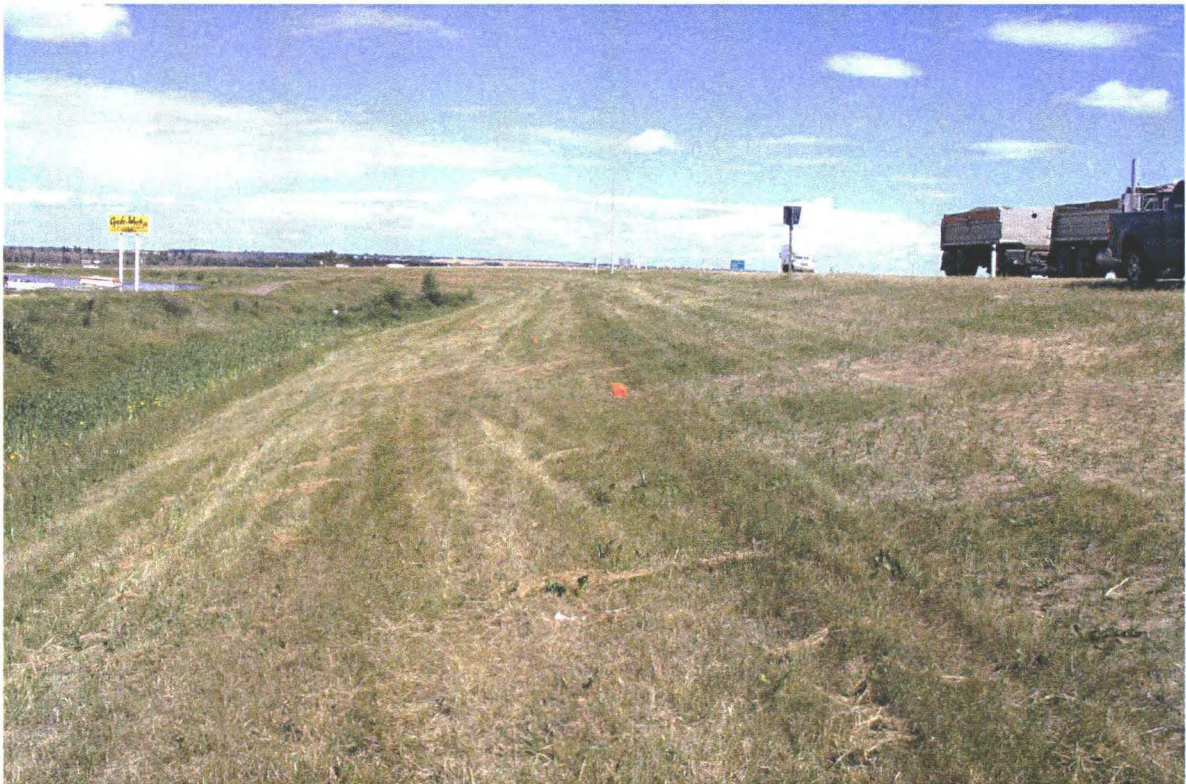
The west sideslope of Hwy 60 is well covered with grass and no erosion features were noted on the sideslope. However, a slump was noted on the east slope of the ditch, about 10 m north of the culvert. The slump was about 2 m high and 20 m wide. The toe of the ditch slope seems to have been eroded by the water running in the ditch. A surficial crack extends 30 m from the slump towards the north, parallel to the ditch suggesting that the slump is on the verge of growing in size.

A small slump was also observed on the west slope of the ditch, located opposite to the above-mentioned slump. The height of that slope is 2.8 m and the west ditch slope has a 22 degree inclination.

Erosion along the toe of the ditch slopes due to runoff in the ditch and from flow exiting from the CSP culvert may have triggered the ditch slope failures. The slump in the east slope of the lower level ditch could eventually retrogress toward the highway and endanger the stability of the highway embankment.

PHOTO 2: View of the lower level highway ditch, looking north.

In the long term, the slump on the east ditch slope should be repaired. Extending the rip-rap as mentioned earlier may help preventing further erosion at the toe of the slope. The slide material should be excavated and removed, and the rip-rap ditch (over non-woven geotextile) should be extended 50 m north beyond the existing CSP culvert. The slope should be reconstructed using compacted pit run gravel (AIT 6-80) as backfill material. The gravel backfill will also provide some

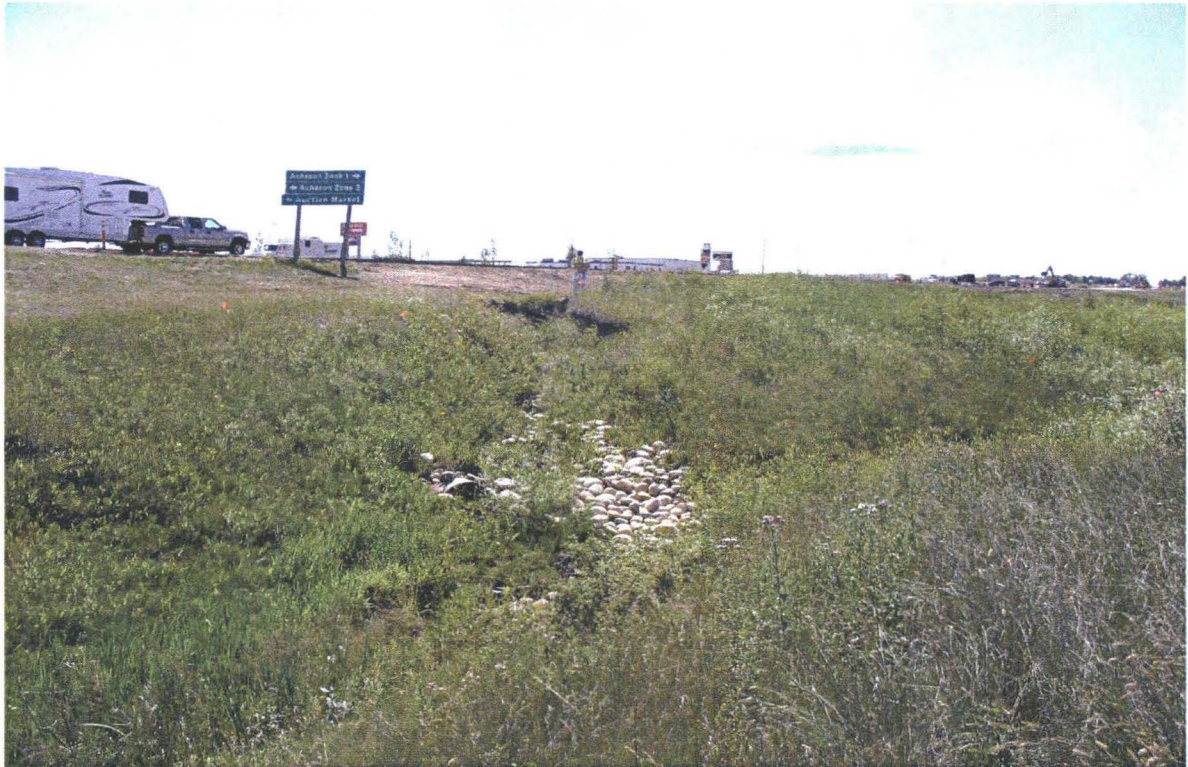
At the end of the transition turn there is a 900 mm diameter CSP culvert, which discharges into the deeper ditch section onto a rip-rap apron made of rounded alluvial boulders 100 mm to 250 mm in diameter. The culvert outlet was clogged with mud and sticks.

PHOTO 3: Looking southeast at the erosion gully and the transition turn of the ditch. The 900 mm diameter CSP outlet is also visible.

The culvert outlet should be also be cleaned out. Additional riprap (over non-woven geotextile) should be placed in the lower level ditch to extend the current rip-rap north beyond the CSP culvert outlet and partway up the west ditch slope opposite the culvert outlet.

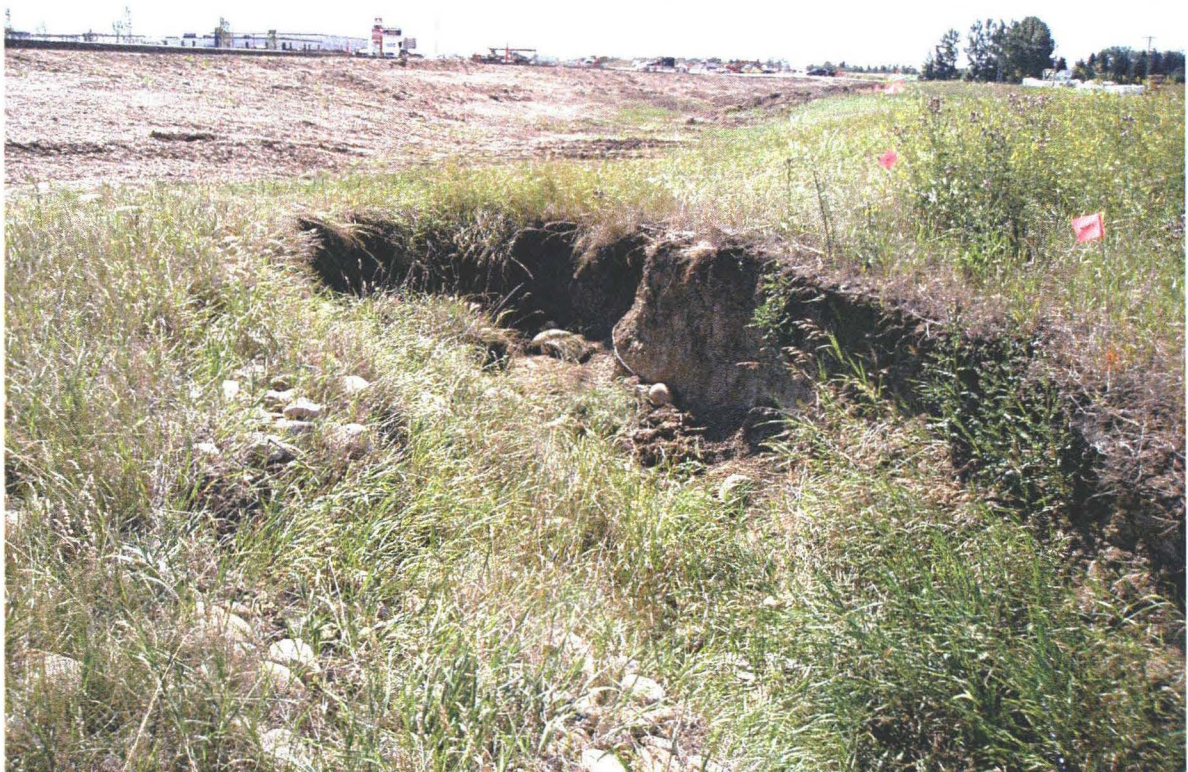
The soil at the erosion gully location is mainly composed of silty sand. Some riprap boulders mentioned above were observed at the bottom of the gully as the soil around them has been eroded.

Given the soil at that location is composed of silty sand and that it is eroded easily, the rate of erosion increases quickly as the exposed surface increases. Since the

PHOTO 4: Erosion gully.
