September 10, 2001

File: 15-76-11

**NORTH CENTRAL REGION LANDSLIDE ASSESSMENT
SH 757:02 PARKLAND COUNTY BOUNDARY (NC16)
2001 ANNUAL INSPECTION REPORT**

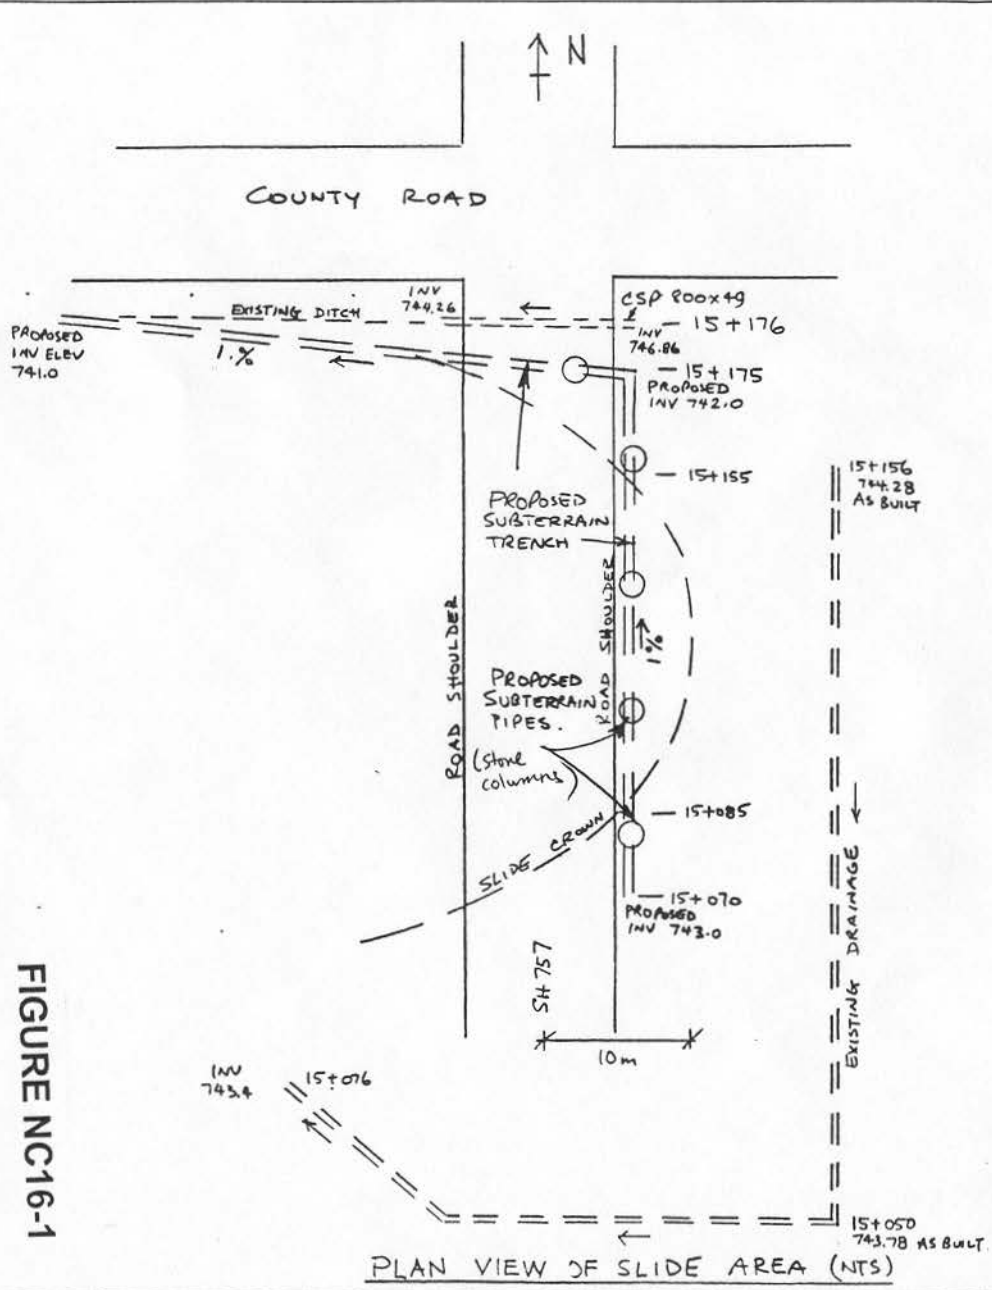
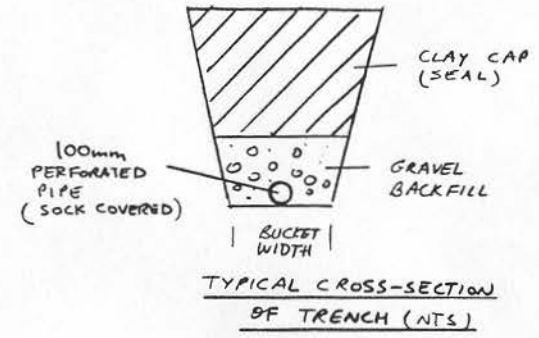
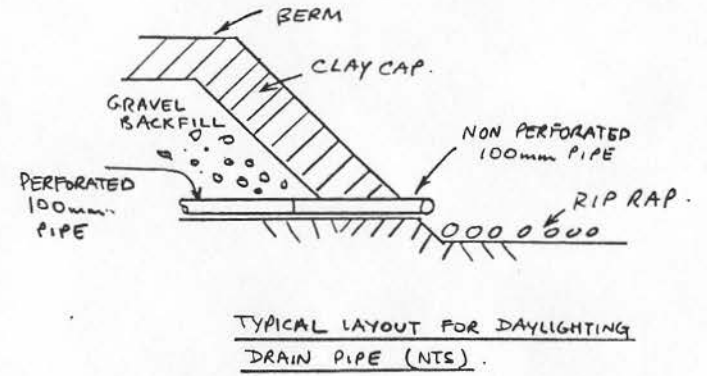
FIGURE NC16-1

Repair of the failed area was undertaken in the fall of 1991. The following remedial measures were undertaken. These measures are shown schematically in plan and cross-section on Figures NC16-1 and NC16-2 in Section F.

- The failed area was sub excavated and replaced with 3.5 m of compacted lightweight fill (sawdust). A clay cap was placed over the sawdust prior to replacing the pavement structure.
- Five stone columns (600 mm dia x 18.3 m long) were installed on the east shoulder of the roadway to relieve water pressure in the underlying coal layer.
- A trench drain was installed at the site. The proposed drain layout is shown on the site plan and cross-section. Record of the actual location and depth of the drain was not available in the files.

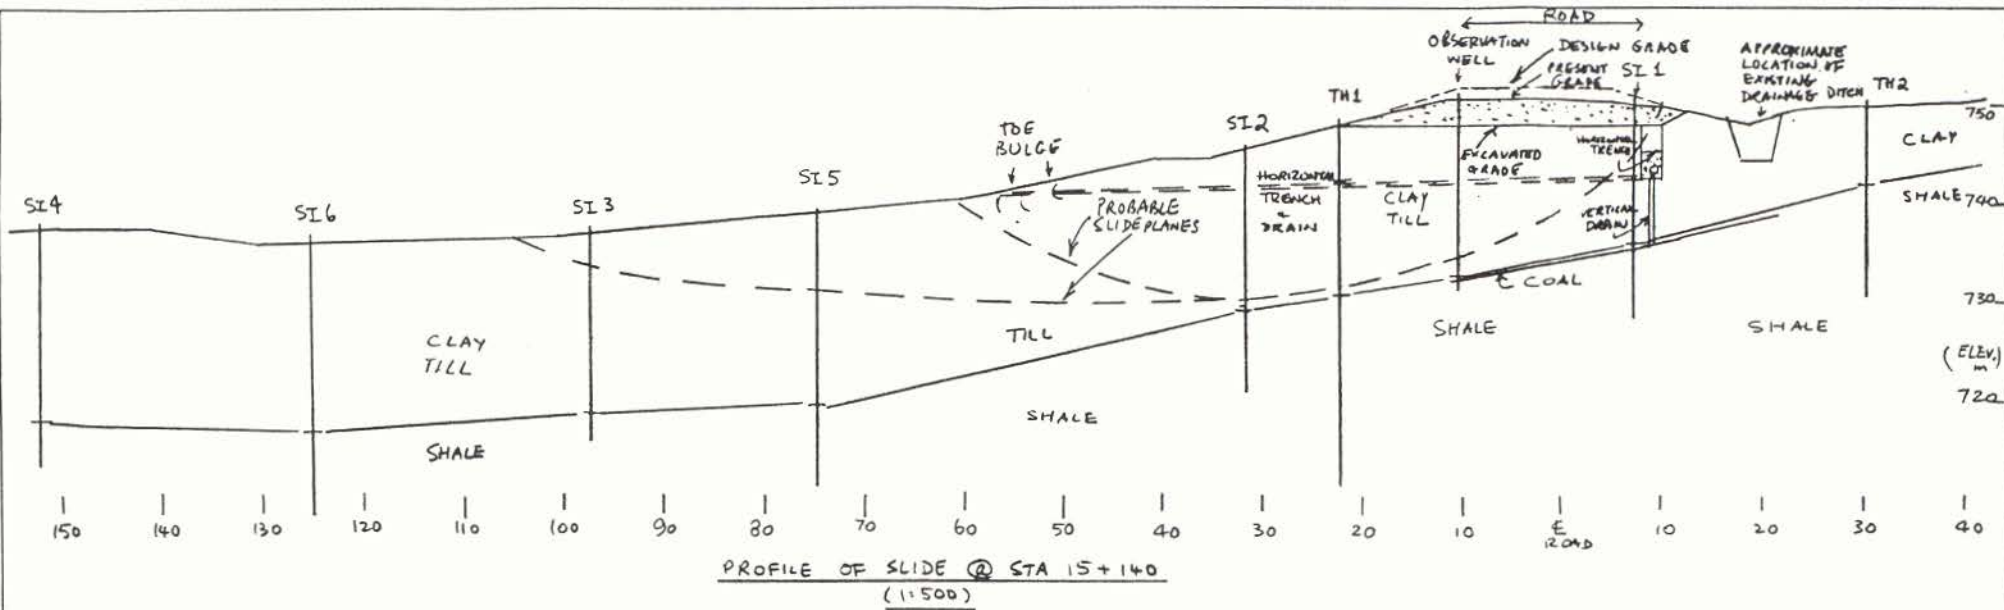
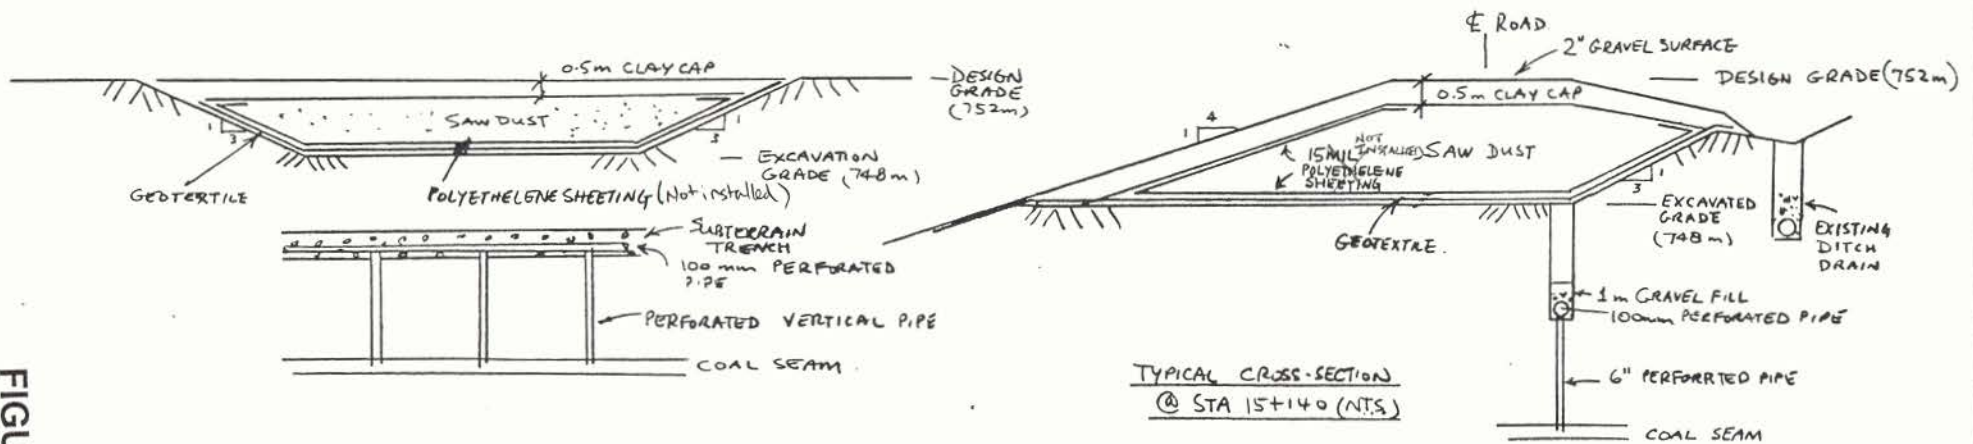
FIGURE NC16-2

LONGITUDINAL CROSS-SECTION OF FILL
STA 15+076 TO STA 15+176 (N.T.S.)

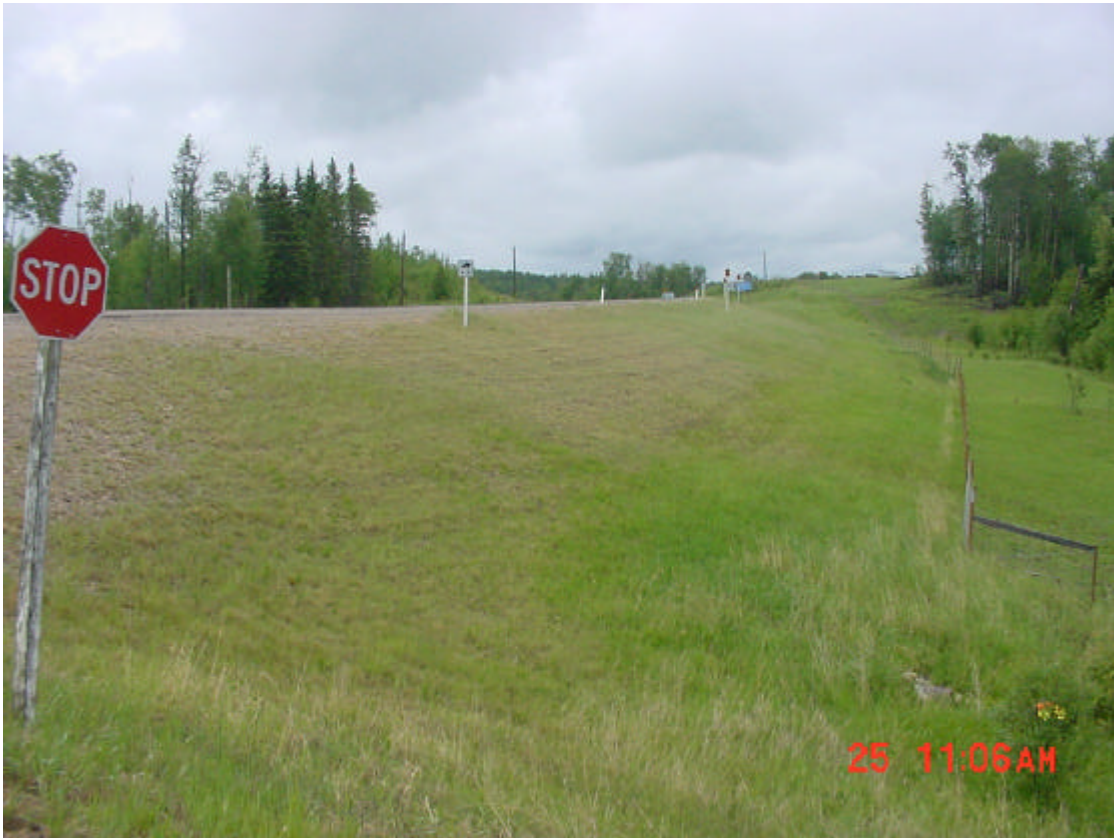
- No distress was noted in the side slope or on the pavement surface. No signs of instability (i.e. cracking, bulging, seepage) were noted on the side slope or in the toe area of the embankment.
- The culvert outlet at the north end of the embankment appeared to be performing satisfactorily.
- No signs of instability or settlement were noted in the east ditch.

PHOTO NC16-1 LOOKING SOUTHEAST AT EMBANKMENT REPAIR AREA
CULVERT OUTLET IN BOTTOM RIGHT CORNER

Based on the above noted observations, the repair appears to be performing satisfactorily. Therefore, no action is recommended at this site.

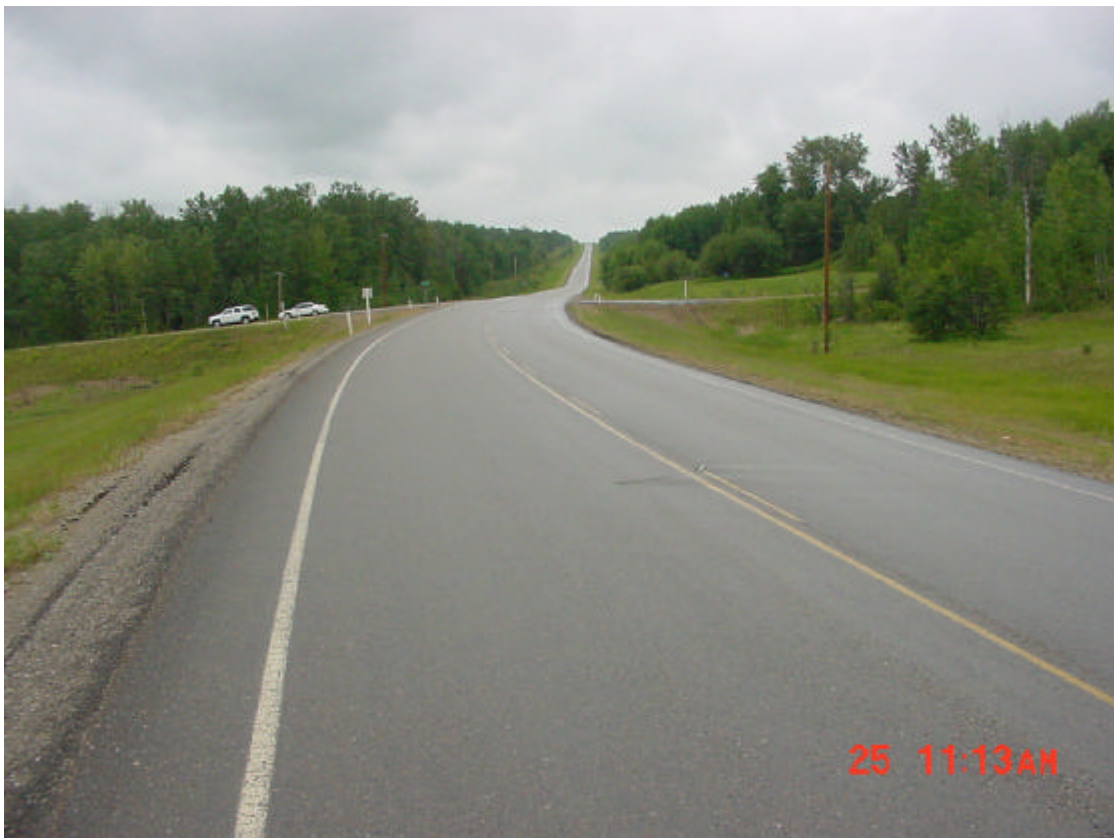
PHOTO NC16-2 LOOKING NORTH FROM SOUTH END OF REPAIR AREA

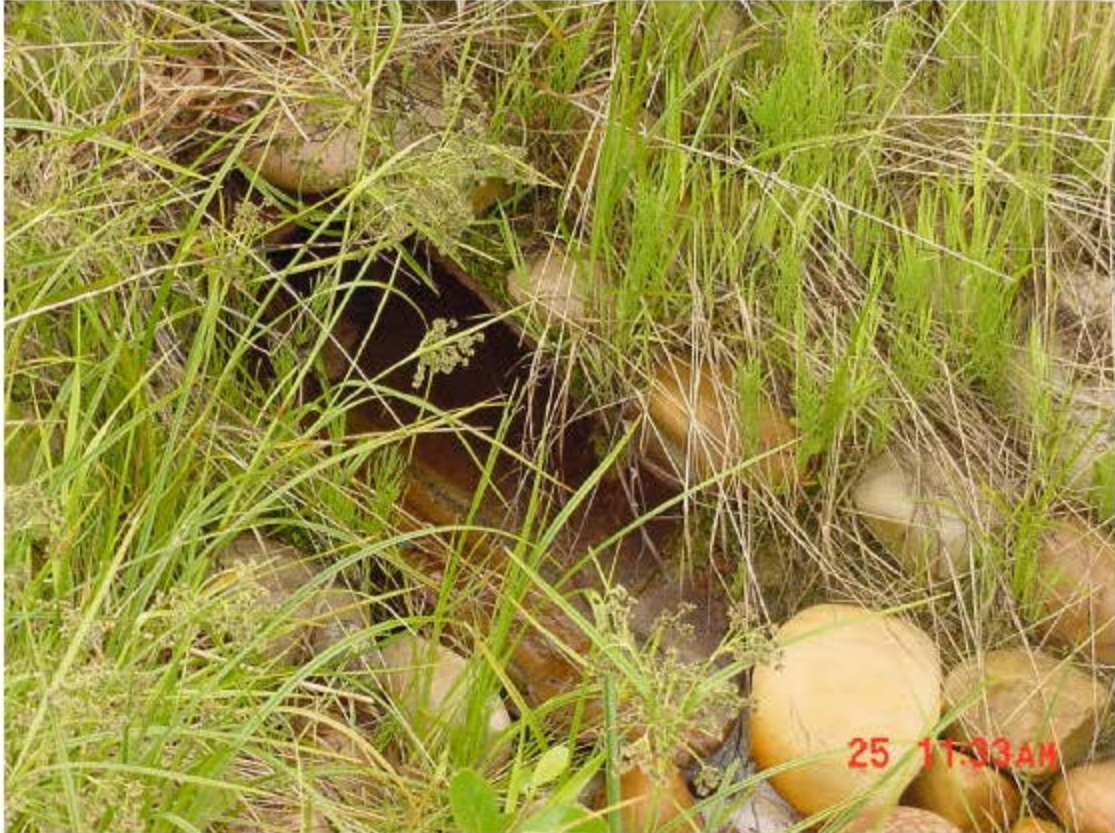
PHOTO NC16-3 CULVERT OUTLET ON WEST SIDE OF EMBANKMENT
