**THURBER ENGINEERING LTD.**

October 4, 2004

**NORTH CENTRAL REGION GEOHAZARD ASSESSMENT  
HWY 759:02 SOUTH OF BERRYMOOR BRIDGE (NC7)  
2004 ANNUAL INSPECTION REPORT**

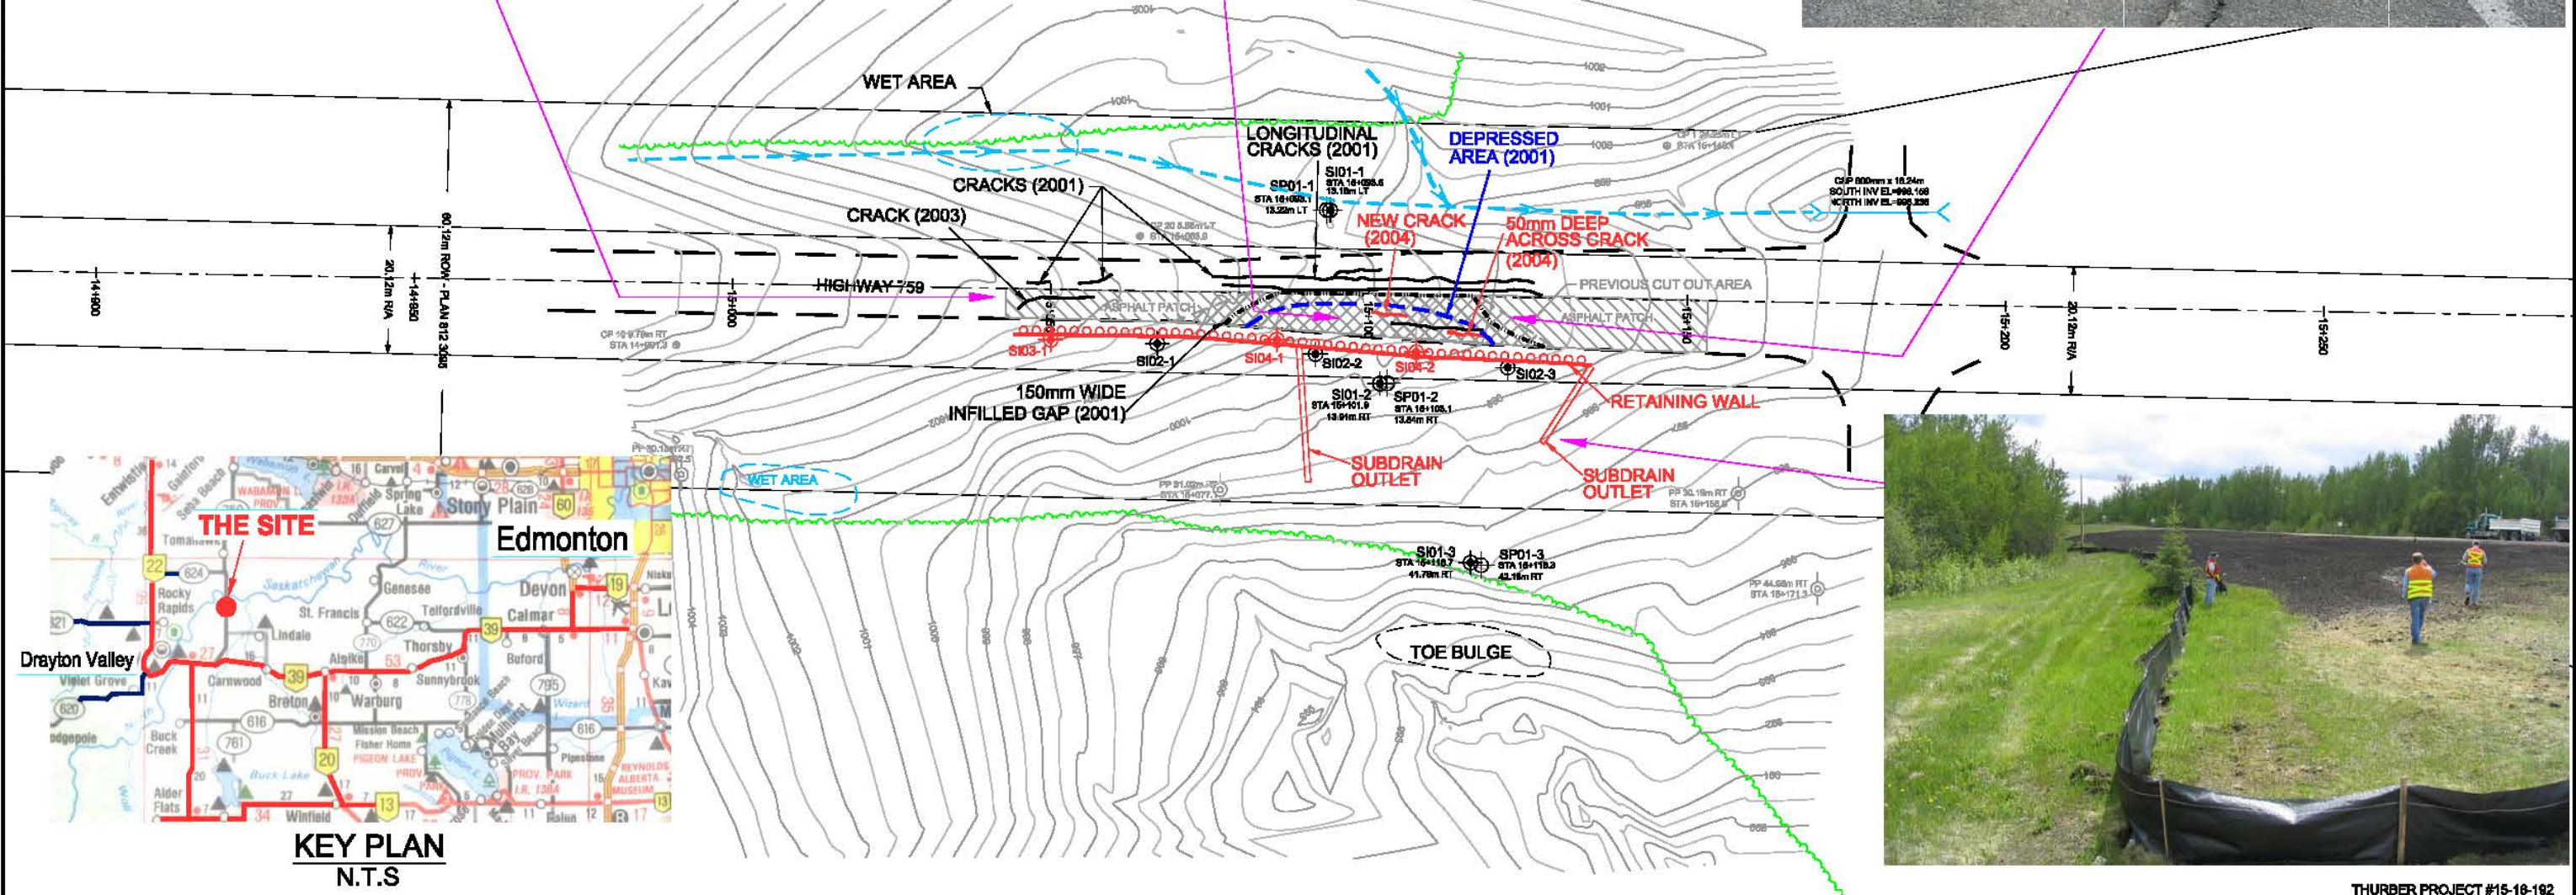
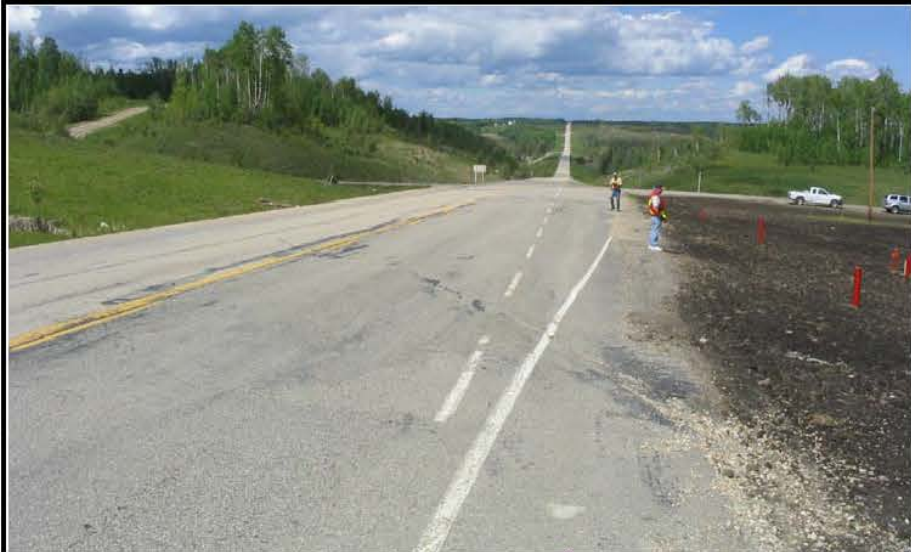
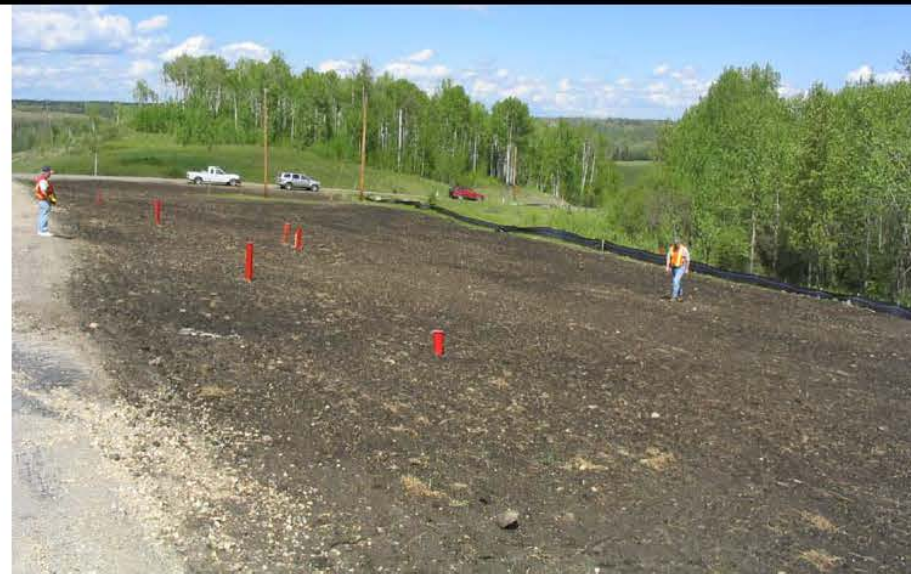
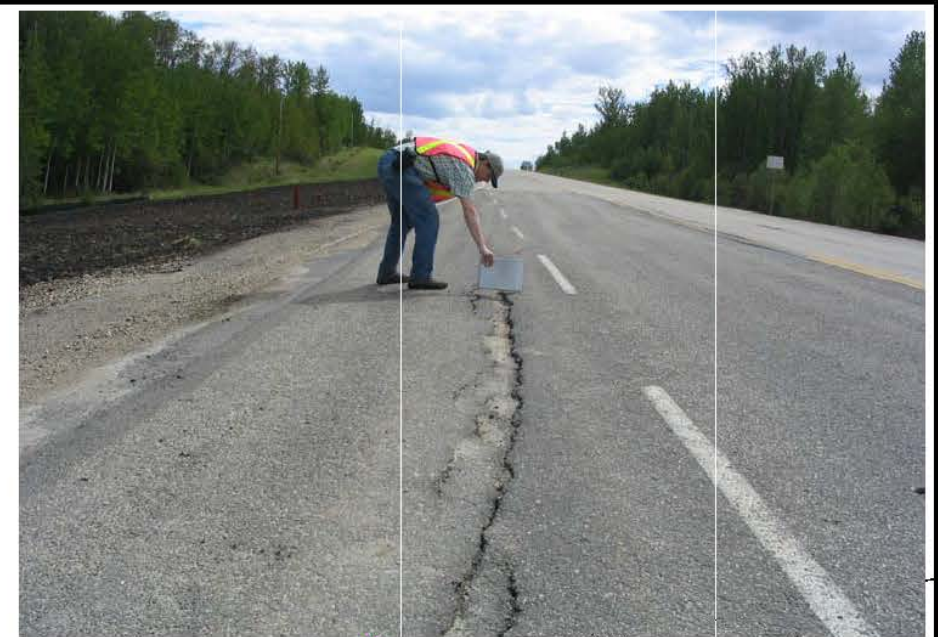
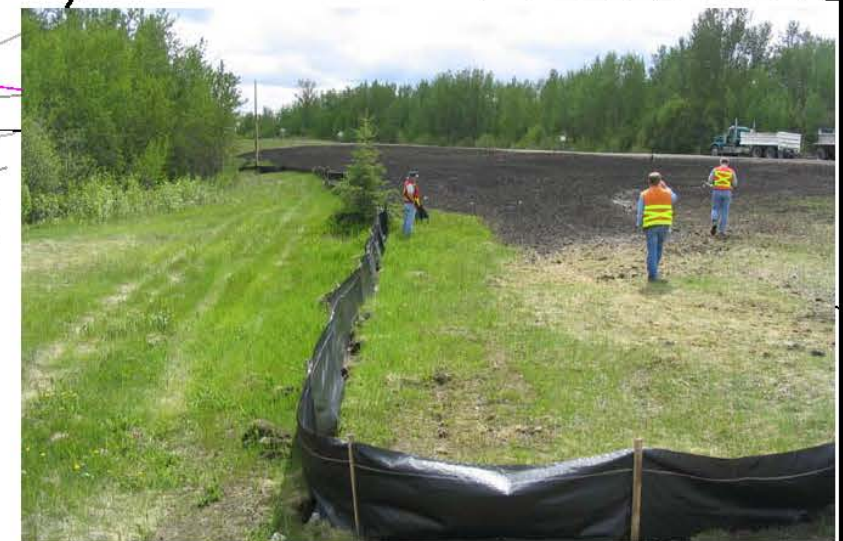
DRAWING No.  
**FIGURE NC7-1**

- A few new cracks and further widening and settlement of old cracks (Figure NC7-1) were noted, however, these are believed to be caused by the recent construction activity for the construction of the pile wall adjacent to the highway.
- The east side slope was recently reshaped, topsoiled and seeded as part of the construction of the pile wall.
- There are two new subdrain outlets on the east side slope, one located at the north end exiting at about mid slope height and the other located approximately at the centre of the pile wall exiting at the toe of the side slope. Water was noted flowing out of both subdrains
- The silt fence placed during construction at the toe of the south side slope is standing straight and in good condition.

The current road surface is not in good condition and high differential drop sections should be milled and the area should be re-patched to provide smoother driving conditions. The new patch will also provide a better baseline for

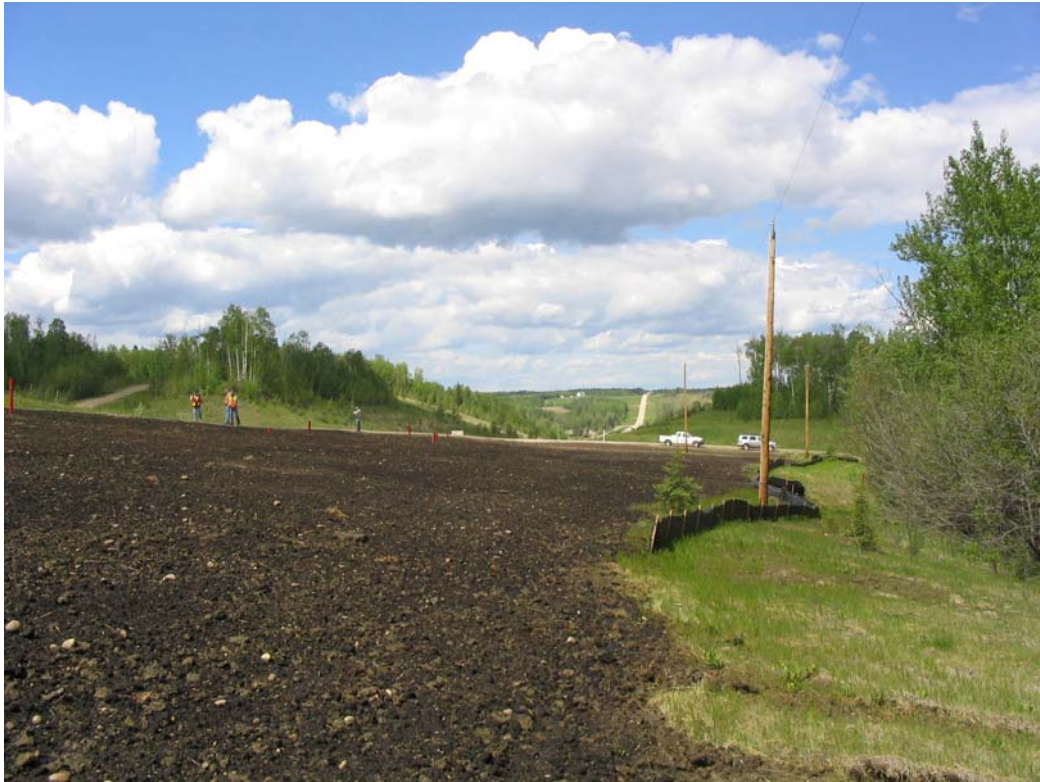
Photo 1. Side slope after pile wall construction.

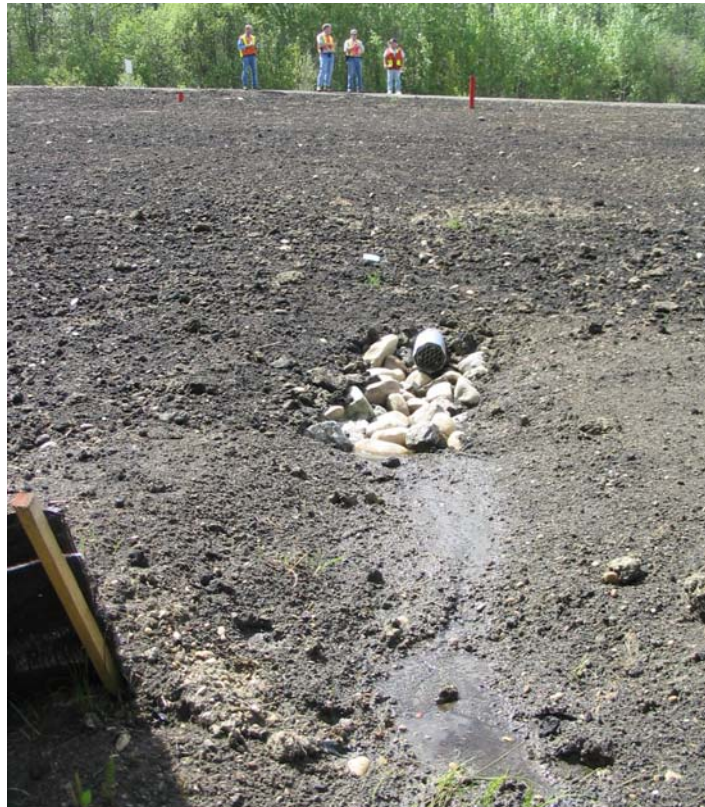
Photo 2. Subdrain outlet
