**NORTH CENTRAL REGION GEOHAZARD ASSESSMENT
HWY 759:02 SOUTH OF BERRYMOOR BRIDGE (NC7)
2005 ANNUAL INSPECTION REPORT**

This letter documents the 2005 annual site inspection of an area of slope instability located along Hwy 759:02 approximately 1 km south of the Berrymoor Bridge over the North Saskatchewan River (11.5 km north of Jcn. Hwy 759 and Hwy 39).

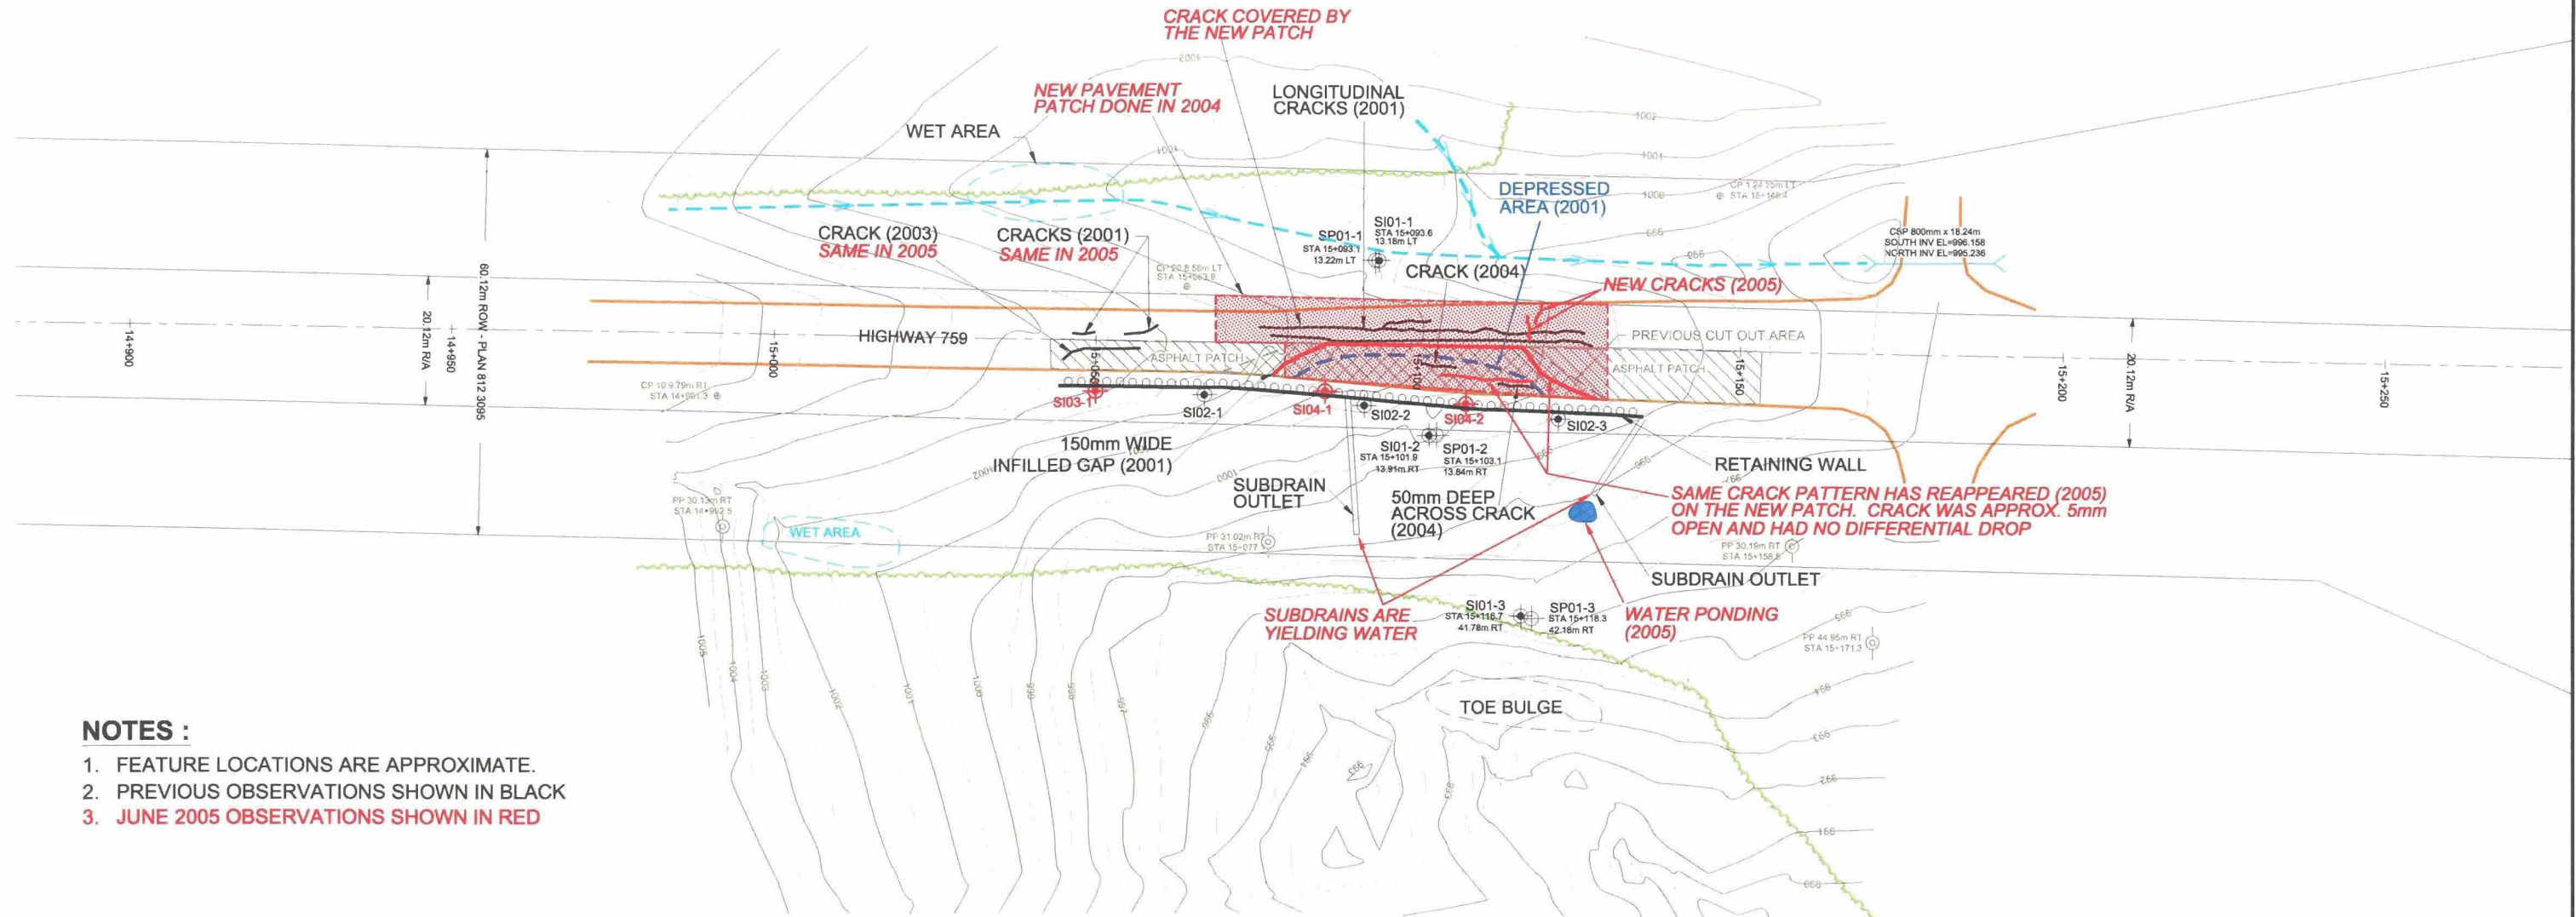
ENGINEER:	RVC	DRAWN:	ZD	APPROVED:	
DATE:	JULY	SCALE:	1:1000 APPROX.	DRAWING No.:	FIGURE NC7-1

The changes in condition since last year are shown on the site sketch plan in Figure NC7-1 in Section F of the binder. Selected photographs taken during the visit are also included in Section F.

The old main pavement crack has reappeared on the new overlaid (2004) pavement surface as showed in the drawing on Section F. The new crack is approximately 5mm open and there is no noticeable differential drop across the crack.

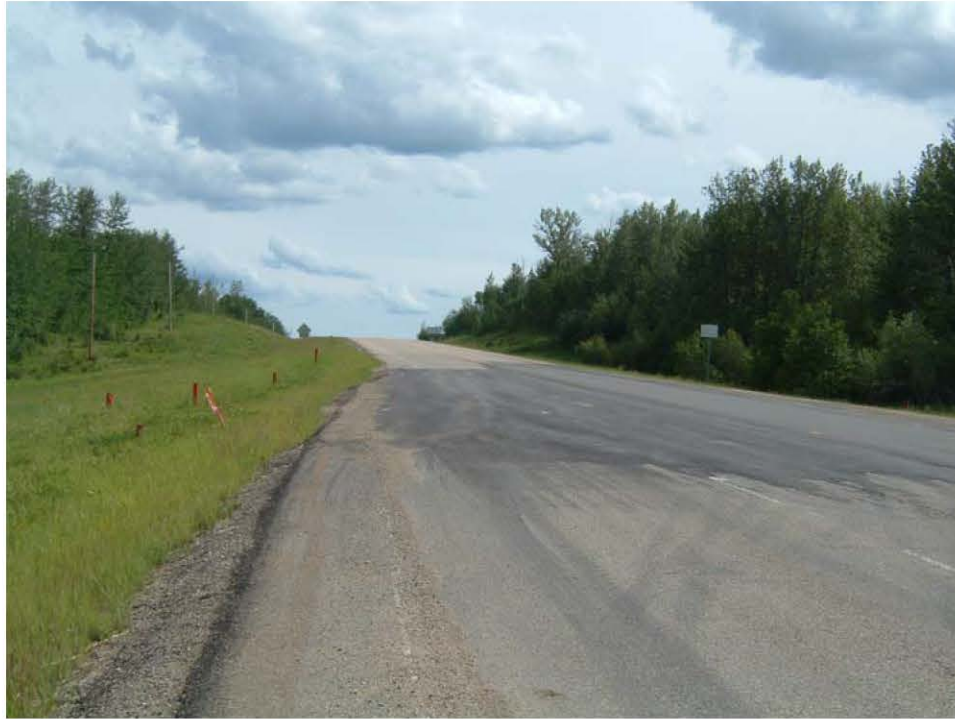
Photo 1 – New overlaid area, looking south (2005).

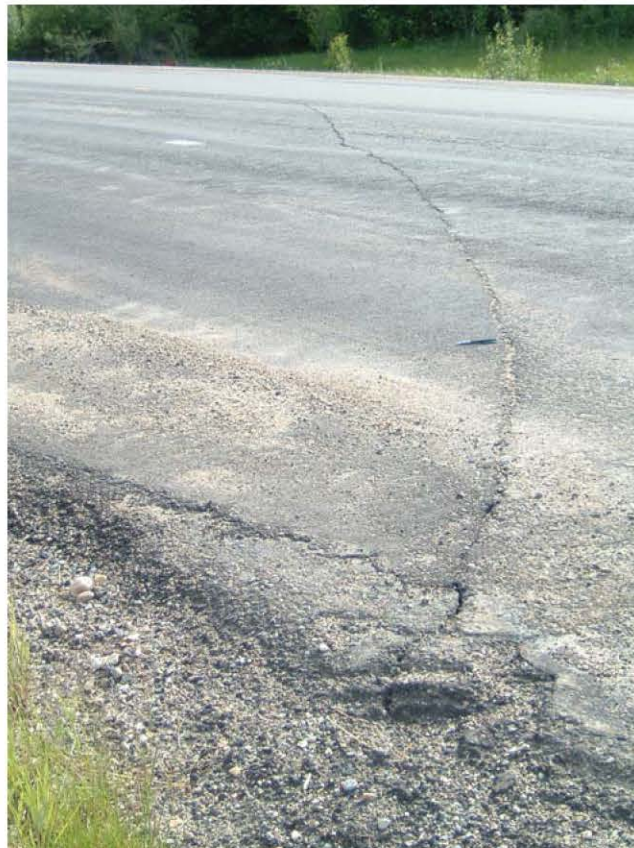
Based on the above, the reappearing of the main crack on the new overlay is likely related to reflective crack from the original crack, rather than related to slope movement.

Photo 2. Main crack reappears through the new overlaid asphalt patch (2005).

Based on the above observations this site appears to be performing well, with the exception of the reappearance of the main crack through the new patch (2004). However, this crack is likely a reflective crack and should be repaired as per AIT Asphalt Pavement Transverse Crack Repair – Mill and Fill Specification 53.8. A crack repair drawing is attached at the end of this report. The estimated cost for the repair is approximately \$ 6,000.

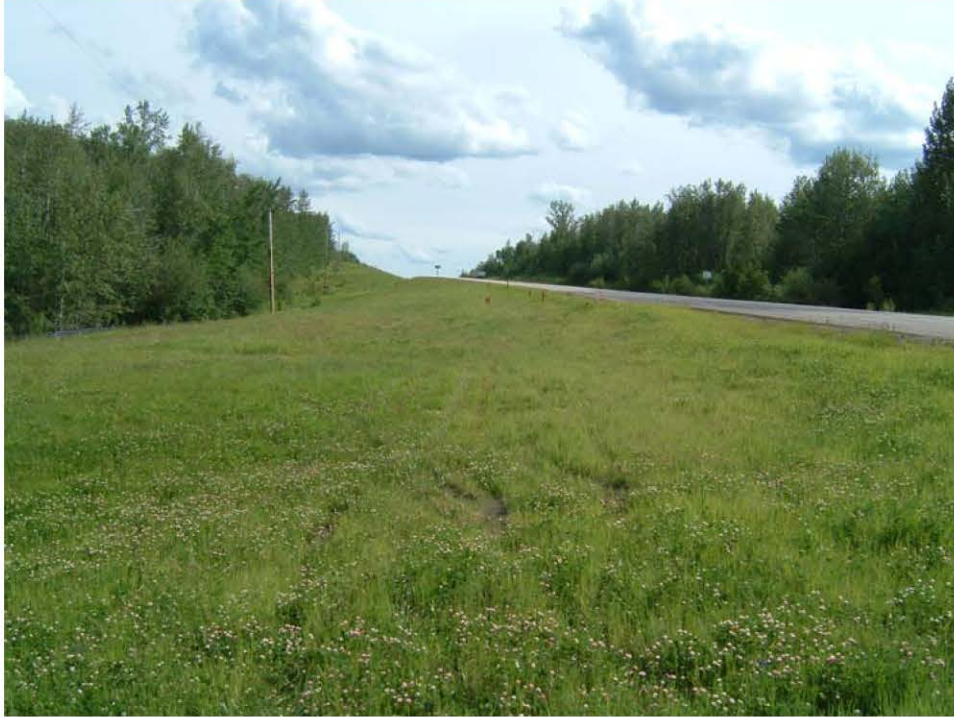
The side slope vegetation has grown reasonable well since the end of the pile wall construction and is fully established.

Photo 3. Side slope fully re-vegetated (2005).

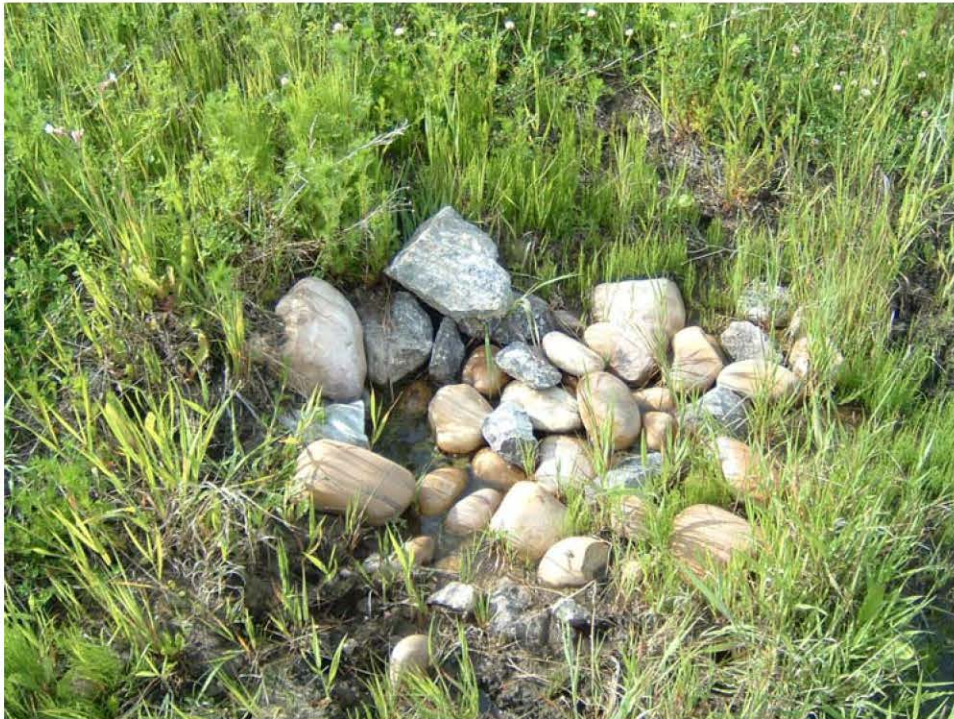
The two existing drains outlets installed during the construction of the pile wall in 2004 were working properly with water flowing.

Photo 4 – North end drain outlet (2005).

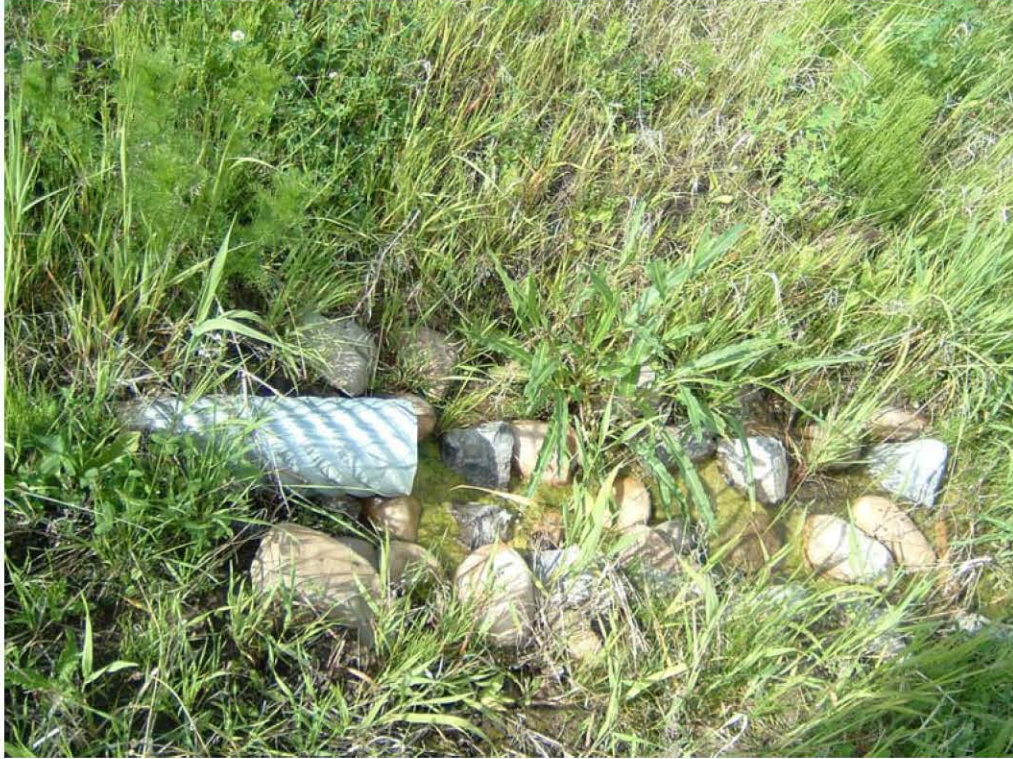
Photo 5 – South end drain outlet (2005).
