**STONY PLAIN REGION  
GEOHAZARD RISK ASSESSMENT  
SITE INSPECTION FORM**

<b>SITE NUMBER AND NAME:</b> NC 22 - Pavement Dip	<b>HIGHWAY AND KM:</b> Hwy 759:02, km 1.42	<b>PREVIOUS INSPECTION DATE:</b> June 2, 2009	<b>INSPECTION DATE:</b> May 20, 2010
<b>LEGAL DESCRIPTION:</b> NW 11-49-6-W5M	<b>NAD 83 COORDINATES:</b> -51362 E, 5898567 N	<b>RISK ASSESSMENT:</b> PF: 9      CF: 2 <b>TOTAL: 18</b>

**NC-22 Pavement Dip at Hwy 789:02, km 1.42**

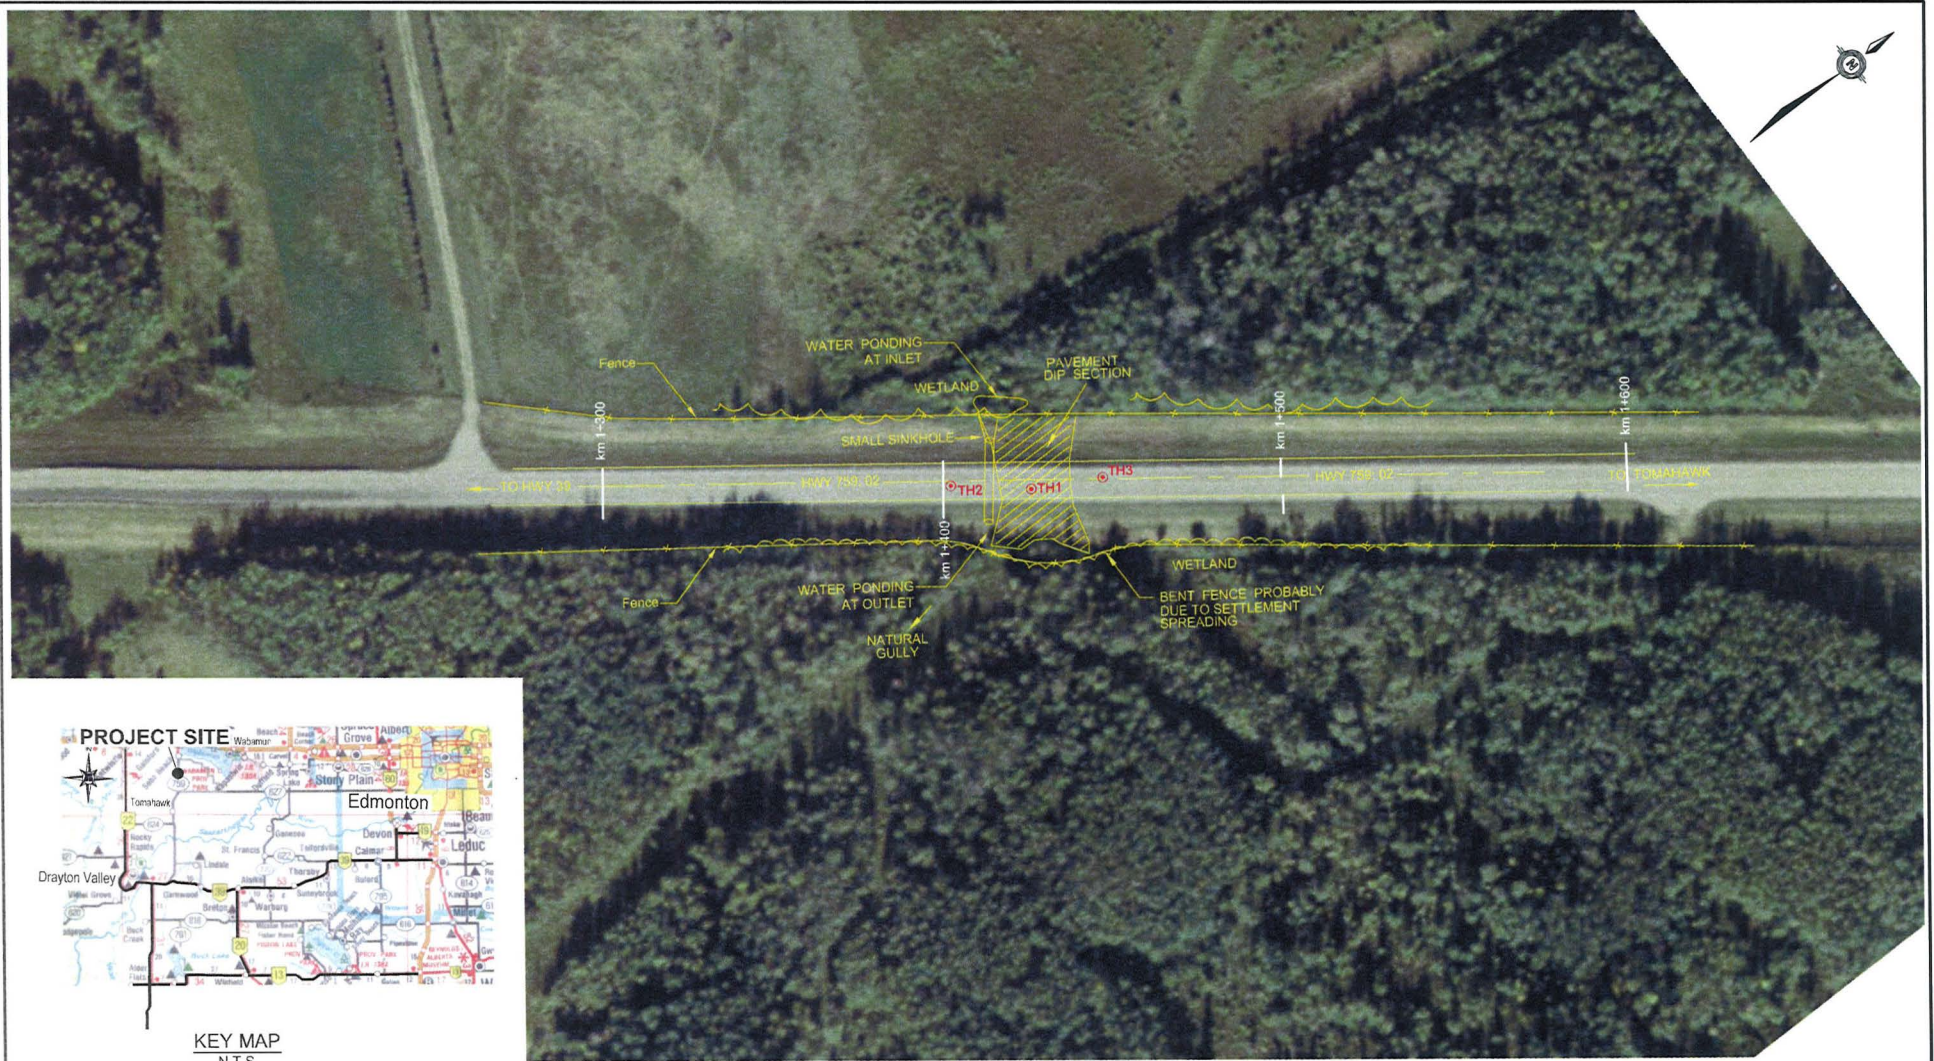
Figure NC-22

Location and site plan shown on Figure NC-22.  
 Site conditions shown in Photo 1.  
 Risk level unchanged from 2009.  
 No additional pavement has been placed since 2001.

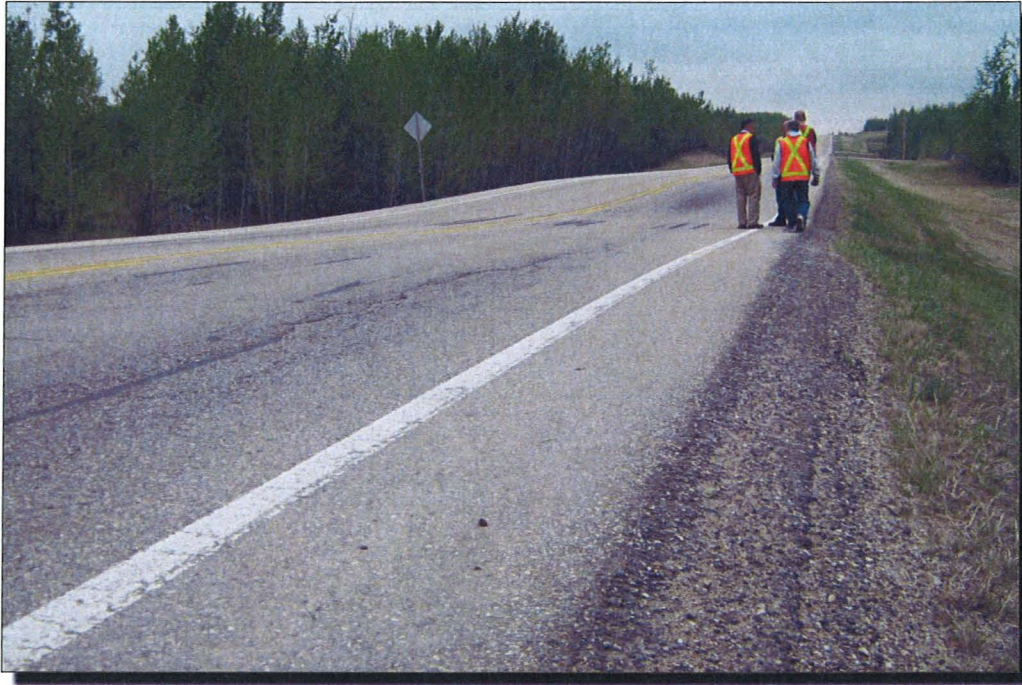
- Length of pavement dip is approximately 30 m long and appears to be relatively uniform across the width of the pavement;
- Pavement dip appears to be about 0.6 m;

- Pavement cracks are sealed. Relatively unchanged pattern from 2007 and 2008 inspections;
- 800 mm diameter culvert located south of the pavement dip. Culvert appears to be blocked and standing water is located within the ditch on both sides of the highway;

- Lateral spreading of embankment suspected due to concave shape of sideslopes in dip area and deflection of the barbed wire fence.

**Photo 1**  
Pavement dip site, facing north

- Recommended for pilot project for foam injection. Project to be conducted Summer/Fall 2010. Survey monitoring points should be measured before and after foam injection and re-grading of road surface to monitor performance. Three surveys should be conducted after construction. The surveys should be conducted at 3 month intervals.
- MCI should replace the existing culvert and develop a construction plan for improvement of both ditches.
- TRANS operations staff and EBA to discuss milling pavement versus leveling asphalt with pavement options after foam injection is complete.

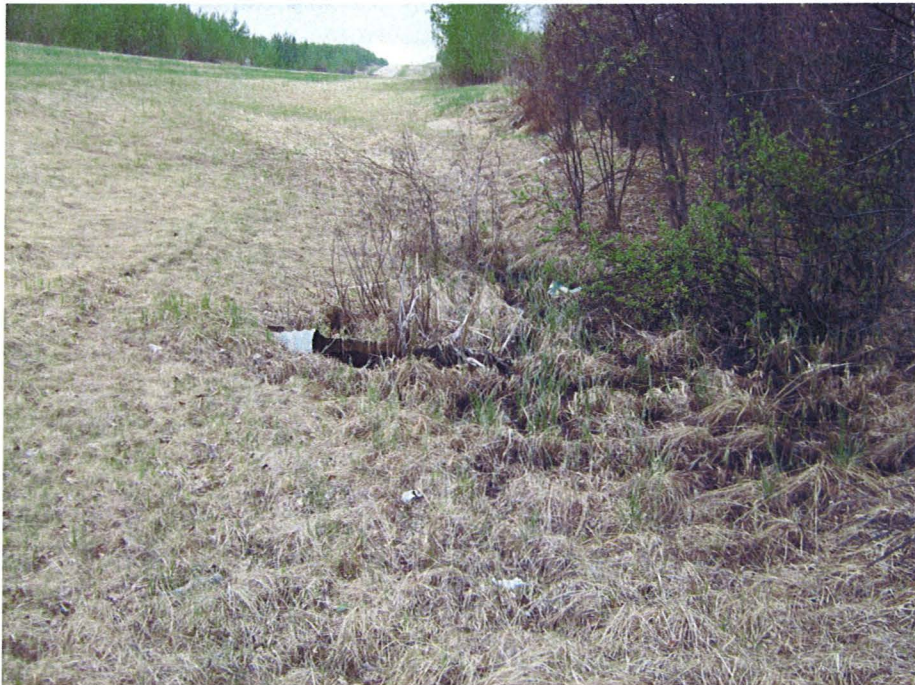
Blocked culvert and poor ditch drainage along west ditch

1. Maintenance contractor to conduct re-grading, culvert replacement and ditch improvements upon completion of foam injection program.
