# ALBERTA TRANSPORTATION PAVEMENT MONITORING RESULTS FALL 2011

## **NORTH CENTRAL (STONY PLAIN) REGION**

### SITE NC22: HWY 759:02, KM 1.5 (NORTH OF JUNCTION HWY 39 AND HWY 759)

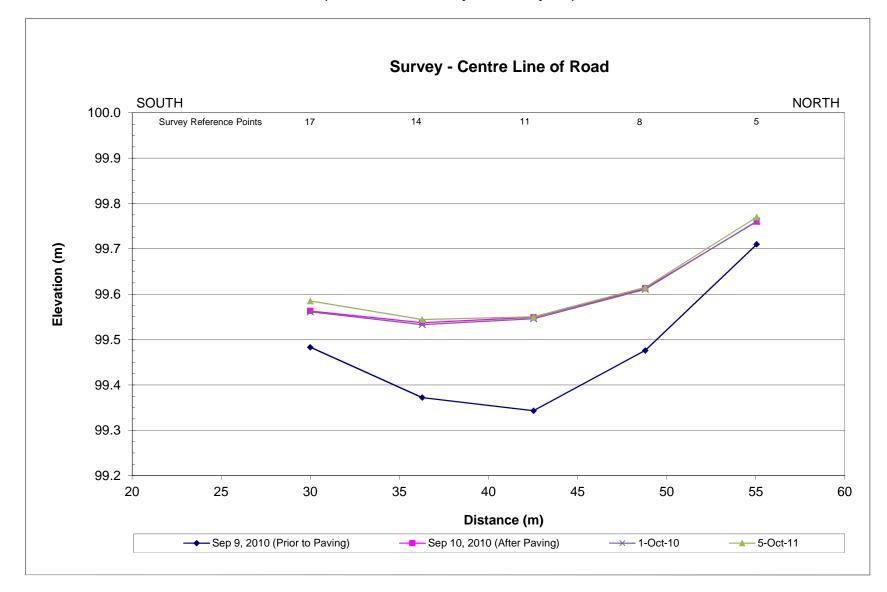
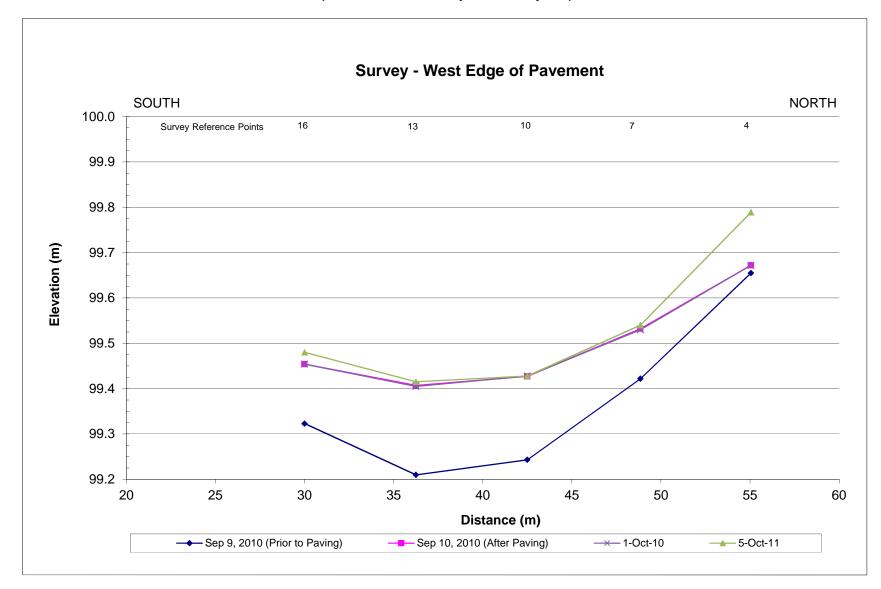
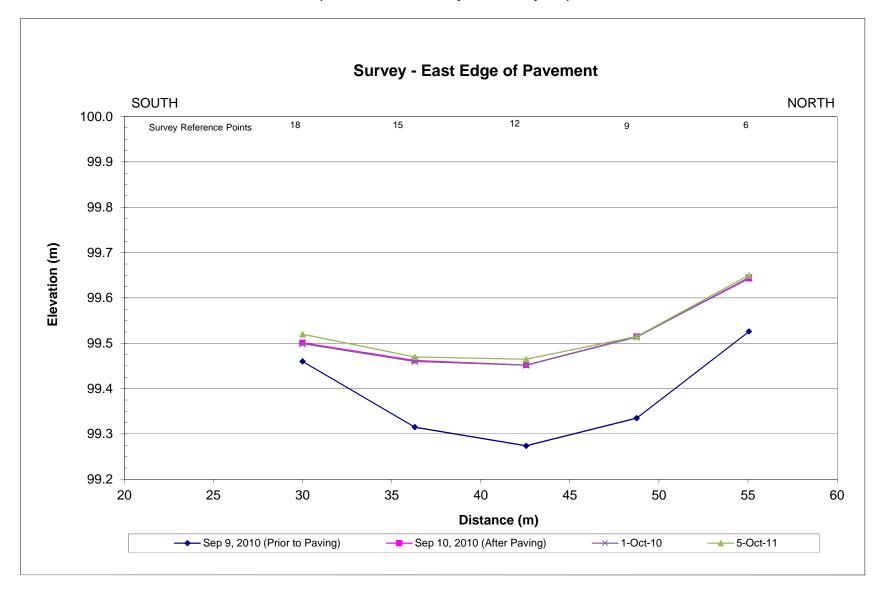
#### Survey Monitoring Change in Elevation (m)

A level survey was completed on the day of paving, September 10, 2010 and data collected was used as the benchmark for comparing subsequent monitoring to performance of the remedial measures. The fall 2011 monitoring shows variable settlement ranging from no settlement to 8 mm of settlement. The survey also shows some heave in monitoring up to 109 mm. Survey error is more likely for the anomalous readings.

In general it appears that, aside from a couple of anomalous readings, the latest survey shows there has been negligible settlement compared to the baseline survey. It is expected that additional level surveys will be required to identify a trend in the survey data and the magnitude of variance/error from that trend. An inspection of the pavement surface on November 9, 2011 did not encounter any new cracking which could be interpreted to be signs of deflection due to settlement.

Survey monitoring should continue for one more year as per proposed scheduling. Two events of monitoring should be done during frost free months of 2012. Upon completion of those surveys, EBA will prepare a brief summary of the monitoring, along with any conclusions and recommendations for future applications of this repair method.
