# STONY PLAIN REGION GEOHAZARD RISK ASSESSMENT SITE INSPECTION FORM

SITE NUMBER AND NAME:	HIGHWAY AND KM:	PREVIOUS INSPECTION DATE:	INSPECTION DATE:		
NC 22 - Pavement Dip	Hwy 759:02, km 1.42	May 20, 2010	June 14, 2011		
LEGAL DESCRIPTION:	NAD 83 COORDINATES:	RISK ASSESSMENT:			
NW 11-49-6-W5M	-51362 E, 5898567 N	PF: 9 CF: 2 <b>TOTAL:</b>	TAL: 18

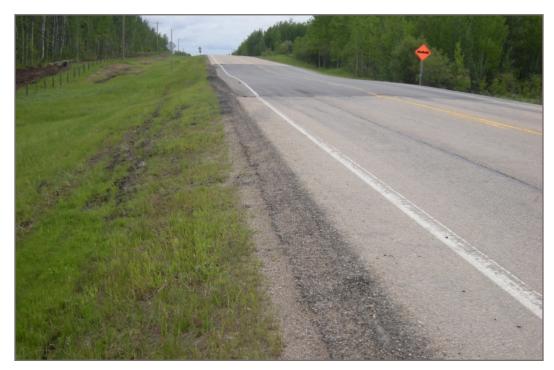
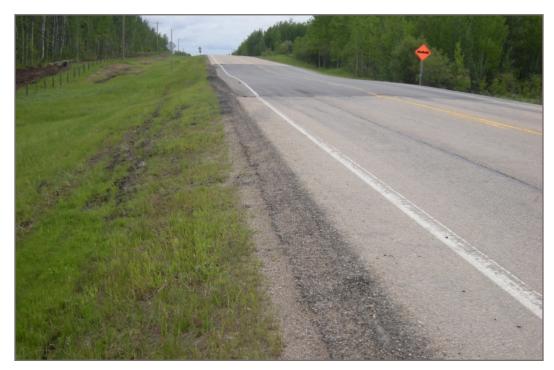
Asphalt pavement placed after foam injection in Spring 2010.

- New asphalt pavement placed in summer 2010. Cracks beginning to reflect through new pavement;
- 800 mm diameter culvert located south of the pavement dip. Culvert appears to be blocked and standing water is located within the ditch on both sides of the highway;

Photo 1: Asphalt overlay placed after foam injection

- Continue to monitor survey pins installed as part of the foam injection study.
- MCI should replace the existing culvert and develop a construction plan for improvement of both ditches.
- TRANS operations staff and EBA to discuss milling pavement versus levelling asphalt with pavement options.

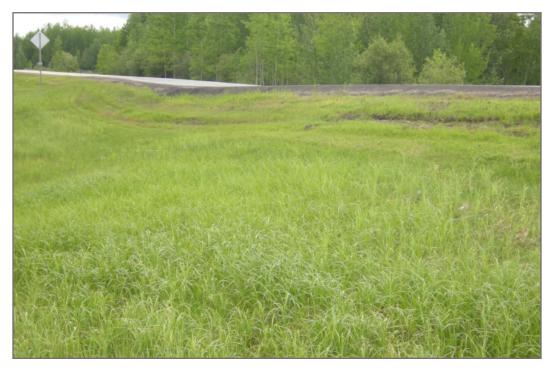
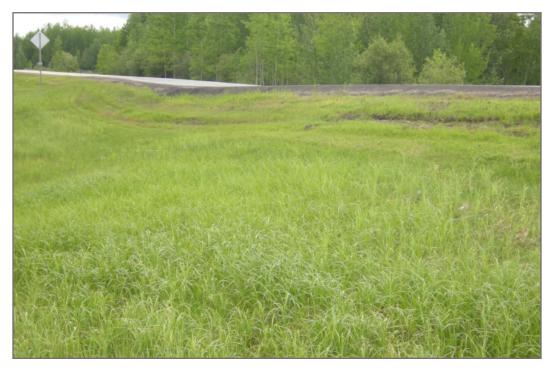
- Length of pavement dip area is approximately 30 m long and appears to be relatively uniform across the width of the pavement;
- Pavement dip appeared to be about 0.6 m before foam injection implemented;

- Embankment is about 3 m high with approximately 3H:1V sideslopes outside of the dip;
- Sideslopes within dip area are concave and steep (about 1H:1V);

- Small sinkhole observed about 3 m east of the west outlet of the culvert. Relatively unchanged from 2008 inspection;
- Deflection of barbed wire fence observed at toe of east embankment (i.e. northbound lane); and

- Lateral spreading of embankment suspected due to concave shape of sideslopes in dip area and deflection of the barbed wire fence.

Photo 2: Repaired pavement dip facing northeast
