August 1, 2006

File: 15-85-48

**NORTH CENTRAL REGION – STONY PLAIN AREA
GEOHAZARD ASSESSMENT CALL-OUT (CE 142-06)
NC 55: NORTHEAST RAMP EROSION
AT HWY 779 AND HWY 16 INTERCHANGE**

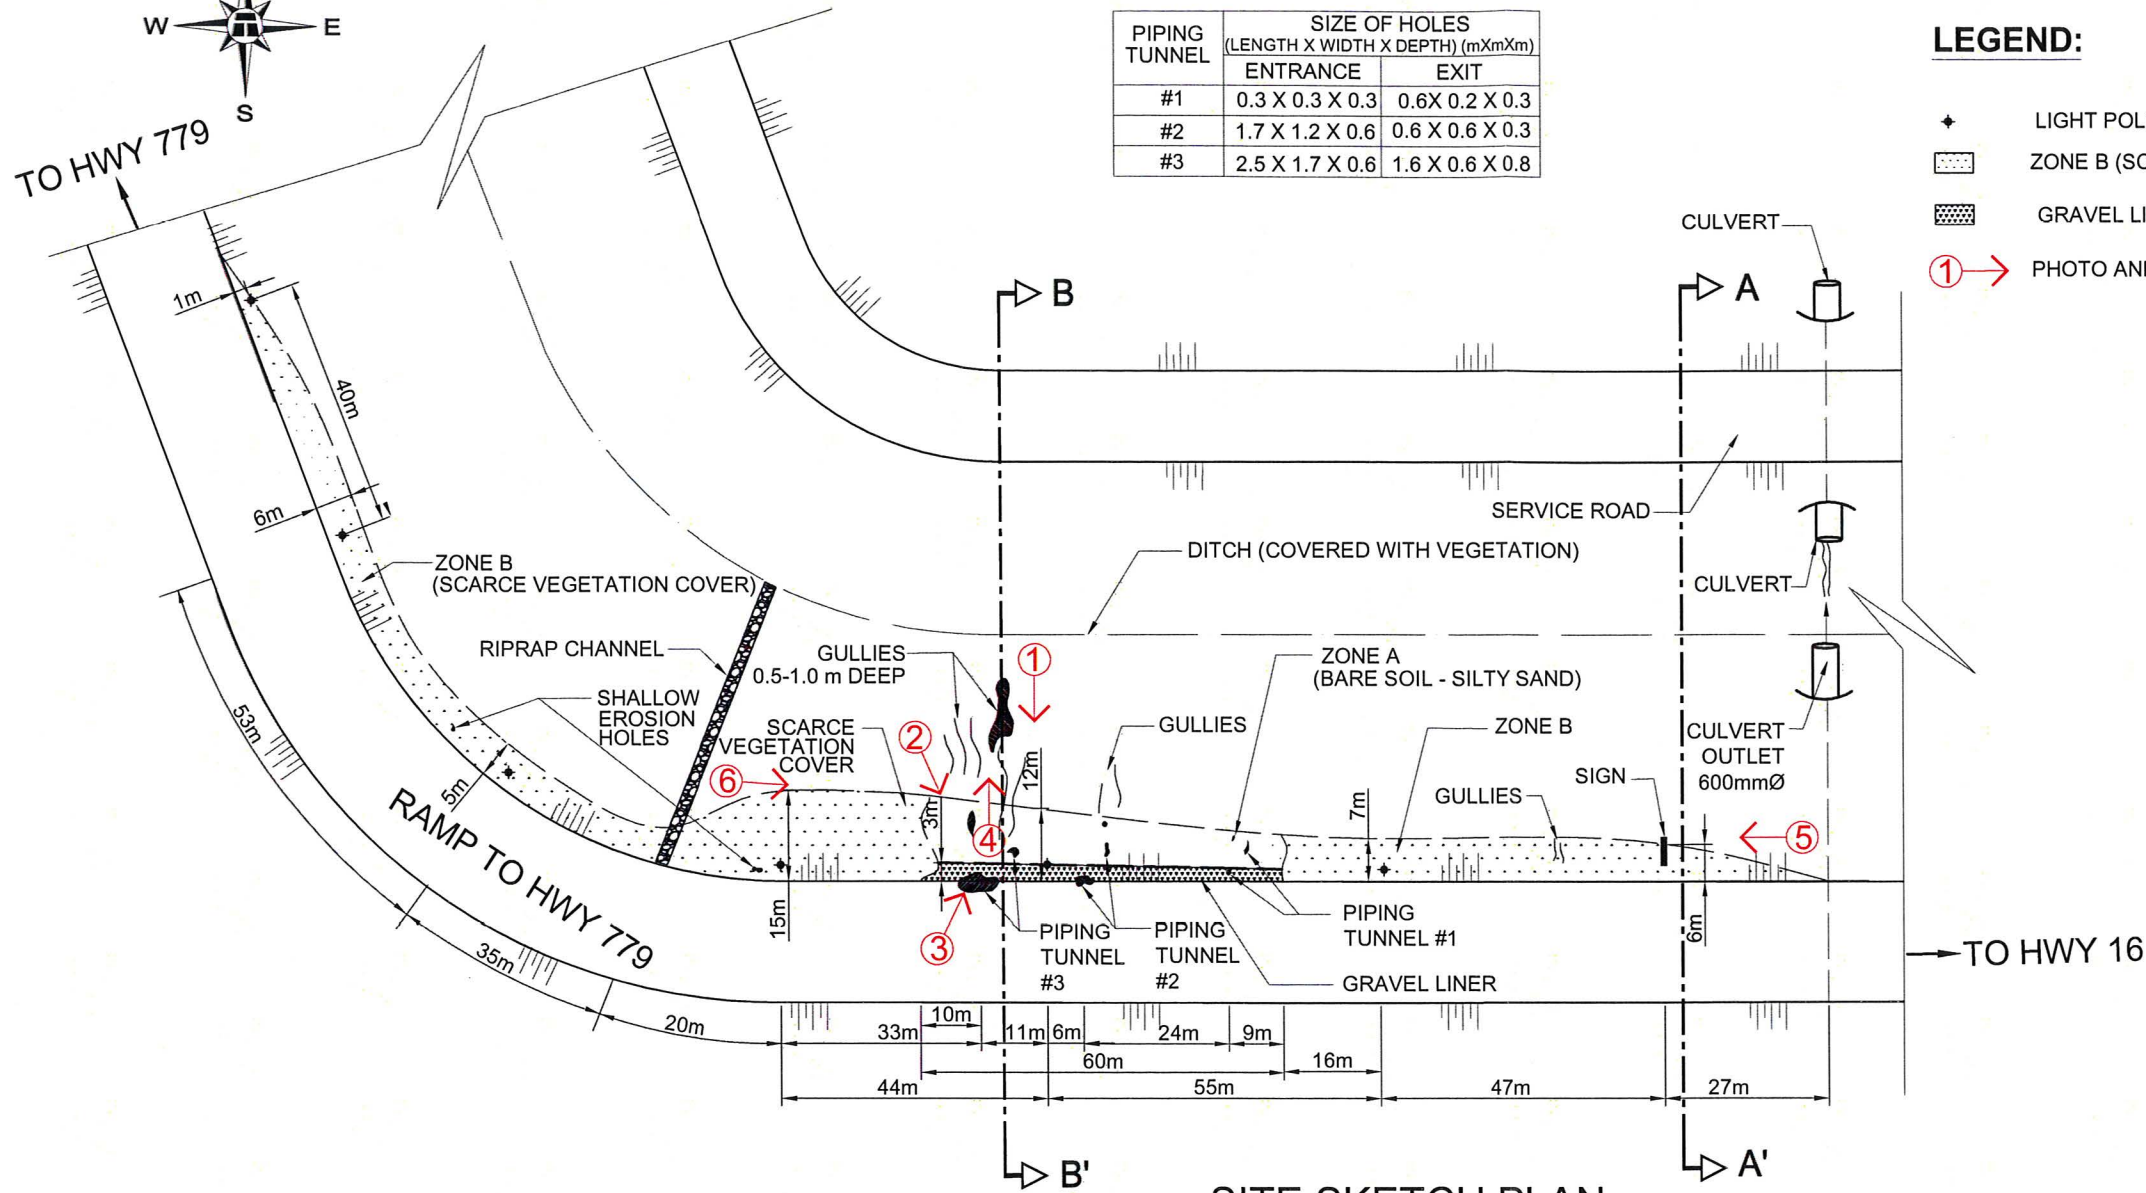
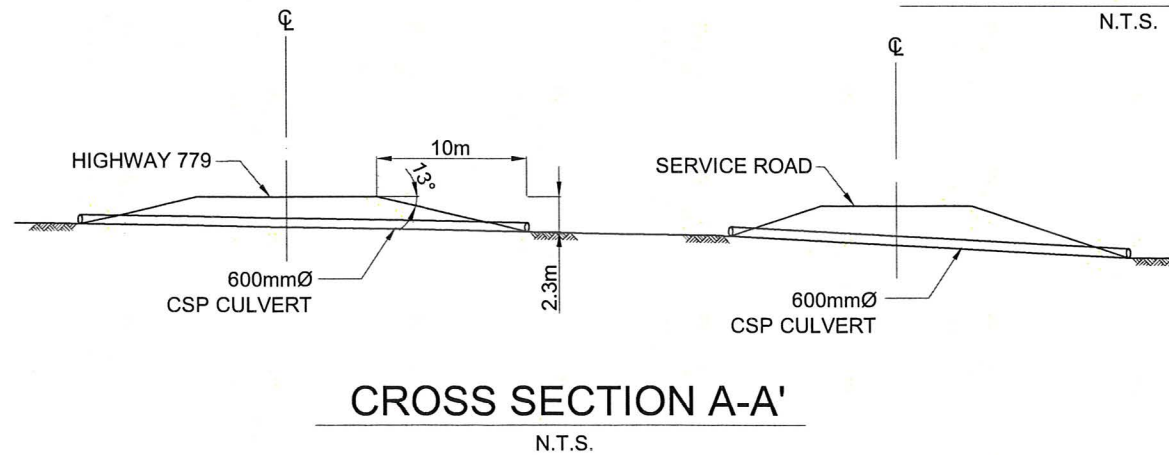
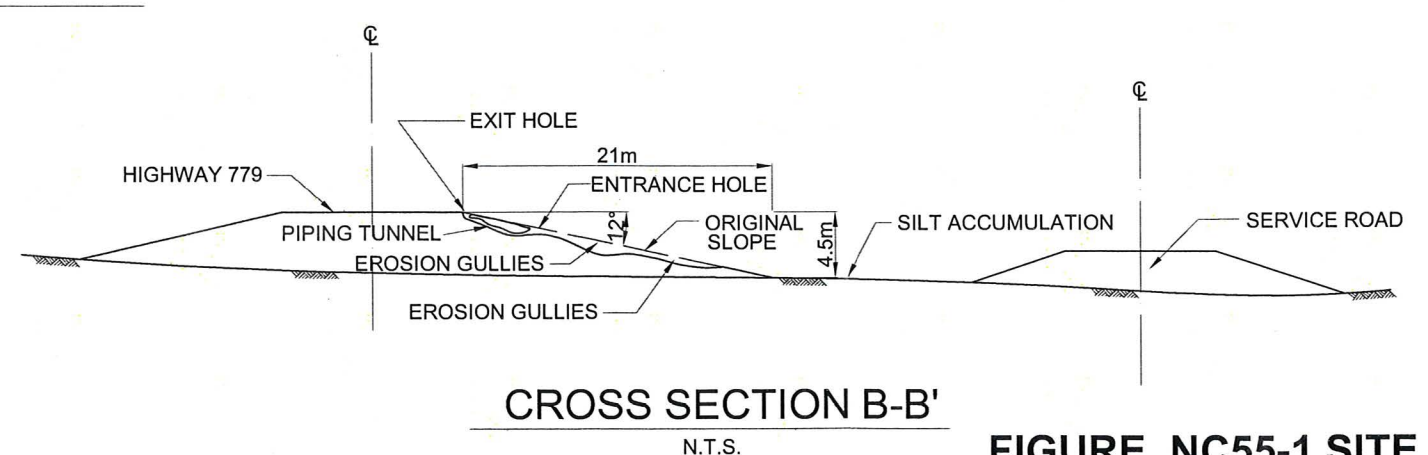
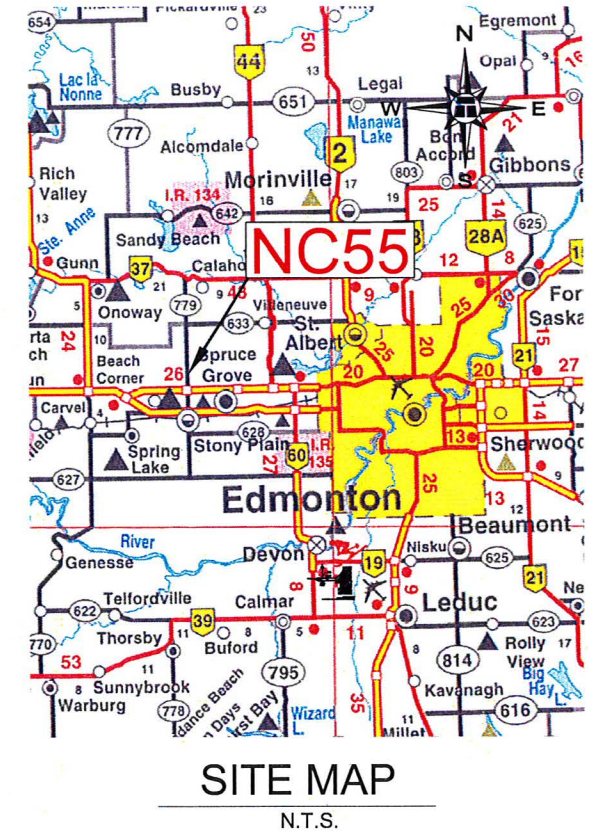
FIGURE NC55-1 SITE PLAN
NC55: HWY 779 & HWY 16 INTERSECTION
NORTH CENTRAL REGION-STONY PLAIN AREA GEOHAZARD ASSESSMENT

about 40 m long where a gravel layer about 3 m wide was present beside the highway, in a zone where bare soil extends from the edge of the gravel layer to the toe of the slope (designated Zone A), and in an area where the vegetation was scarce (designated Zone B) as illustrated on Figure No. NC55-1.

Three erosion holes associated with piping were noticed, as described below and shown on Figure No. NC55-1.

Several shallow erosion holes caused by running water were noticed along the highway north shoulder, where large amount of gravel and scarce vegetation cover were present. The holes were about 0.6 m x 0.3 m wide and 0.20 m deep. They are shown on Figure No. NC55-1.

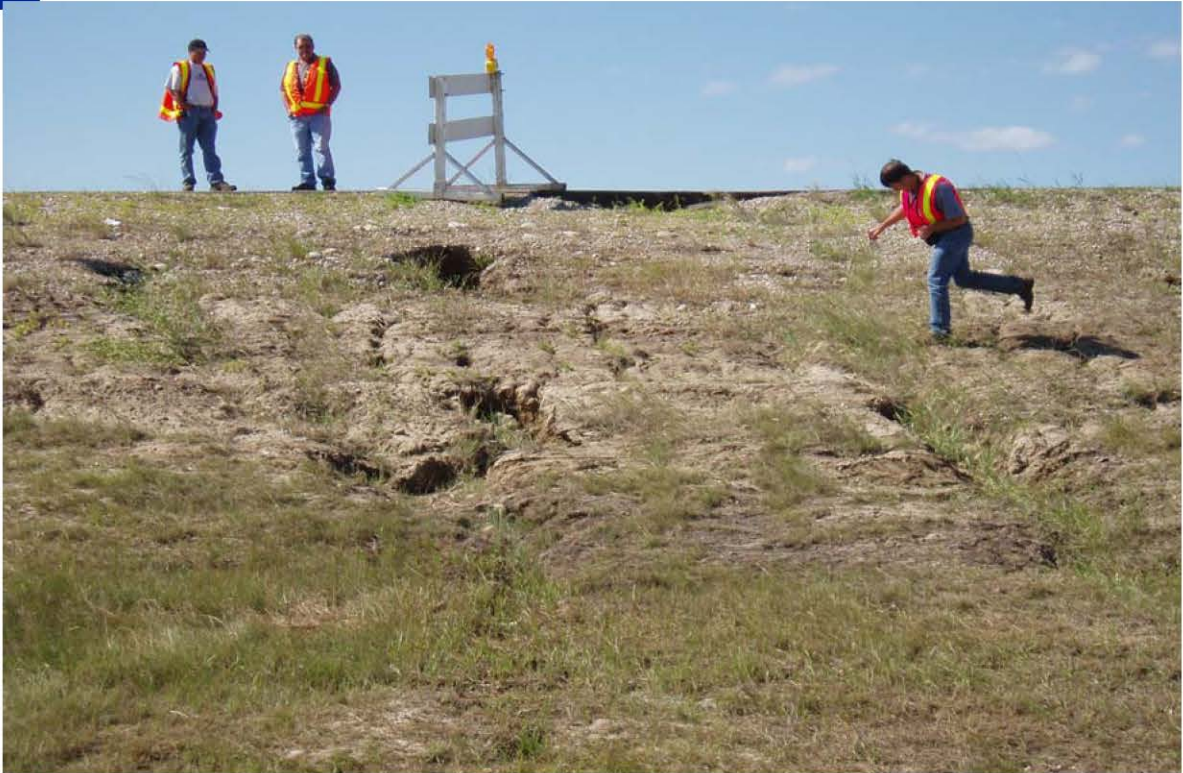
PHOTO 1: View of the north slope of the northeast ramp.

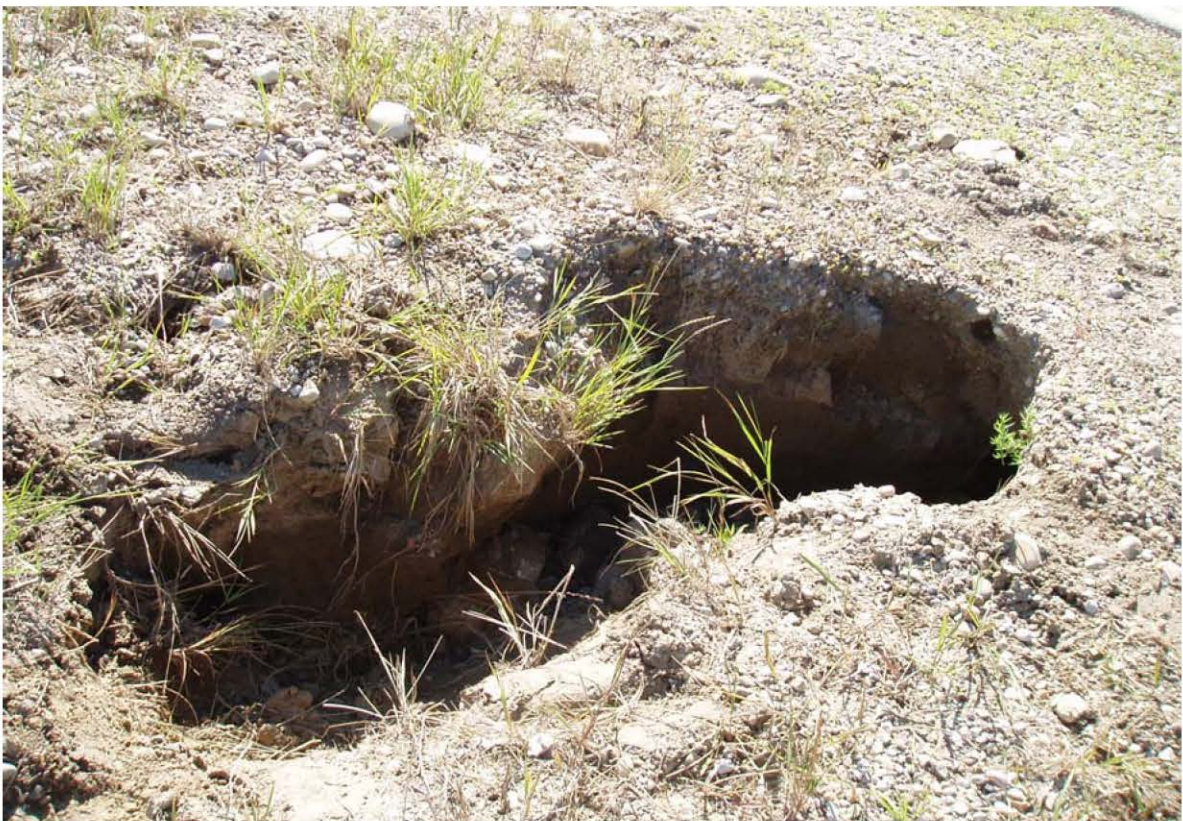
A hole 2.5 m long x 1.7 m wide x 0.6 m deep was noted beside the highway shoulder, penetrating about 0.4 m into the pavement. About 6 m downslope there was another hole 1.6 m long x 0.6 m wide and 0.8 m deep. These holes were connected underneath the surface through a piping tunnel, the former being the entrance hole and the latter being the exit hole. Erosion gullies were noticed outside the exit hole, running downslope.

PHOTO 2: Entrance hole of piping tunnel No. 3.

- The piping tunnels should be excavated;
- The affected sideslope areas should be re-graded scraping the surface of the sand fill and using it to carefully backfill the excavated piping holes and erosion gullies in thin track-packed lifts to a smooth consistent finished surface;
- The re-graded area should be covered with a minimum of 100 mm of imported clayey topsoil which should be track-packed in place in a direction up-and-down (not parallel to) the slope;
- In order to provide erosion protection in the north slope, the eroded Zones A and B should be double seeded and covered with straw matting (low flow soil covering) to ensure sufficient grass coverage.

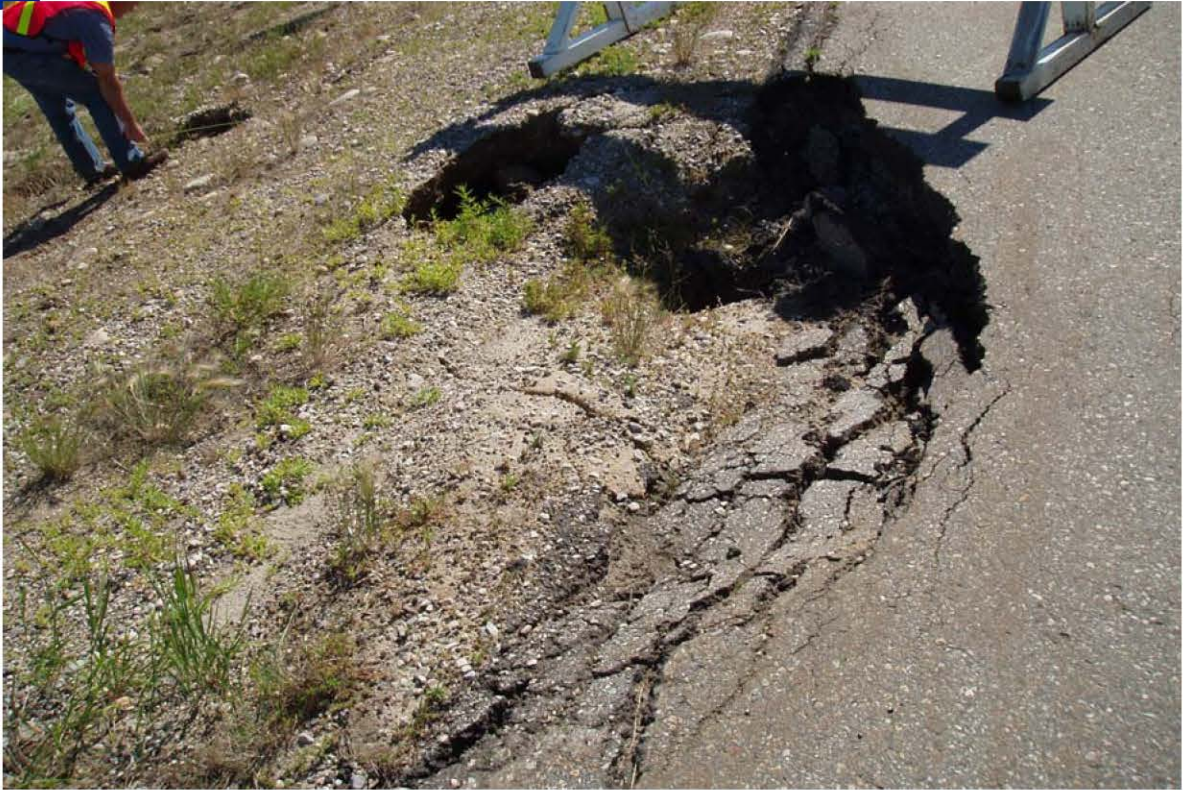
PHOTO 3: Exit hole of piping tunnel No. 3, penetrating into the pavement.

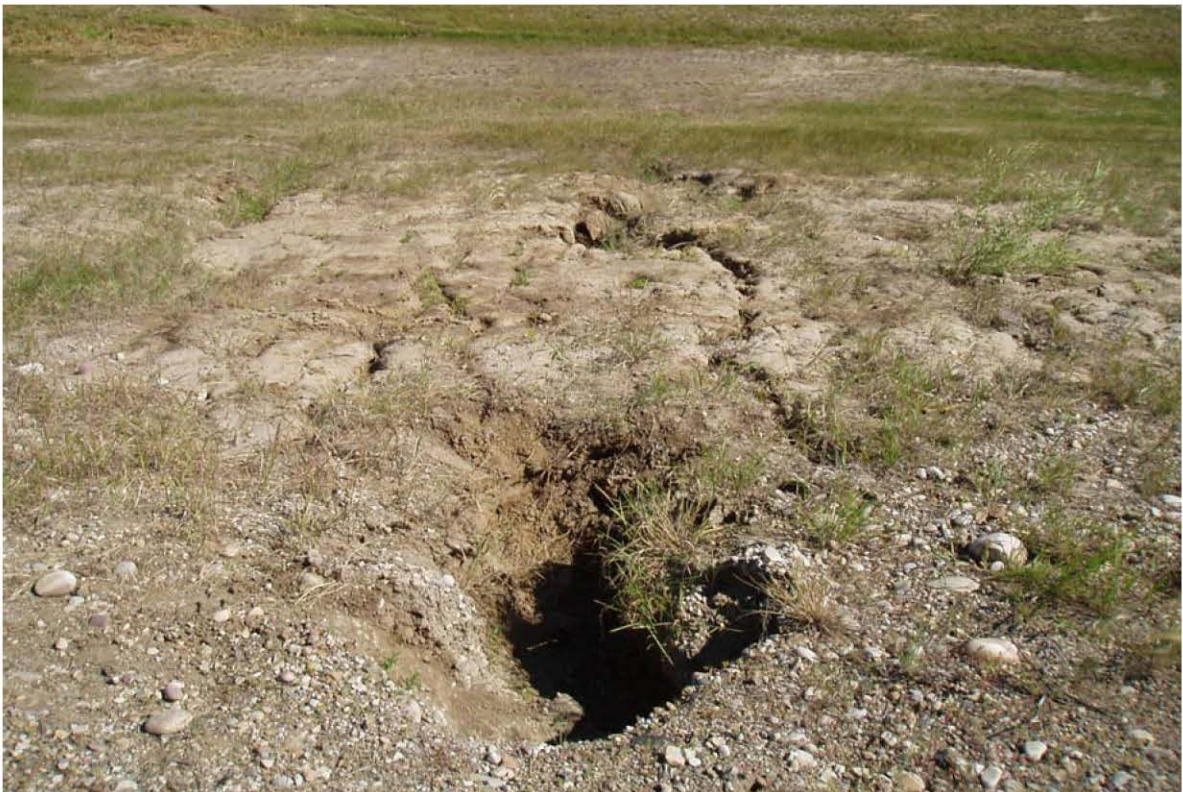
Some of the concentrated runoff created erosion gullies, starting from the edge of the gravel layer and extending downhill, as rainwater removed the silty sand grains. As the velocity of water increased so did its erosive capacity and gullies widened and deepened towards the bottom of the slope.

PHOTO 4: View facing downslope of the entrance hole of piping tunnel No. 3, erosion gullies and lack of vegetation.

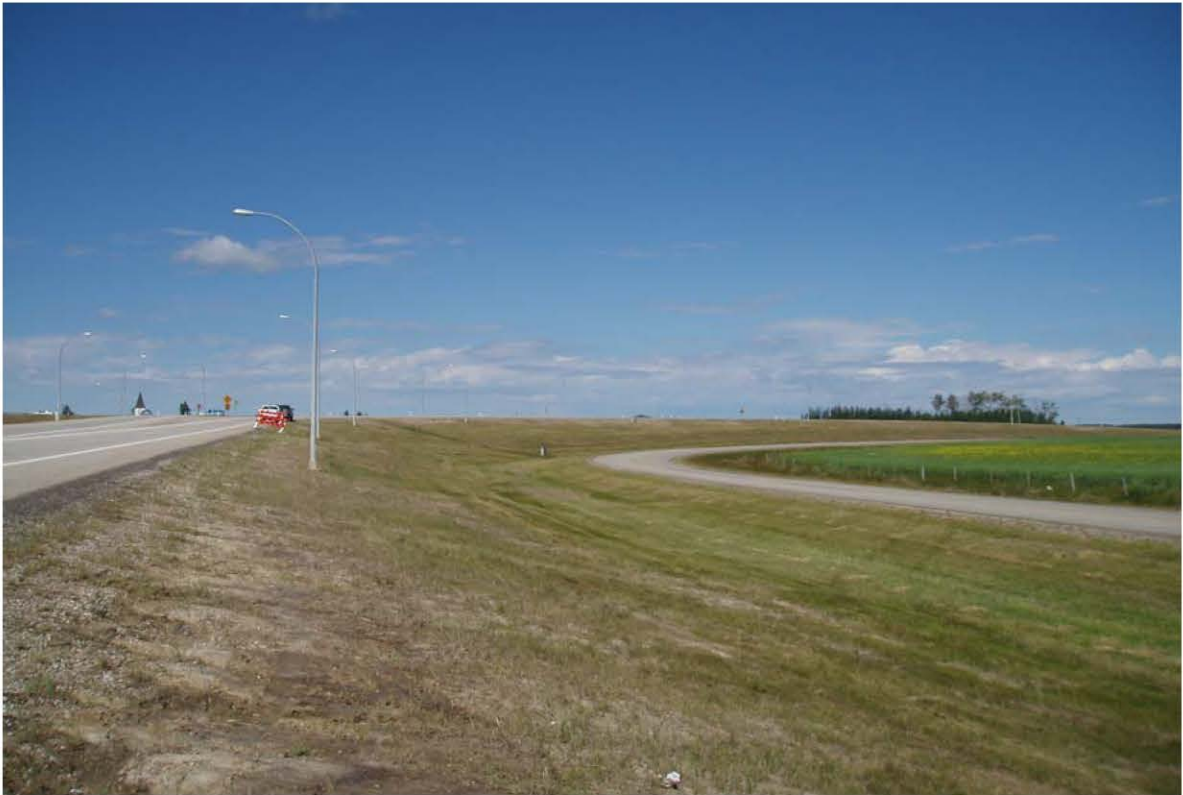
PHOTO 5: West view of the northeast ramp and adjacent service road.

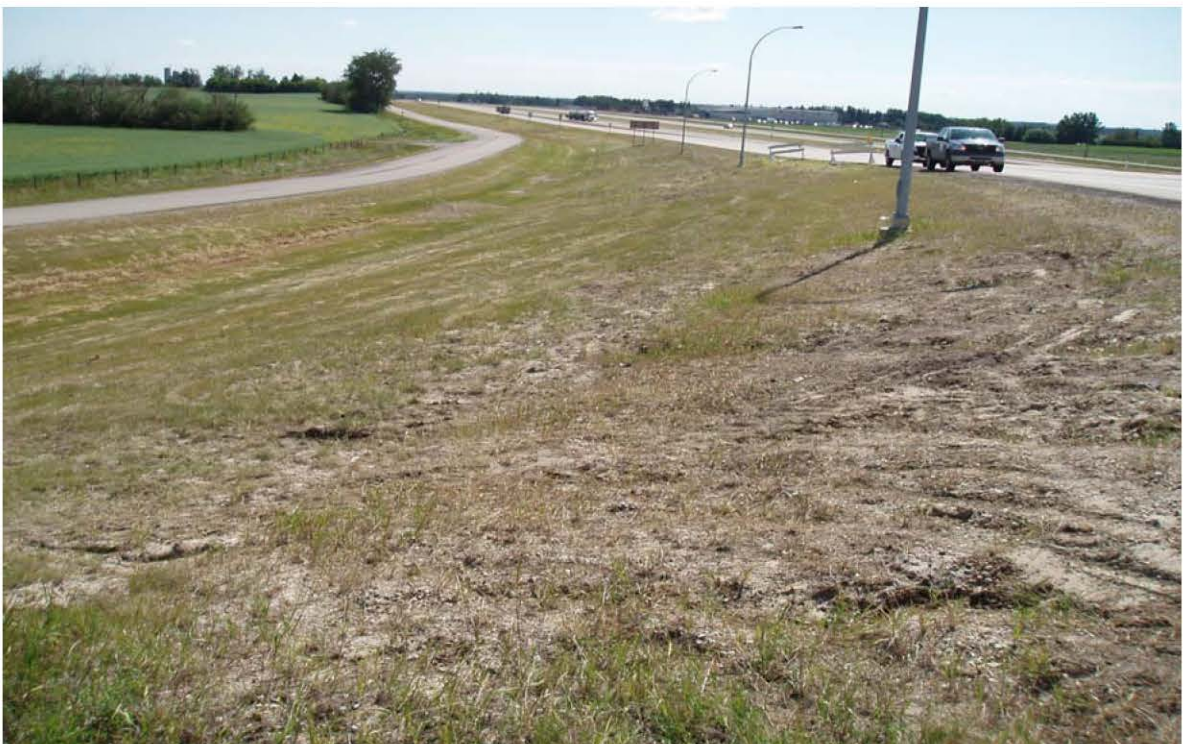
PHOTO 6: East view of northeast ramp and service road.
