## GEOHAZARD RISK MANAGEMENT PROGRAM

### North Central Region – Edson / Stony Plain Area

#### 2019 Inspection Report

Site Number	Site Name		Hwy	km
NC39	South of Sturgeon River Crossing		825:02	8.73
Legal Land Description	NE 29-55-22-W4M			
NAD 83 Coordinates	3TM 114	N5961514	E 51115	
Operational Site Instrumentation	Slope Inclinometers		0	
	Pneumatic Piezometers		3	
	Vibrating Wire Piezometers		0	
	Standpipe Piezometers		1	
Date of Last Instrumentation Readings	May 10, 2019

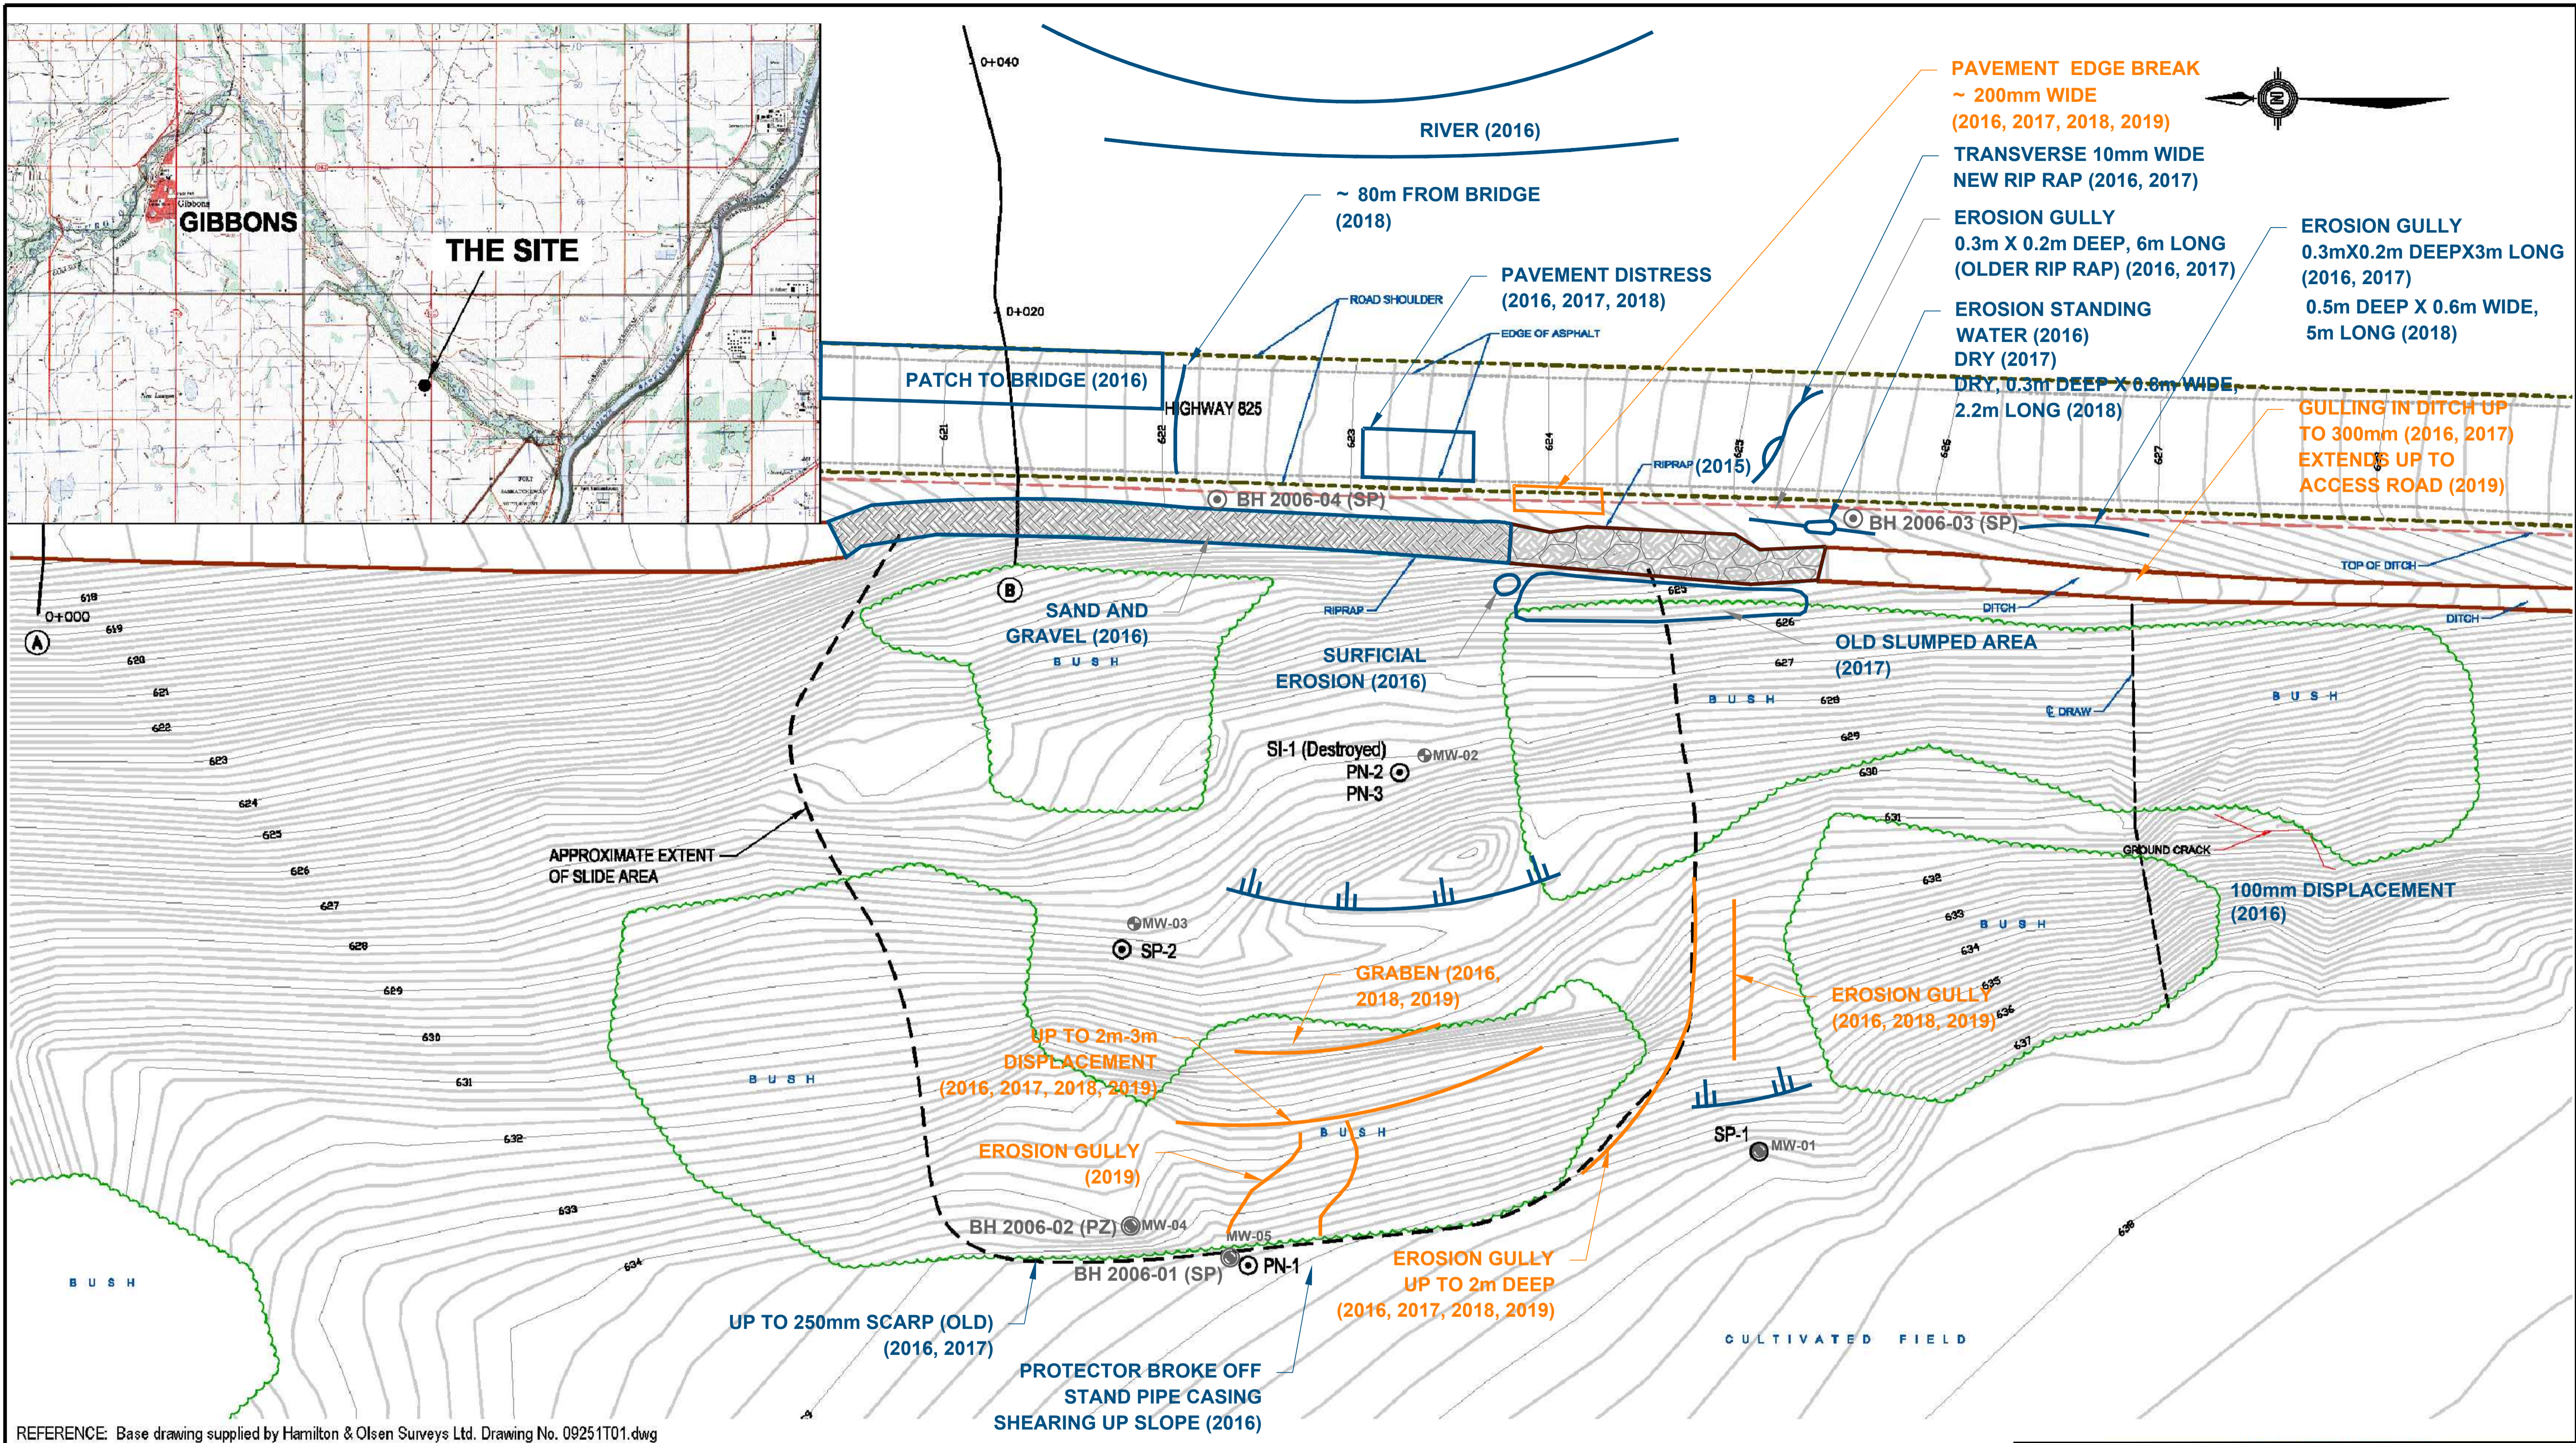
FIGURE - 1

<input checked="" type="checkbox"/> Erosion	Surficial erosion several meters upslope from the north end of riprap. Erosion gullies along the west ditch near BH 2006-03. Erosion gully downslope from SP1 and PN1.	<input type="checkbox"/> Yes	<input checked="" type="checkbox"/> No
<input type="checkbox"/> Seepage		<input type="checkbox"/> Yes	<input type="checkbox"/> No
<input type="checkbox"/> Other		<input type="checkbox"/> Yes	<input type="checkbox"/> No

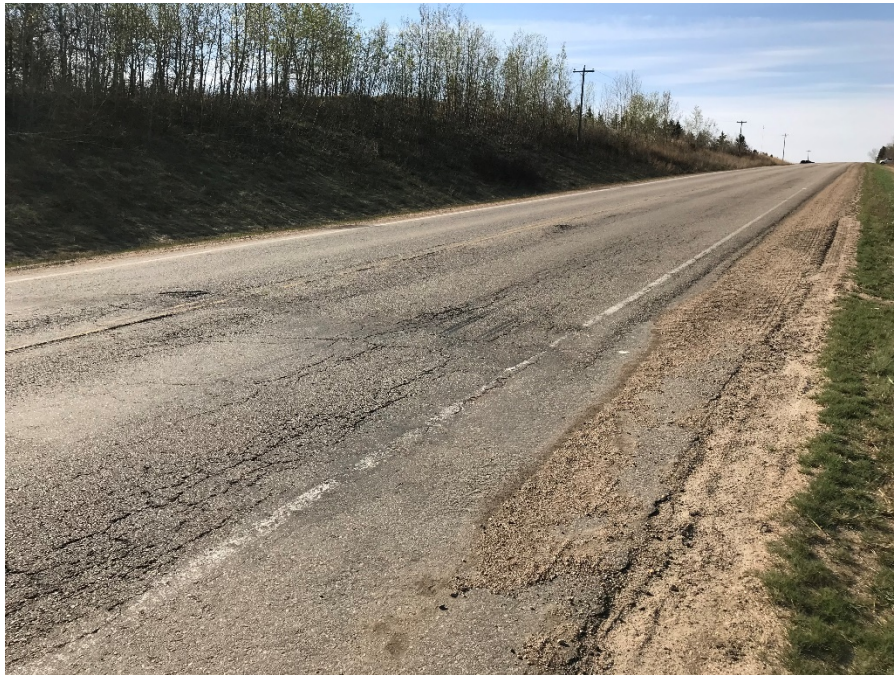
<b>Discussion</b>	<p>Pavement cracking consisting of transverse and longitudinal cracks was observed at various locations at the site. Photo 1 is located approximately 10 m north of the riprap and shows an area of severe longitudinal cracking that is progressing into alligator cracking. Photo 2 shows a portion of the collapsed shoulder along the riprap. Increased erosion was observed around the collapsed shoulder. Cracks at the site had widths up to about 10 mm with no vertical differential. No significant change in pavement cracks were observed compared to the 2016 inspection.</p> <p>Surficial erosion of the backslope was observed at localized areas. More erosion gullies were observed along the west ditch than in previous years and appeared to be getting more interconnected. Photo 3 shows some interconnected erosion features in the west ditch. Water was observed to be pooling in the gullies. Cobbles were also observed within the erosion gullies.</p> <p>Irrigated fields at the crest of the slope are currently being used for agricultural purposes. An erosion gully leading from the slope crest near SP1 was observed.</p> <p>The scarps and grabens remained unchanged since the 2016 inspection. Scarps up to 3 m high were observed along the graben as shown in Photo 5. The graben remained well vegetated. The slope was very well vegetated and appeared to have covered the previous signs of visual distress at the toe along the highway. An overall view of the toe is shown in Photo 6.</p>

**Photo 1:** Patch of pavement distress approximately 10 m north of rip rap. Looking southeast.

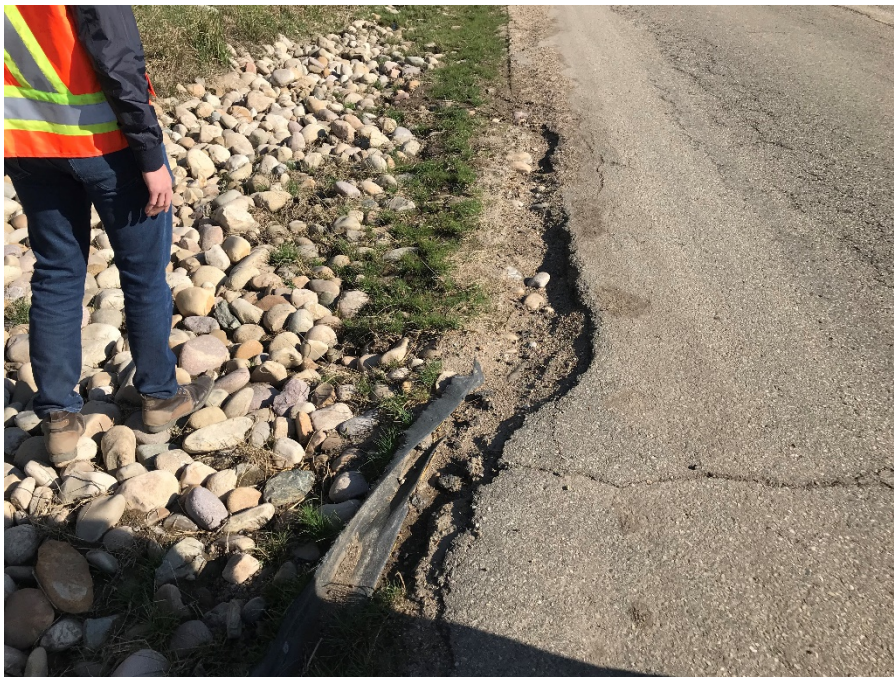
**Photo 2:** Collapsed pavement shoulder along rip rap approximately 200 mm wide. Looking north.

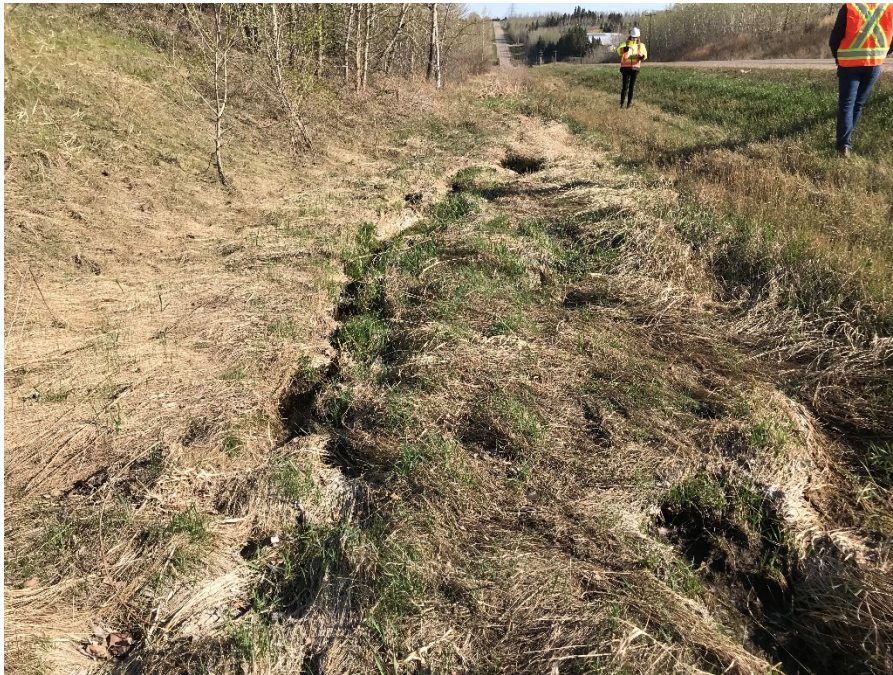
**Photo 3:** Erosion gullies along west ditch. Looking north.

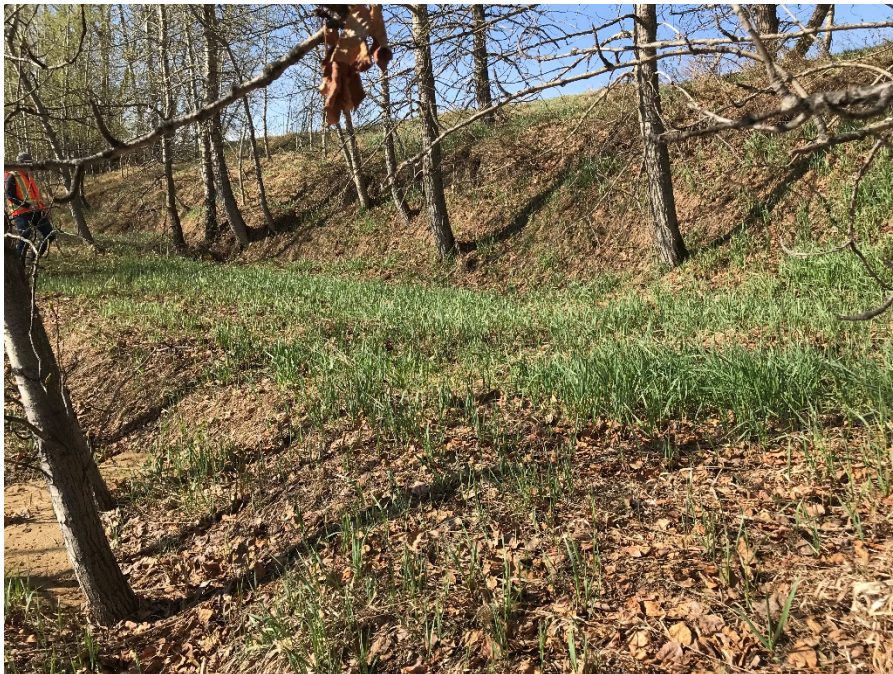
**Photo 4:** Well vegetated graben. No fresh cracking observed.  
Looking southwest.

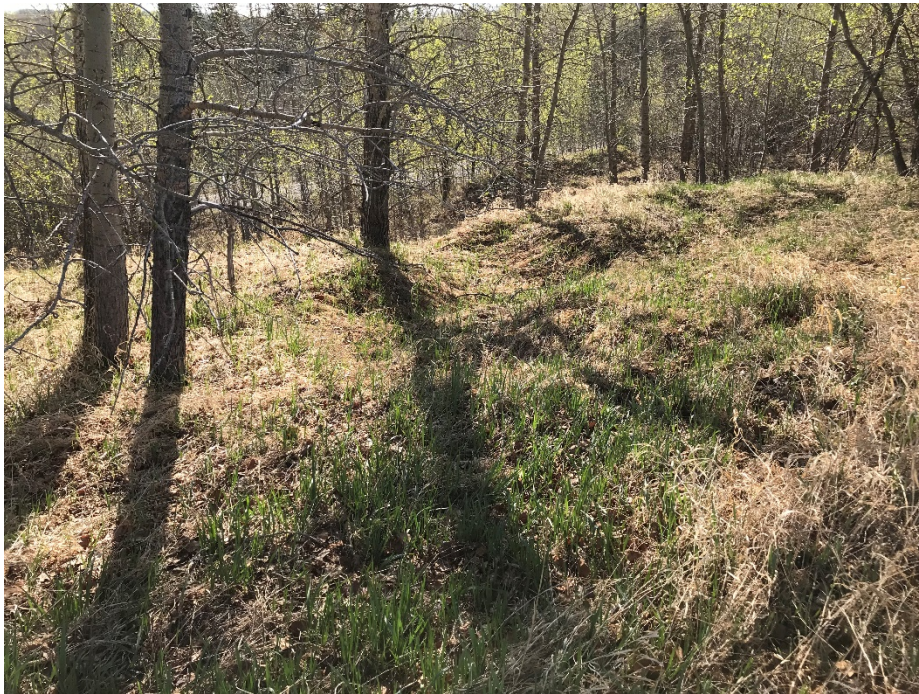
**Photo 5:** Erosion near PN-1. Looking southeast.

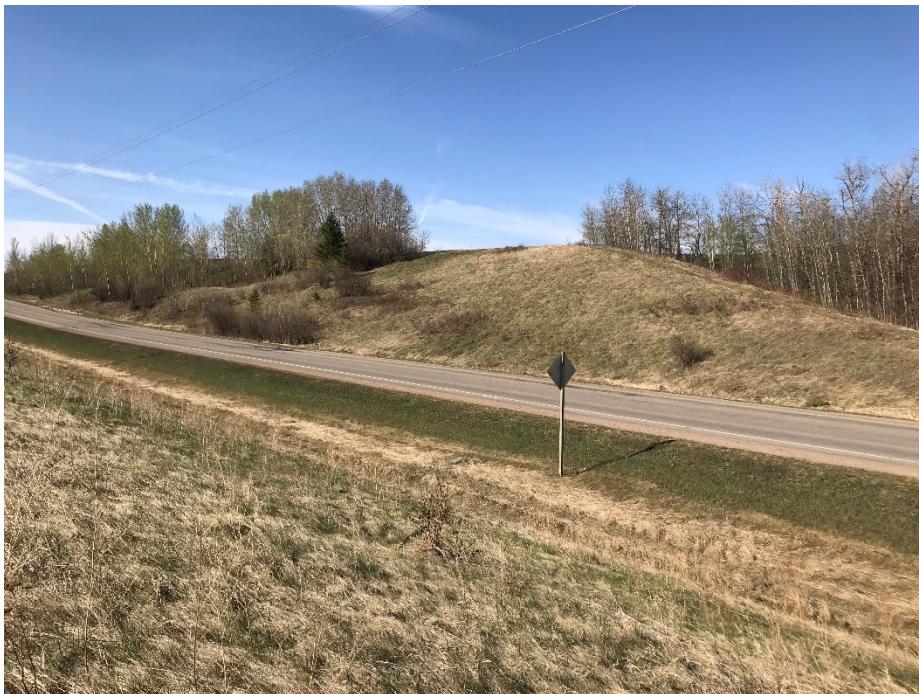
**Photo 6:** Well vegetated backslope obscuring previously observed exposed bedrock. Looking southwest.
