## GEOHAZARD RISK MANAGEMENT PROGRAM

### North Central Region – Edson / Stony Plain Area

#### 2020 Inspection Report

<b>Site Number</b>	<b>Site Name</b>		<b>Hwy</b>	<b>km</b>
NC39	South of Sturgeon River Crossing		825:02	9.1
<b>Legal Land Description</b>	NW 28-55-22-W4M			
<b>NAD 83 Coordinates</b>	12U	N 5962159	E 353532	
<b>Operational Site Instrumentation</b>	<b>Slope Inclinometers</b>		0	
	<b>Pneumatic Piezometers</b>		3	
	<b>Vibrating Wire Piezometers</b>		0	
	<b>Standpipe Piezometers</b>		0	
<b>Date of Last Instrumentation Readings</b>	May 28, 2020

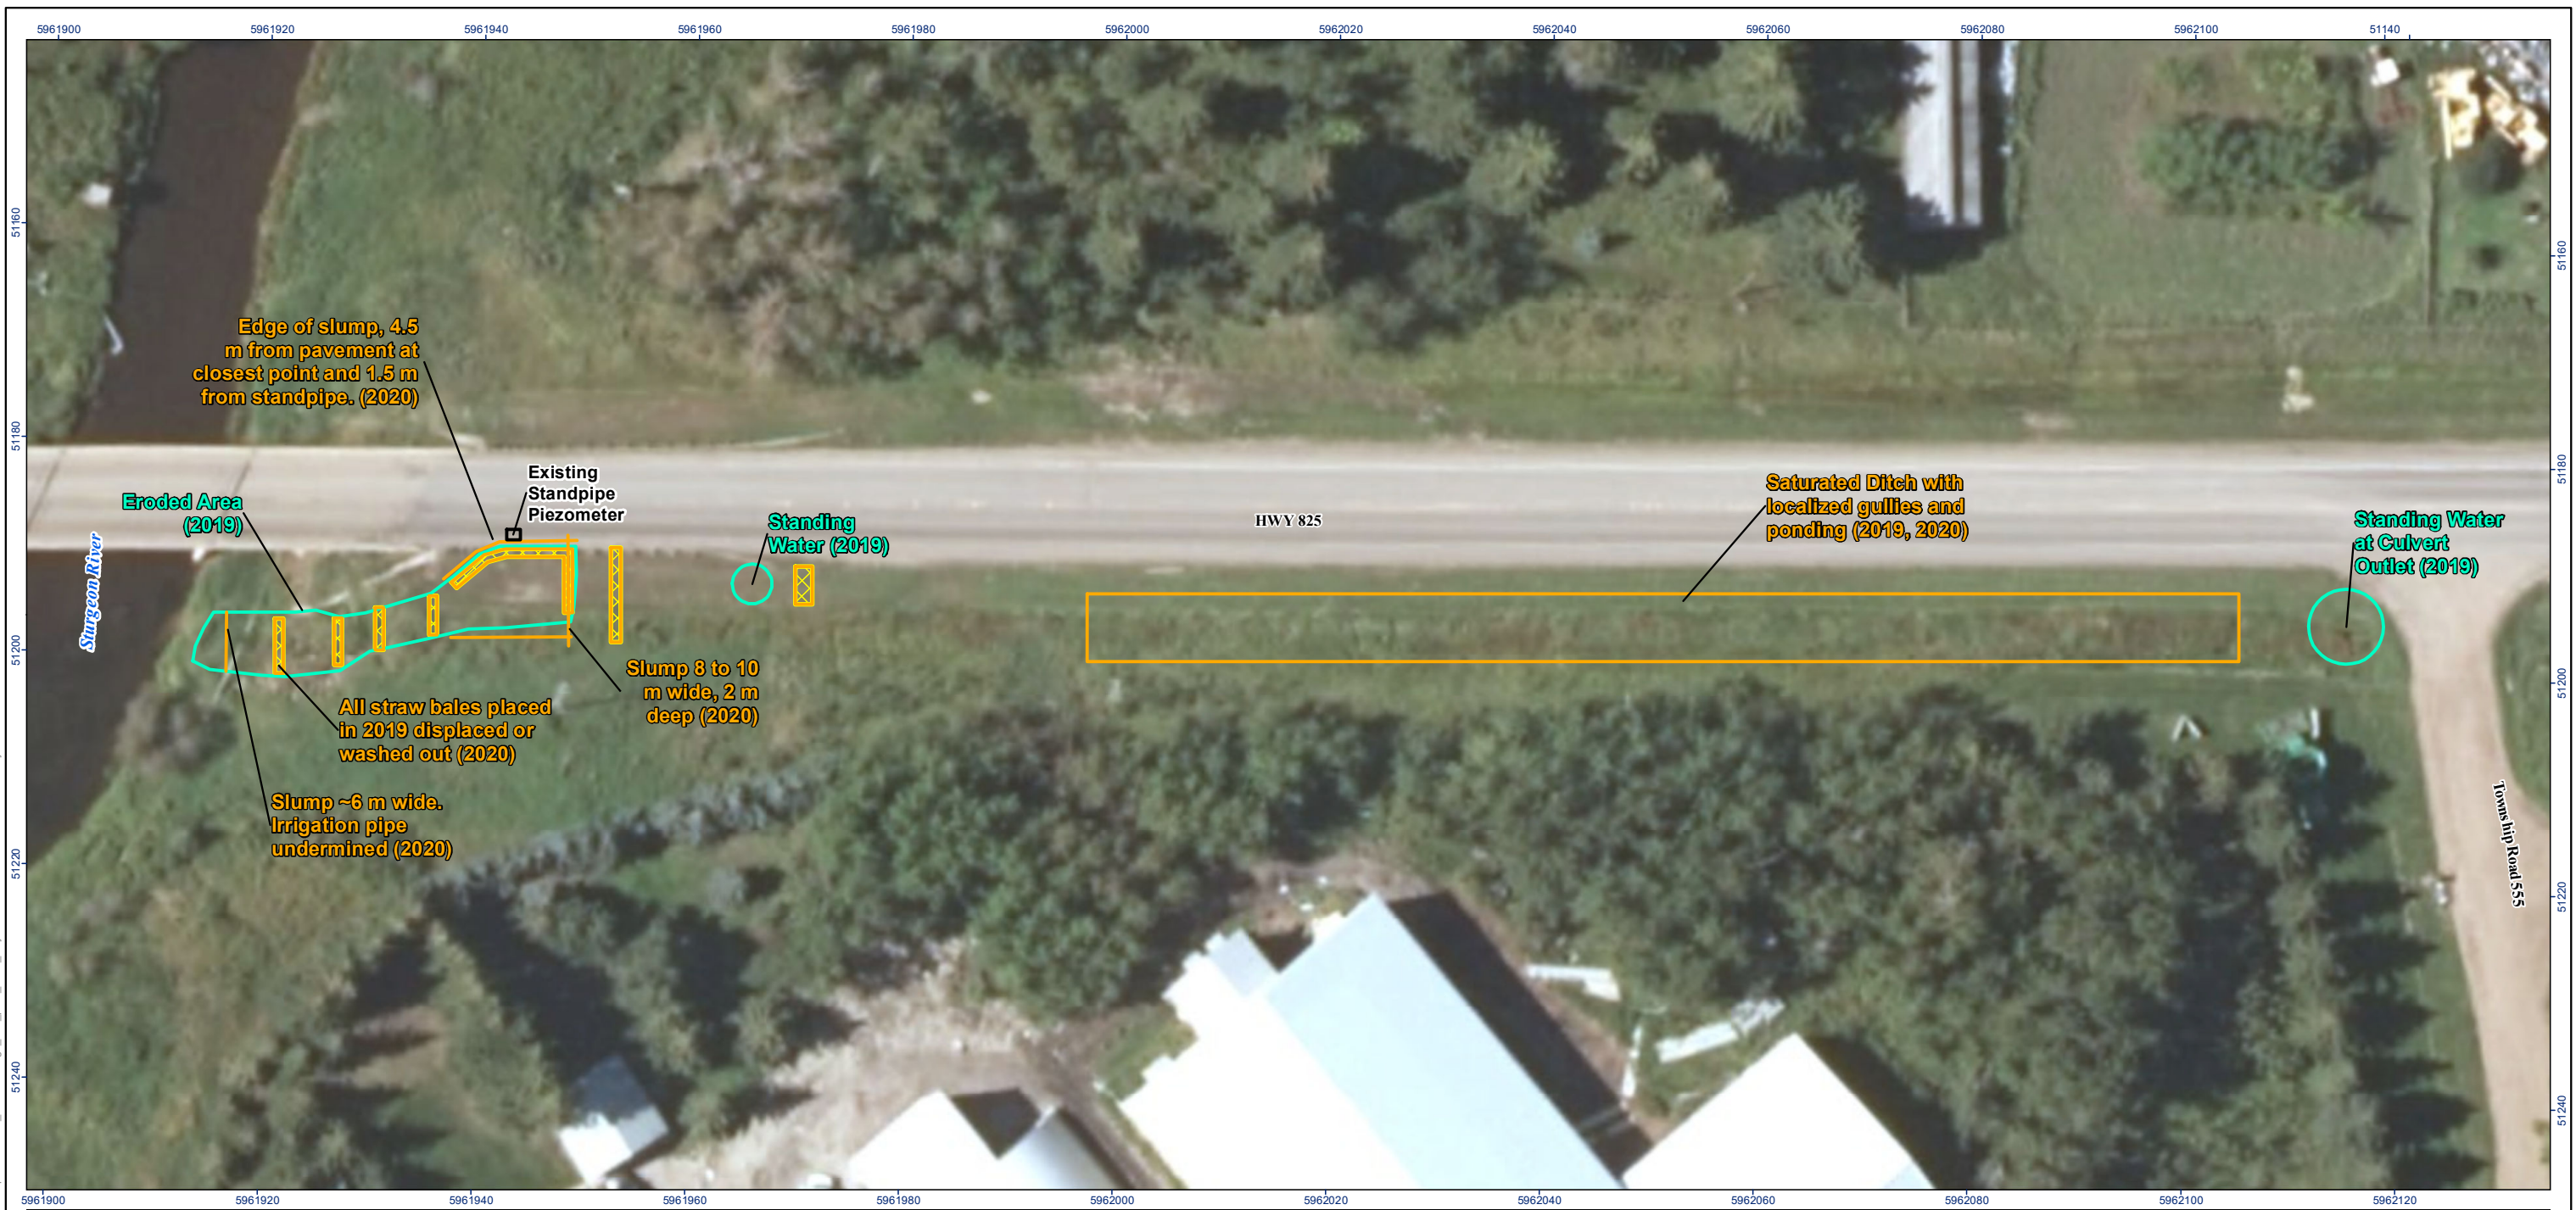
*Figure No.*  
**1**

*Title*  
**Site Plan**

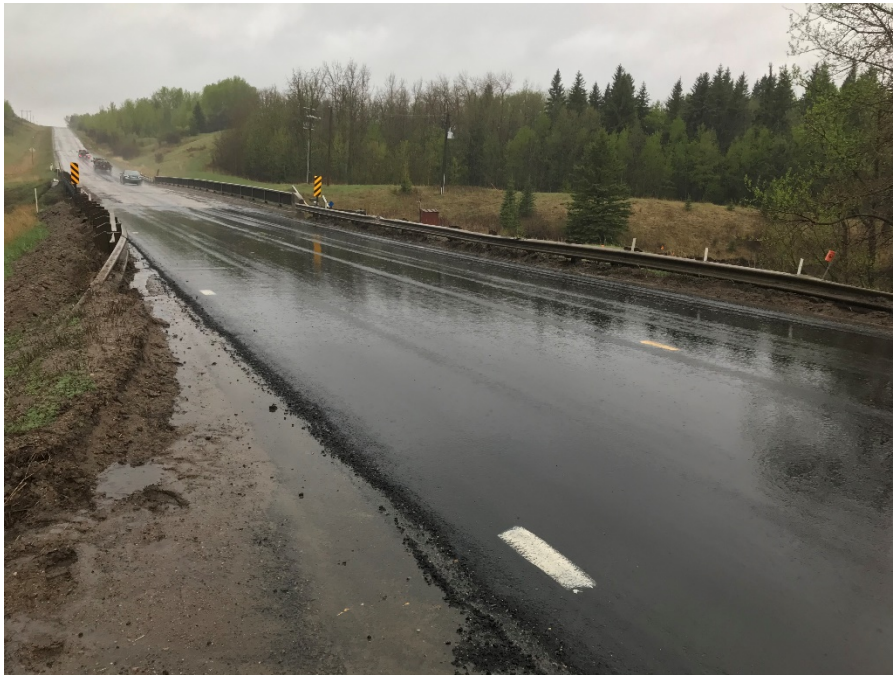
Photo 1: Highway 825. Looking southwest.

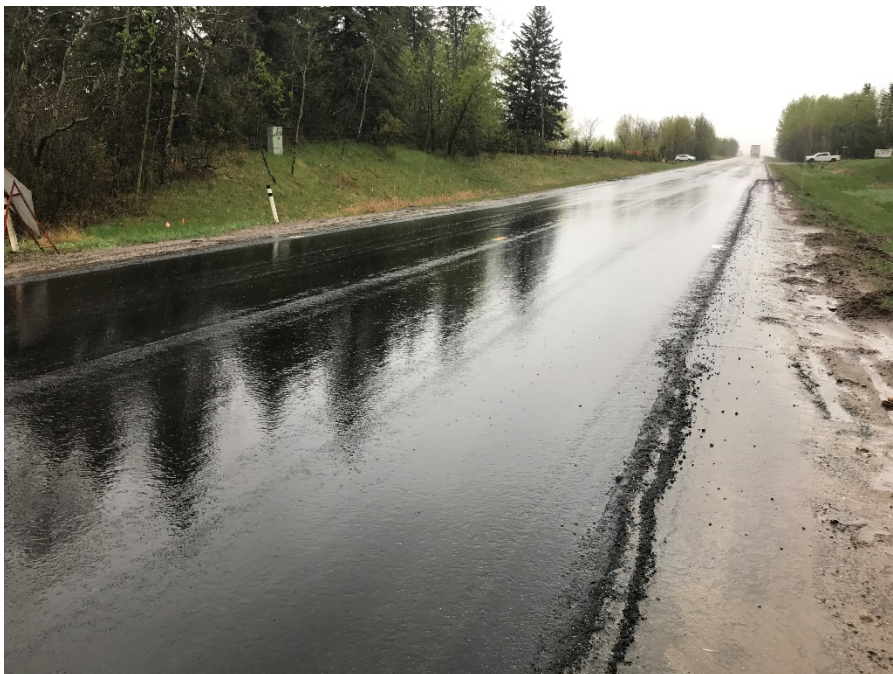
Photo 2: Highway 825. Looking northwest.

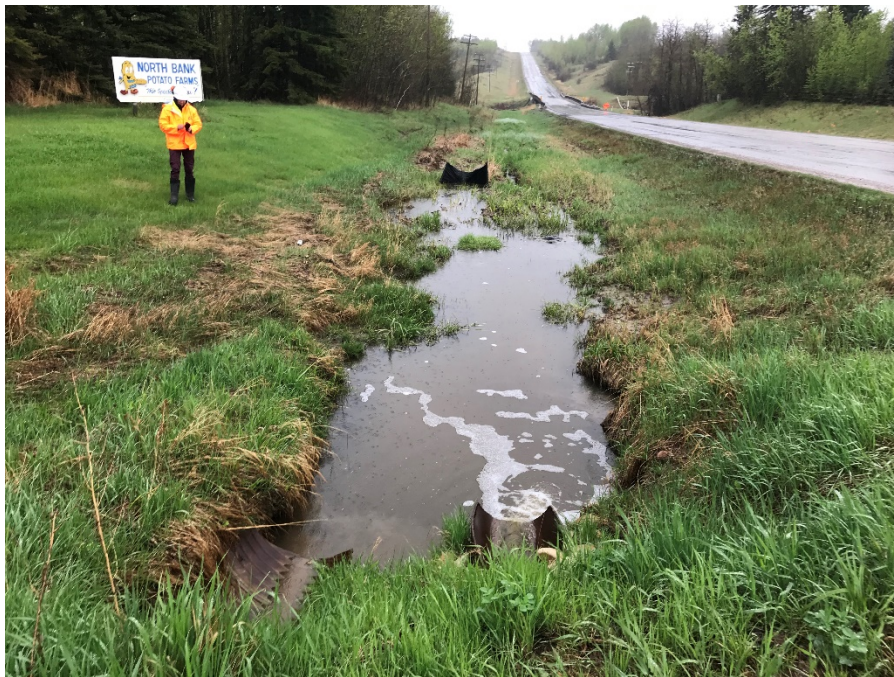
<b>Assessment</b>	<p>As-built drawings suggest 3 m of black organic fill exists at the site which may have become soft and saturated after prolonged rainfall in 2019. The soil appeared to have high sand and silt content and is prone to erosion from surface run-off upstream of the ditch. The increased rainfall experienced in 2019 may have resulted in high velocity concentrated flow in the ditch increasing the rate of erosion. The water flow may have down-cut the soil and caused the soil to collapse at a small local scale which propagated until a mass wash out occurred from surface water flow.</p> <p>Given the observed widening of the slump and undermining of the irrigation pipe, erosion and slumping is on-going at a relatively significant rate.</p> <p>Instruments monitored as part of the GRMP show variations in piezometric level of +/- 0.5 m since Fall 2019. The two piezometers in the lower part of the slope showed increase in piezometric levels. However, all three instruments are located south of the bridge and along the backslope.</p> <p>A standpipe was observed adjacent to the scarp, but it is unknown if it is operational.</p>

**Photo 3:** Erosion gully along east ditch. Looking south from culvert outlet.

<b>Recommendations</b>	<p>The site should be monitored regularly by the MCI for retrogression of the scarp towards the roadway and bridge structure.</p> <p>Rock check dams can be placed along the east ditch to reduce the water flow velocity until full remediation can take place.</p> <p>Long term-remediation may include removing the loose soil and organics and replacing with imported clay fill to reinstate the ditch grades. The rock check dams can likely remain in place as part of erosion control.</p> <p>Ditch grading should be completed to promote surface water drainage; however, this should be completed as part of long-term remediation to reduce the rate of current erosion.</p> <p>If available, borehole data from the standpipe near the scarp should be reviewed and the standpipe added to the instrumentation monitoring program.</p> <p>Site inspections should continue to be completed annually.</p>

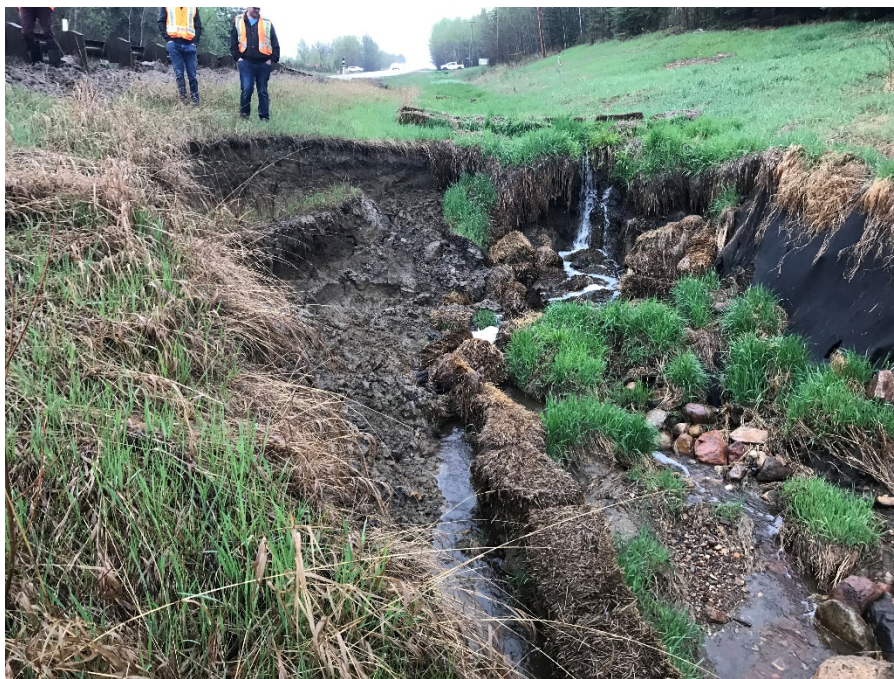
**Photo 4:** Slump adjacent to bridge abutment approximately 8 m to 10 m wide. Straw bales fell into slump from scarp retrogression. Looking north.

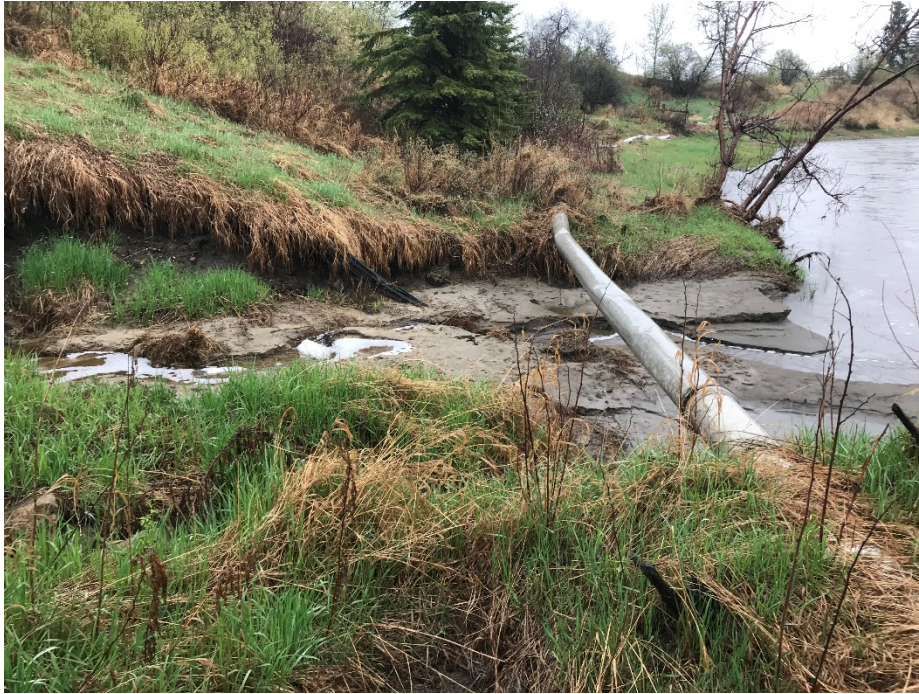
**Photo 5:** Irrigation pipe undermined by erosion and slump, approximately 6 m wide. Looking east.

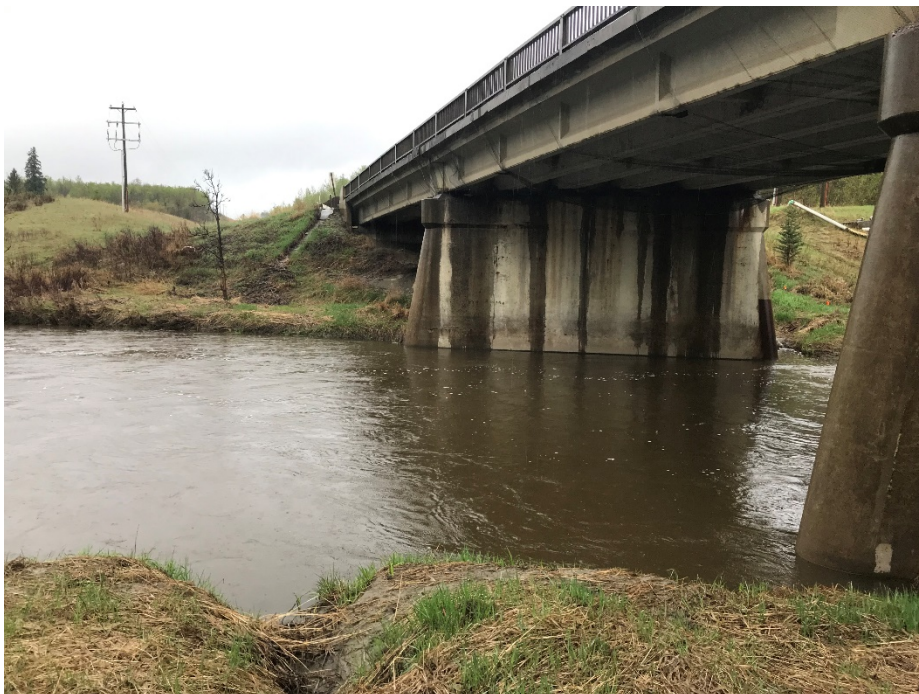
<b>Discussion</b>	<p>Inspection of NC39 has shifted from the site south of the bridge to the new erosion site on the bridge's north abutment as per the January 2020 Annual Review meeting. The legal land description, coordinates, and highway kilometer have been updated accordingly.</p> <p>The eroded area was first observed by AT on June 27, 2019 after a series of rainfall events. Stantec responded to a call-out request in July 2019 and the current inspection marks the first site inspection since the call-out.</p> <p>At the time of inspection, Highway 825 was patched approximately 1 week prior and no signs of pavement cracking were observed as shown in Photos 1 and 2. In discussion with the MCI, patching was part of the maintenance schedule and was not due to the erosion and slumping.</p> <p>Erosion and ponding continued to be observed in the east ditch as shown in Photo 3. Due to high water levels within the ditch, it was uncertain whether erosion had increased.</p> <p>Straw bales were along the ditch and around the scarp in 2019 prior to the call-out. During the 2020 inspection, many bales were missing and presumed to be washed into the river. In addition, the bales placed along the scarp had fallen into the slump as shown in Photo 4.</p> <p>The erosion underlying the irrigation pipe appeared to be wider than during the 2019 call-out as shown in Photo 5. The pipe is believed to be inoperable since it was found disconnected at several locations west of the slump.</p> <p>The bridge appeared unaffected by the current slumping. The east side of the bridge is shown on Photo 6.</p>

**Photo 6:** Bridge appeared unaffected. Looking south.
