December 7, 2006

15-85-32

**NORTH CENTRAL REGION GEOHAZARD ASSESSMENTS  
(STONY PLAIN AREA)  
CALL-OUT FOR SLIDE ON HWY 825:02 (NC54)  
3.4KM NORTHEAST OF FORT SASKATCHEWAN, ALBERTA**

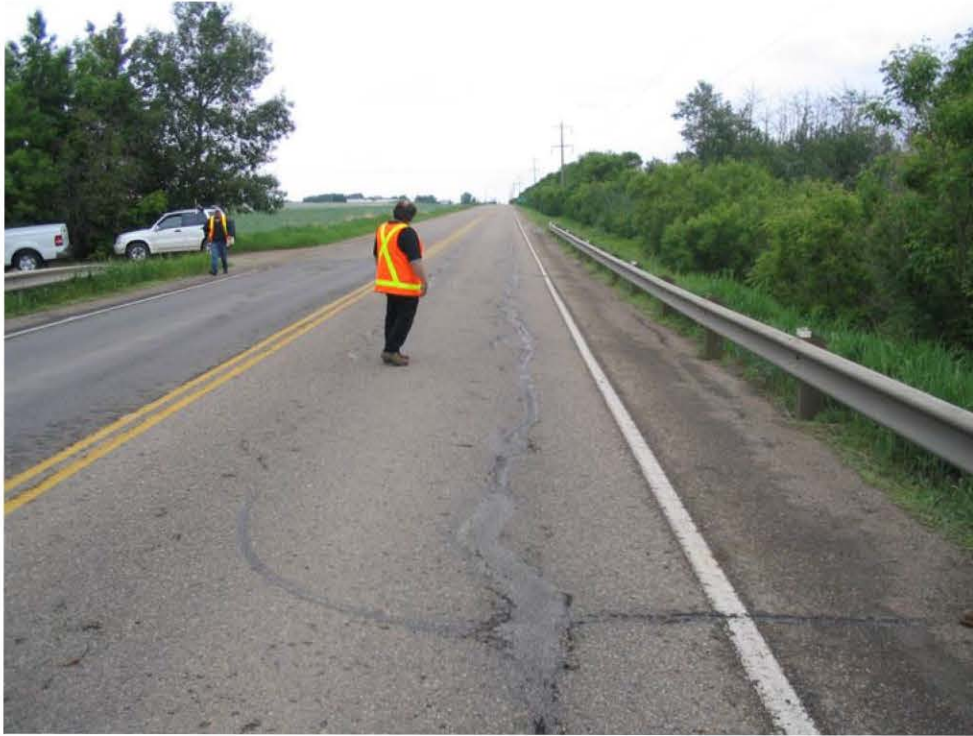
- Longitudinal paving joint cracks were observed along the middle of east bound of the road pavement.
- The guard rail installed in 2002 along the east side of the highway was about 70 m long and was straight.

Photo 1 - Looking north at longitudinal crack along pavement, June 7, 2006.

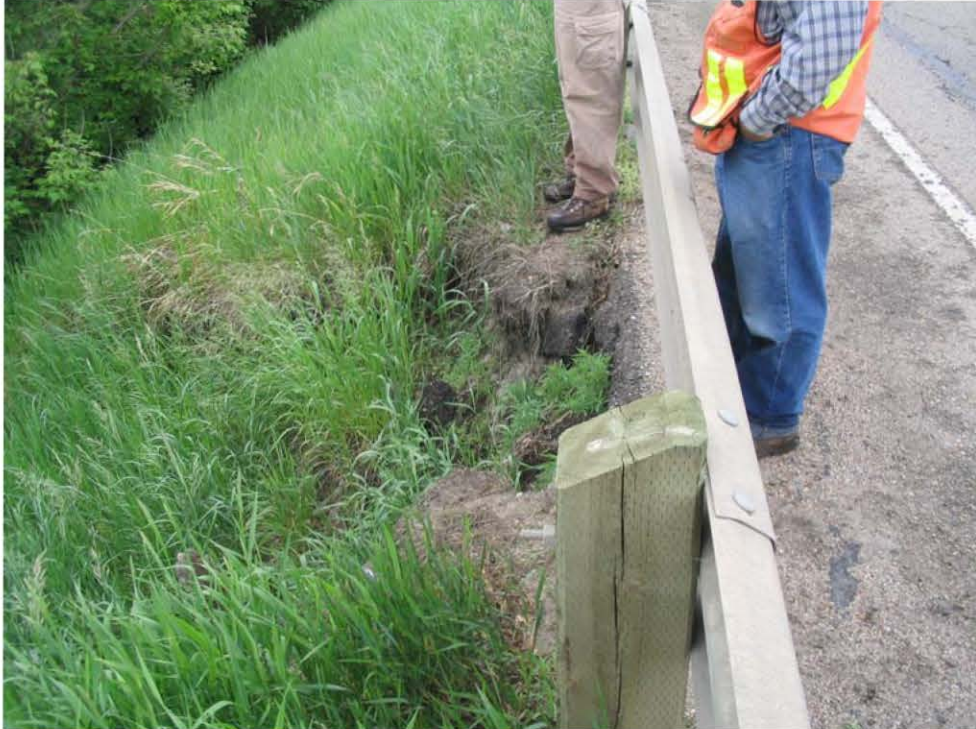
- A slide scarp located to the north side of the existing 1200 mm CSP culvert was noticed. The slide scarp was about 3.5 m wide at the top of slope and about 15 m wide at the base of the slope at the creek. The backscarp of the slide was located at the edge of the paved road surface extending about 1 m in width. The toe of the shallow slide was located at about 11 m from the edge of the paved road at the creek bank. Sandy silt soil was noted in the slump area.

The highway embankment failure appears to be due to failure of a relatively steep embankment triggered by erosion at the toe of the slope. The slide appears to be a shallow slide due to the presence of sandy silt soil. Beaver activity might have caused the lower portion of the slope to become saturated and contributed to the sliding. The slide may continue to grow in size and retrogress into the highway if remedial measures are not carried out.

Photo 2 - Looking east at slide zone, June 7, 2006.

The slide is currently progressing at a slow rate and is not affecting the roadway at the present time. Therefore, the immediate action would be to continue to visually monitor the slide on a regular basis. Due to the risk that the slide could continue to move and extend into the road surface or grow in length to the west, further geotechnical investigation should be carried out to determine the existing soil conditions and extent of the failure zone and develop suitable remedial options.

- Option 1 - construct a short driven Steel "H" pile wall about 5 m in length with timber lagging to retain the edge of the highway and place heavy rip rap to protect a 20 m long section of the toe of the slope from creek erosion.
- Option 2 – excavate the slide zone and rebuild the embankment with a gabion wall at the toe of the slope.
- Option 3 – excavate the slide zone and rebuild the embankment slope with gravel reinforced with geogrid layers, complete with hard armour such as heavy rip rap or a product like Delta Lock along the toe of the slope.

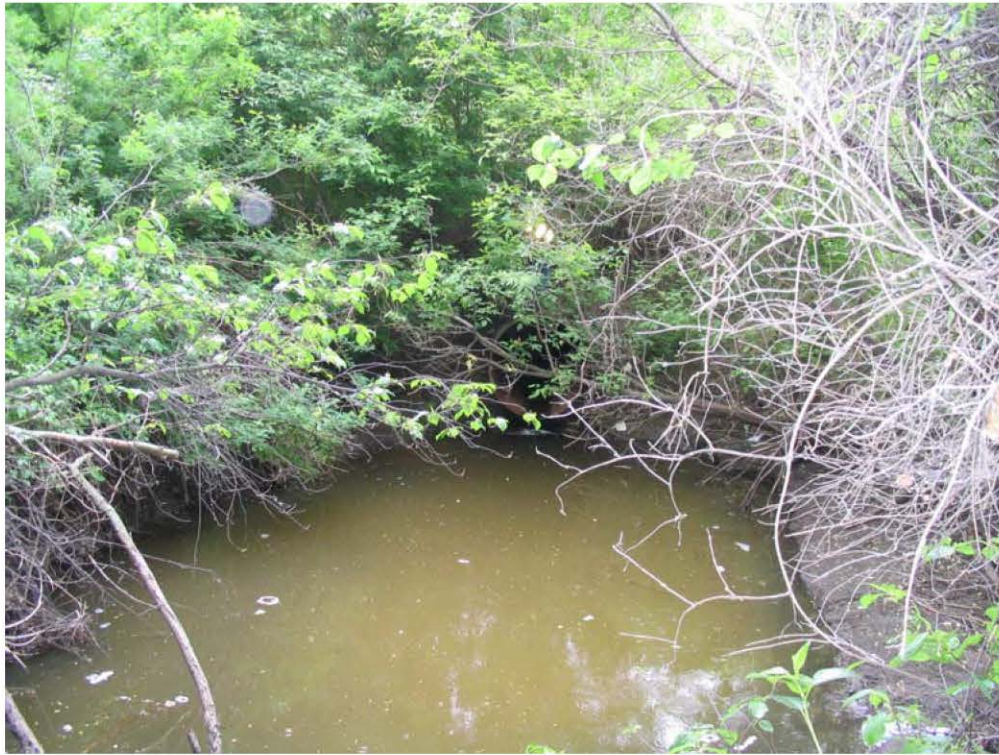
- The creek is oriented approximately parallel to the east of the highway and bends sharply to the west passing through a 1200 mm CSP culvert. The creek was about 1.5 to 2 m wide. A 0.3 m deep scour was observed at the culvert outlet. No riprap was observed at the culvert outlet. Scour and erosion signs were observed in the east bank of the creek at the bend location.

Photo 3 - Scour at the culvert outlet, June 7, 2006.

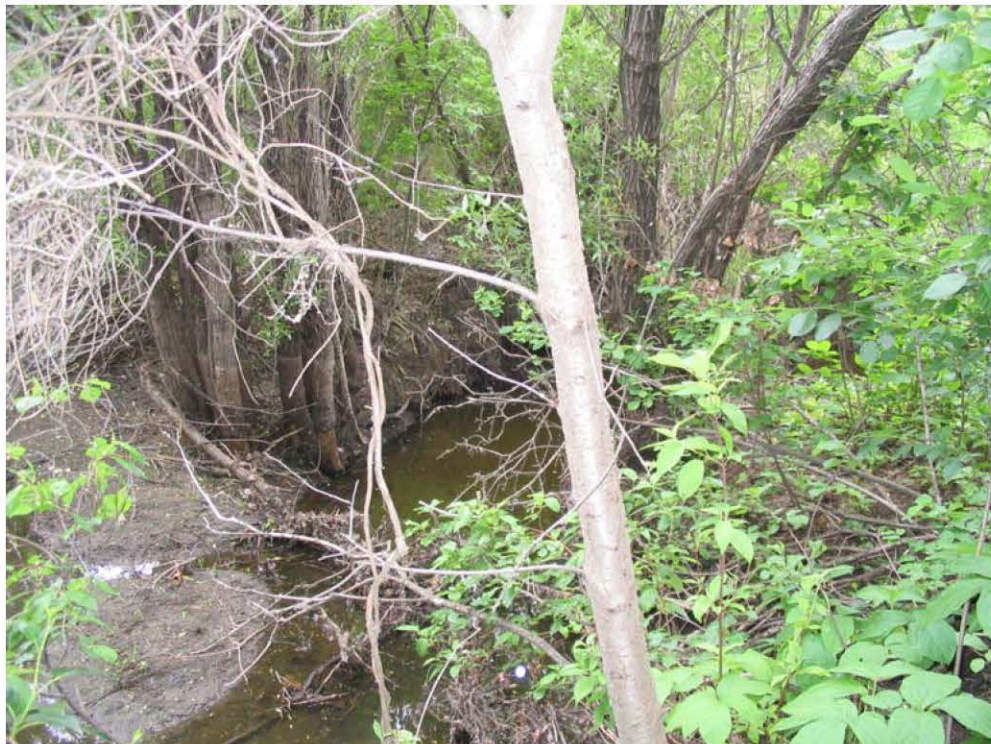
Photo 4 - Erosion along the east bank, June 7, 2006.

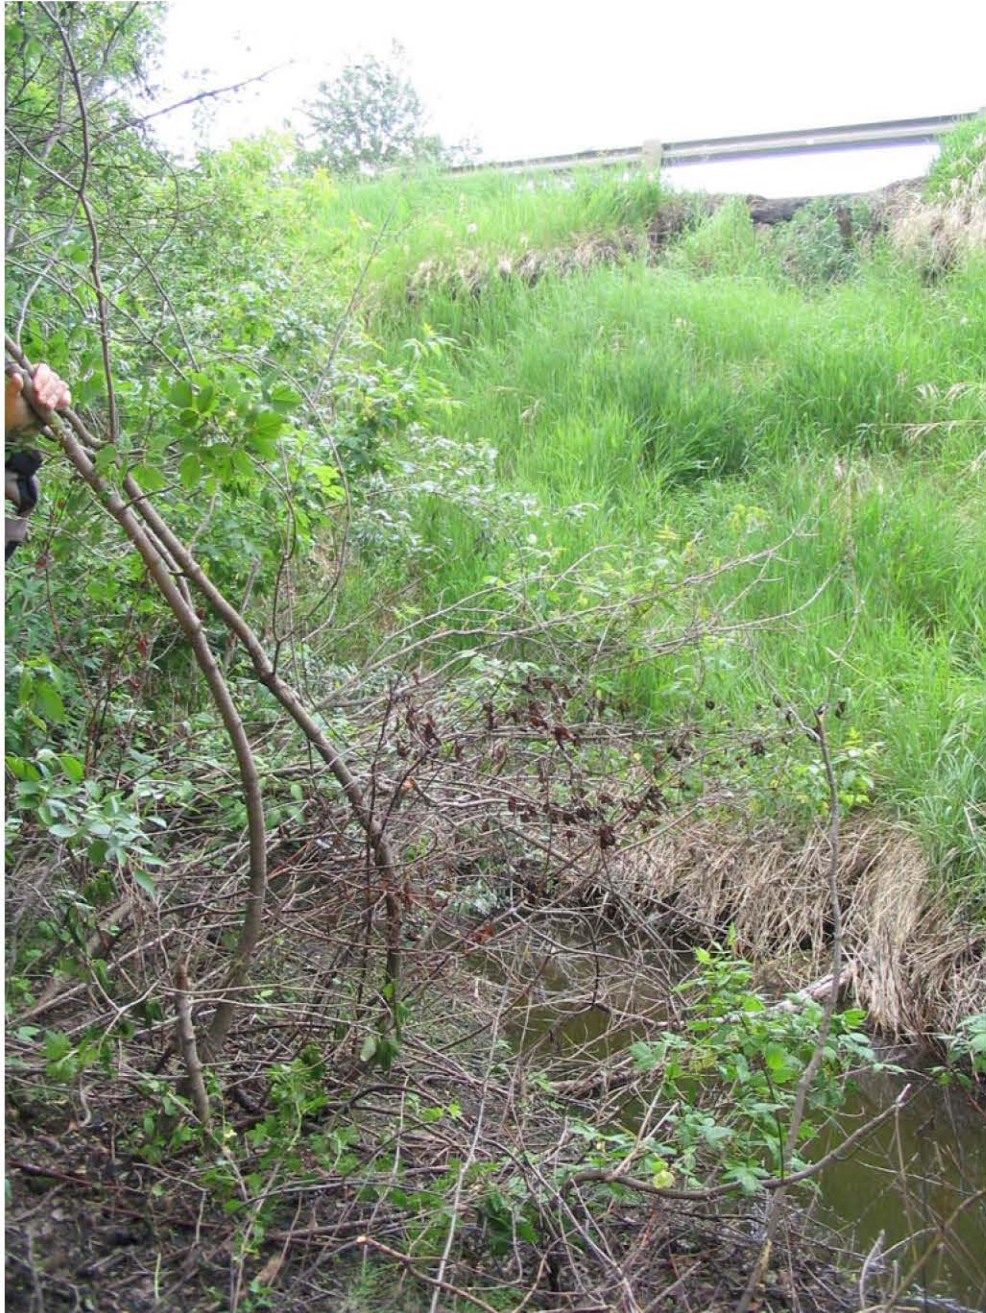
Photo 5 - Looking west at toe of slide zone, June 7, 2006.

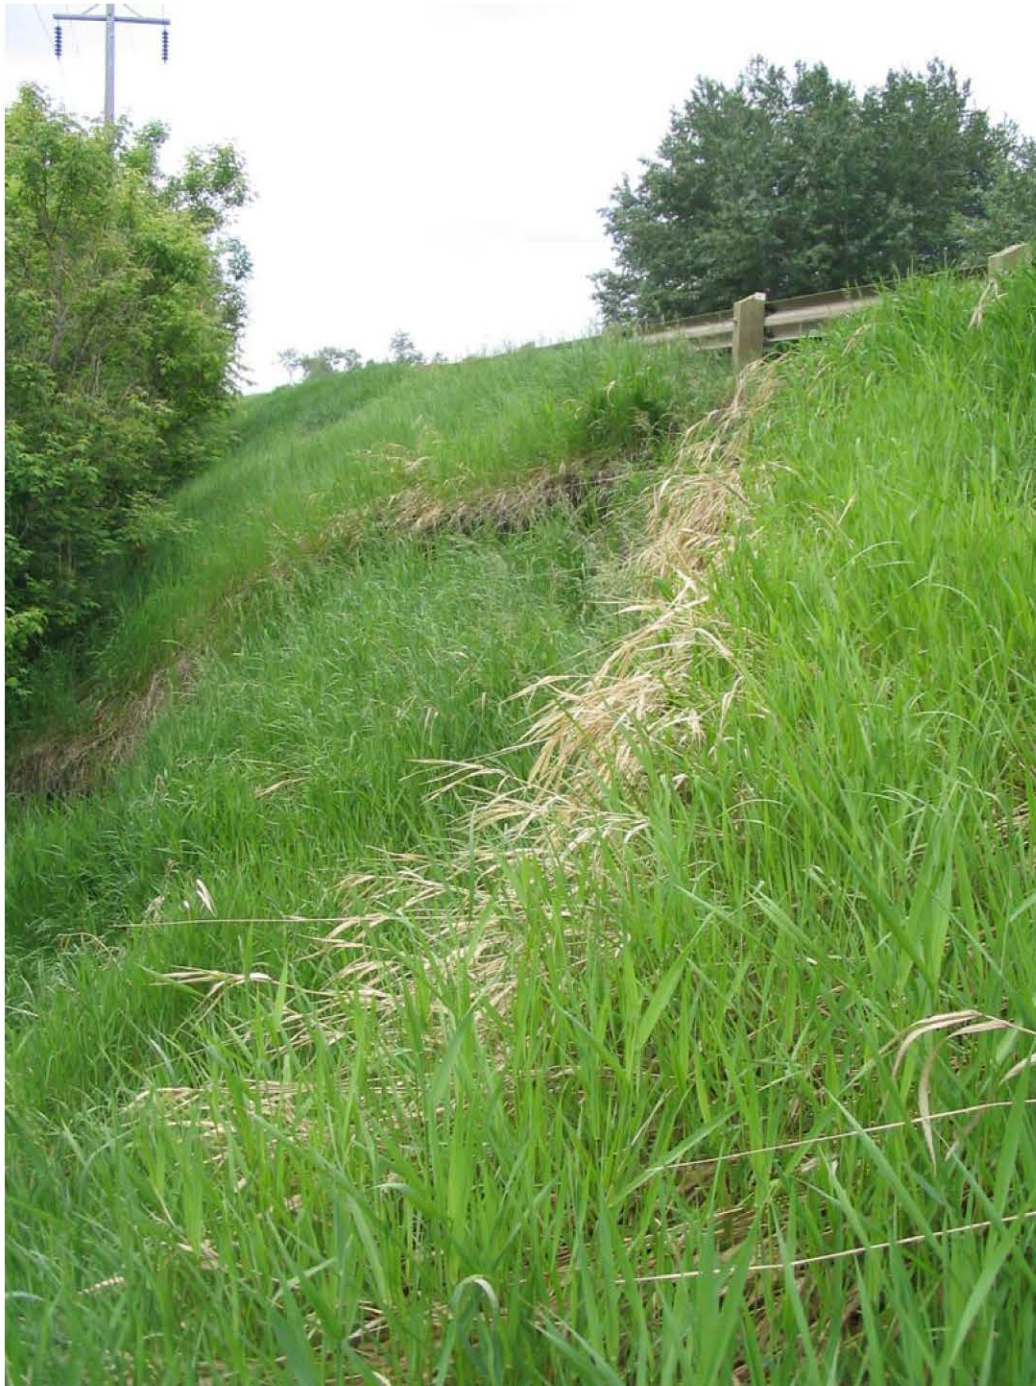
Photo 6 - Scarp to the east of the creek, June 7, 2006.

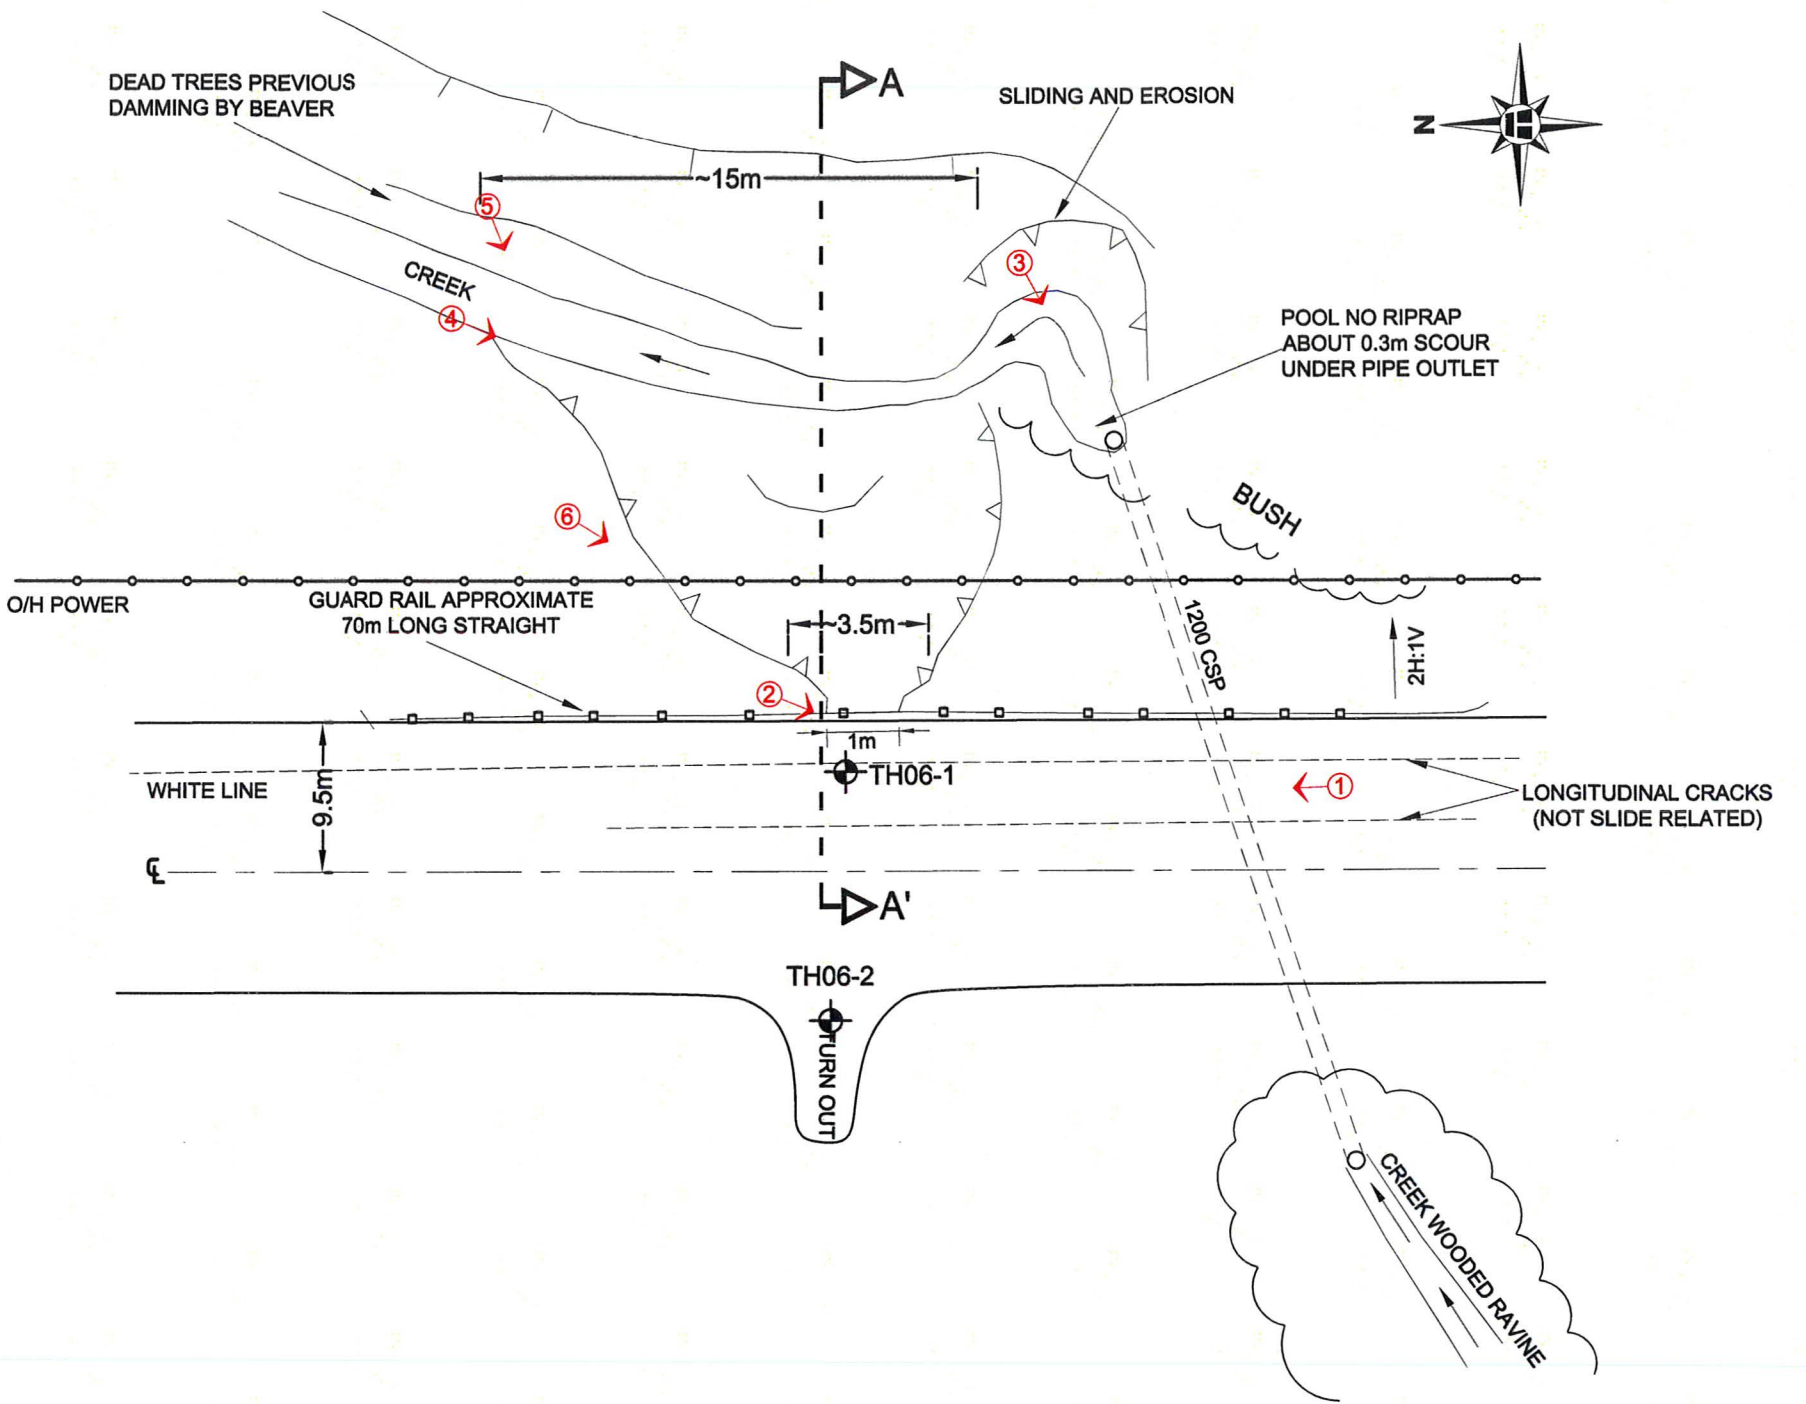
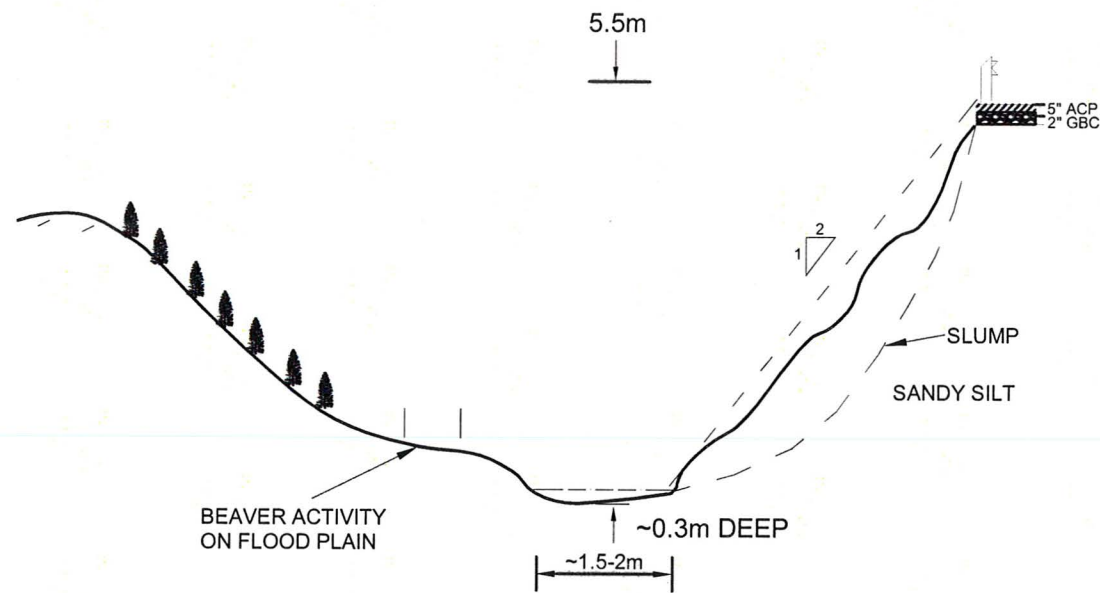
ENGINEER: MMS	DRAWN: JW	APPROVED: DWP
DATE: AUG. 2006	SCALE: NTS	DRAWING No. <b>FIGURE NC54-1</b>

A sketch plan and approximate slope cross-section of the slide area are provided on Figure NC54-1, attached. Selected photos of the site are also attached. At the location of the slide area, the highway is 19 m wide and paved. The embankment is approximately 5.5 m high with a side slope angle of about 27° to the horizontal (approximately 2.0H:1V). During the site reconnaissance the following additional observations were made:

We recommend drilling two test holes about 10 m to 12 m deep complete with standpipe piezometers at the proposed locations as shown on Figure NC54-1 to identify the subsoil stratigraphy and groundwater conditions for the design remedial options. A site survey will also be required for design.
