May 11, 2011

ISSUED FOR USE
EBA FILE: E12101085.004
Via Email: sabhago.oad@gov.ab.ca

Subject: April 15, 2011 Call Out Inspection
Embankment Overtopping and Slope Erosion
Hwy 825:02

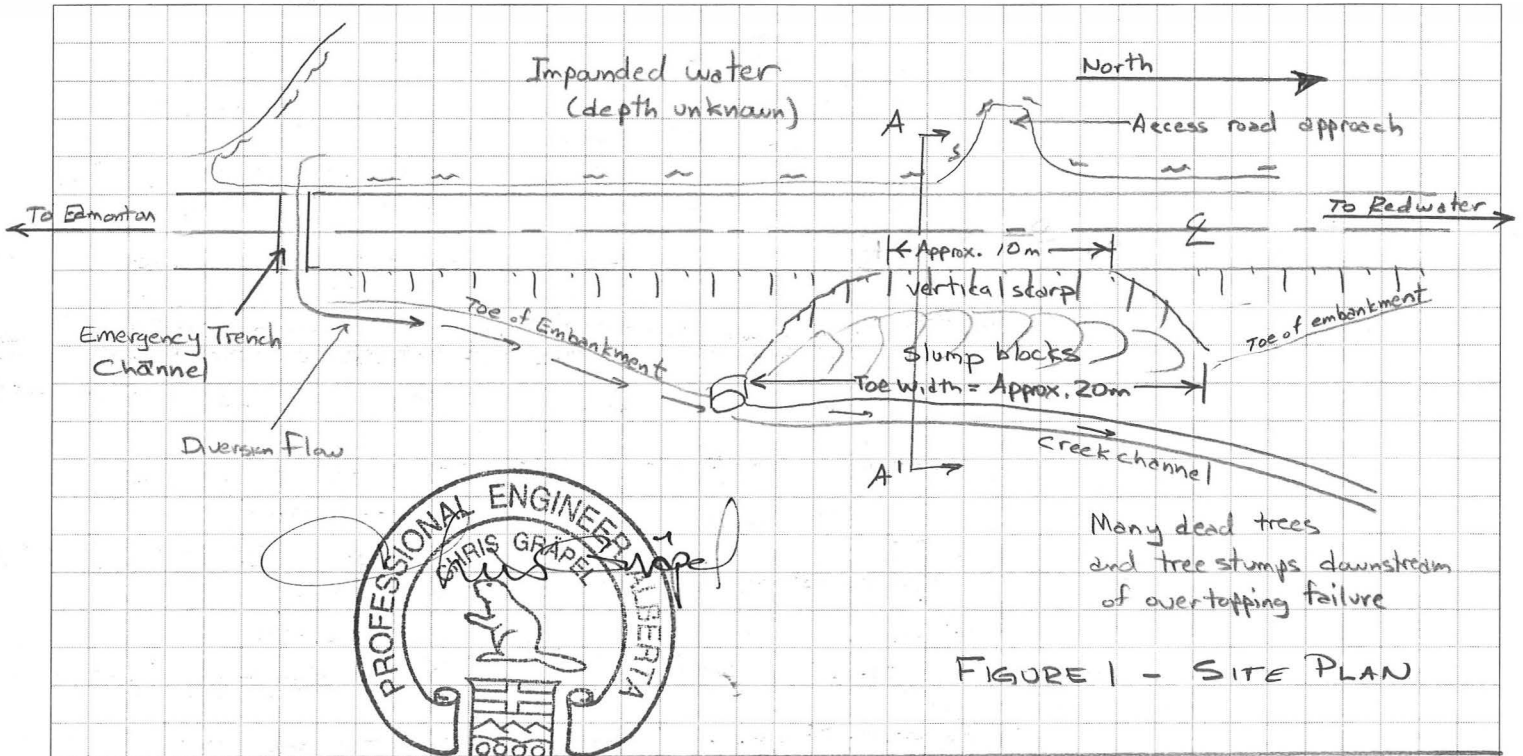
FIGURE 1 - SITE PLAN

- The downstream slope of the embankment crossing was partially washed out. The extent of overtopping erosion is presented in the attached Figure 1. Three guardrail posts were suspended in mid-air at the time of the inspection. A vertical back scarp is present at the edge of the southbound lane about 3 m high. Eroded/slumped blocks of embankment fill are located at the bottom of the vertical scarp;
- There do not appear to be any signs of slope failure in the remaining lower sections of embankment slope on the downstream side. It is not possible to assess the condition of the upstream slope as it was inundated at the time of inspection;
- The creek runs along the toe of the former downstream toe of the embankment; and
- Efforts to unplug the culvert using water jets were underway during the start of EBA's inspection and were suspended shortly thereafter without success.

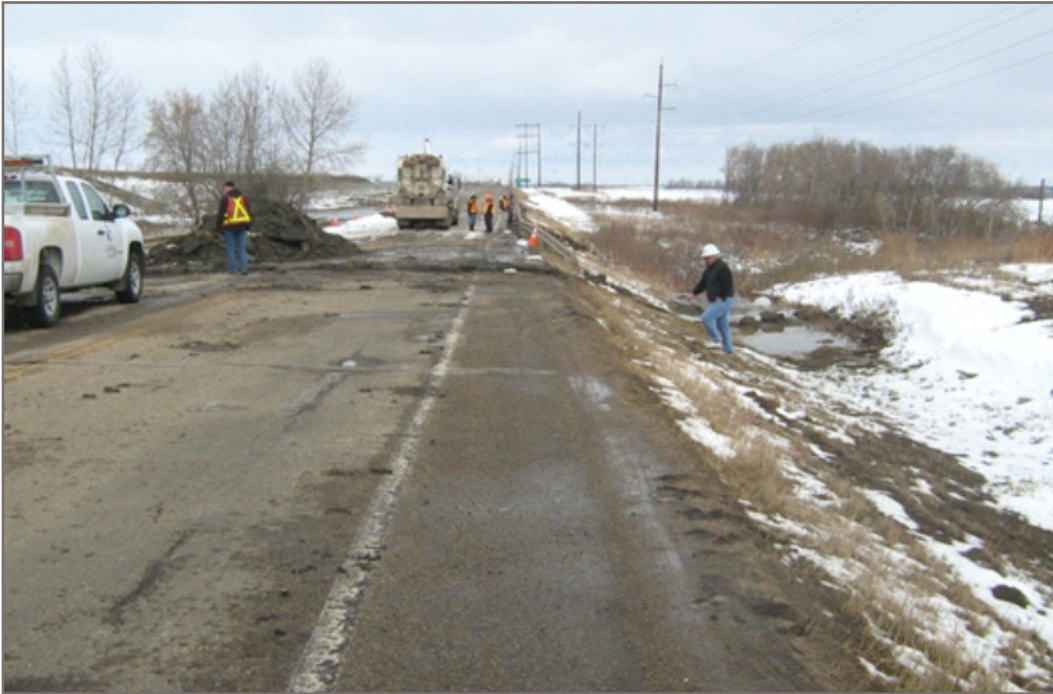
The overtopping appears to have started when the culvert beneath the road was blocked. The blockage appears to have been either due to woody debris as the area upstream of the culvert inlet has a high incidence of dead trees. Furthermore, downstream of the embankment there appear to be a significant number of dead trees, some cut down by beavers and others with chain saws.

Photo 1: Hwy 825 washout due to blocked culvert. Facing northeast.

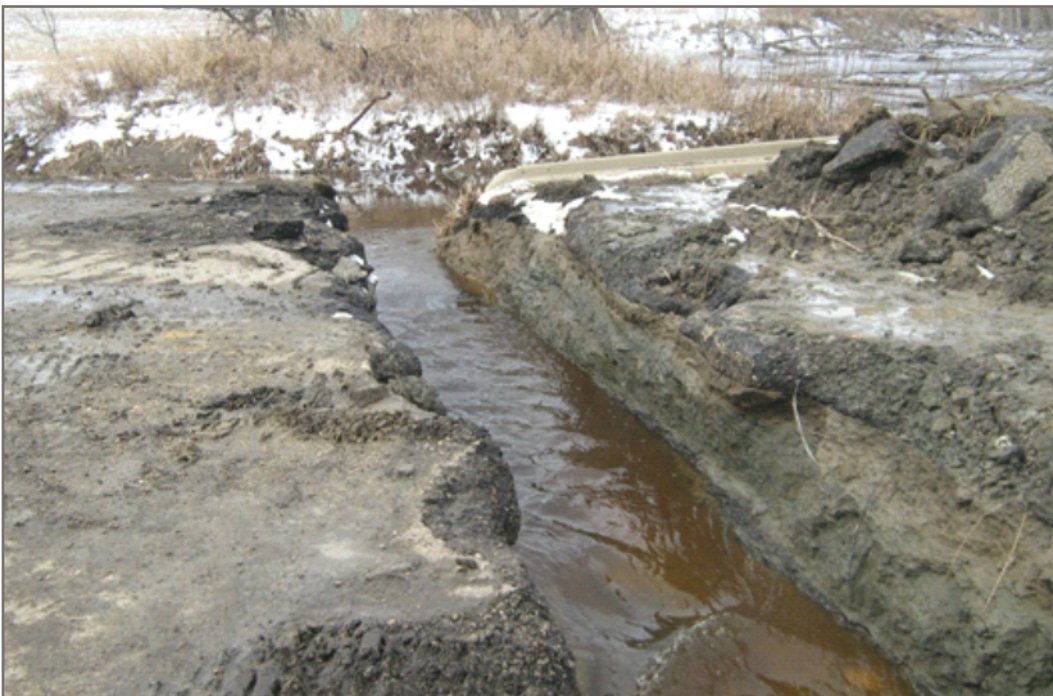
- The trench was excavated across the road to divert water through a lower part of the embankment to avoid losing the high section of the embankment;
- There are two utilities located on the upstream side of the embankment – a waterline, diameter and purpose (municipal or industrial) unknown and a Telus fibre optic line;

Photo 2: Trench across Hwy 825 promoting drainage due to blocked culvert. Facing northwest.

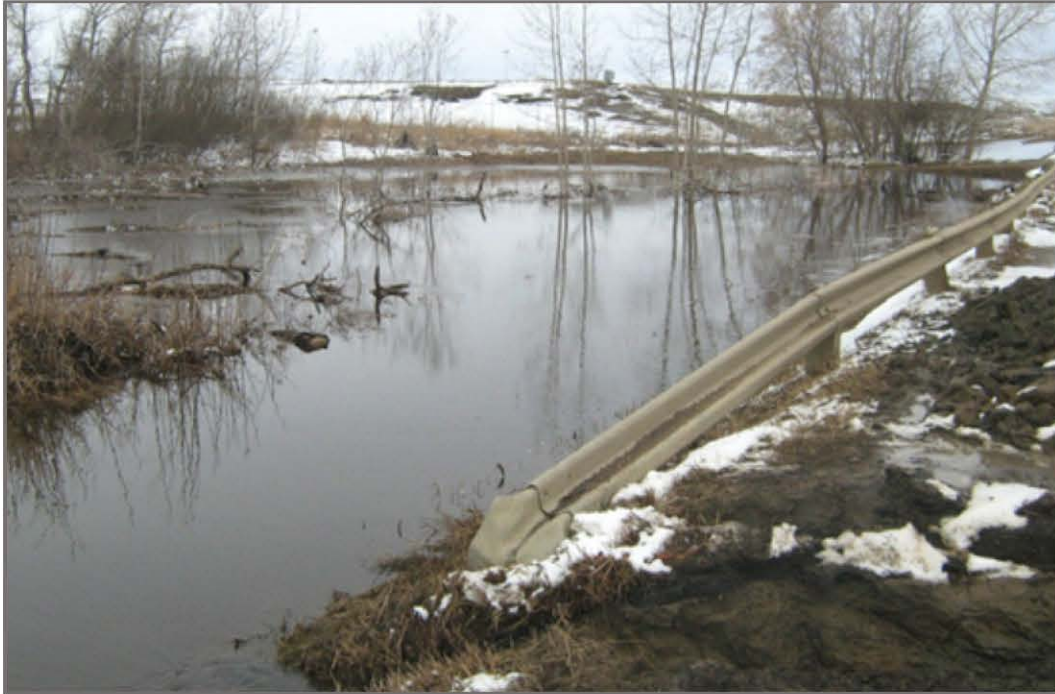
Photo 3: Flooding on upstream side of blocked culvert of Hwy 825. Facing northeast.

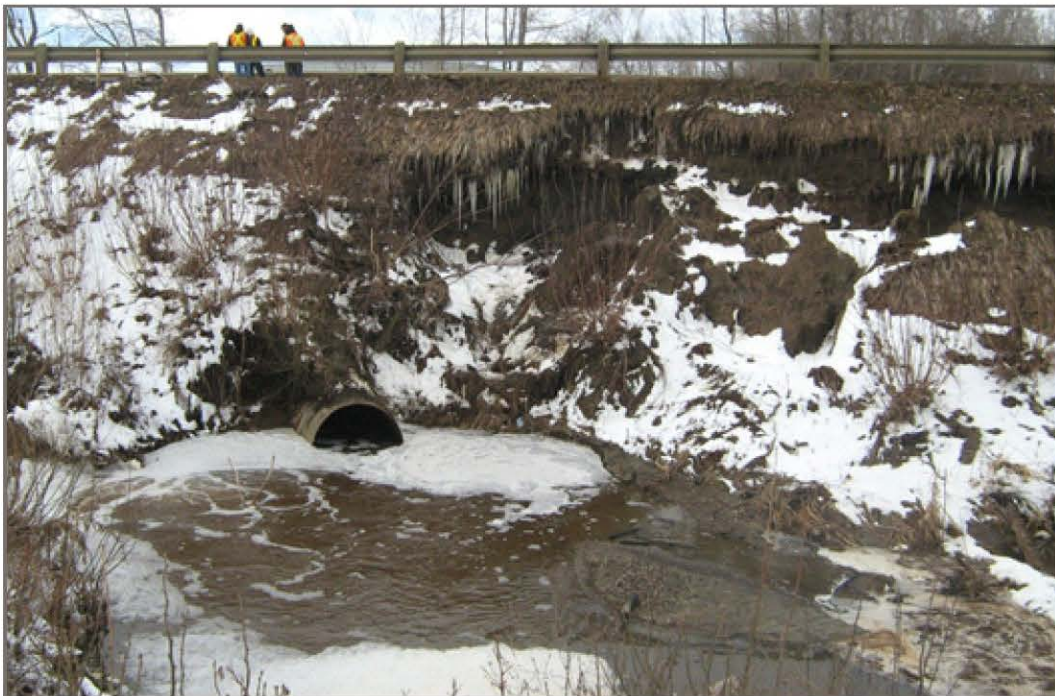
Photo 4a: Extent of slope failure on downstream side of blocked culvert. Facing northwest.

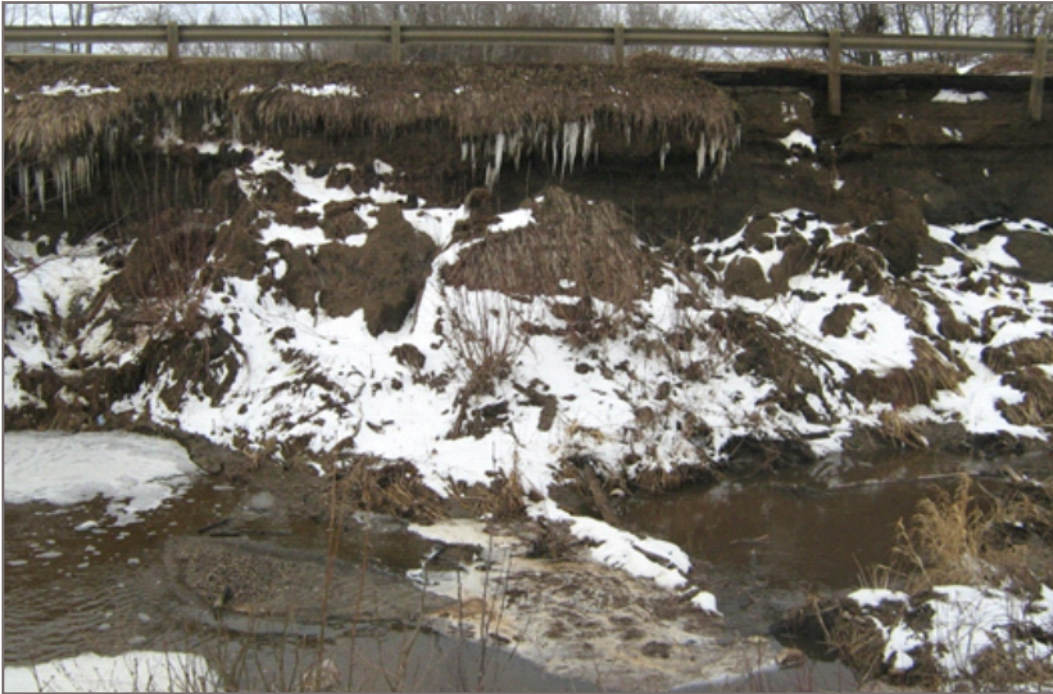
Photo 4b: Extent of slope failure on downstream side of blocked culvert (continued).
Facing northwest.

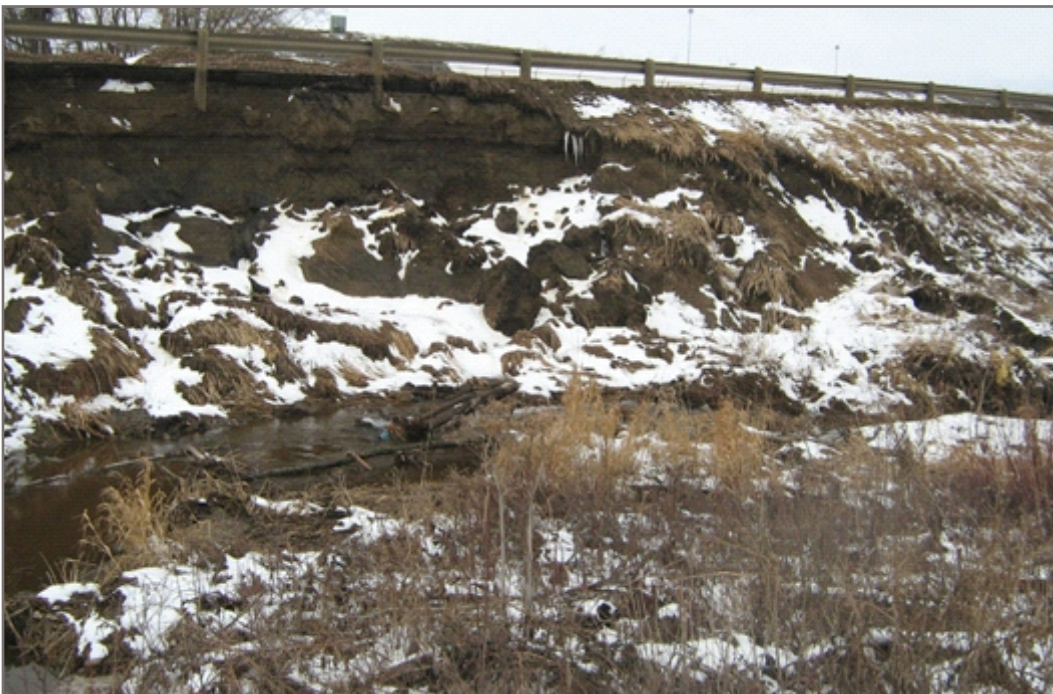
Photo 4c: Extent of slope failure on downstream side of blocked culvert (continued).
Facing northwest.
