**STONY PLAIN REGION
GEOHAZARD RISK ASSESSMENT
SITE INSPECTION FORM**

| SITE NUMBER AND NAME: NC 47 – Embankment Slope Failure | HIGHWAY AND KM: Access Road 172, km 2.1 | PREVIOUS INSPECTION DATE: June 3, 2009 | INSPECTION DATE: May 21, 2010 |

| PRIMARY SITE ISSUE: Shallow rotational failure of south embankment slope. | |

North Central (Stony Plain)
Geohazard Risk Management Program
NC-47 New Sarepta, Alberta

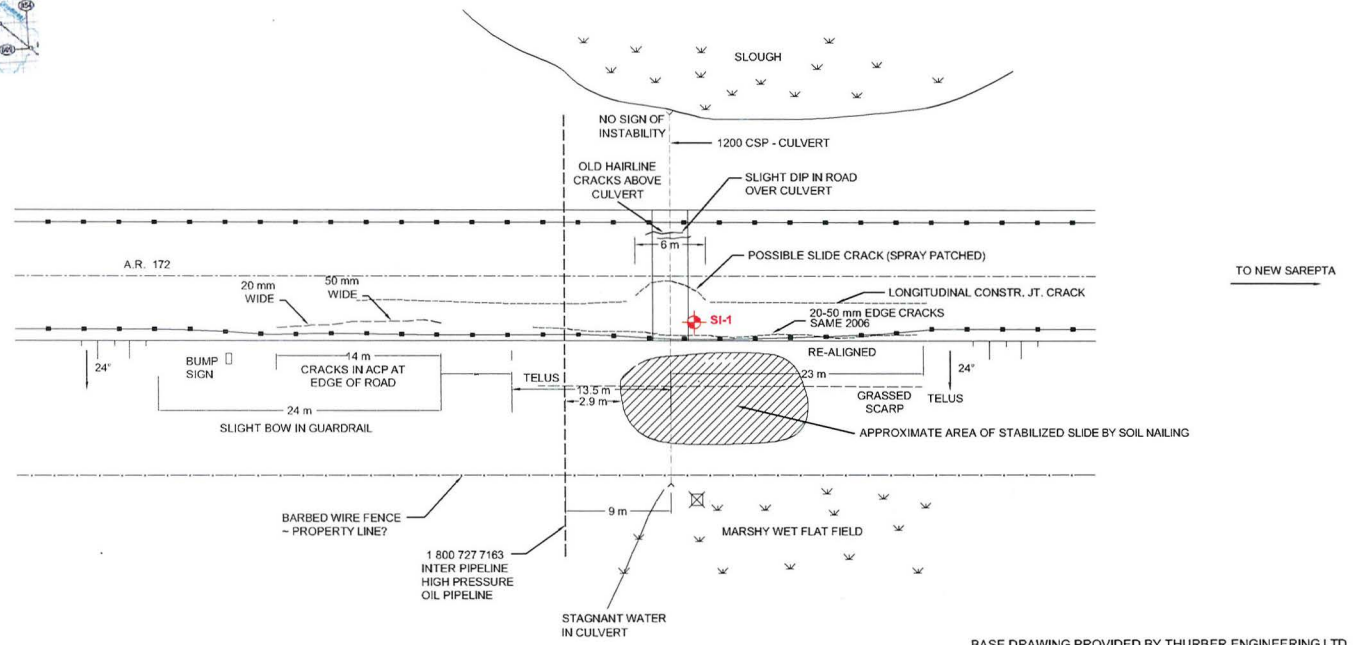
Figure NC-47

Site Plan

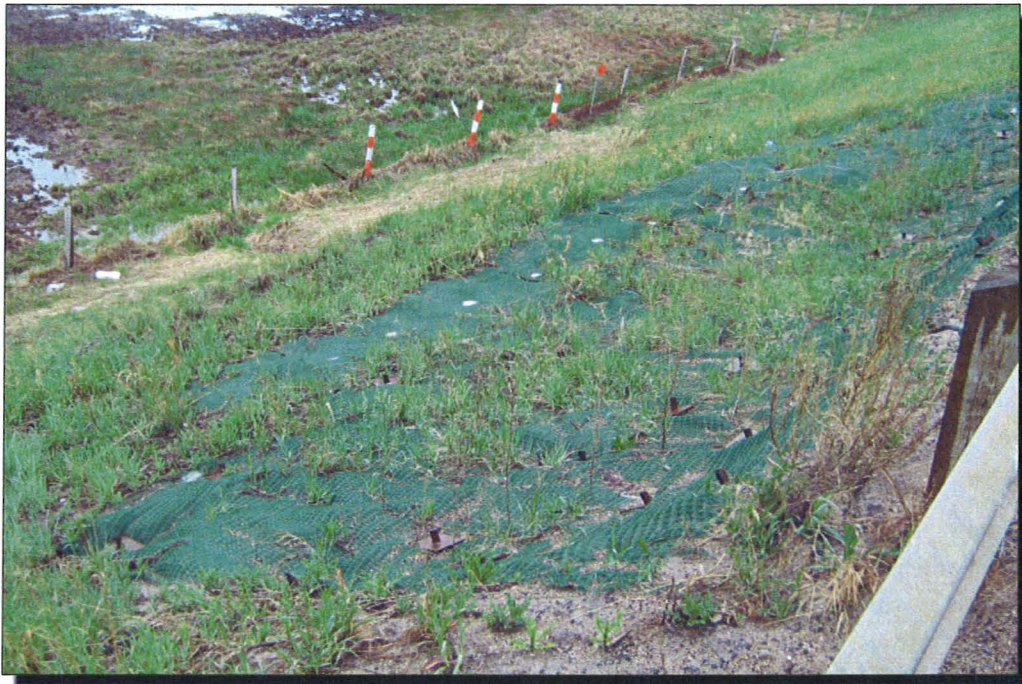
- The fill slope is steeper than what is normally constructed by TRANS being approximately 2H:1V and 6.1 m high.
- The slope failure was repaired in October 2008.
- Soil nails sticking out of ground, potentially a risk to public.
- Shallow slope movements have stopped since application of soil nailing in 2008.
- There were minor deep seated movements noted at approximate embankment base level. These could be associated with lateral spreading along organics or wet soils near the culvert/ creek location.

Photo 1
Repaired sideslope

- Monitor SI to assess if movements at depth continue. Consider removing site from GRMP if Fall 2010 readings show no further movement.
- Monitor SI in Fall 2010 and remove from GRMP.
- Have MCI place topsoil over slope and have seeded to cover soil nails protruding from slope. Topsoil should be seeded. Alternatively, a compost mat (i.e., EcoBlanket™) could be placed over the area.
- Crack near the south side of the road should be sealed.

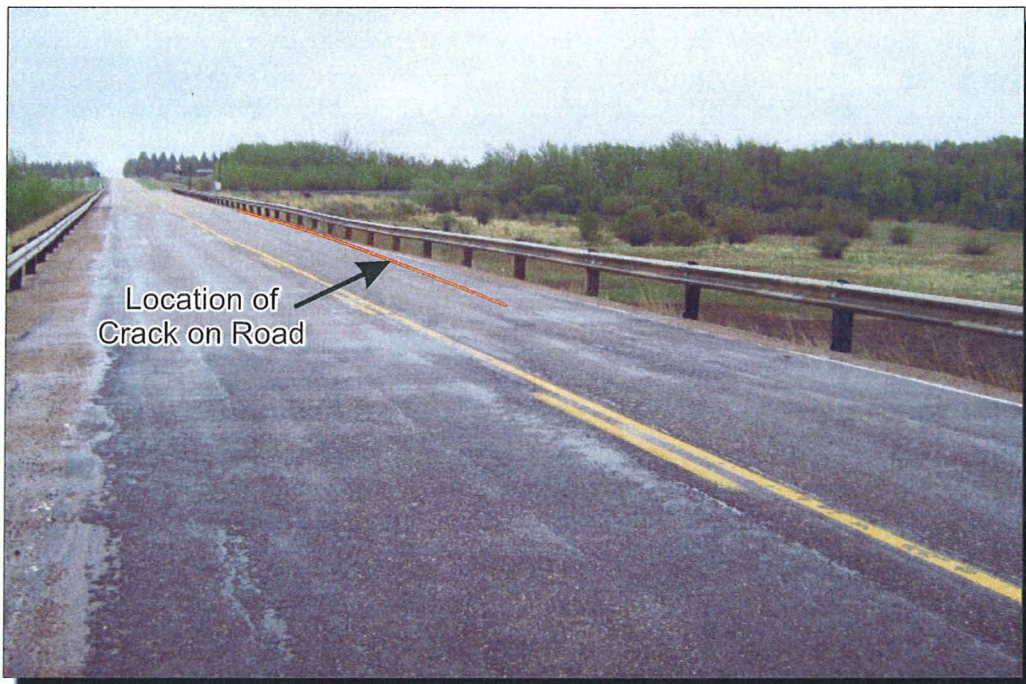
| ITEM | CONDITION EXISTS | | DESCRIPTION AND LOCATION | NOTICABLE CHANGE FROM LAST INSPECTION | |
|---|---|---|---|---|---|
| Pavement Distress | X | | Cracks along shoulder associated with embankment failure 2H:1V embankment failure stabilized with soil nails | | X |

Photo 2
Looking east along Access Road 172; crack present on roadway
