# ALBERTA TRANSPORTATION INSTRUMENTATION MONITORING RESULTS FALL 2011

### NORTH CENTRAL (STONY PLAIN) REGION

#### SITE NC47: AR 172 (EAST OF HWY 21:26) NEW SAREPTA

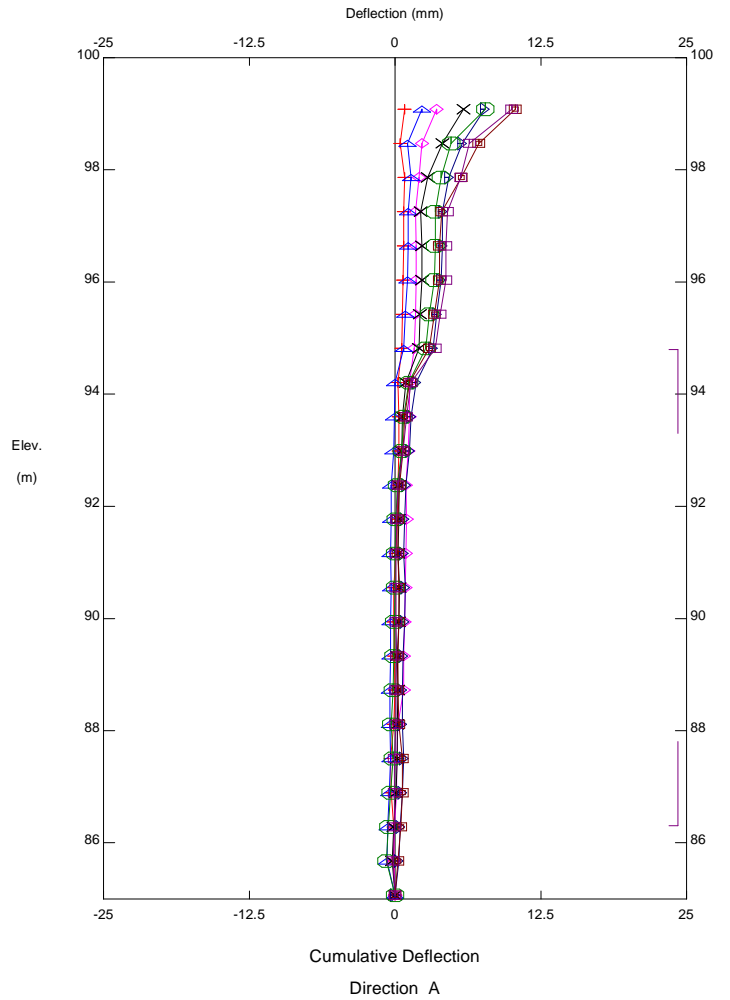
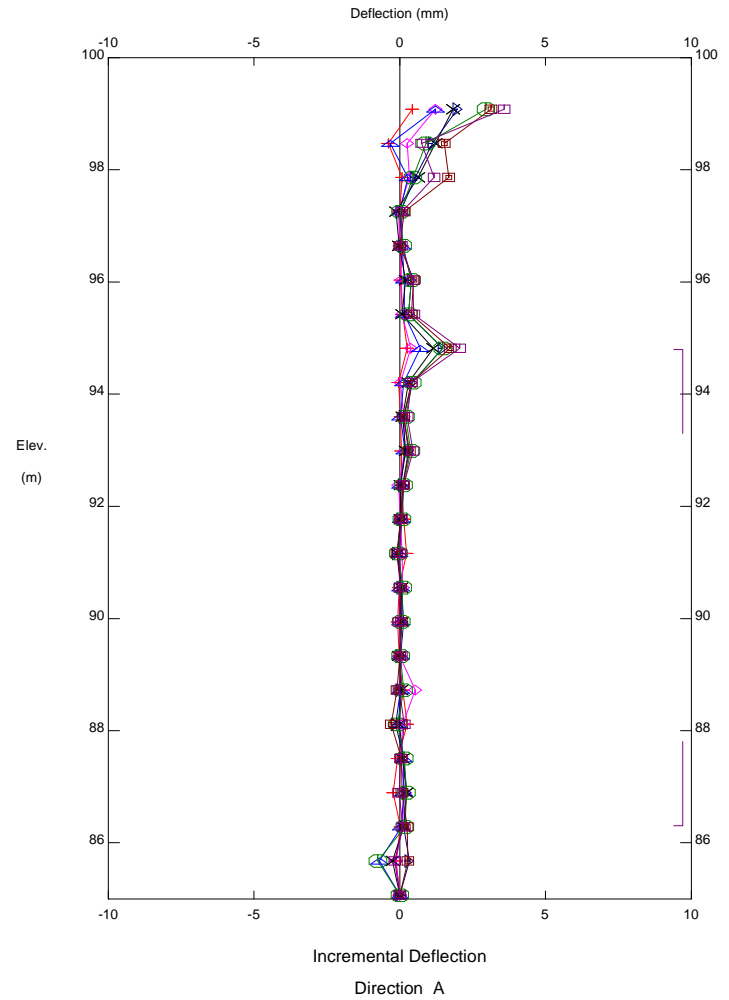
NC47, Inclinator SI-1  
 Alberta Transportation  
 A.R.172 New Sarepta

Air launched soil nails had been installed on either side of the SI in October 2008. As such, EBA has concluded that installation of the soil nails has not damaged the SI. There is no discernible movement recorded by the SI in the upper embankment near the repaired slope failure. There appears to be some minor movement at the base of the embankment near 6 m depth. This is likely due to lateral spreading along soft clay or organic materials left in place in the highway embankment foundation. The rate of movement is calculated at 2.8 mm/year however there has been less than 1 mm of incremental movement at the shear zone since spring 2011 monitoring.

EBA recommends that instrument monitoring at the NC47 site be discontinued. MCI inspection of the site should continue, however, further annual inspections need not be continued in 2012. If any changes occur to the pavement surface or slope, AT should initiate a Call Out as a minimum.
