**STONY PLAIN REGION  
GEOHAZARD RISK ASSESSMENT  
SITE INSPECTION FORM**

<b>SITE NUMBER AND NAME:</b> NC 47 – Embankment Slope Failure	<b>HIGHWAY AND KM:</b> Access Road 172, km 2.1	<b>PREVIOUS INSPECTION DATE:</b> May 21, 2010	<b>INSPECTION DATE:</b> June 15, 2011
<b>LEGAL DESCRIPTION:</b> SE 4-50-22-W4M	<b>NAD 83 COORDINATES:</b>	<b>RISK ASSESSMENT:</b> PF: 2      CF: 4 <b>TOTAL: 8</b>

North Central (Stony Plain)  
Geohazard Risk Management Plan  
NC-47 New Sarepta (AR-172), Alberta

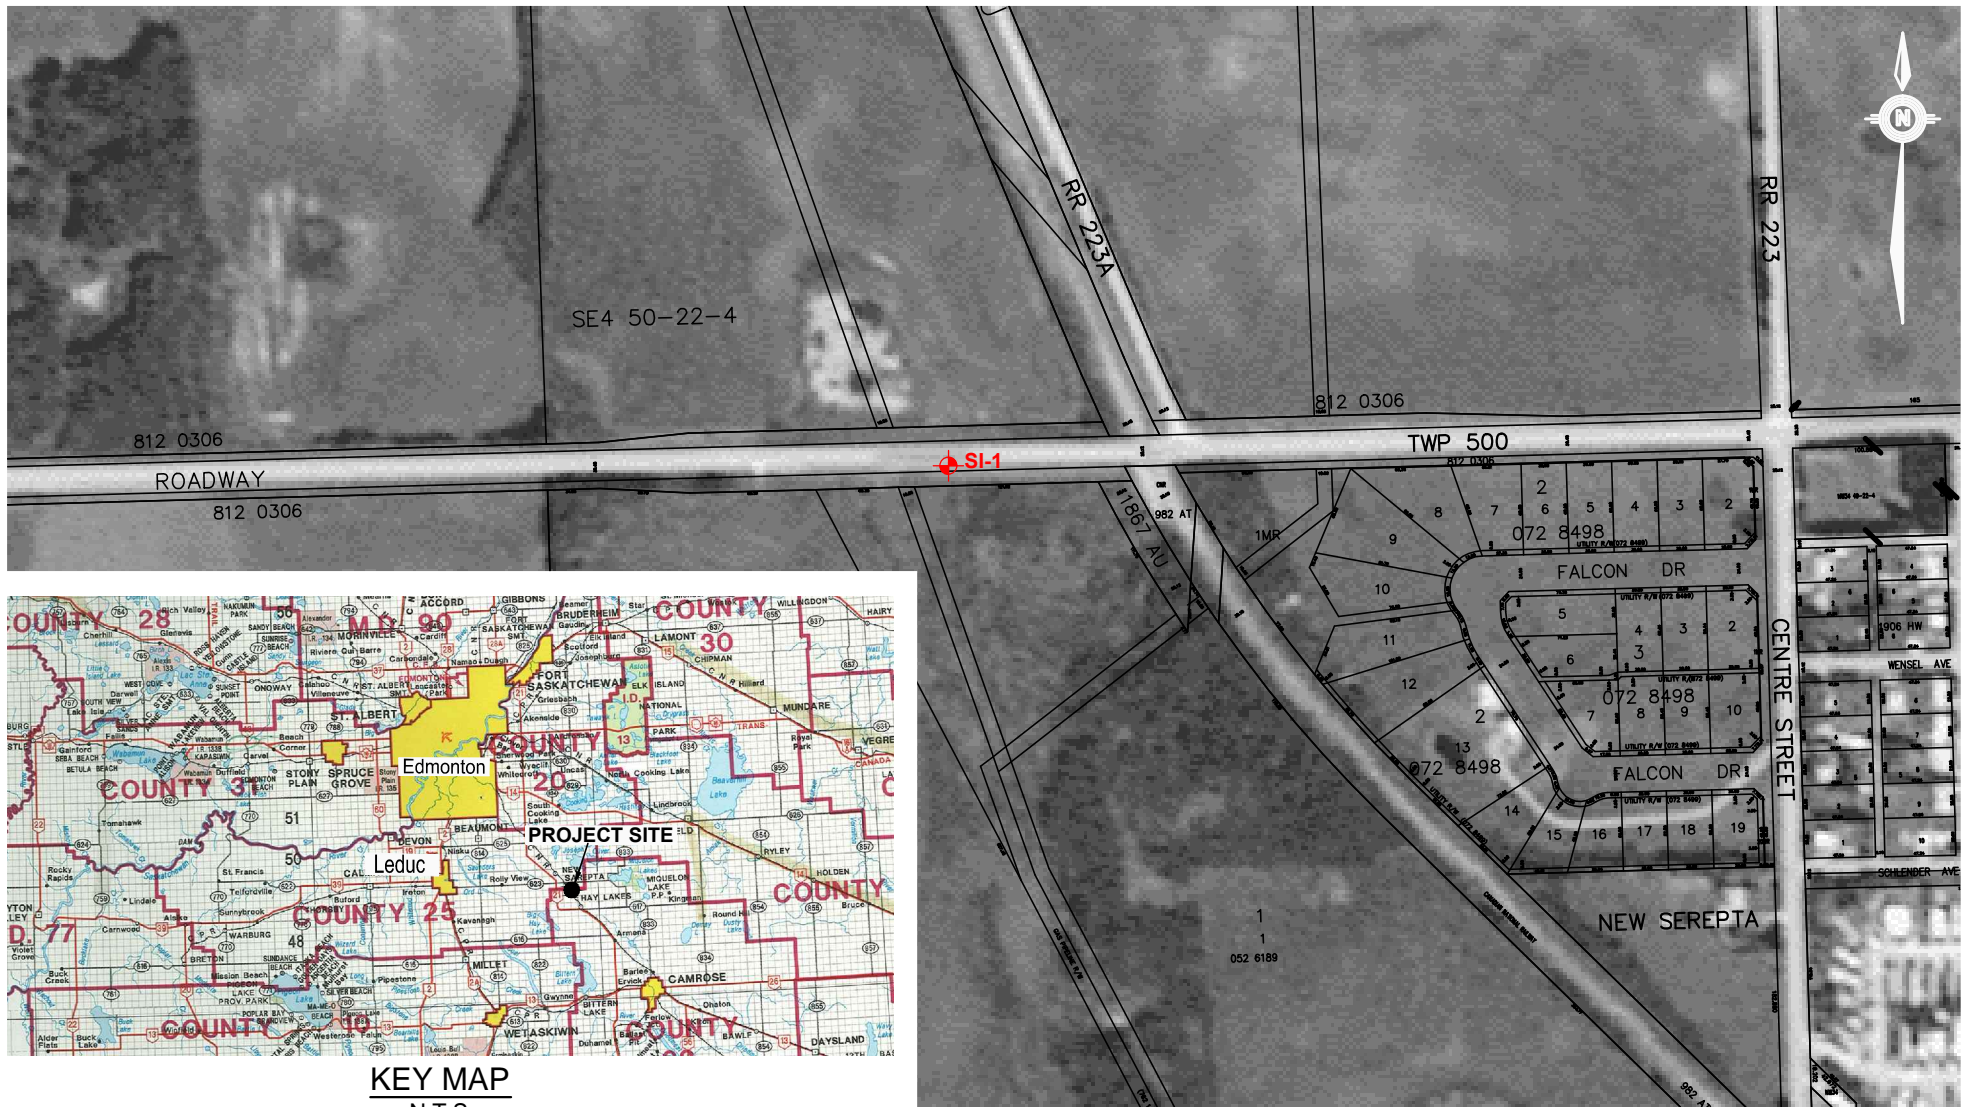
Figure NC-47

Site Plan

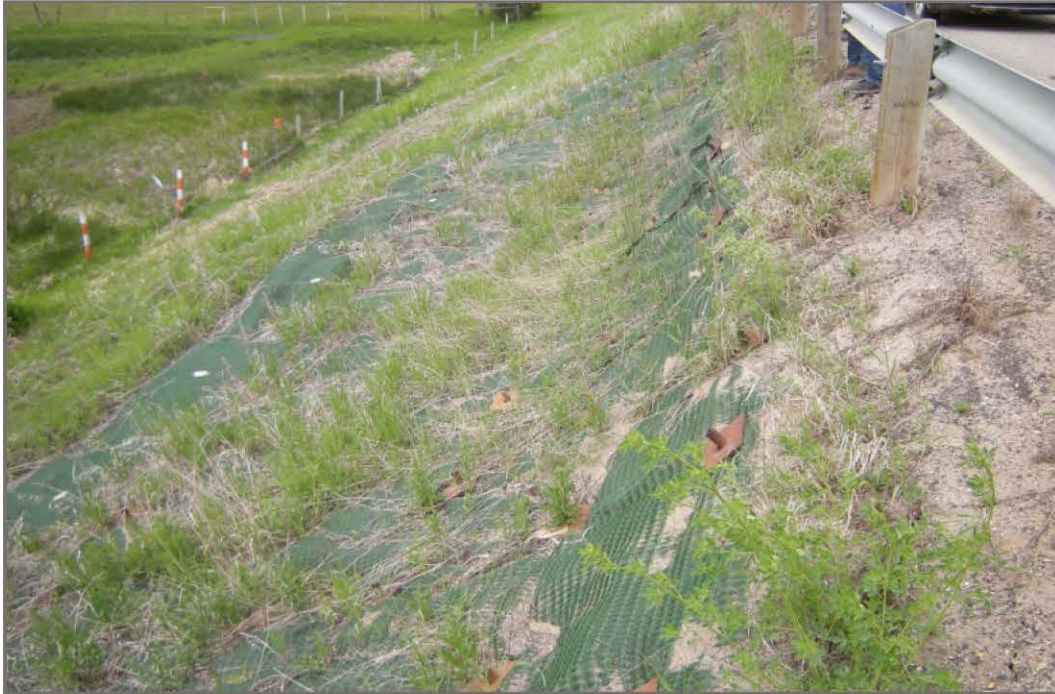
**Photo 1:** Repaired sideslope requires topsoil and seeding

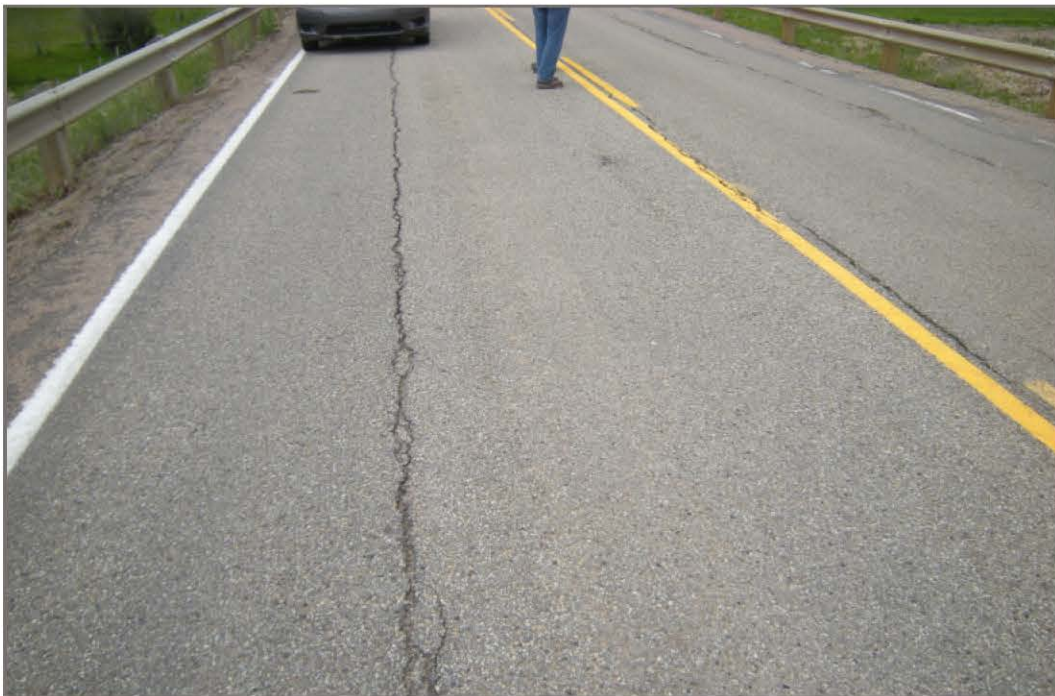
ITEM	CONDITION EXISTS		DESCRIPTION AND LOCATION	NOTICABLE CHANGE FROM LAST INSPECTION	
	YES	NO		YES	NO
Pavement Distress	X		Cracks along shoulder associated with embankment failure 2H:1V embankment failure stabilized with soil nails		X
Slope Movement	X				X
Erosion		X			
Seepage		X			
Culvert Distress		X

**Photo 2:** Looking west along Access Road 172; cracks present along roadway
