SITE NUMBER AND NAME: NC095 – Cloverbar Road at Highway 16 EB	HIGHWAY AND KM: 16:18, km 7.48	PREVIOUS INSPECTION: N/A	CURRENT INSPECTION: June 1, 2023
LEGAL DESCRIPTION: NE 12-53-23-W4M	NAD83 COORDINATES: UTM12U 59638031N, 350446E		RISK ASSESSMENT: PF: 9 CF: 3 Total: 27
AVERAGE ANNUAL DAILY TRAFFIC (AADT): 35,130 (2022)		CONTRACTOR MAINTENANCE AREA (CMA): 510

2023 Site Inspection Photos at NC095

Client/Project Transportation and Economic Corridors 123315222
 Geohazard Monitoring Program
 NC95 - Cloverbar Road at Hwy 16 EB

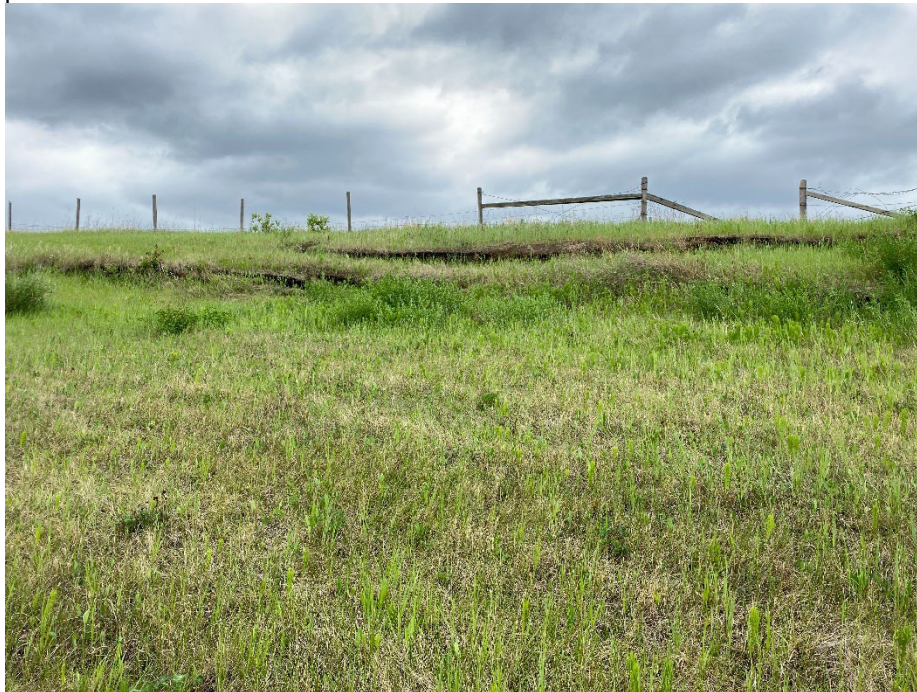
COMMENTS
<ul style="list-style-type: none"> The pavement on Highway 16 does not appear to show any distress related to the slope movement. Two scarps, 0.3 to 0.4 m high and approximately 20 m long, were observed approximately 5 m downslope from the crest (Photos 1 and 2). The toe of the slump block was observed further downslope, above the wet ditch. A depression in the ground, approximately 1.5 m in diameter, was observed on the east side below the lower scarp. Multiple tension cracks were observed on the slope below the two scarps. Cracks were up to 1.8 m long, 25 mm wide, and 75 mm deep. A well-vegetated slump was observed to the west of the two scarps, beginning mid-slope with the toe located just above the wet ditch. Landslide activity can be observed as early as 2012 from Google Earth imagery. The main scarp does not appear to have retrogressed since 2012, although periodic widening of the landslide and localized failures downslope of the main scarp can be seen.

Photo 1: Overall view of scarps on upper slope. Looking south.

- In the short-term, the slope should be regraded and revegetated to seal the ground cracks and protect the ground from water infiltration and erosion.
- Long-term remediation may include the following:
 - Improve drainage: Install a centerline culvert to redirect surface water to the median ditch. The high-level cost for the culvert installation is \$300,000 to \$450,000, excluding engineering costs.
 - Improve drainage: Regrade the south ditch to drain water further east (minimum 100 m) beyond the slope failures. The high-level cost for regrading is \$5,000 to \$10,000, excluding engineering costs.
 - Remove and replace: The slide mass could be excavated, and the embankment slope rebuilt with granular fill. The high-level cost for removal and replacement is \$250,000 to \$350,000, excluding engineering costs.
- Site inspections should continue to be completed once per contract cycle.

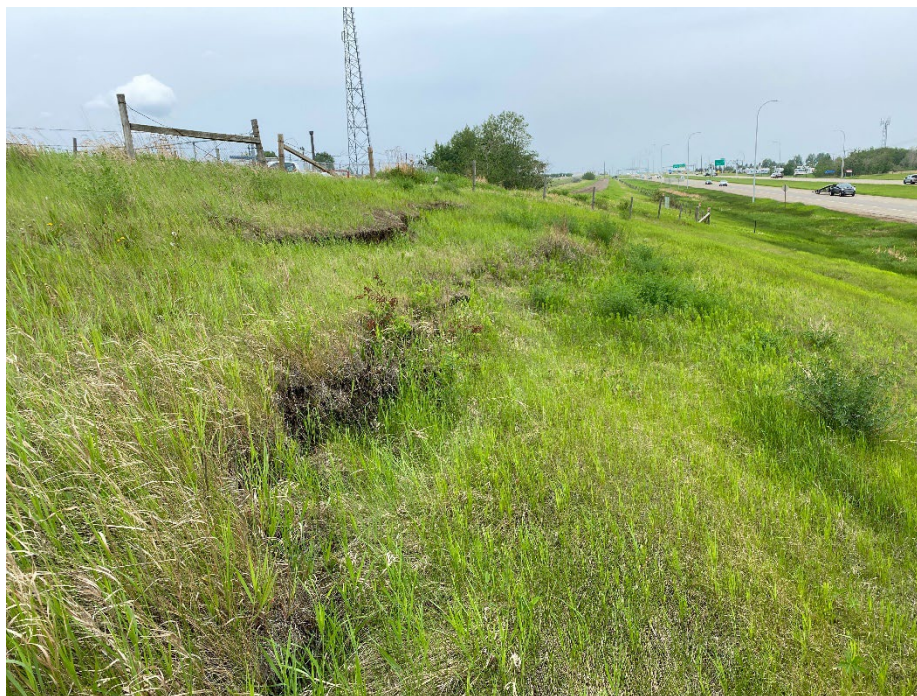
Photo 2: Scarps and surrounding vegetation. Looking west.

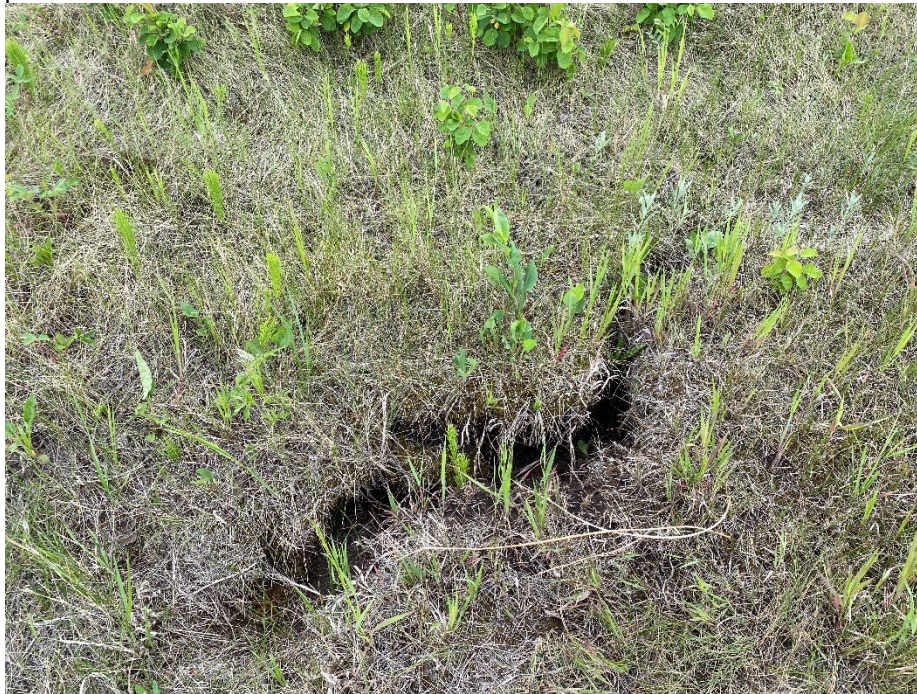
Photo 3: Ground crack downslope from scarps. Looking south.

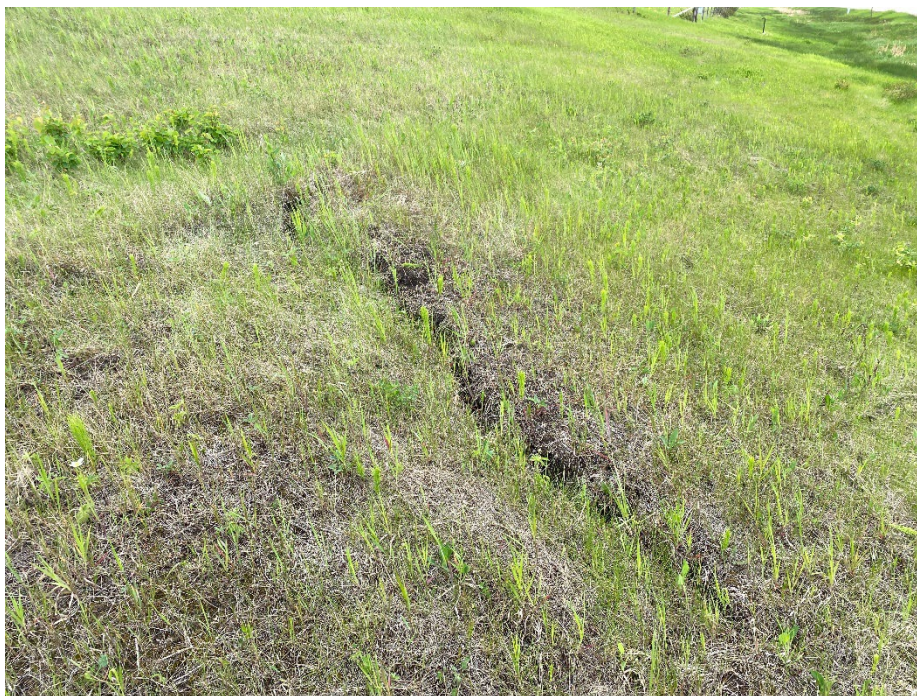
Photo 4: Ground crack (1.8 m long) running vertically across the slope, downslope from scarps. Looking west.

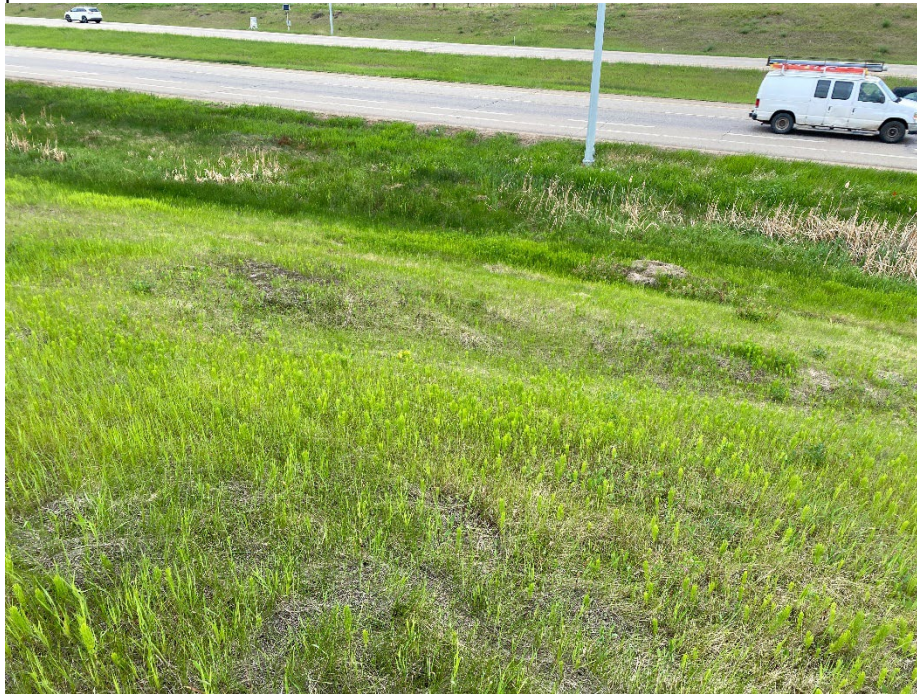
Photo 5: View of west extent of slump looking downslope. Facing northwest.

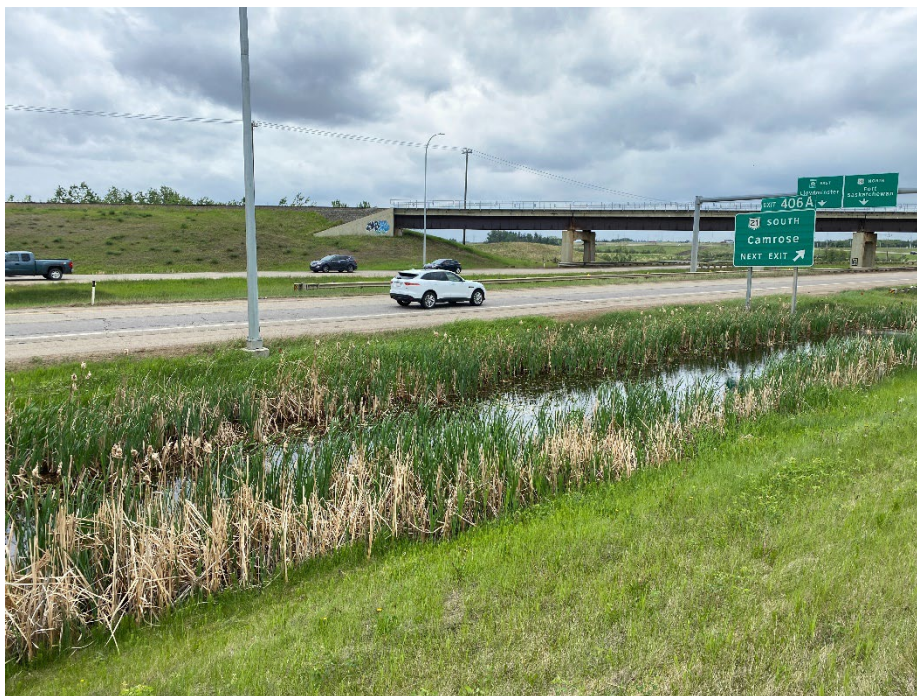
- A vegetated erosion gully exists to the west of the well-vegetated slump, beginning at the upper slope near the unpaved service road at the crest.
- The south ditch of Highway 16 had ponded water and wetland vegetation such as reeds. This wet ditch extended from a few metres west of the lower slope slump to the highway sign located in the south ditch to the east of the light standard.

Photo 6: Water ponding in ditch with long grasses and reeds. Looking northeast.
