**ALBERTA TRANSPORTATION  
GEOHAZARD ASSESSMENT PROGRAM  
NORTH CENTRAL REGION – ATHABASCA  
2019 INSPECTION**

<b>Site Number</b>	<b>Location</b>	<b>Name</b>	<b>Hwy</b>	<b>km</b>
NC 010-1	N. of Gunn & S. of Hwy 651	<b>Willow Bend</b>	33:04	25
<b>Legal Description</b>		<b>UTM Co-ordinates (NAD 83)</b>		
SE-28-57-3-W5M		11 N 5981184	E 672265

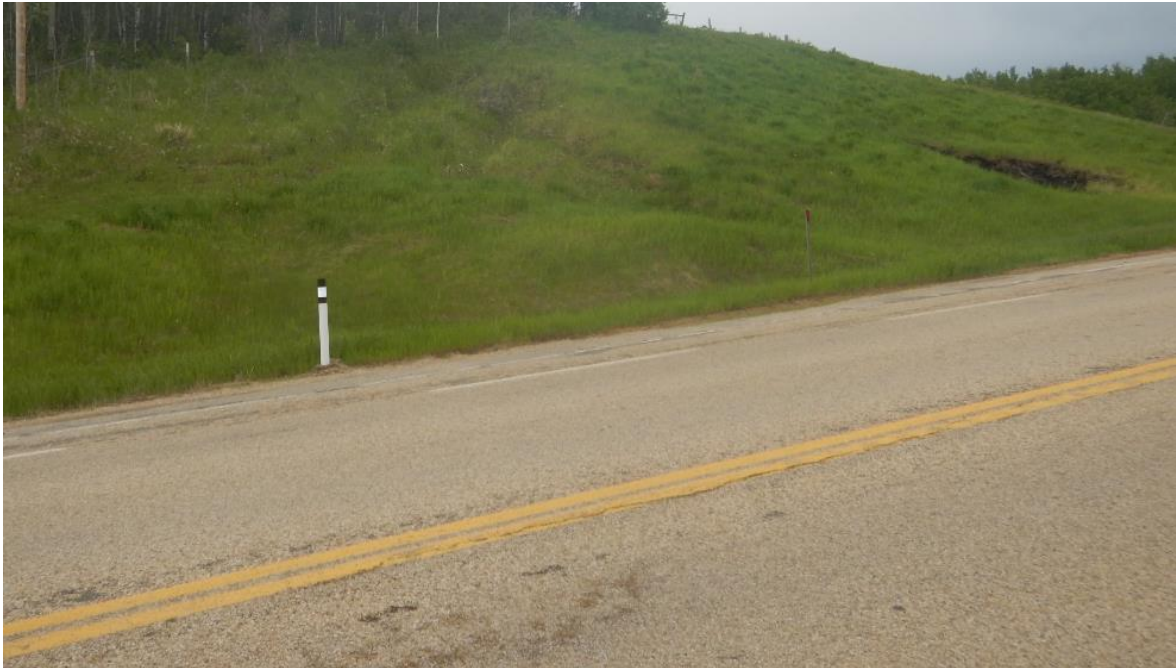
Photo No. 1 – Looking southeast at backslope slump No. 1 located to the south of the landslide area

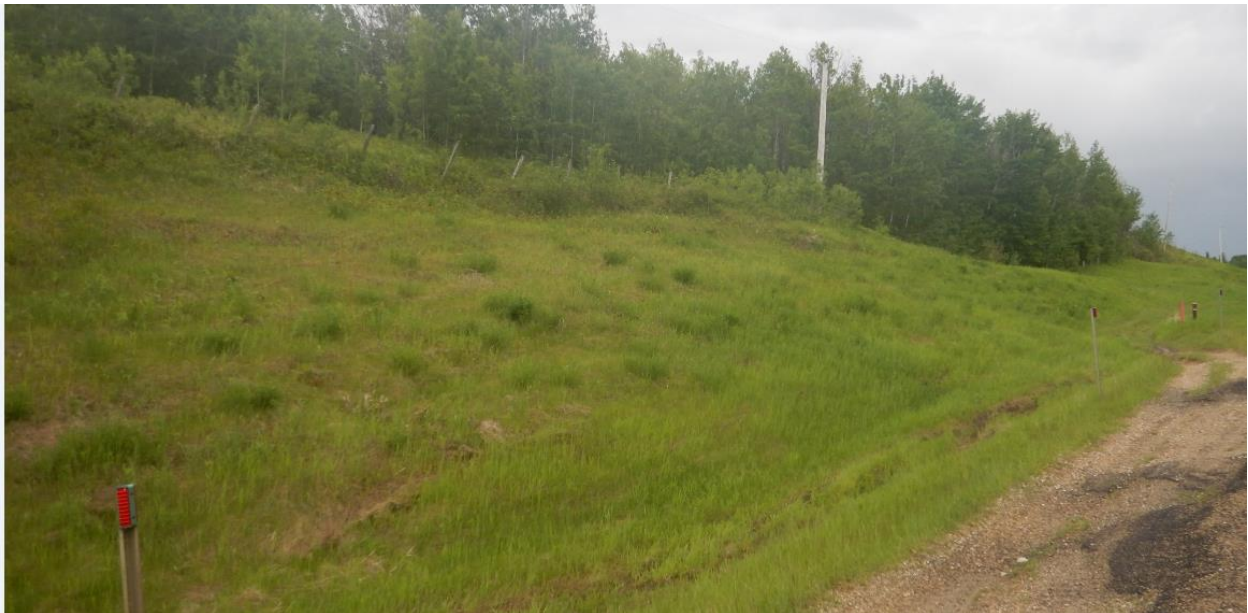
Photo No. 2 – Looking south at slump No.3 located within the limits of the landslide; the toe of the slump is encroaching in the ditch and is partially restraining ditch flow

The local MCI should visually inspect and retouch the bottom of the east ditch (i.e. remove the least amount of dirt), if blocked due to backslope slump movements, to enhance the drainage characteristics of the ditch.

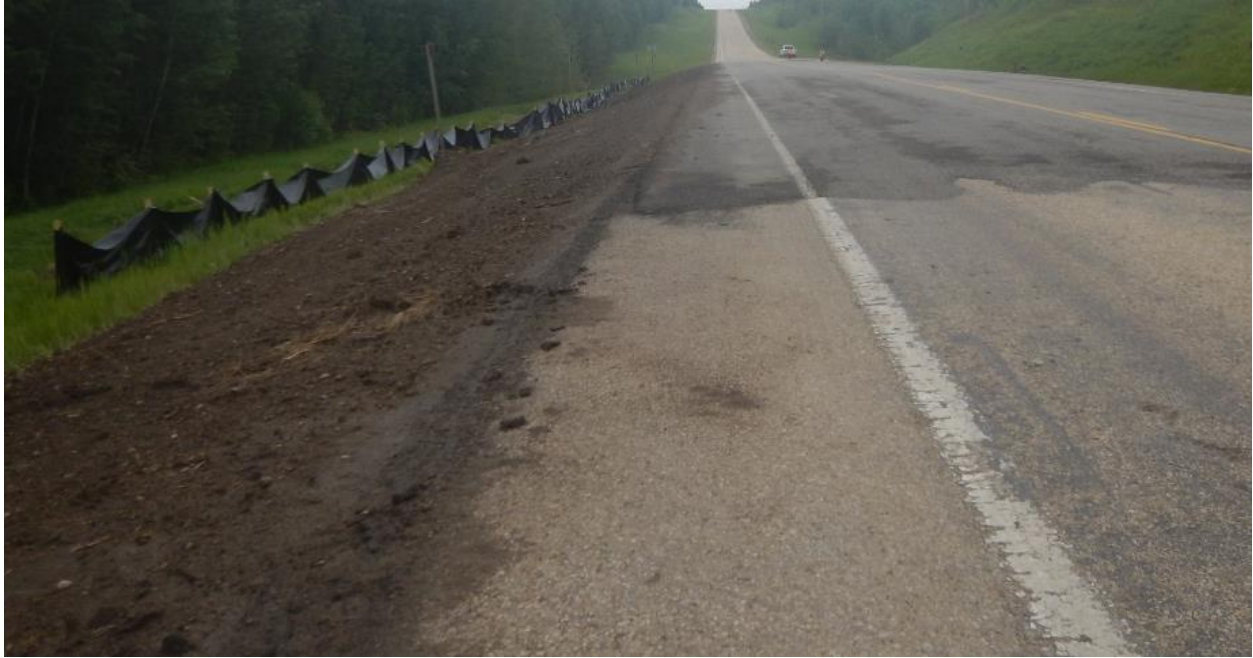
The west side slope improvements completed by AT eliminated previous sharp drop off along the edge of the road and safety hazard concern for runaway vehicles. However, the existing sharp shoulder along the NBL edge of pavement still constitutes a safety hazard to motorists.

Photo No. 3 – Clay wedge placed by AT along the west side slope of the highway to eliminate previous sharp drop off (looking north)

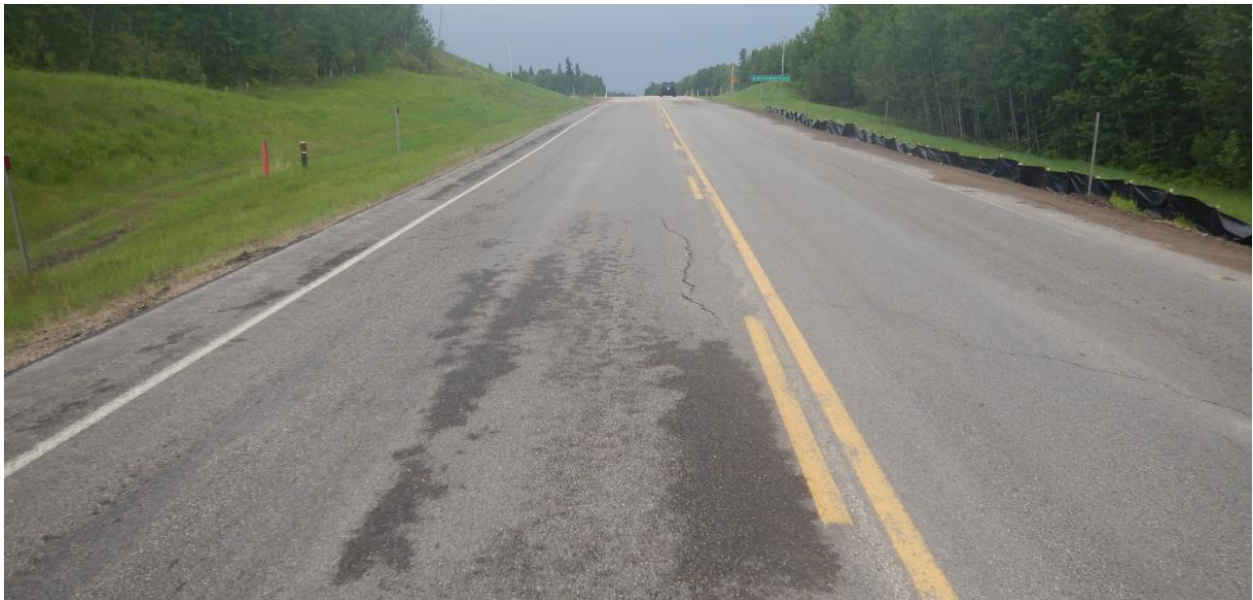
The site observations indicate that the landslide continued to be active as evidenced from the presence of reflective open cracks on the highway surface. It is anticipated that the landslide will continue to move and cause further deterioration to the highway condition until a suitable long-term remedial measure is implemented.

Photo No. 4 – Reflective open longitudinal crack near the north flank of the landslide

The local MCI should continue to monitor the highway condition for the development of new cracks, further opening or drop along the surfaces of existing crack, or pavement distress in response to further movement. As a minimum, crack sealing of open cracks should take place to reduce surface water infiltration into the landslide mass. ACP patch should be placed, as needed, to smoothen the roadway surface.

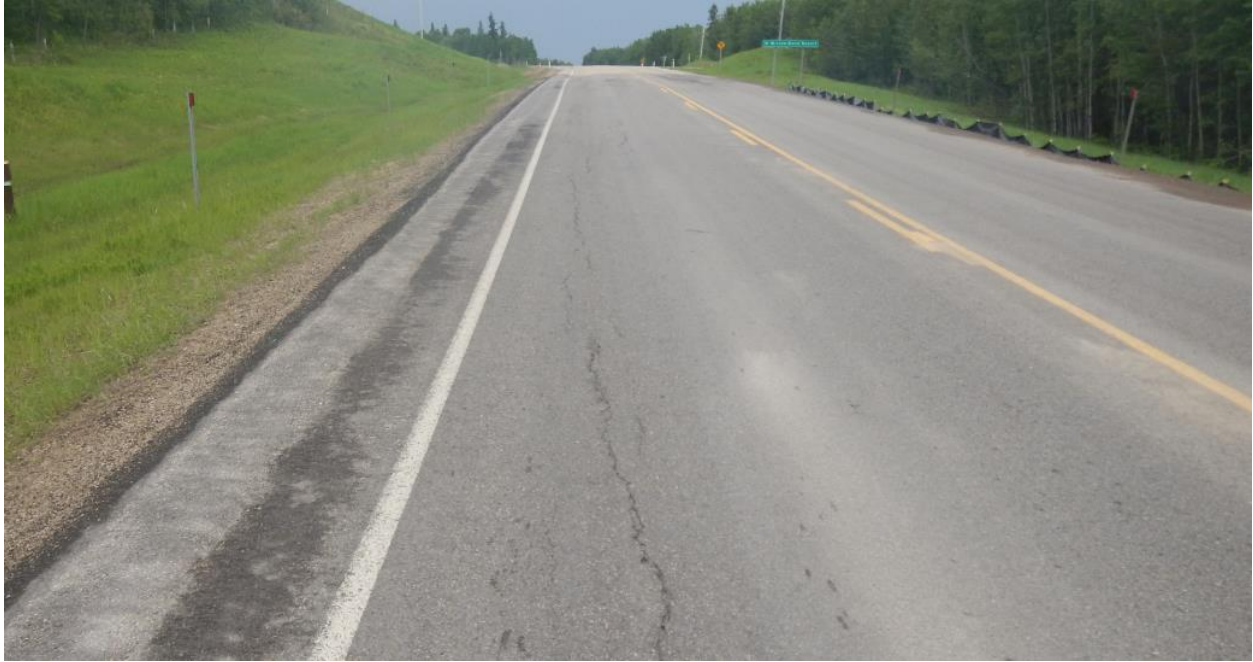
Photo No. 5 – Looking south at a reflective open longitudinal crack near the north flank of the landslide and a sharp drop off on the east side of the highway (NBL)

Consideration should be given for placing the least amount of fill off the highway surface to smoothen the existing east side slope sharp drop off and eliminate the existing hazard. Otherwise, sharp shoulders warning signs should be erected to warn the motorists of the existing hazard.

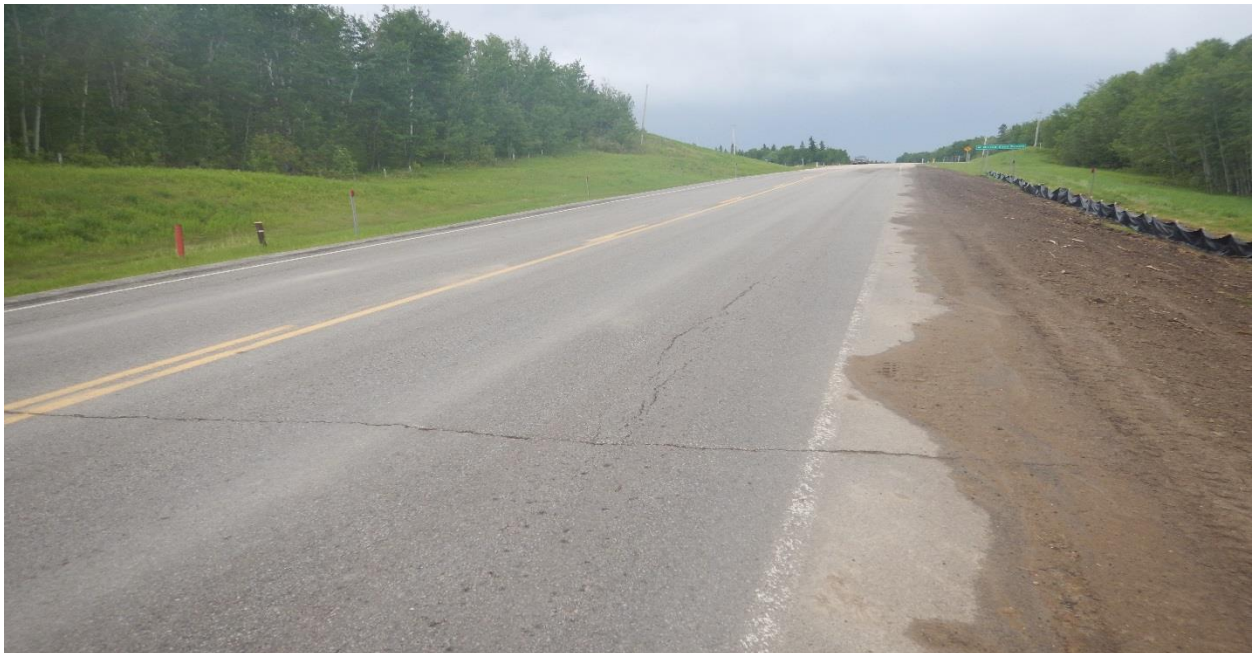
Photo No. 5a – Looking south at a reflective open longitudinal crack on the highway SBL near the middle of the landslide

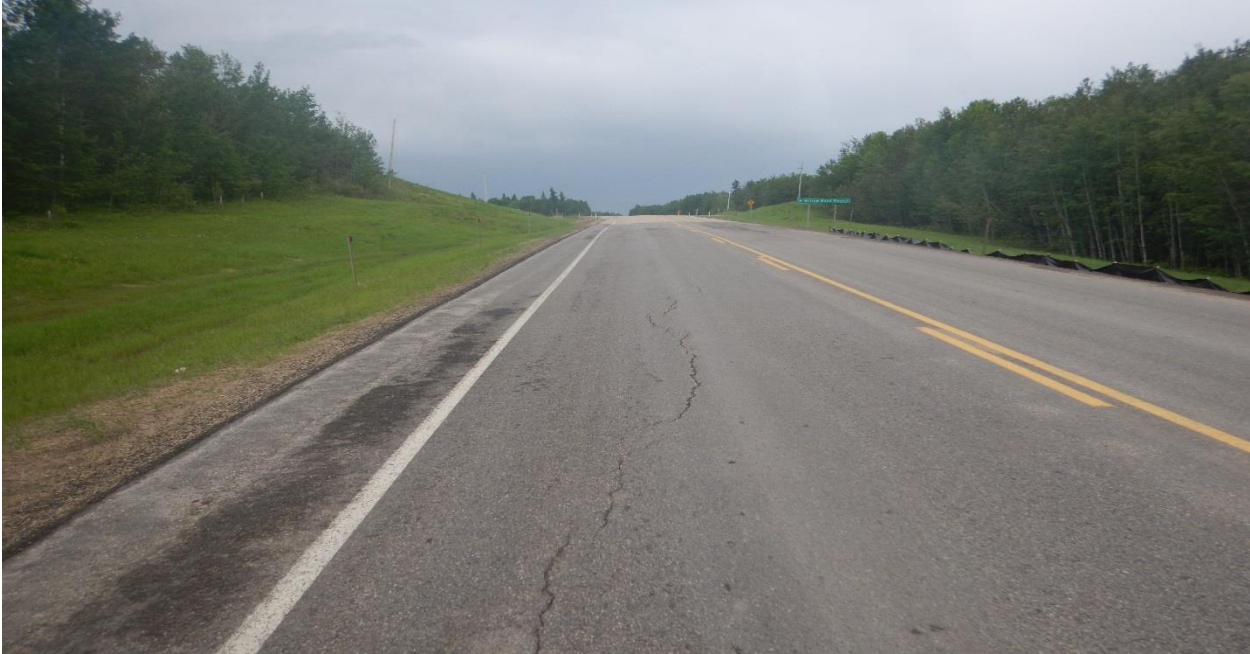
Photo No. 5b – Looking south at a reflective open longitudinal crack on the highway NBL near the middle of the landslide

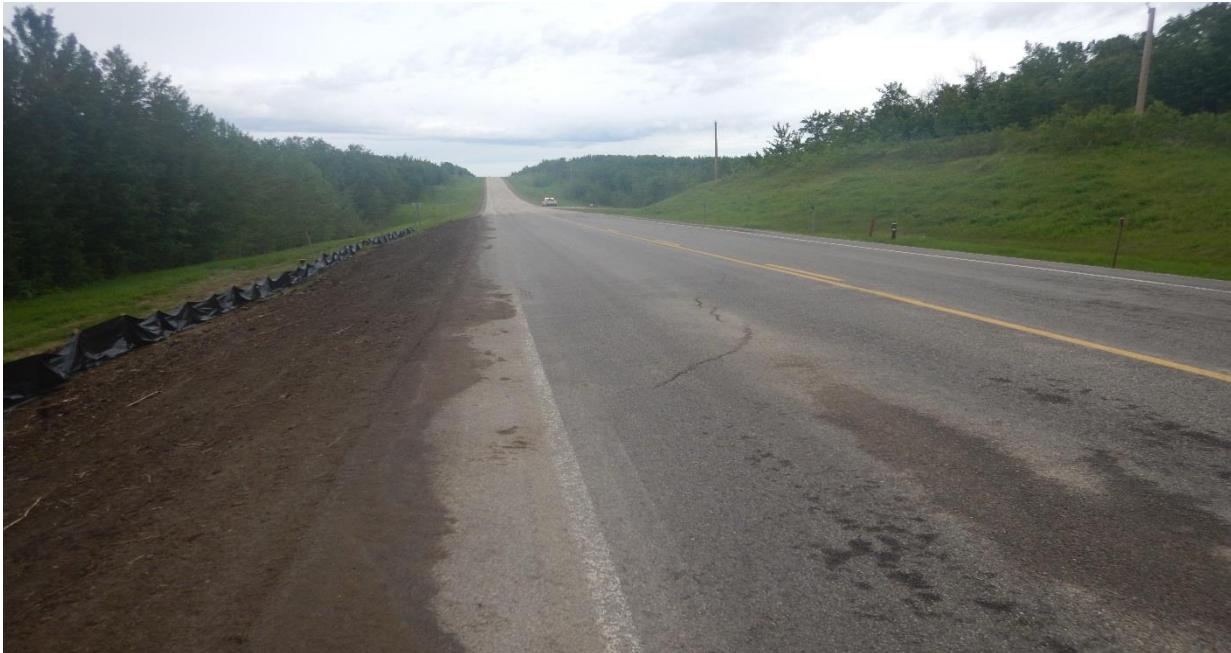
Photo No. 5c – Looking north at a reflective open diagonal at the southern flank of the landslide

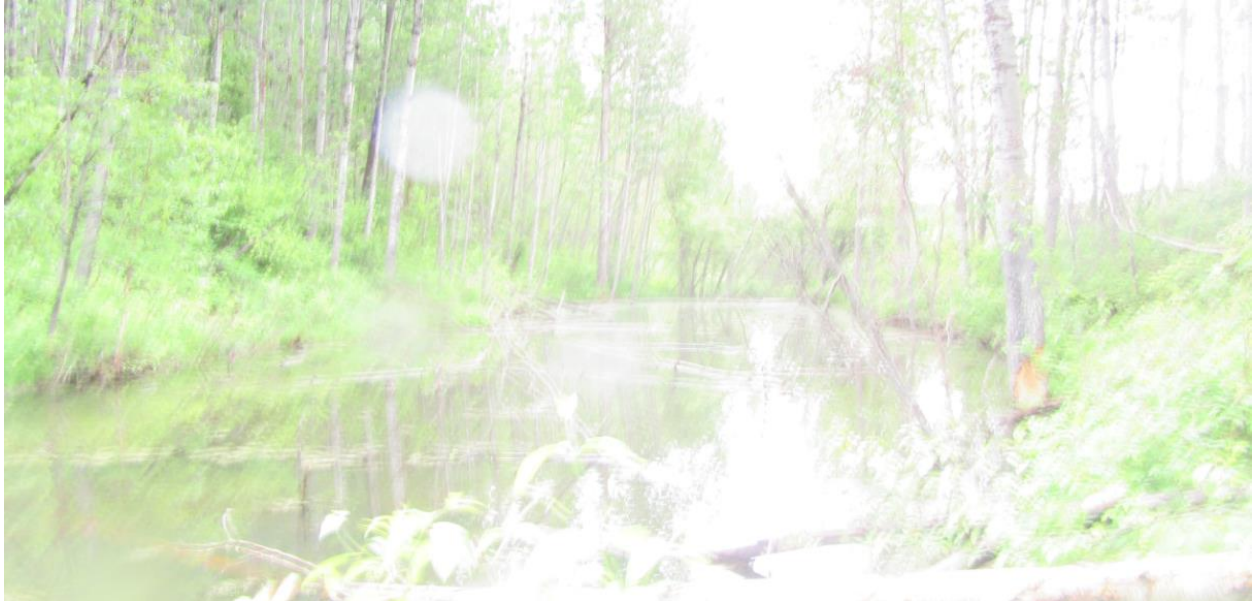
Photo No. 6 – Looking north at the Beaver Pond

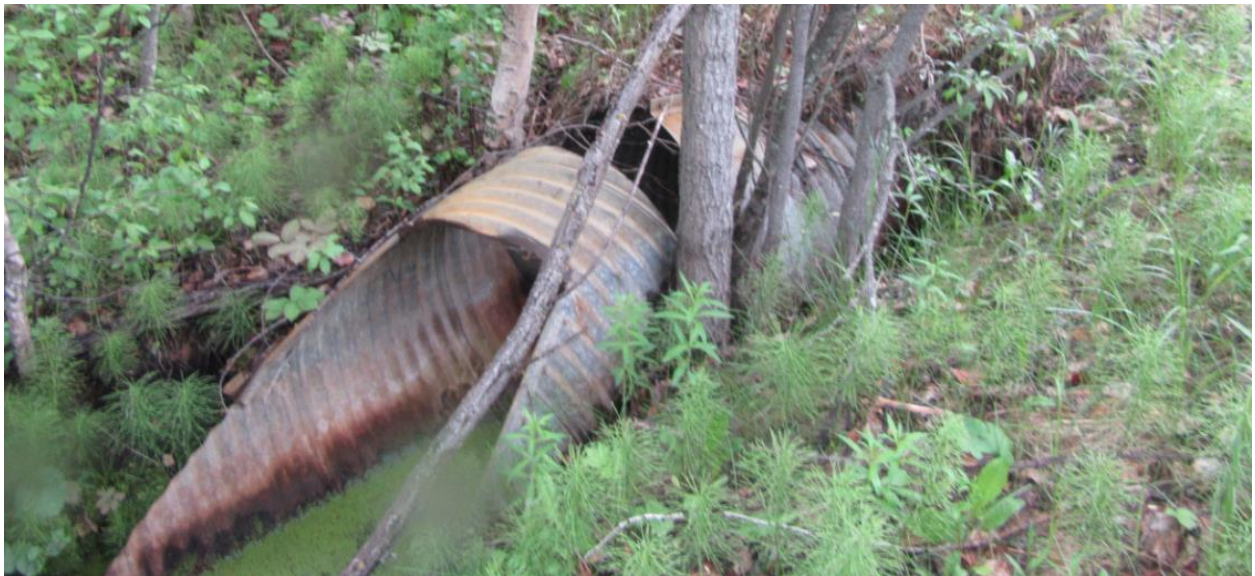
Erosion is the likely cause of the separation developed at the inlet and outlet of the 900 mm culvert. The presence of a local slump above the outlet of the pipe may have been caused by the saturation of embankment fill, where the pipe got separated. The slump may continue to get bigger with time and could eventually retrogress to the highway surface.

Photo No. 7 – Looking north at the separated culvert inlet

Consideration should also be given for repairing the culvert at the inlet and the outlet locations so that it conveys the flow from the pond in a controlled manner below the highway. As a minimum, the separated section of the pipe at the outlet should be excavated and replaced along with repairing the localized slump above the outlet location. Prior to undertaking any repairs, it is also recommended that a CCTV inspection be undertaken from the outlet location of the pipe to check whether it is separated below the highway.

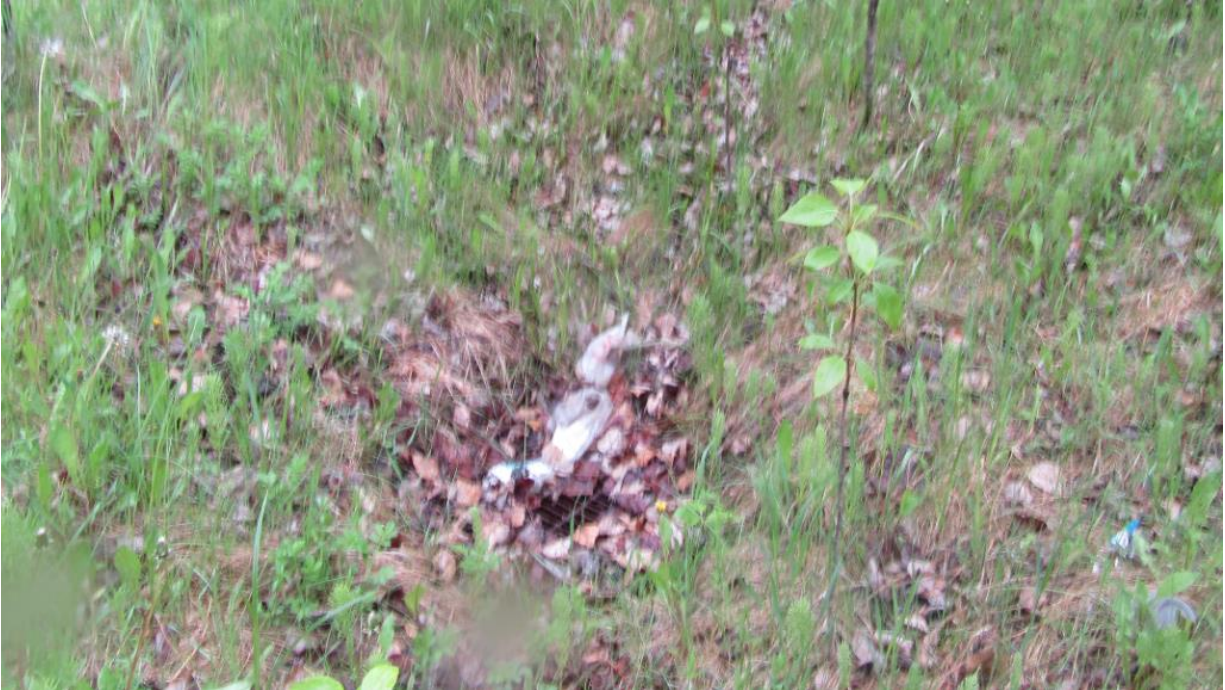
Photo No. 8 – Existing manhole, located to the west side of the highway within the bush, is partially covered with grass and leaves; water still flows into the manhole

Existing grass and leaves around the drop structure, connected to the inlet of the pipe, should be cleared to enhance surface drainage.

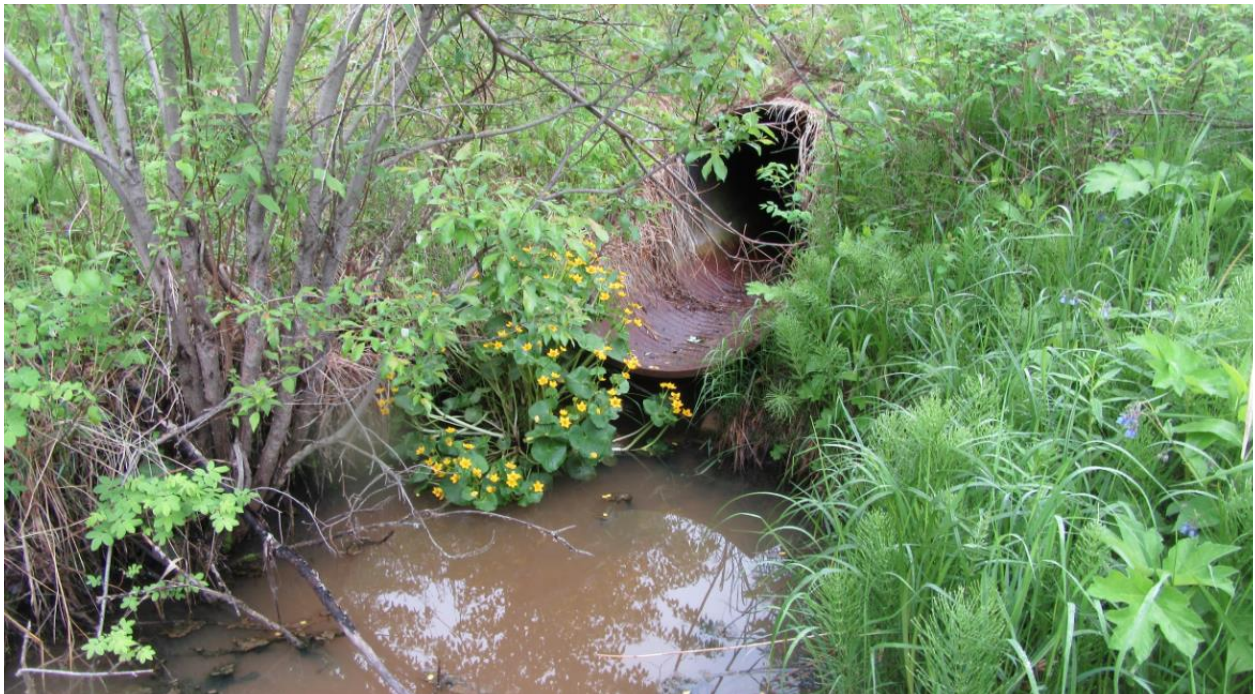
Photo No. 9 – Water flows under the culvert outlet

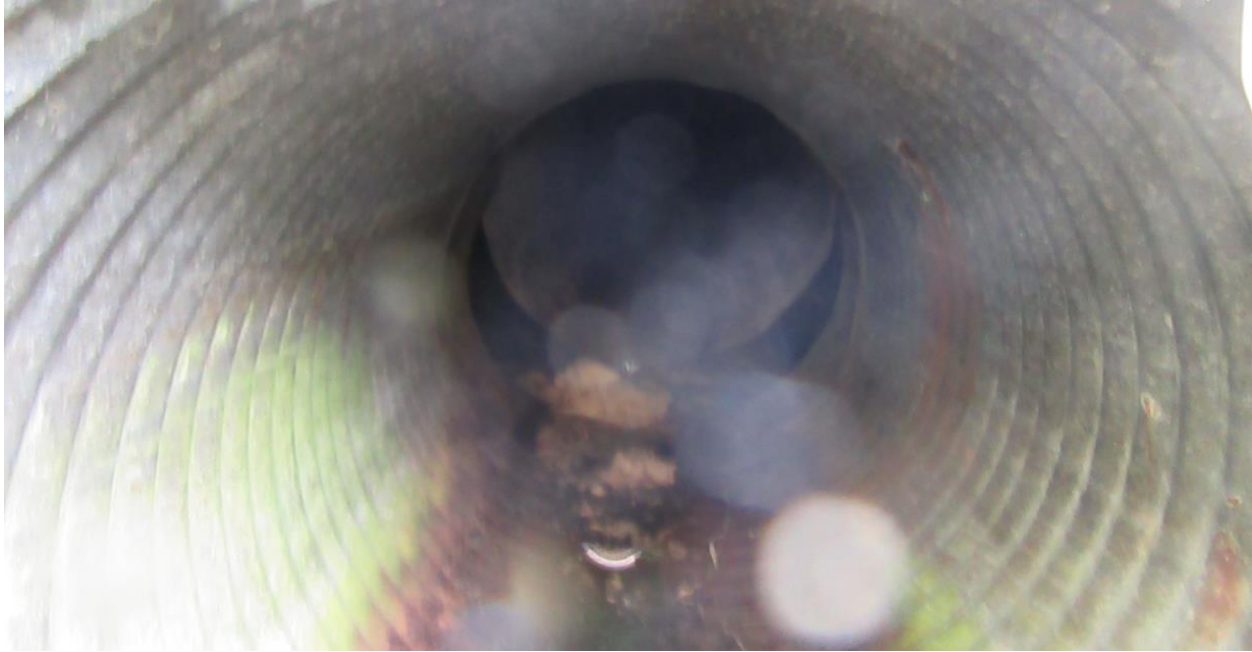
Photo No. 10 – Culvert outlet location: culvert is separated at 4 m from outlet.
