SITE NUMBER AND NAME: NC010 – Willow Bend Slide	HIGHWAY AND KM: 33:04, km 25.005	PREVIOUS INSPECTION: June 10, 2019	CURRENT INSPECTION: June 28, 2021
LEGAL DESCRIPTION: SE 28-57-03-W5	NAD83 COORDINATES: UTM11U 5981185N, 672306E		RISK ASSESSMENT: PF: 11 CF: 5 Total: 55
AVERAGE ANNUAL DAILY TRAFFIC (AADT): 1930 (Referenced from PMA)		CONTRACTOR MAINTENANCE AREA (CMA): 509

2021 Site Inspection Photos at NC010

ALBERTA TRANSPORTATION
GEOHAZARD MONITORING PROGRAM
NC010-1: HWY 33:04 WILLOW BEND (km 25)
SITE FEATURES PLAN AND CROSS - SECTION A-A'

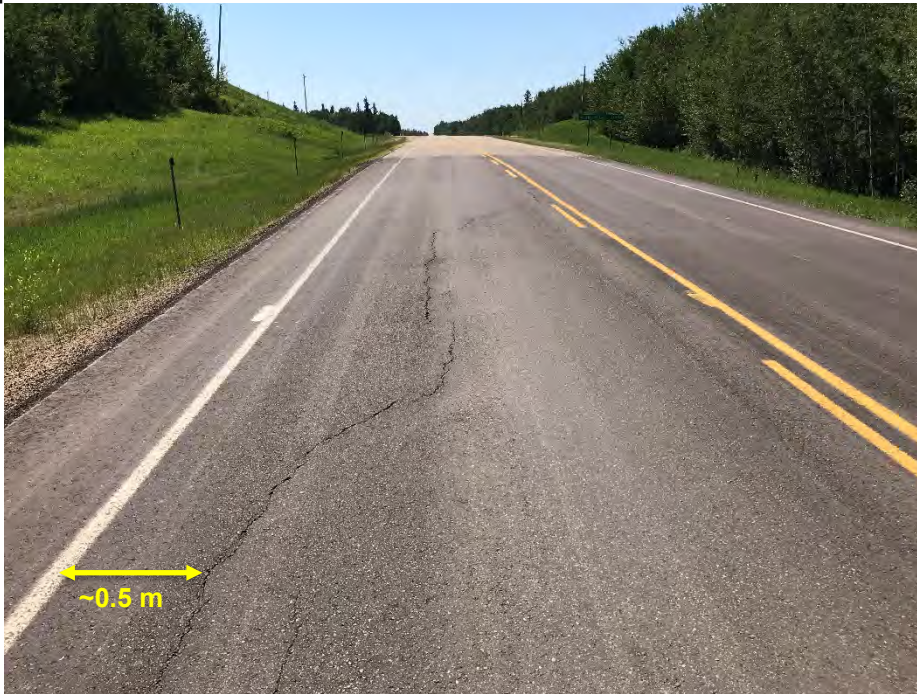
COMMENTS
<ul style="list-style-type: none"> • Site conditions generally unchanged from previous inspection in 2019 (Figure 1). • Pavement cracks have reflected through the previous patch in 2017 suggesting an active landslide (Photos 1 and 2). Pavement cracks appear similar to previous visit and may have temporarily slowed down since 2021 had relatively low precipitation. Additionally, no additional fill placement has occurred since 2019. • Pavement crack is approximately 0.5 m away from the shoulder line on the northbound lane (NBL). • SI97-3 does not show any movement suggesting the landslide scarp is located on the highway. Previous SI readings indicate the slip surface is about 7 m below the highway surface. • The NBL shoulder appears to be relatively steep and may constitute a safety hazard to motorists. • Water ponding was observed in a relatively large wheel rut at the base of the backslope slump #3 (Photo 3). • No changes to the backslope slumps #1-3 were observed due to thick vegetative cover. • Separation observed about 0.5 m into the inlet of the 900 mm diameter culvert, possibly due to erosion (Photo 4).

Photo 1: Pavement cracks reflecting through 2017 patch. Looking south.

- The local MCI should continue to monitor the highway condition for development of new cracks and progression of existing cracks.
- Crack sealing should be completed to reduce surface water infiltration into the landslide.

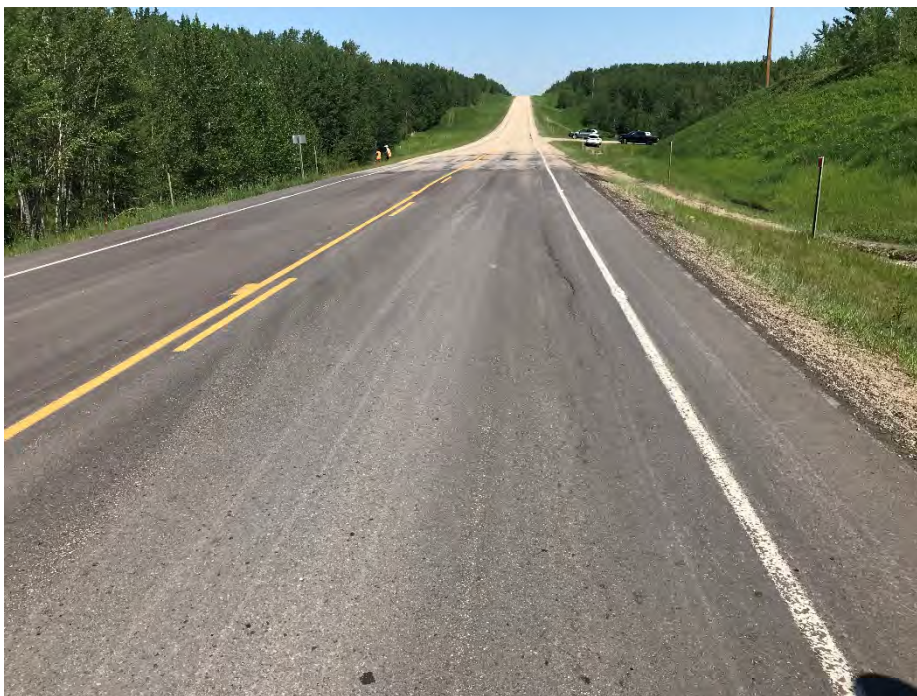
Photo 2: Pavement cracks reflecting through 2017 patch. Looking north.

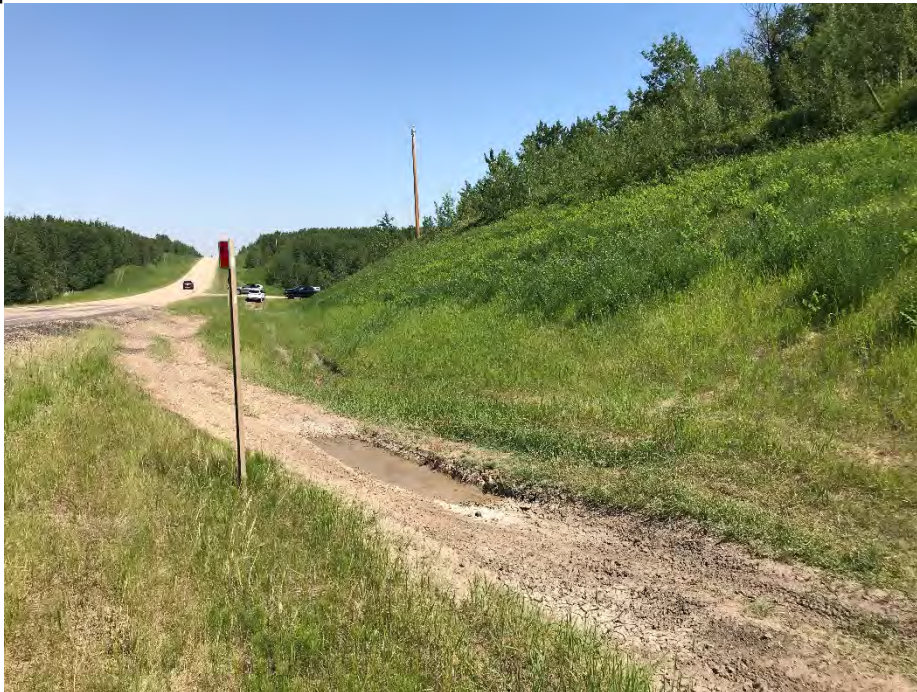
Photo 3: Ponding in wheel rut at toe of backslope slump #3. Looking north.

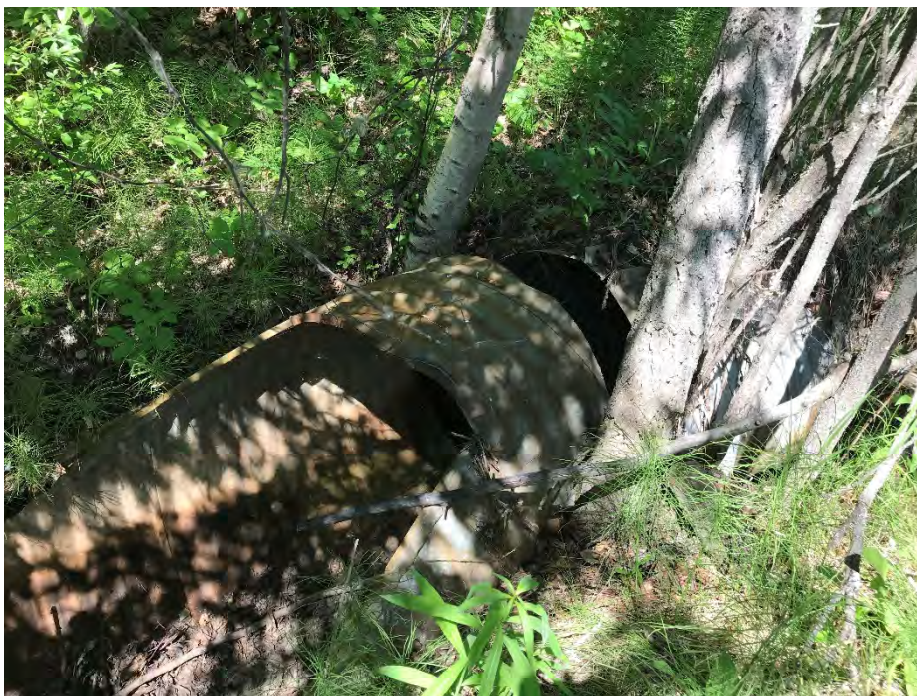
Photo 4: Separation at culvert inlet. Looking north.

- A small amount of fill could be placed to reduce the steepness of the NBL shoulder. Sharp shoulder signs may also be placed to warn motorists.
- The 900 mm diameter culvert should be inspected via CCTV to check for separation below the highway. Separated sections of the culvert should be excavated and replaced. Repair of the slump at the outlet can also be completed concurrently for efficiency.

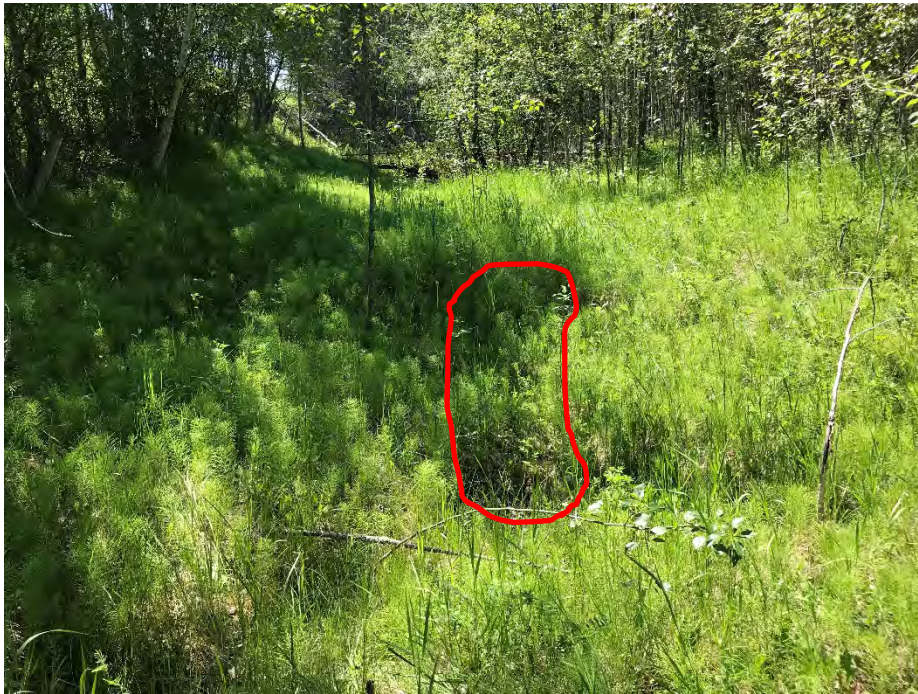
- Local slump observed above the 900 mm diameter culvert outlet, possibly due to saturation of the embankment fill at the location of the separation (Photo 5). Water could be heard flowing at the outlet with no flow coming out (Photo 6).
- The Consequence Factor was increased by 1 to 5 due to the potential loss of full roadway and significant detours required to reroute traffic.

Photo 5: Subsidence along culvert. Looking south.

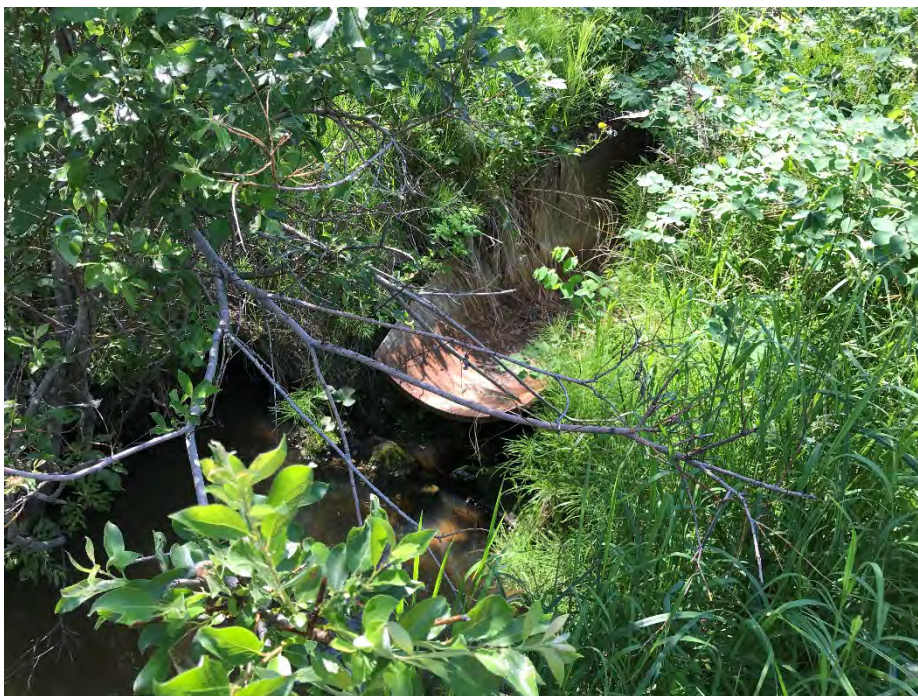
Photo 6: No flow at culvert outlet but can hear flowing water. Looking south.
