<b>SITE NUMBER AND NAME:</b> NC010 – Willow Bend Slide	<b>HIGHWAY AND KM:</b> 33:04, km 25.005	<b>PREVIOUS INSPECTION:</b> September 16, 2022	<b>CURRENT INSPECTION:</b> May 31, 2023
<b>LEGAL DESCRIPTION:</b> SE 28-57-03-W5	<b>NAD83 COORDINATES:</b> UTM11U 5981185N, 672306E		<b>RISK ASSESSMENT:</b> PF: 13 CF: 6 Total: 78
<b>AVERAGE ANNUAL DAILY TRAFFIC (AADT):</b> 2780 (2022)		<b>CONTRACTOR MAINTENANCE AREA (CMA):</b> 509

NORTH CENTRAL REGION GRMP  
EDSON / STONY PLAIN  
SITE INSPECTION FORM

2023 Inspection Photos at NC010

TRANSPORTATION AND ECONOMIC CORRIDORS  
 GEOHAZARD MONITORING PROGRAM  
 NC010-1: HWY 33:04 WILLOW BEND (km 25)  
 SITE FEATURES PLAN AND CROSS - SECTION A-A'

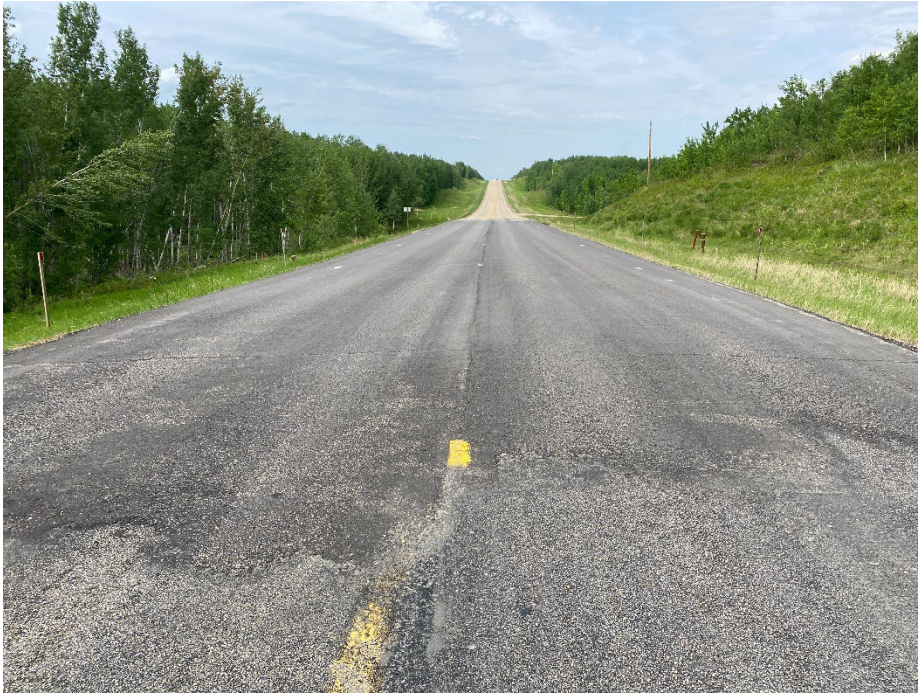
<b>COMMENTS</b>
<ul style="list-style-type: none"> <li>• Site conditions were generally unchanged since the 2019 site inspection (Figure 1) except that pavement has been recently patched with no cracks reflecting (Photos 1 and 2).</li> <li>• SI97-3 does not show any movement suggesting the landslide scarp is located on the highway. Previous SI readings indicate the slip surface is about 7 m below the highway surface.</li> <li>• The NBL shoulder appears to be relatively steep and may constitute a safety hazard to motorists.</li> <li>• Water ponding was observed in a relatively large wheel rut at the base of the backslope slump #3.</li> <li>• Sedimentation was observed in the wheel tracks on the east side of the highway, south from backslope slump #3 (Photo 3).</li> <li>• No changes to the backslope slumps #2-3 were observed due to thick vegetative cover.</li> </ul>

**Photo 1:** Pavement recently patched in Fall 2022. Looking north.

- The local MCI should continue to monitor the highway condition for development of new cracks and progression of existing cracks.
- Crack sealing should be completed to reduce surface water infiltration into the landslide.

- Milling and paving may continue as a short-term solution until long-term repairs can be performed. For any planned milling, the highway should be overlaid such that the final elevation matches the existing elevation or lower (i.e., no net addition of loads).

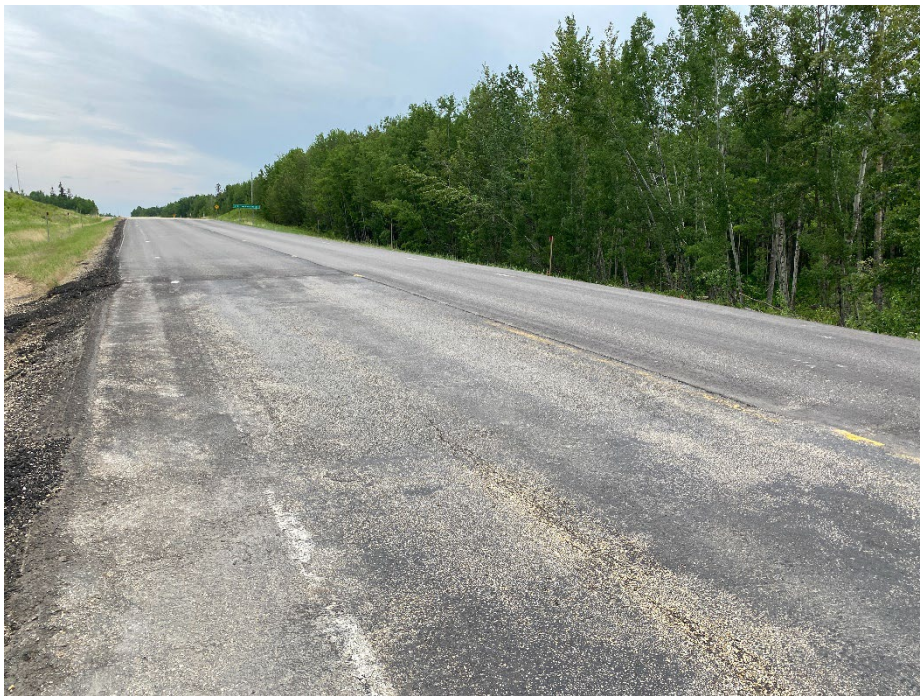
**Photo 2:** Pavement recently patched in Fall 2022. Looking south.

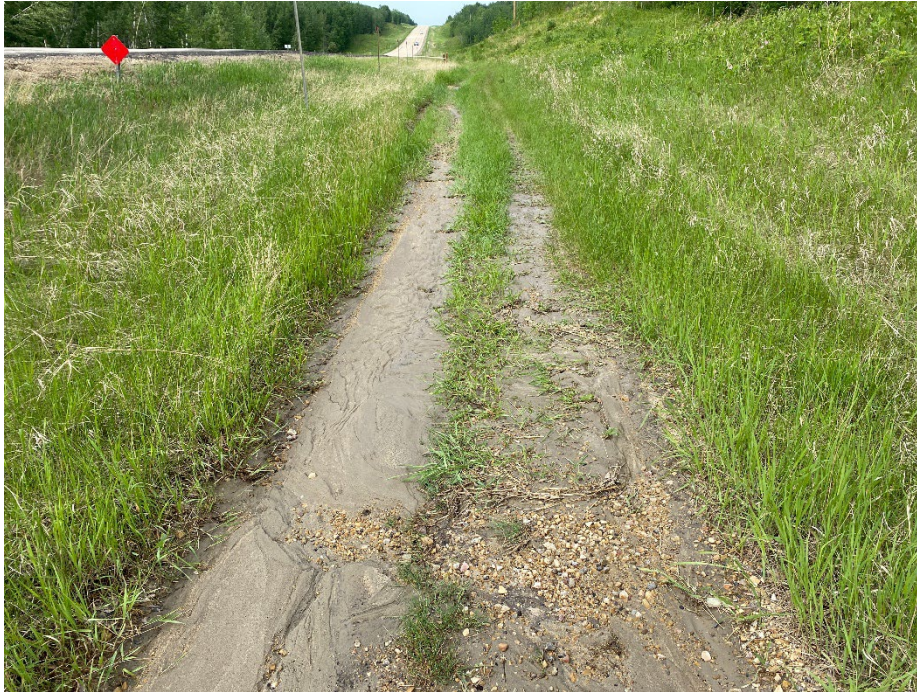
**Photo 3:** Signs of flowing water and sedimentation in wheel tracks on east side of highway, south from backslope slump #3. Looking north.

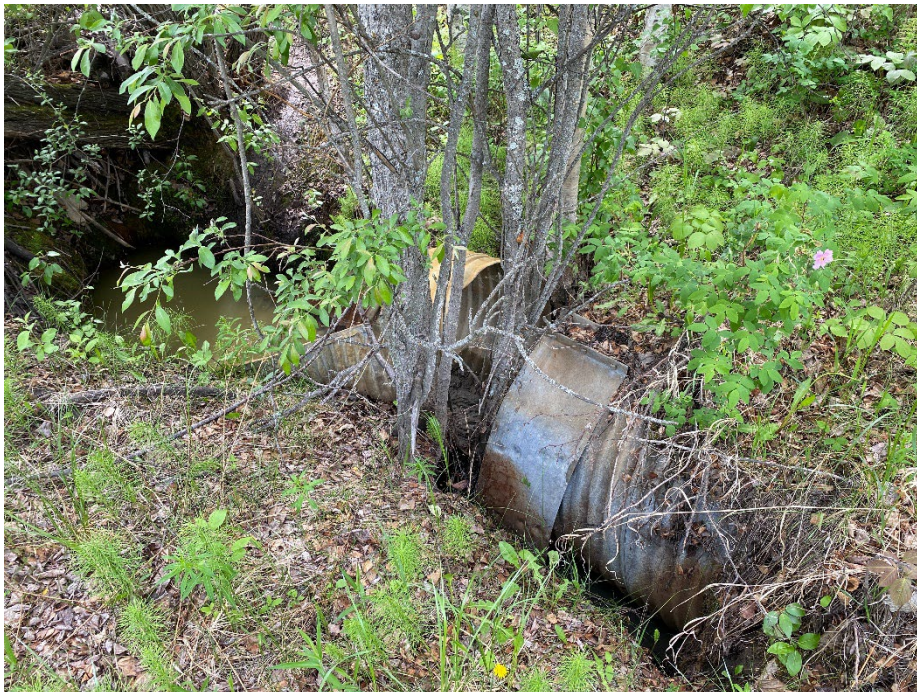
- Standing water was observed at the culvert inlet.
- A separation was observed about 0.5 m into the inlet of the 900 mm diameter culvert. Further erosion has occurred on the east side of the inlet, creating a gap between the ground surface and the culvert (Photo 4).

**Photo 4:** Separation at culvert inlet. Looking southwest.

- A small amount of fill could be placed to reduce the steepness of the NBL shoulder. Sharp shoulder signs may also be placed to warn motorists.
- The 900 mm diameter culvert should be inspected via CCTV to check for separation below the highway. Separated sections of the culvert should be excavated and replaced. Repair of the slump at the outlet can also be completed concurrently for efficiency.

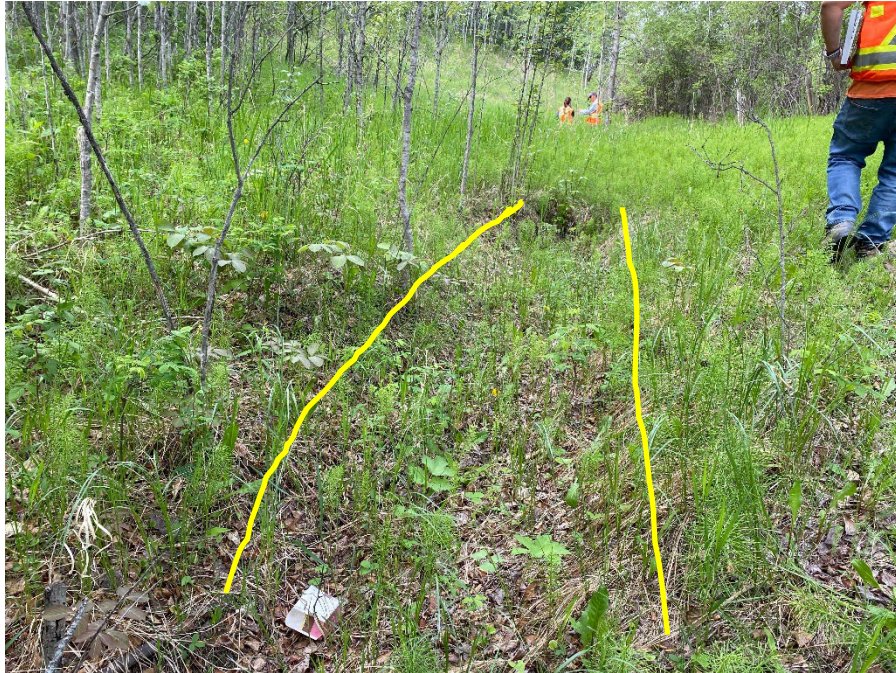
- Subsidence of the ground along the 900 mm diameter culvert alignment between the inlet and the catch basin was observed (Photo 5).
- The catch basin cover north of the inlet of the 900 mm diameter culvert was observed to be in a state of disrepair. The metal is extremely weak and falling apart due to heavy rusting. This may present a hazard to anyone/ wildlife walking in the area. The depth from the top of the catch basin to the bottom of the culvert was measured to be approximately 2.4 m.

**Photo 5:** Subsidence along culvert alignment. Looking north.

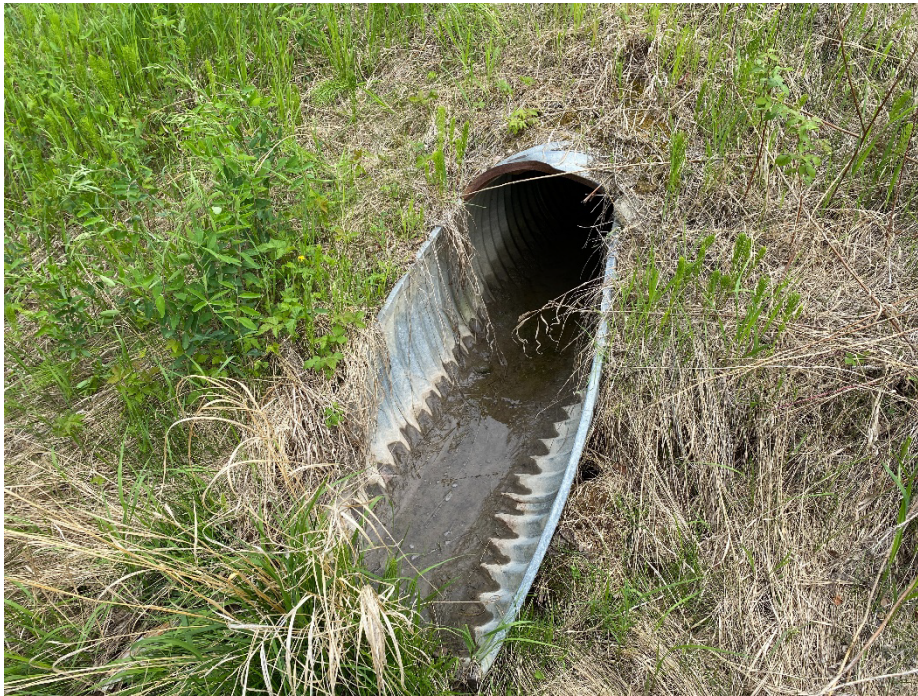
- No flow was observed at the culvert outlet; however, it is possible that water is still flowing through (or around) the culvert given the wet sediment observed inside the culvert outlet (Photo 6).

**Photo 6:** No flow at culvert outlet but wet sediment present. Looking southeast.
