**NORTH CENTRAL REGION GRMP  
EDSON / STONY PLAIN  
SITE INSPECTION FORM**

<b>SITE NUMBER AND NAME:</b> NC092 – Cattlepass Culvert BF 80823	<b>HIGHWAY AND KM:</b> 37:02, km 23.855	<b>PREVIOUS INSPECTION:</b> May 22, 2020	<b>CURRENT INSPECTION:</b> June 28, 2021
<b>LEGAL DESCRIPTION:</b> NE 33-54-27-W4M	<b>NAD83 COORDINATES:</b> UTM12U 5955908N, 307552E		<b>RISK ASSESSMENT:</b> PF: 10 CF: 4 Total: 40
<b>AVERAGE ANNUAL DAILY TRAFFIC (AADT):</b> 2530 (2020)		<b>CONTRACTOR MAINTENANCE AREA (CMA):</b> 510

<b>SUMMARY OF INSTRUMENTATION:</b> No instrumentation installed at this site. <b>LAST READING DATE:</b> N/A	<b>INSPECTED BY:</b> Stantec: Leslie Cho AT: Bernard Ching and Rishi Adhikari
<b>PRIMARY SITE ISSUE:</b> Two slope failures south of Highway 37 bisected by a cattlepass culvert.	
<b>APPROXIMATE DIMENSIONS:</b> 25 m wide by 12 m long x 3.5 m deep	
<b>DATE OF ANY REMEDIAL ACTION:</b> No remedial action completed to date

2021 Site Inspection Photos at NC092

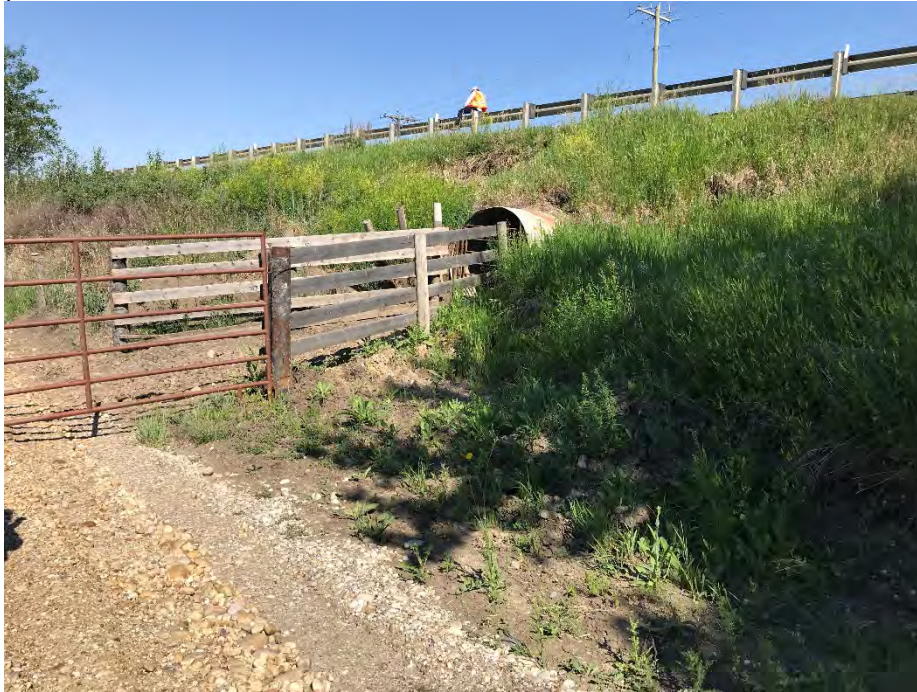
<b>COMMENTS</b>
<ul style="list-style-type: none"> <li>• Slumps appear to have progressed since previous visit including a higher scarp at the guardrails. The scarp west of the cattlepass increased from about 1.5 m to 2.0 m high. The scarp east of the cattlepass increased from about 1.8 m high to about 2.5 m high.</li> <li>• There appears to be additional loss of lateral soil support at the guardrails.</li> <li>• Toe bulge increased in height from 400 mm to 600 mm.</li> <li>• A sag was observed about 3 m to 4 m inside the south end of the cattle pass culvert. The sag location appears to be approximately in line with the two scarps and may potentially be separated at the joints.</li> <li>• The farmer east of the site informed us that the cattle gate periodically will not open or close due to landslide activity. He occasionally regrades the landslide to maintain functionality of the gate. New posts were installed in the last year or so on the west side of the south end of the cattlepass culvert. The wooden posts are now significantly leaning.</li> <li>• The highway surface currently does not appear to be affected by the slope failure.</li> <li>• A black utility cable (likely Telus) was observed running east-west through the landslide with little slack available. Stantec has notified Telus of the site conditions upon completion of the site inspection.</li> <li>• Thick vegetative growth obscured observations of previous open ground cracks.</li> </ul>

**Photo 1:** Slump across cattlepass culvert. Looking northwest

<b>RECOMMENDATIONS</b>
<ul style="list-style-type: none"><li>• The MCI should continue to monitor the highway surface and guardrails until remediation can be undertaken.</li><li>• The MCI should discuss possible solutions with the farmer to maintain functionality of the gate but to refrain from further grading work at the toe of the landslide. Loss of soil support at the toe can trigger additional slope movements.</li><li>• In the short-term, fill can be placed at the base of the slope failure to act as a temporary buttress. The nearby Calahoo pit may be a potential source of granular material for this purpose.</li><li>• Long-term remediation may include the following:<ul style="list-style-type: none"><li>– Soil nailing: The embankment side slope can be rebuilt and stabilized with soil nails. A shotcrete facing is not necessary and can help save on construction costs. The high-level cost for removal and replacement with soil nailing is \$300,000 to \$400,000, excluding engineering costs.</li><li>– Removal and replace: The slide mass could be excavated, and the embankment side slope rebuilt with granular fill. Fill used for temporary buttressing may be salvaged for this purpose. The high-level cost for removal and replacement is \$150,000 to \$200,000, excluding engineering costs.</li><li>– Both options will need to consider the Telus line observed in the landslide. A gas line marker was also observed on the west side of the residential access and may complicate the above remediation strategies.</li></ul></li><li>• Site inspections should be completed annually.</li></ul>

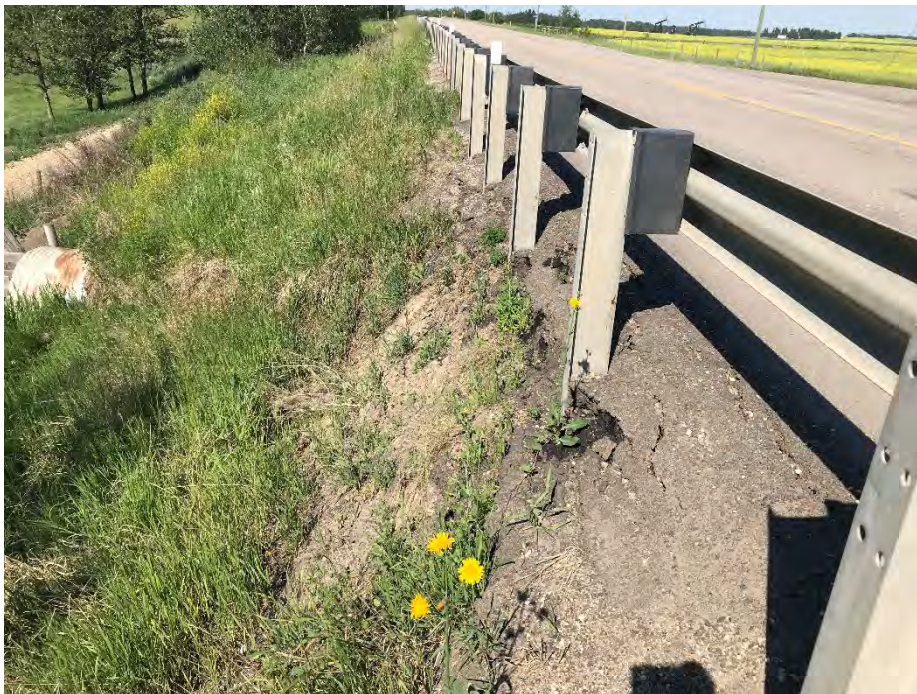
**Photo 2:** Slump across cattlepass culvert. Looking northwest

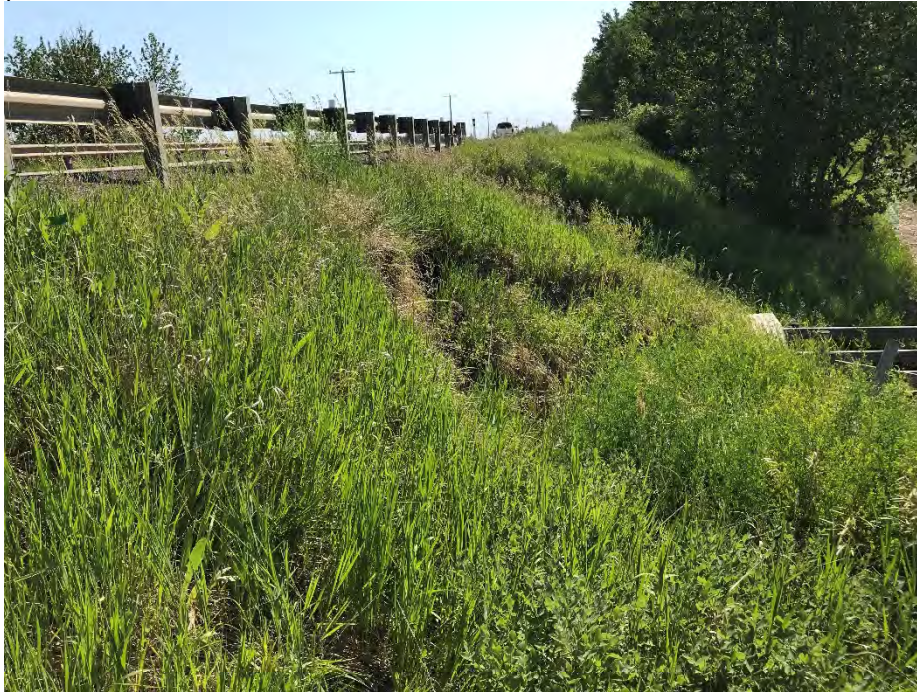
**Photo 3:** Scarp at west slump. Looking east.

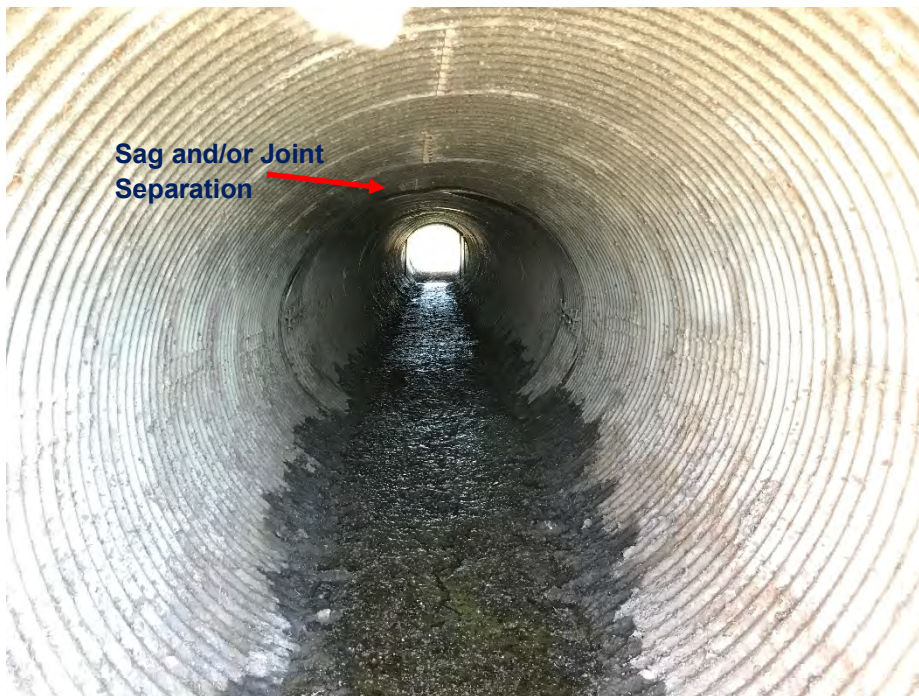
**Photo 4:** Sag and/or separation at south end. Looking east.

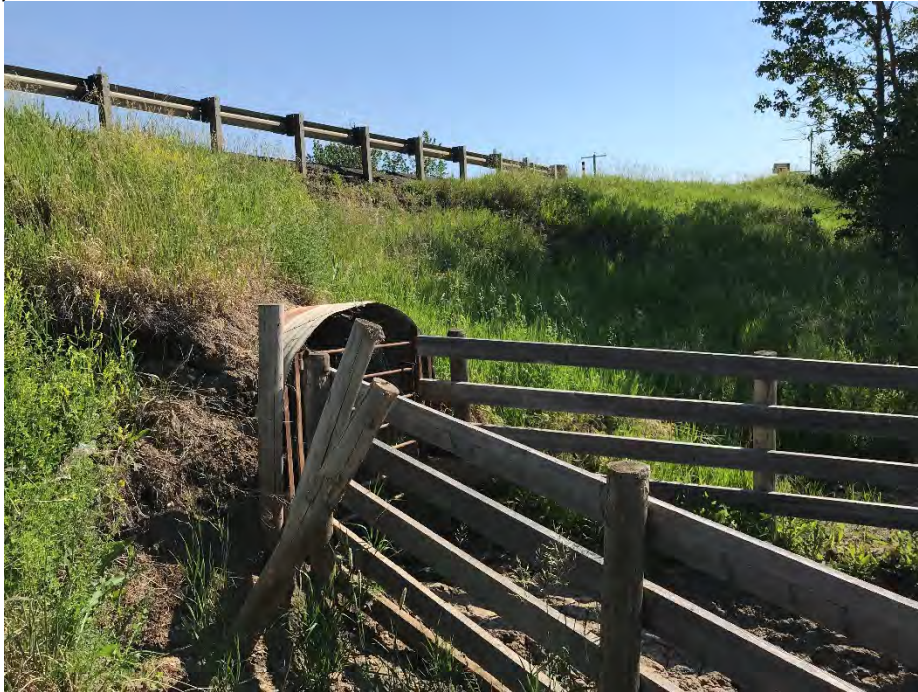
**Photo 5:** Fresh scarp about 1 m high adjacent at south end of cattlepass culvert. New wooden posts significantly leaning. Looking northeast.

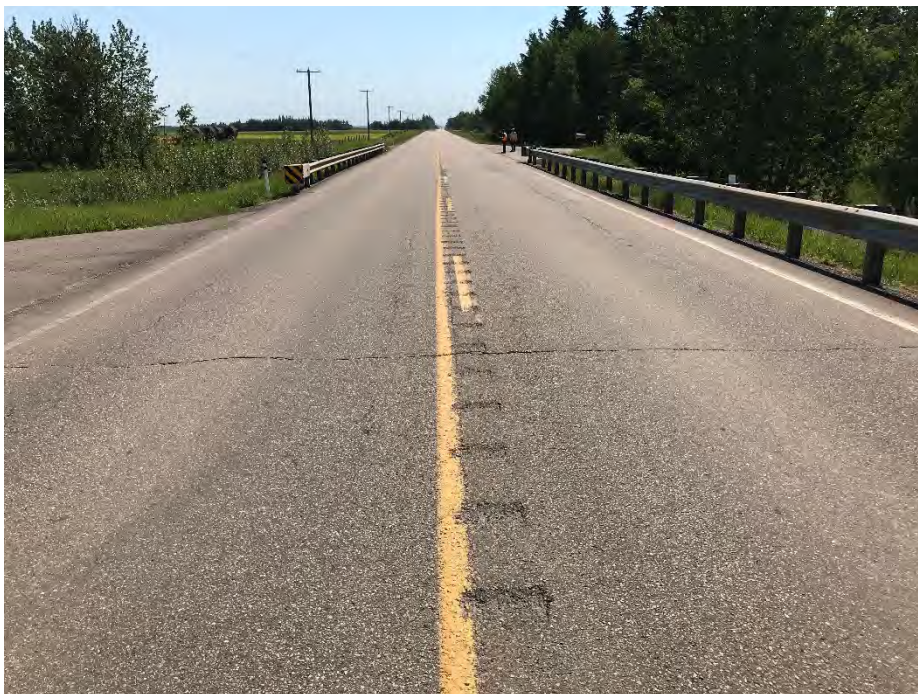
**Photo 6:** Highway surface at slump location. Looking east.
