<b>SITE NUMBER AND NAME:</b> NC092 – Cattlepass Culvert BF 80823	<b>HIGHWAY AND KM:</b> 37:02, km 23.855	<b>PREVIOUS INSPECTION:</b> June 28, 2021	<b>CURRENT INSPECTION:</b> June 14, 2022
<b>LEGAL DESCRIPTION:</b> NE 33-54-27-W4M	<b>NAD83 COORDINATES:</b> UTM12U 5955908N, 307552E		<b>RISK ASSESSMENT:</b> PF: 10 CF: 5 Total: 50
<b>AVERAGE ANNUAL DAILY TRAFFIC (AADT):</b> 2740 (2021)		<b>CONTRACTOR MAINTENANCE AREA (CMA):</b> 510

<b>SUMMARY OF INSTRUMENTATION:</b> No instrumentation installed at this site. <b>LAST READING DATE:</b> N/A	<b>INSPECTED BY:</b> Stantec: Leslie Cho, Sonja Pharand AT: Rocky Wang, Amy Driessen
<b>PRIMARY SITE ISSUE:</b> Two slope failures south of Highway 37 bisected by a cattlepass culvert.	
<b>APPROXIMATE DIMENSIONS:</b> 25 m wide by 12 m long x 3.5 m deep	
<b>DATE OF ANY REMEDIAL ACTION:</b> No remedial action completed to date

2022 Site Inspection Photos at NC092

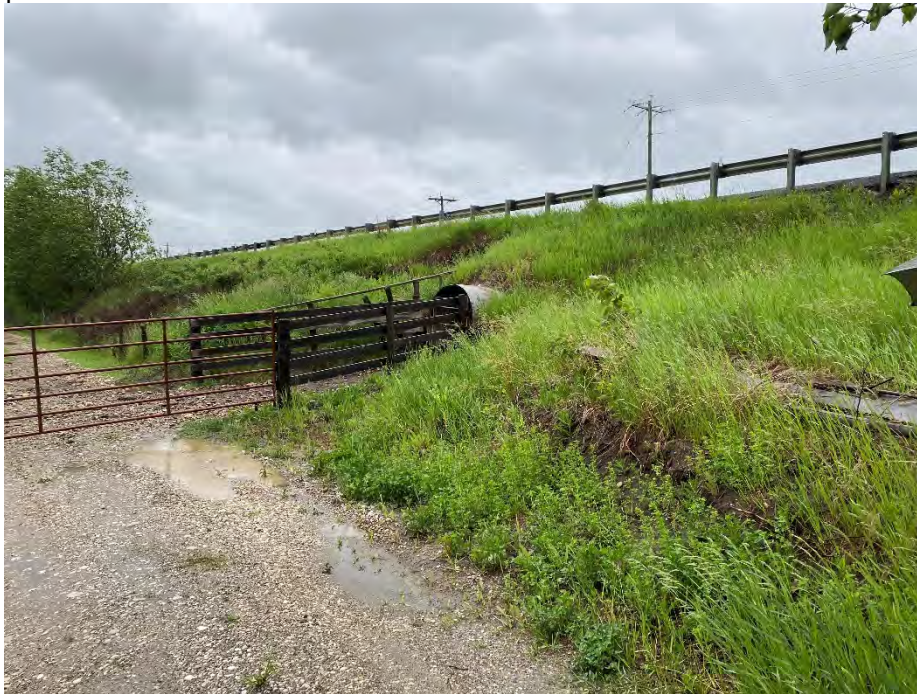
<b>COMMENTS</b>
<ul style="list-style-type: none"> <li>Slumps appear to have remained the same size as previous visit with the scarp west of the cattlepass about 2.0 m high and the scarp east of the cattlepass about 1.5 m high. Some fresh scarps observed near the crest on west side of cattlepass. Fresh scarp at east extent next to the pavement is approximately 0.3 m high.</li> <li>There does not appear to be additional loss of lateral soil support at the guardrails.</li> <li>Toe bulge was about 600 mm high.</li> <li>A sag was observed about 3 m to 4 m inside the south end of the cattle pass culvert since 2021. The sag location appeared to be approximately in line with the two scarps and may potentially be separated at the joints.</li> <li>In past site inspections, the farmer east of the site informed us that the cattle gate periodically will not open or close due to landslide activity. He occasionally regrades the landslide to maintain functionality of the gate. New posts were installed in 2020-2021 on the west side of the south end of the cattlepass culvert. The wooden posts were significantly leaning in 2021 but have been repaired. Regrading on the east side of the cattlepass may have been completed. The toe appears to have been cut back in an area 1.7 m wide and long, and 0.7 m high.</li> <li>The highway surface currently does not appear to be affected by the slope failure.</li> <li>A black utility cable (likely Telus) was observed running east-west through the landslide.</li> </ul>

**Photo 1:** Slump across cattlepass culvert. Looking northwest

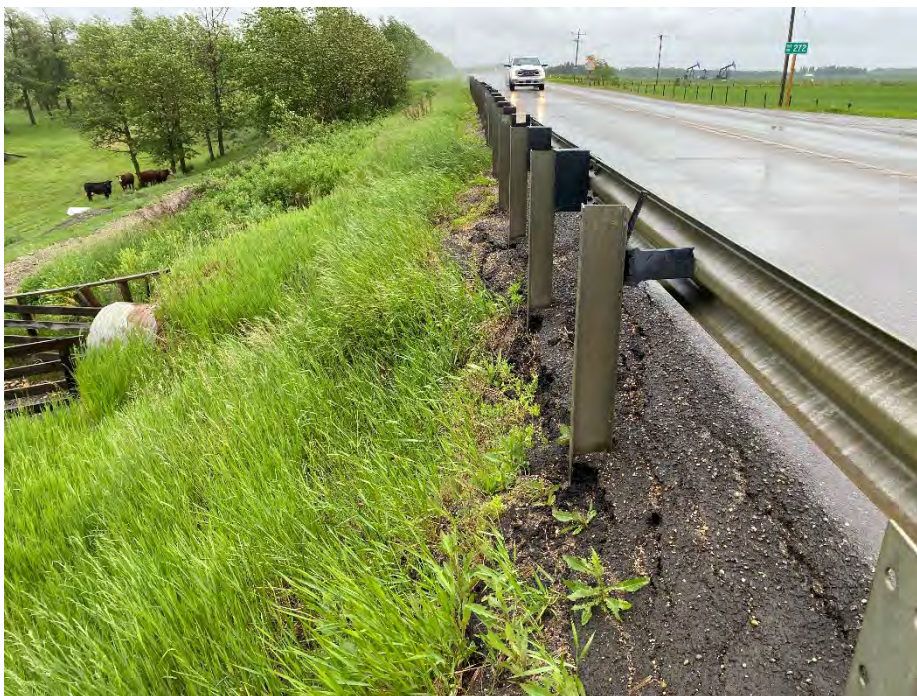
**Photo 2:** Slump across cattlepass culvert. Looking northwest

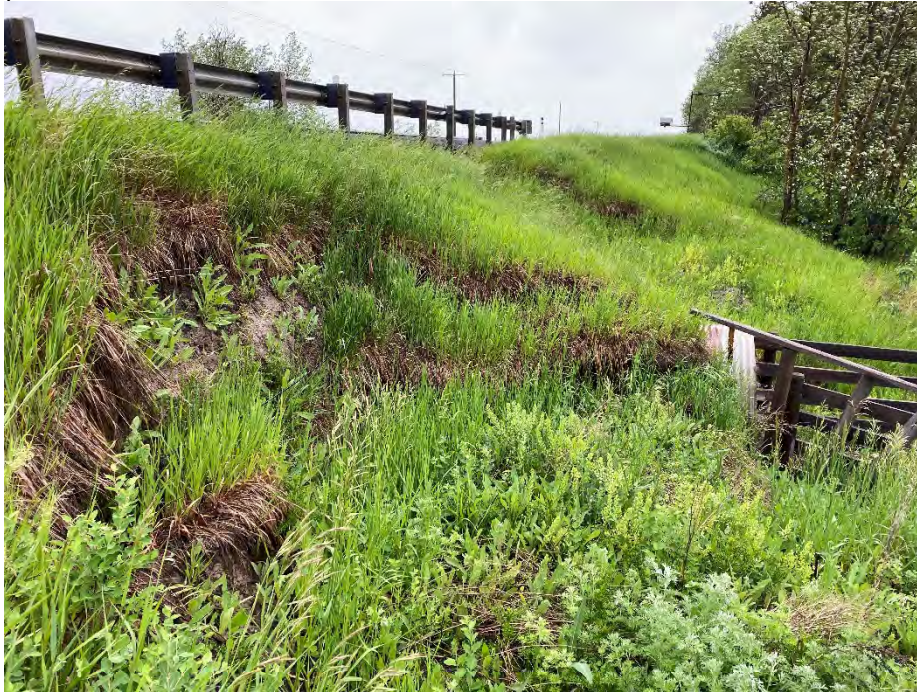
**Photo 3:** Scarp at west slump. Looking east.

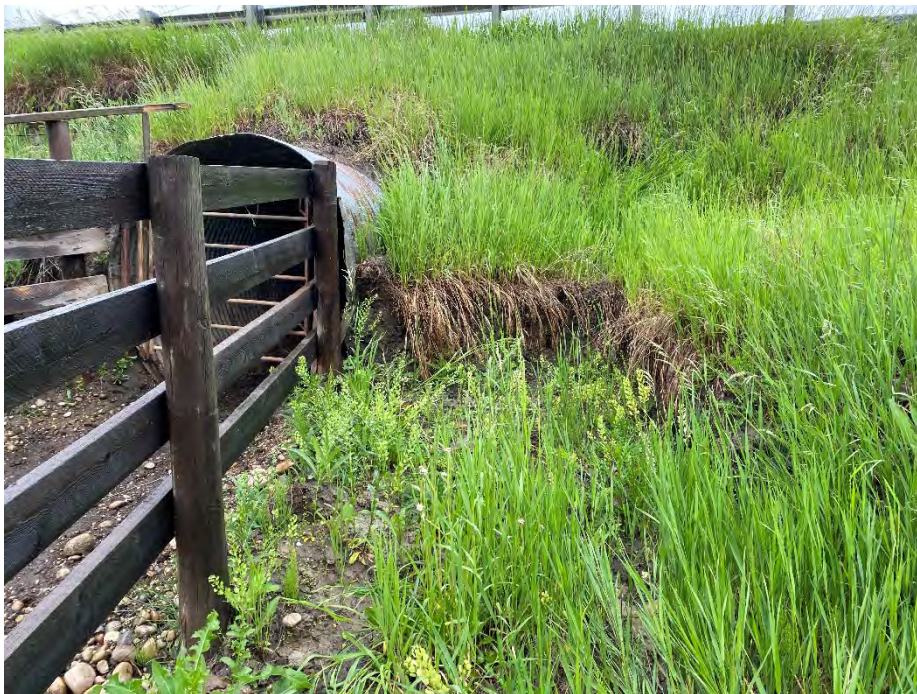
**Photo 4:** Possible regraded area on east side of culvert. Looking north.

- The MCI should continue to monitor the highway surface and guardrails until remediation can be undertaken.
- The MCI should discuss possible solutions with the farmer to maintain functionality of the gate but to refrain from further grading work at the toe of the landslide. Loss of soil support at the toe can trigger additional slope movements.

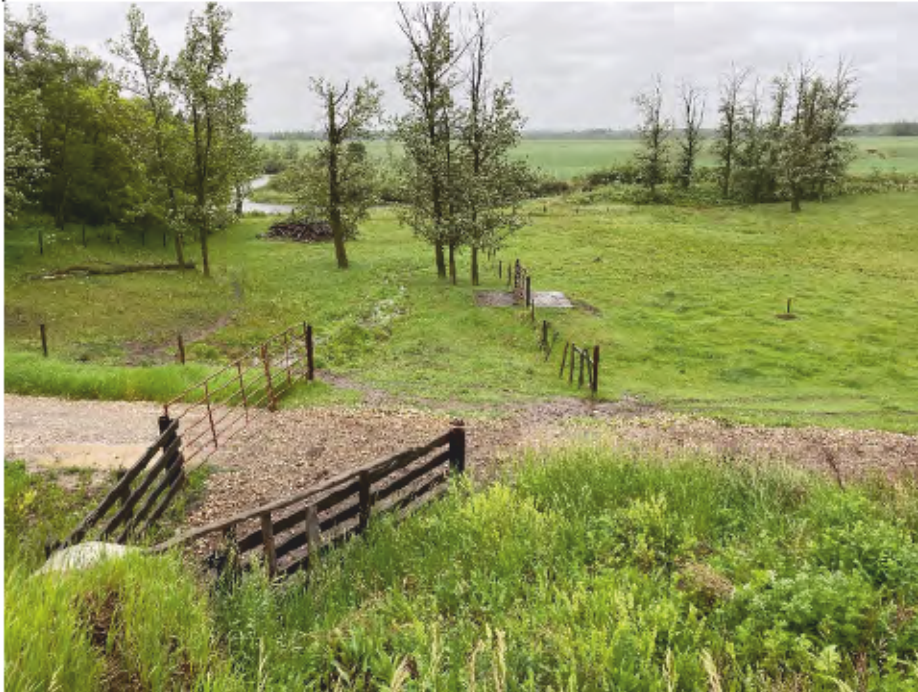
**Photo 5:** Repaired fence and farmer's road. Looking south.

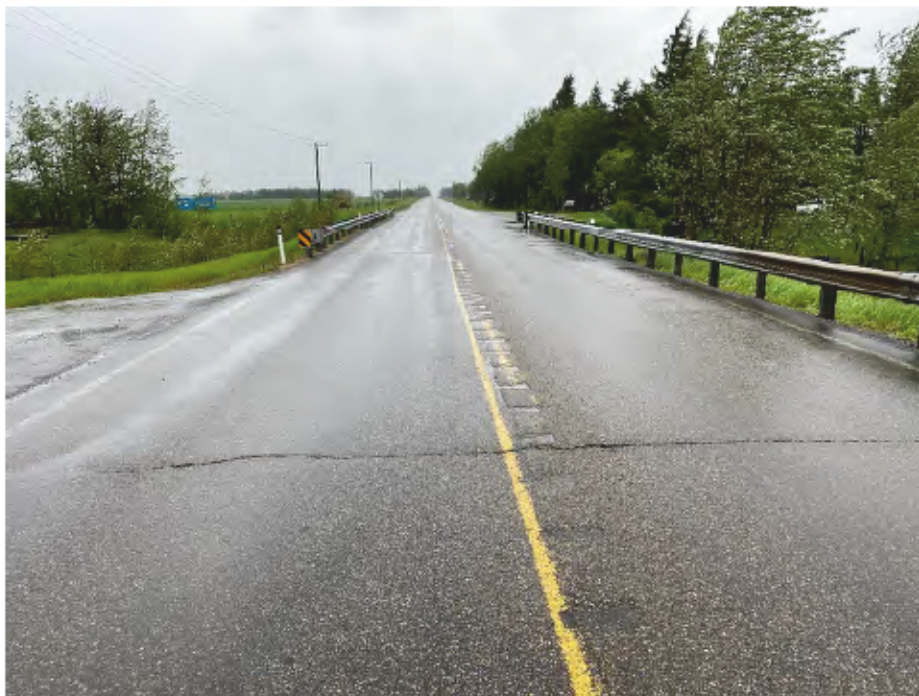
**Photo 6:** Highway surface at slump location. Looking east.
