**NORTH CENTRAL REGION GRMP
EDSON / STONY PLAIN
SITE INSPECTION FORM**

SITE NUMBER AND NAME: NC092 – Cattlepass Culvert BF 80823	HIGHWAY AND KM: 37:02, km 23.855	PREVIOUS INSPECTION: June 1, 2023	CURRENT INSPECTION: June 20, 2024
LEGAL DESCRIPTION: NE 33-54-27-W4M	NAD83 COORDINATES: UTM12U 5955908N, 307552E		RISK ASSESSMENT: PF: 10 CF: 6 Total: 60
AVERAGE ANNUAL DAILY TRAFFIC (AADT): 2740 (2023)		CONTRACTOR MAINTENANCE AREA (CMA): 510

Client/Project
 Transportation and Economic Corridors
 Geohazard Monitoring Program
 NC92 - Highway 37:2 Cattlepass Culvert

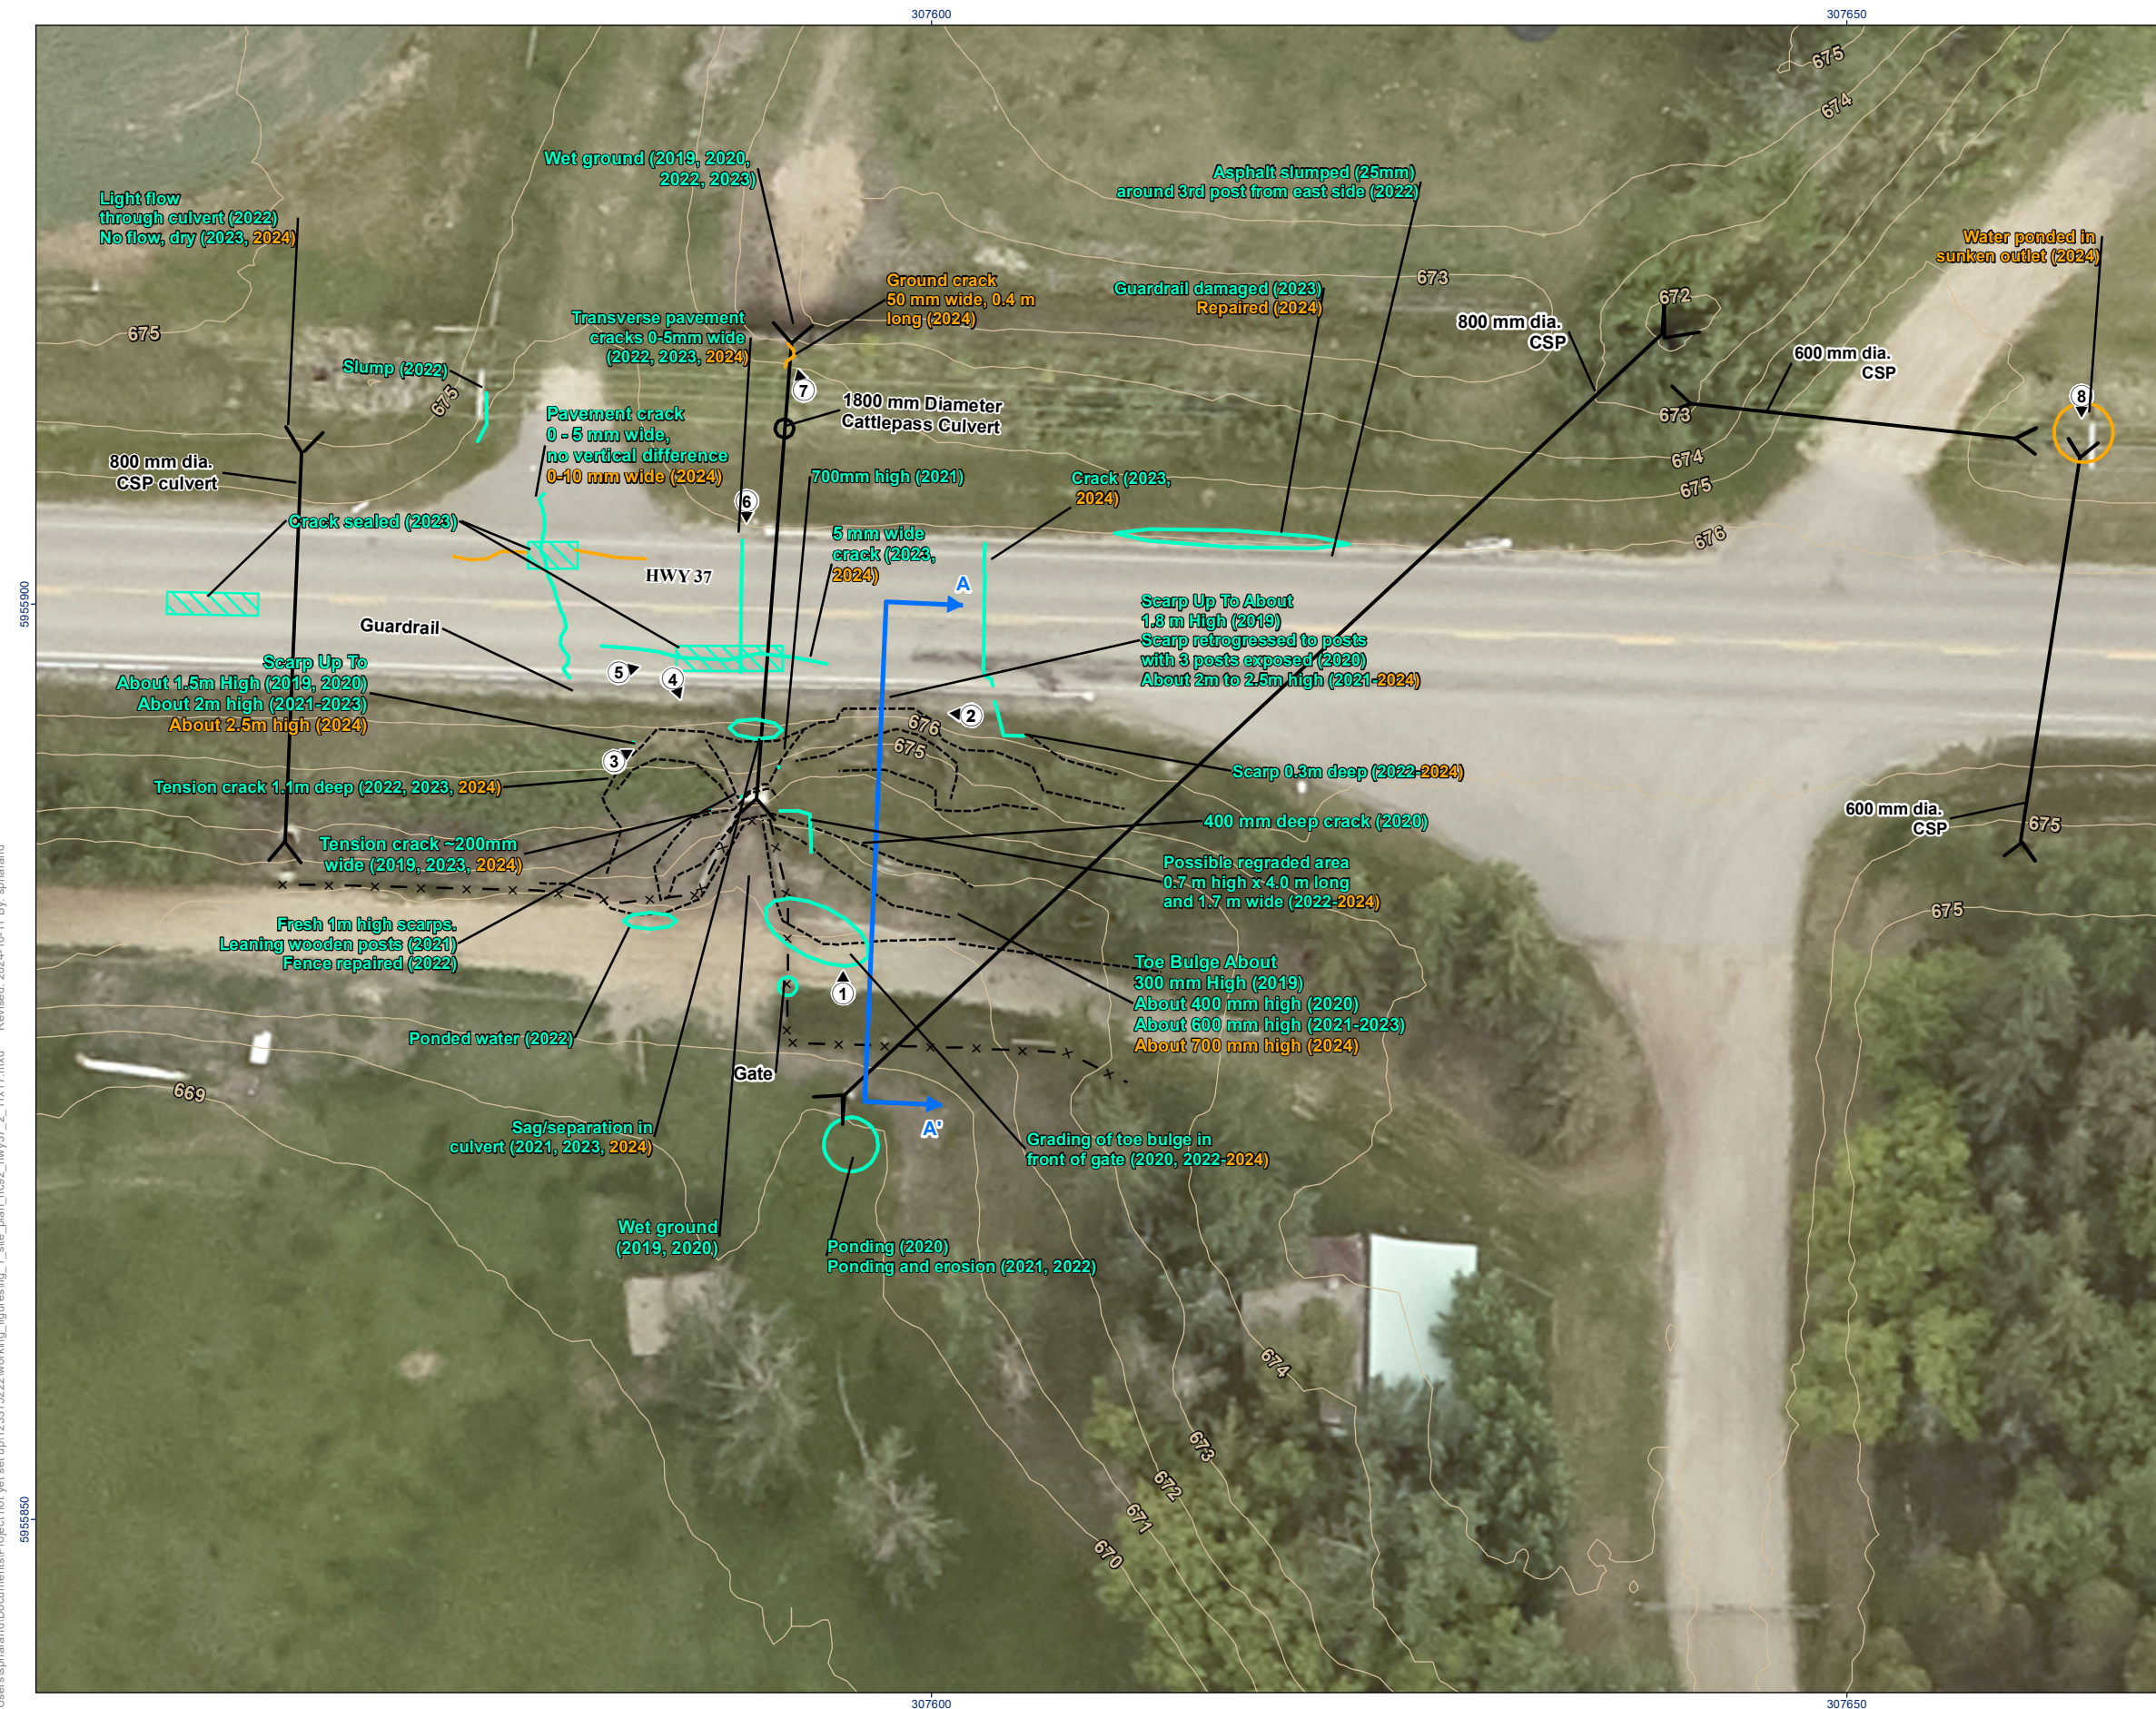
Figure No.
1

Title
Site Plan

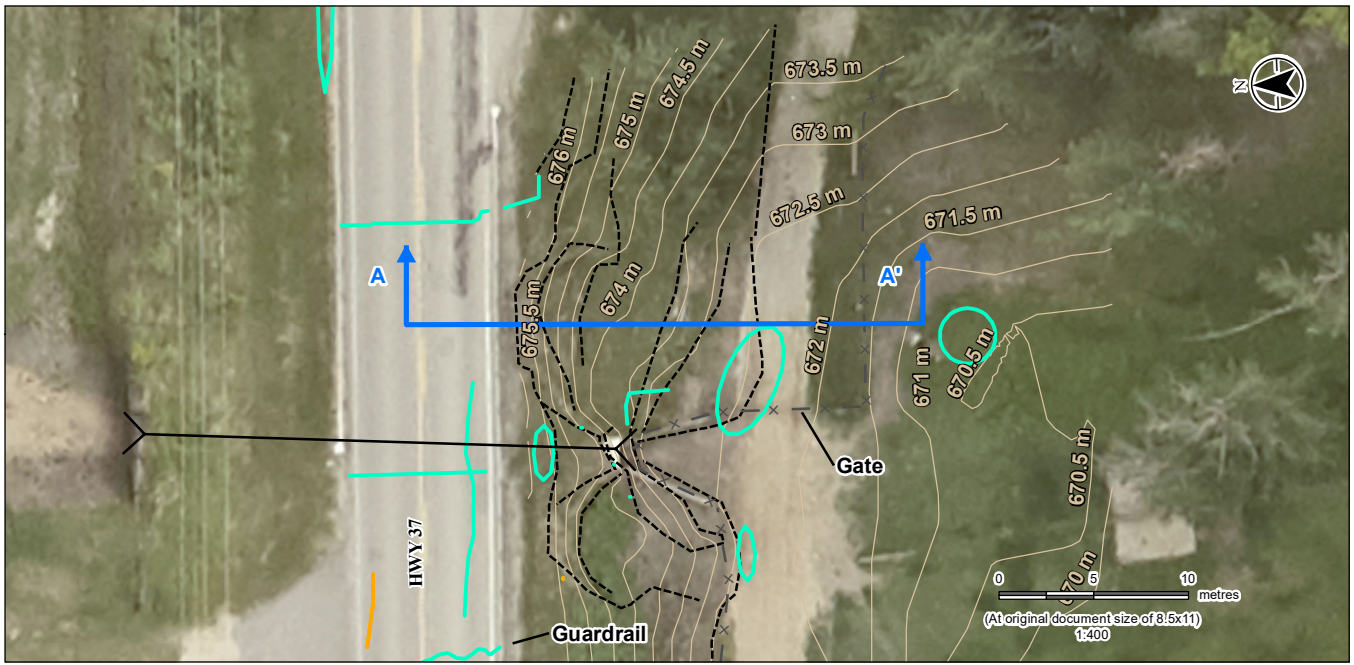
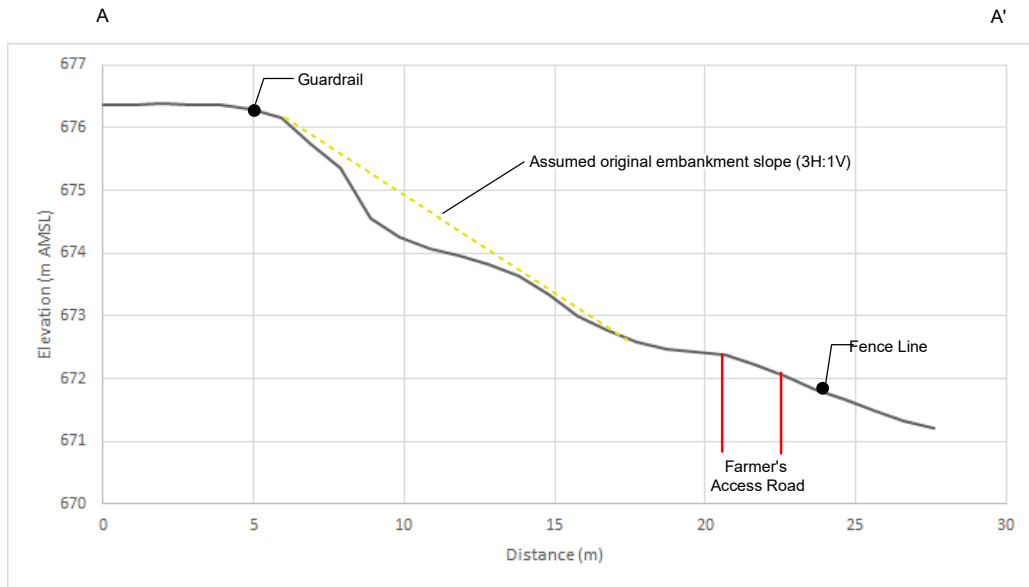
Figure No. 2
 Title: Ground Profile of Section A - A'

Cross Section A - A'

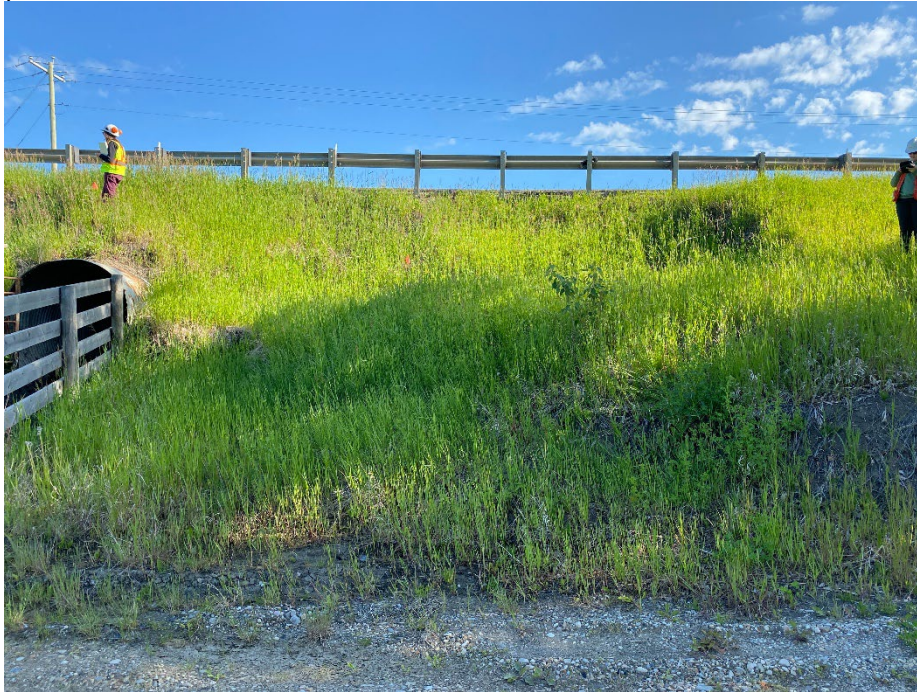
COMMENTS
<ul style="list-style-type: none"> • Little to no change was observed at the slump on the east side of the cattlepass, with the scarp up to about 2.5 m high. The scarp at the east extent next to the pavement remains approximately 0.3 m high (Photos 1 and 2). • The height of the toe bulge was about 700 mm high, approximately 100 mm higher than measured in 2023 (Photo 1). • There does not appear to be additional loss of lateral soil support at the guardrails. • The west slump appeared to have retrogressed compared to the 2023 inspection. The scarp west of the cattlepass was about 2.5 m high and 2 m away from the guardrail (Photos 3 and 4). • Tension cracks were observed on the west side of the west scarp and on the west side of the culvert opening, near the top of the culvert. Both appeared unchanged since last visit. • A sag was observed about 3 m to 4 m inside the south end of the cattle pass culvert since 2021. The sag location appeared to be approximately in line with the two scarps and is potentially separated at the joint. • In past site inspections, the farmer east of the site informed us that the cattle gate periodically will not open or close due to landslide activity. He occasionally regrades the landslide to maintain functionality of the gate. New posts were installed in 2020-2021 on the west side of the south end of the cattlepass culvert. The wooden posts were significantly leaning in 2021 and was repaired in 2022. Regrading on the east side of the cattlepass may have been completed as part of fence repair. The toe appears to have been cut back in an

Photo 1: Slump on east side of culvert. Possible regraded area on east side of culvert, well vegetated. Looking north.

- The MCI should continue to monitor the highway surface and guardrails until remediation can be undertaken.
- The MCI should discuss possible solutions with the farmer to maintain functionality of the gate but to refrain from further grading work at the toe of the landslide. Loss of soil support at the toe can trigger additional slope movements.
- In the short-term, fill can be placed at the base of the slope failure to act as a temporary buttress. The nearby Calahoo pit may be a potential source of granular material for this purpose.
- Stantec has submitted a design and work order for remediation of the embankment slope by removal of the failed soils and replacement with granular fill reinforced with geogrid.
- Site inspections should be completed annually.

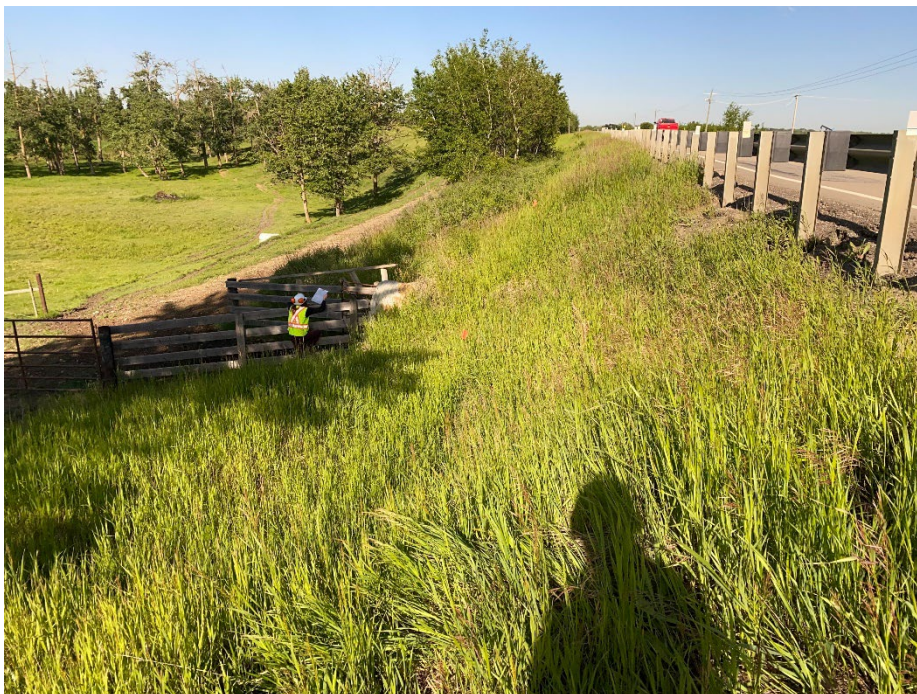
Photo 2: Slump across cattlepass culvert. Looking west

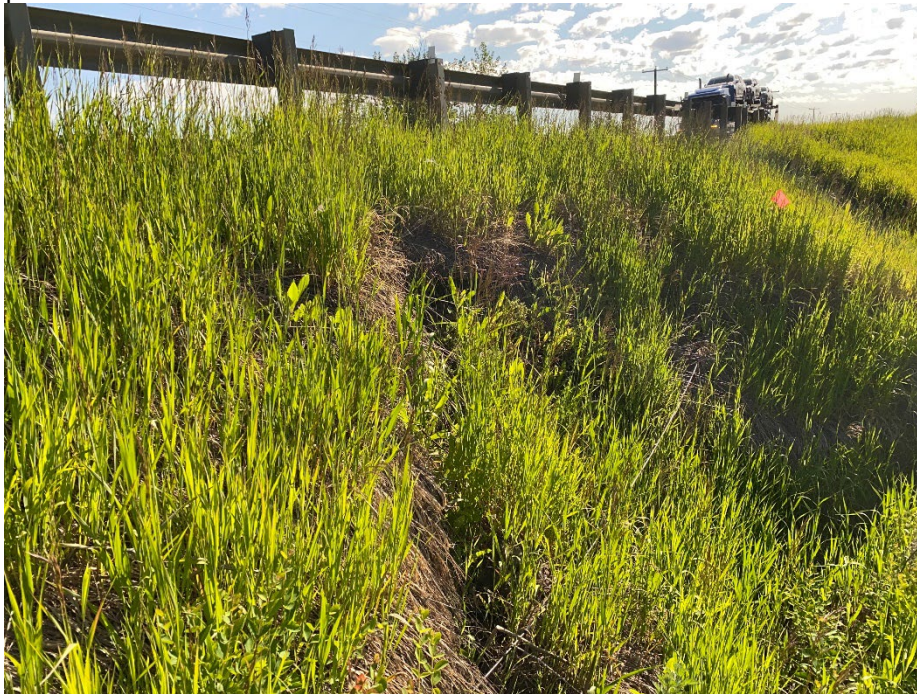
Photo 3: Scarp at west slump. Looking northeast.

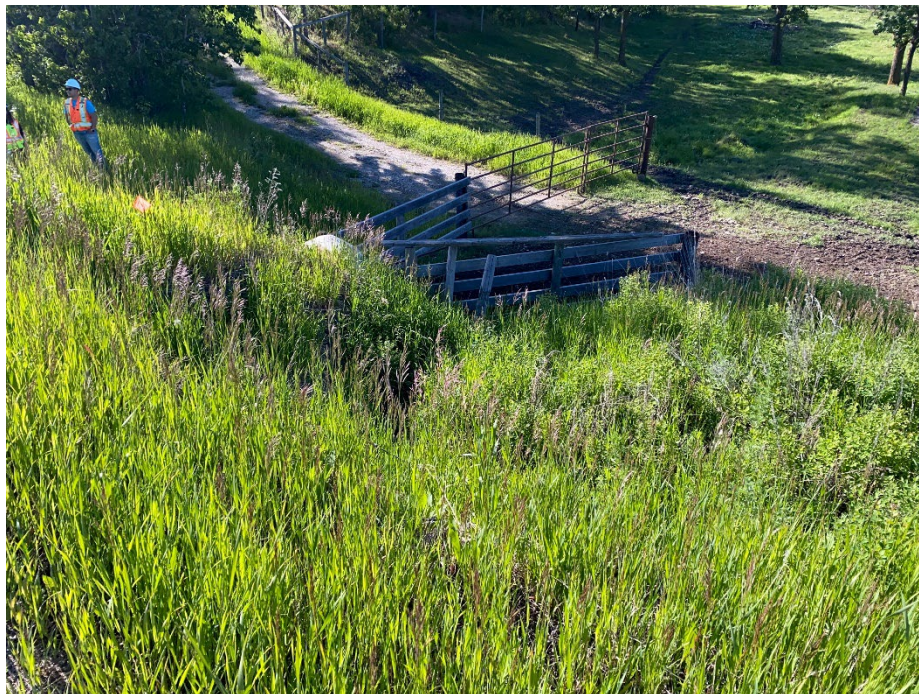
Photo 4: West slump next to culvert entrance. Looking southeast.

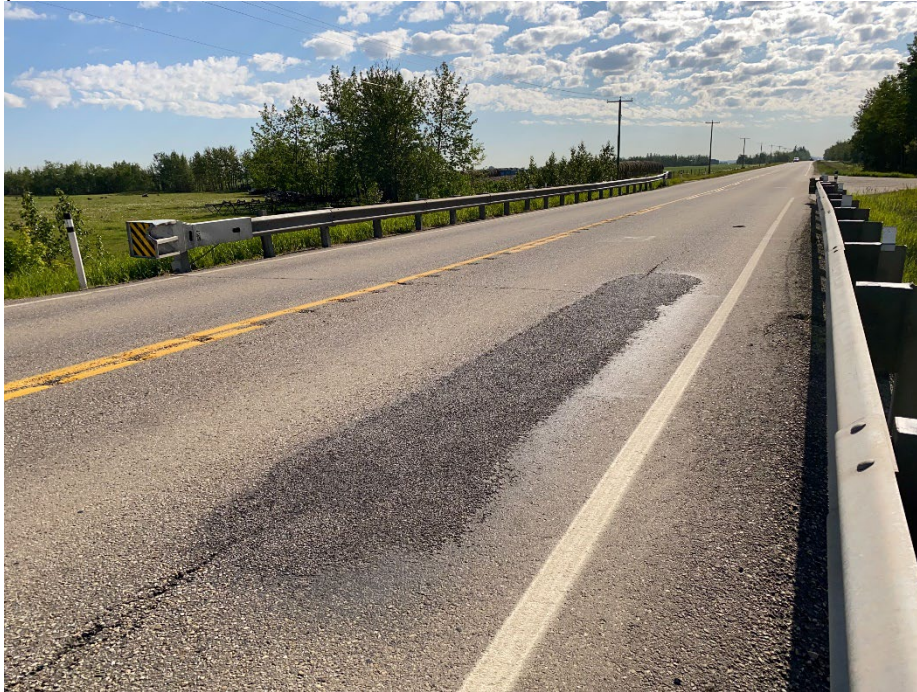
- A longitudinal crack in the EBL was observed above the culvert and is partially patched. The crack extends past the patch on both sides and is up to 10 mm wide (Photo 5).

Photo 5: Highway surface above culvert. Looking east.

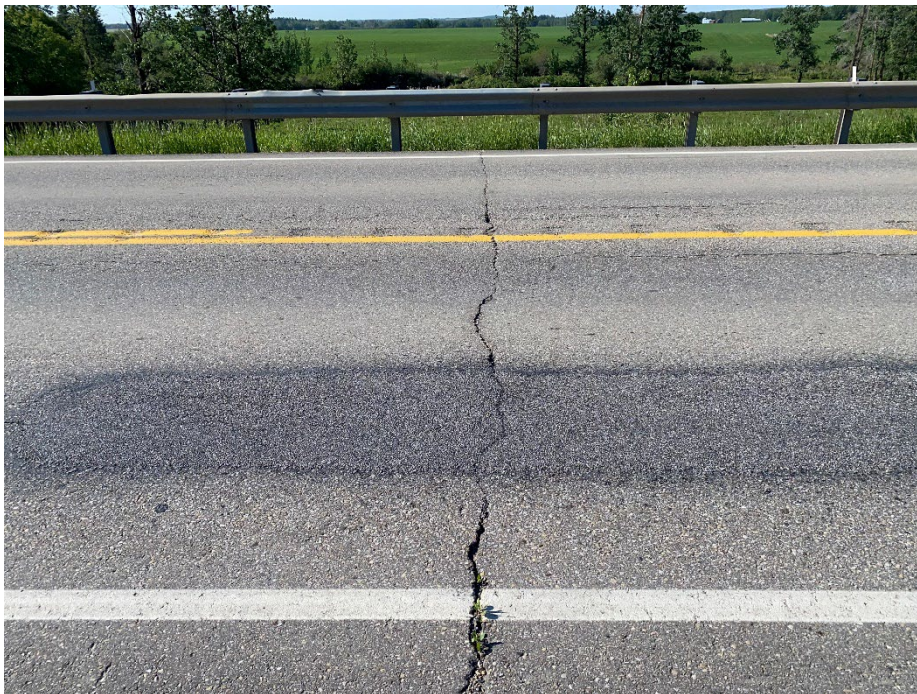
- The transverse crack above the eastern scarp appeared unchanged, and has reflected through the pavement patch (Photo 6).
- The north guardrail was damaged on the east end, and the south guardrail was damaged on the west end during the 2023 inspection. The guardrail in both sections was repaired.

Photo 6: Transverse pavement crack above eastern scarp. Looking south.

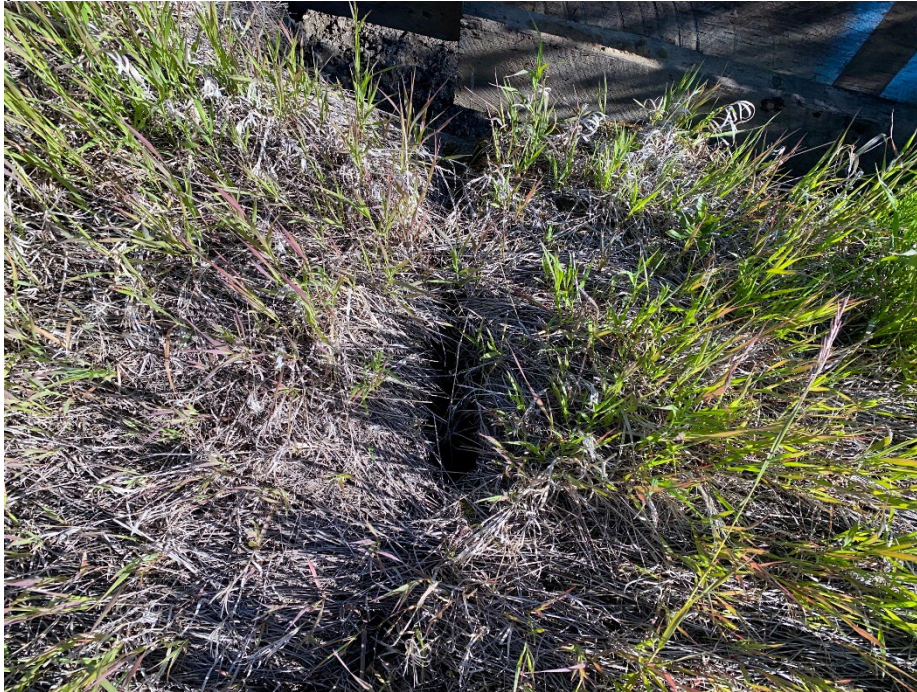
- A black utility cable (likely Telus) continues to be observed running east-west through the landslide.
- A ground crack approximately 50 mm wide was observed above the north end of the cattlepass culvert, at the fence line (Photo 7).

Photo 7: Ground crack along centreline of cattlepass culvert at north end. Looking northwest.

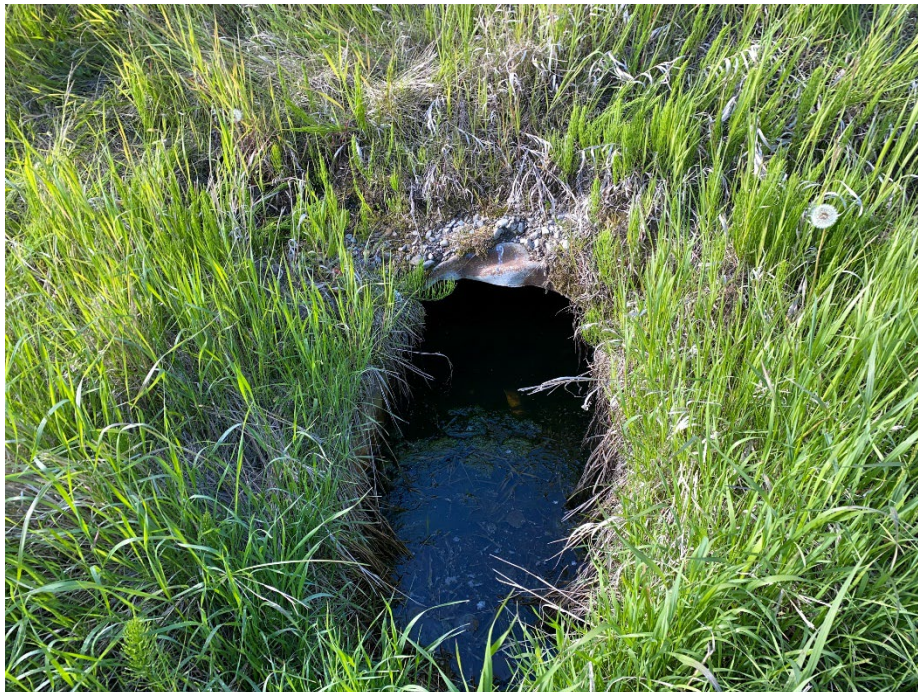
- The culvert inlet in the ditch to the east of the private driveway, on the south side of the highway is sunken into the ground. The outlet in the north ditch is also sunken into the ground, and water is pooling in the outlet, unable to flow out (Photo 8).

Photo 8: Water ponded in sunken culvert outlet in ditch east of private access, north side of highway. Looking south.
