ALBERTA TRANSPORTATION LANDSLIDE RISK ASSESSMENT

SECTION A: GEOTECHNICAL FILE REVIEW NORTH CENTRAL REGION

SITE NC86: HWY39:06, KM 4.9, HWY 39 and TWSHP ROAD 491A INTERSECTION

NC86 - HWY 39 AND TWP RD 491A
GEOHAZARD MONITORING PROGRAM
NEAR DRAYTON VALLEY
BOREHOLE LOCATION PLAN

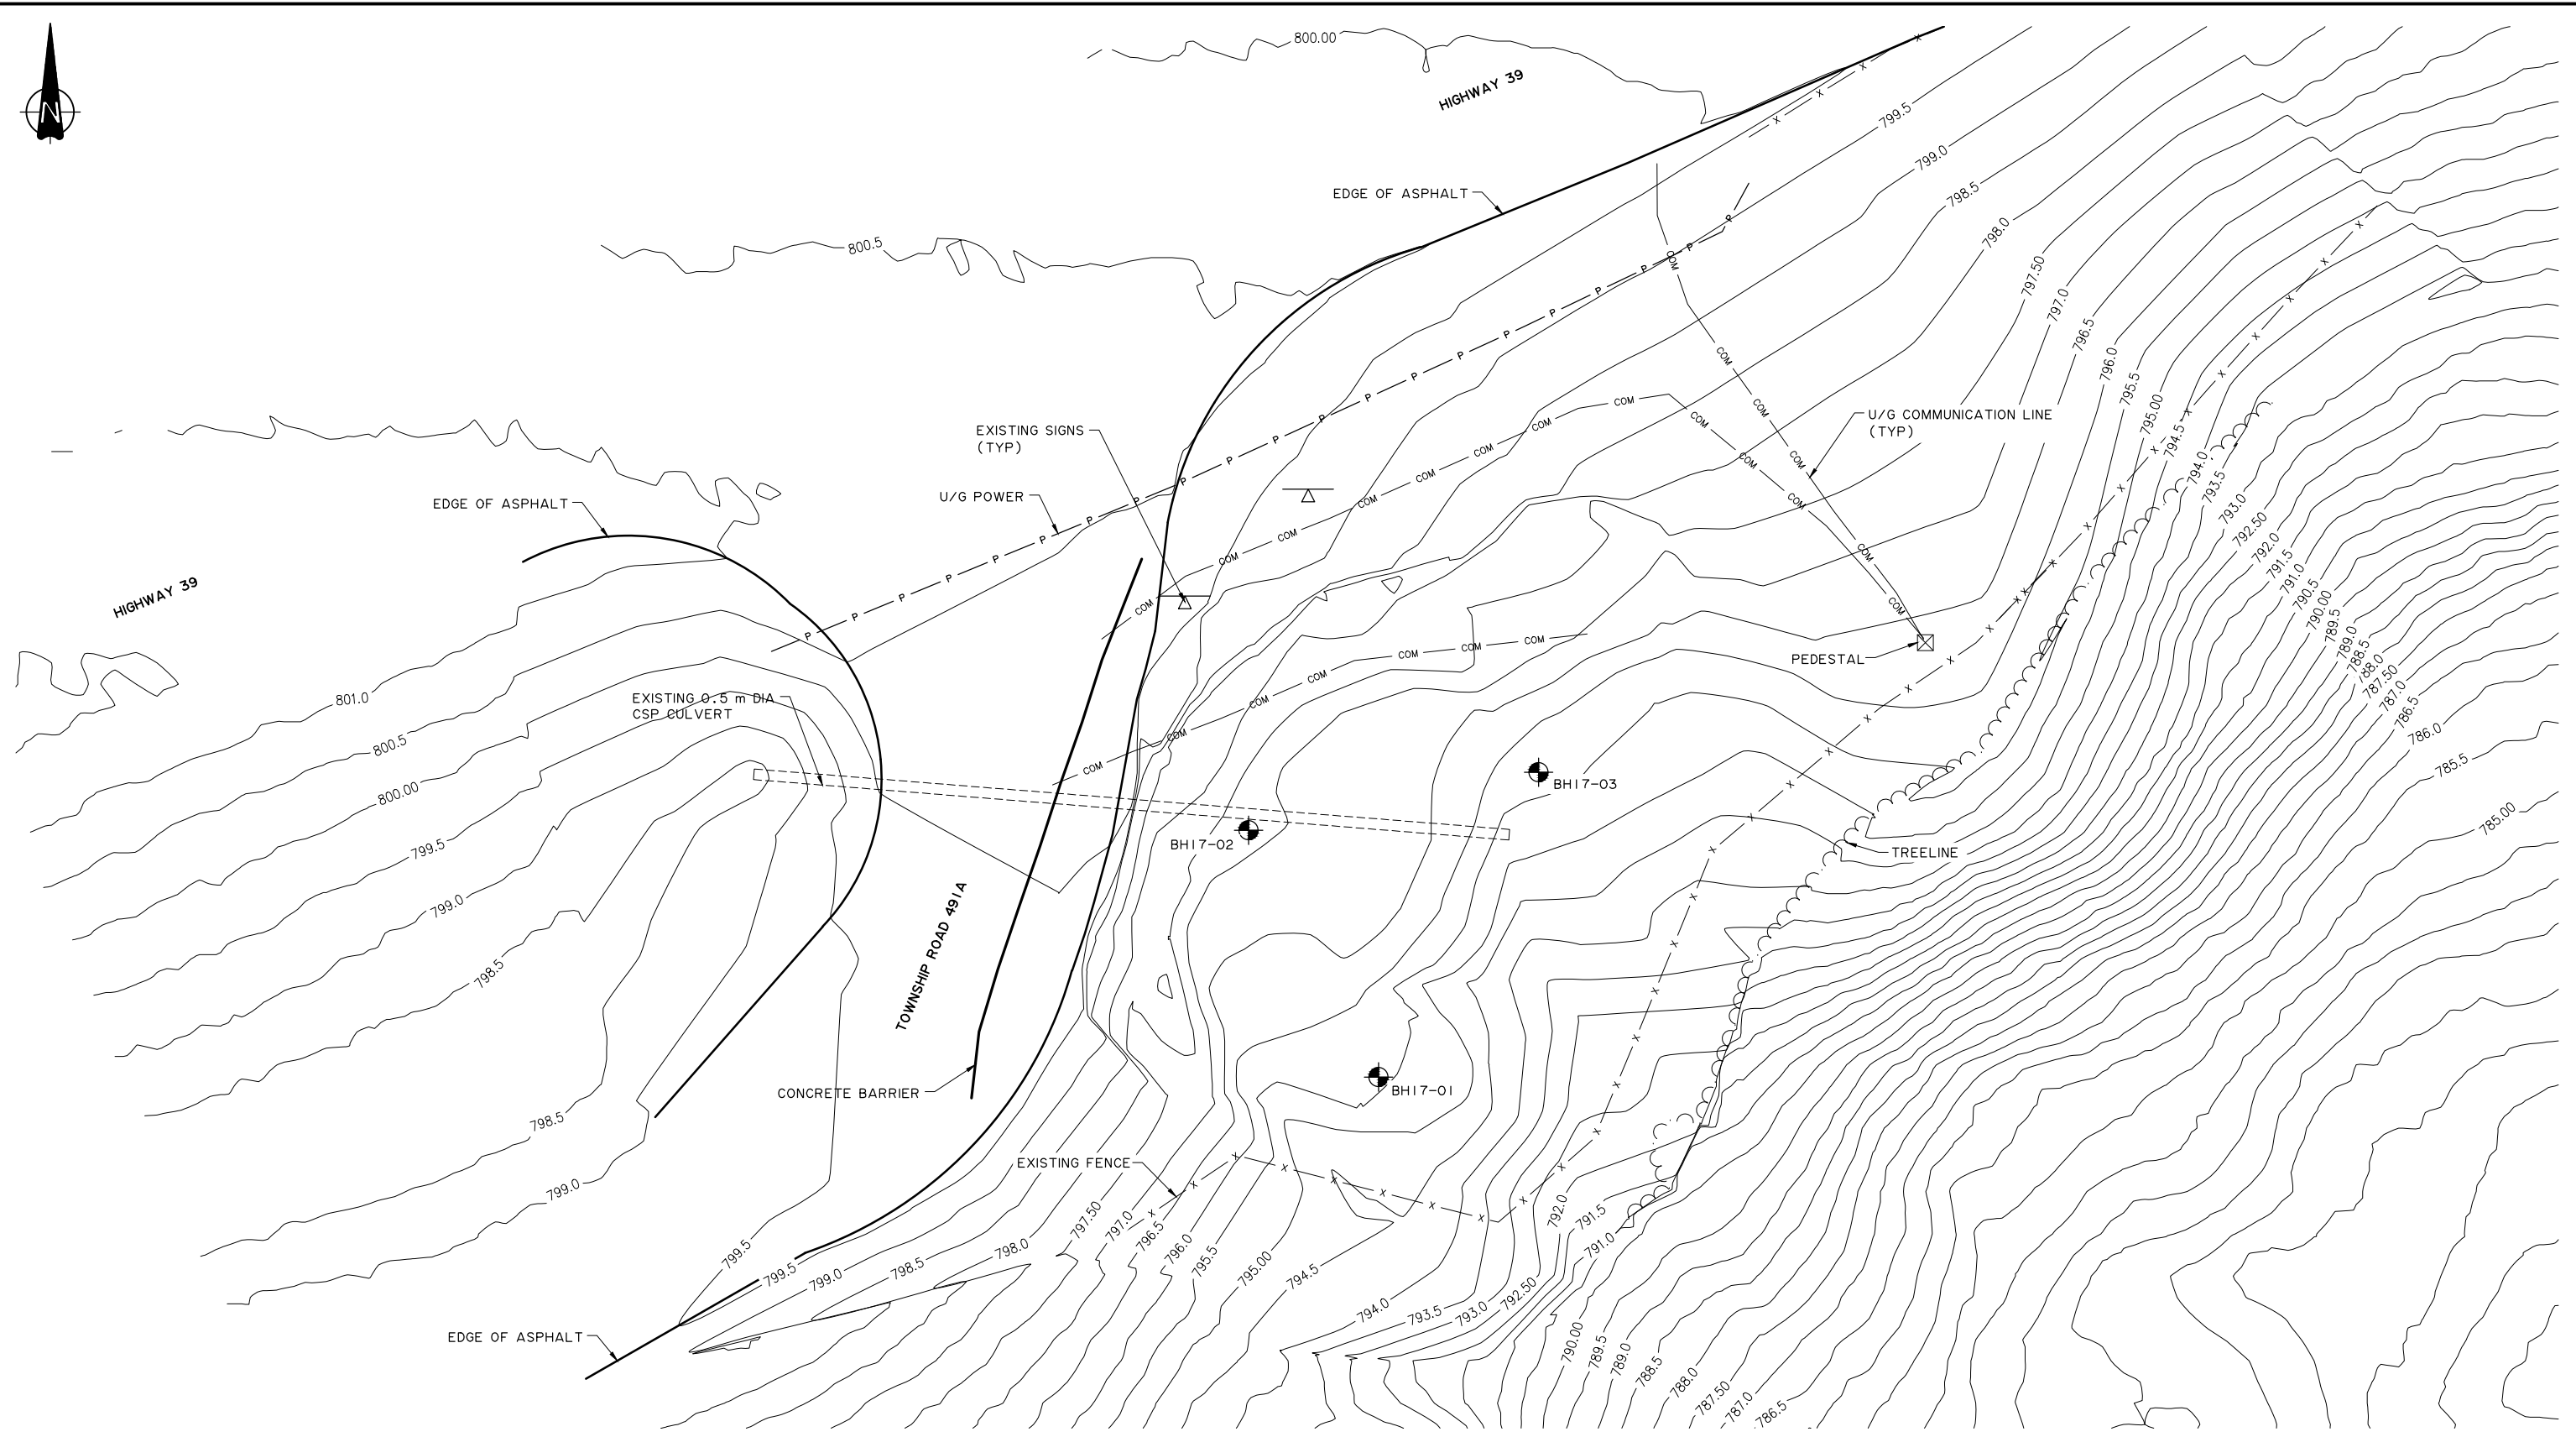
CONTRACT	HIGHWAY	SHEET	DRAWING
-	39:02	1 of 1	FIG-1

Two slope inclinometers, three vibrating wire piezometers, and one standpipe piezometer were installed at the site to monitor ground movements and groundwater levels in 2017. The location of these instruments is shown on **Figure 1**.
