SITE NUMBER AND NAME: NC086 – Poplar Creek Slide	HIGHWAY AND KM: 39:06, km 4.915	PREVIOUS INSPECTION: May 22, 2020	CURRENT INSPECTION: June 29, 2021
LEGAL DESCRIPTION: SW 11-49-06-W5	NAD83 COORDINATES: UTM11U 5897673N, 648158E		RISK ASSESSMENT: PF: 3 CF: 3 Total: 9
AVERAGE ANNUAL DAILY TRAFFIC (AADT): 3,280 (2020)		CONTRACTOR MAINTENANCE AREA (CMA): 509

NORTH CENTRAL REGION GRMP
EDSON / STONY PLAIN
SITE INSPECTION FORM

2021 Site Inspection Photos at NC086

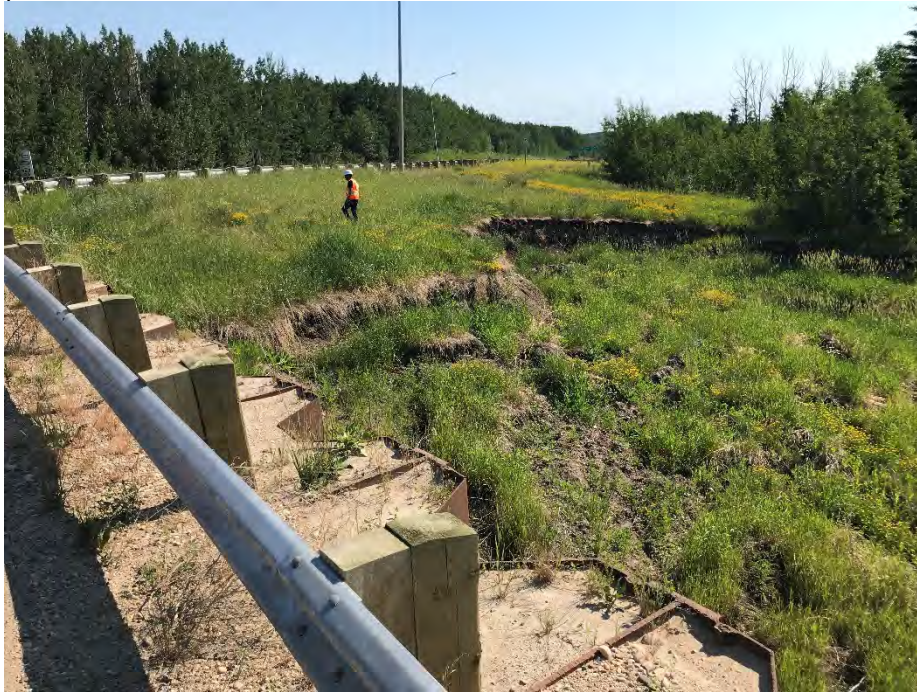
COMMENTS
<ul style="list-style-type: none"> The landslide is progressing downslope of the wall (Photos 1 and 2). A measurement from the top of pile wall to the top of ground was taken between the 9th and 10th guardrail post south of the stop sign. The height was measured to be 3.5 m. The landslide mass appears to be extending further east beyond the limits of the pile wall. The current east limit is approximately 20 m east of SI1. This is approximately in line with the east limit of the pile wall. The scarp is approximately 12 m south of the guardrail. SI1 showed negligible cumulative movement of less than 1 mm at a depth of about 14 m in the clay shale since initialization in 2018. The light standard south of Highway 39 and about 20 m from the intersection had a 3° lean towards the slide mass (Photo 3). The MCI informed Stantec that many light standards in this area have a similar lean. The culvert and ditch across TWP RD 491A were dry. The riprap at both ends of the culvert were cracked. The north ditch of Highway 39 was wet. The separation between the new and old pavement appeared unchanged (Photo 4). Longitudinal cracking of Highway 39 was observed and did not appear to have changed.

Photo 1: Slope movement downslope of pile wall. Looking northeast.

- The site should be regularly monitored by the MCI. In particular, the landslide should be monitored for additional progression towards the light standard which would indicate the slide is beyond the extent of the pile wall. In addition, the depth of the landslide from the top of the pile wall should be checked to ensure that it does not exceed the design height of 6 m.

- Should the landslide progress beyond the east extent of the pile wall, the pile wall can be extended to protect the highway. The high-level cost of extending the pile wall by 20 m is \$300,000, excluding engineering. Conflicts with streetlight power and communications cable are expected if the pile wall is extended east.

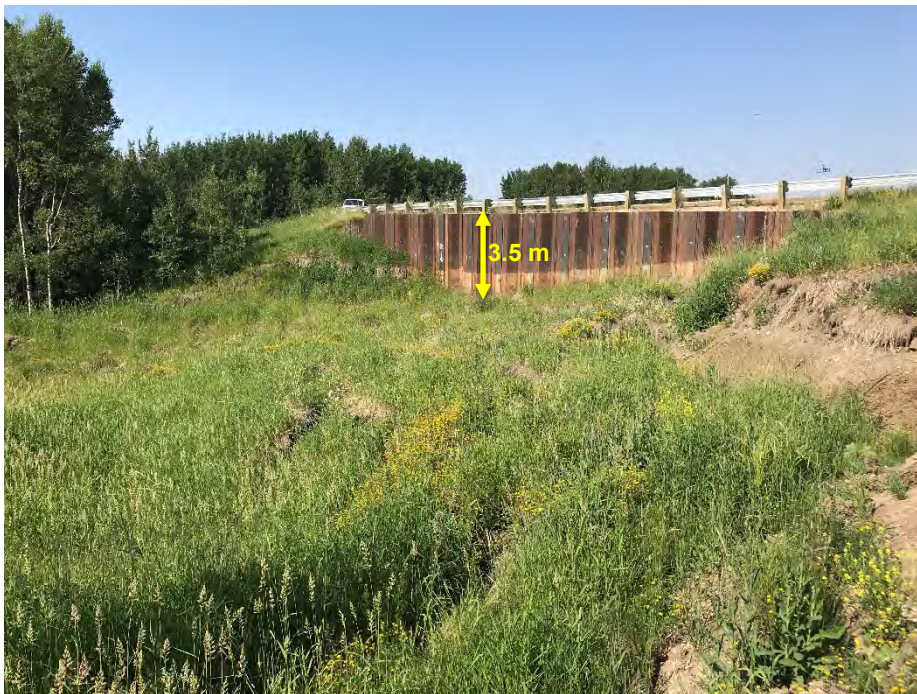
Photo 2: Slope movement downslope of pile wall. Looking southwest.

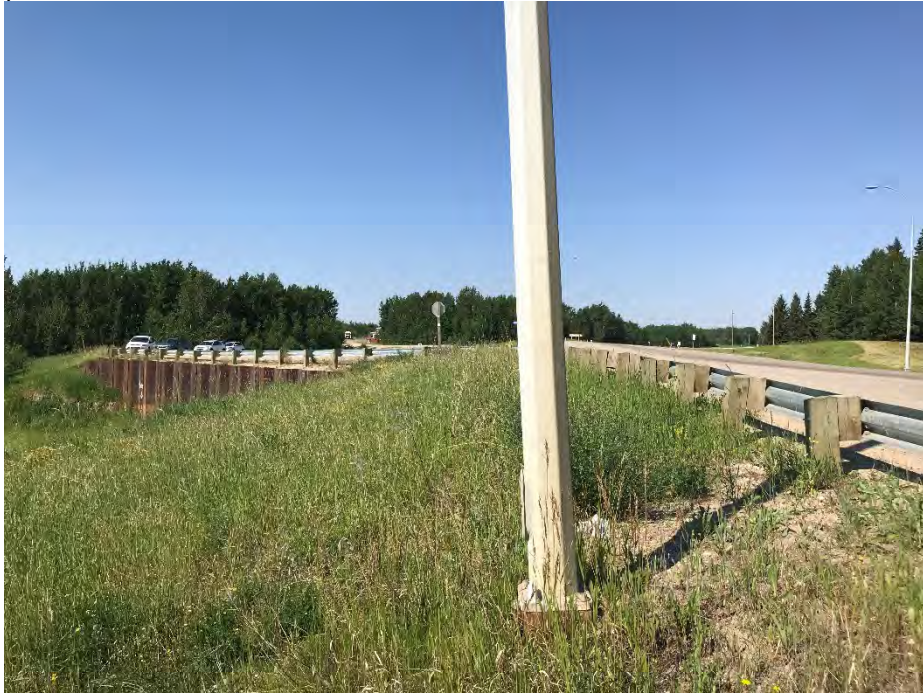
Photo 3: Leaning light standard. Looking southwest.

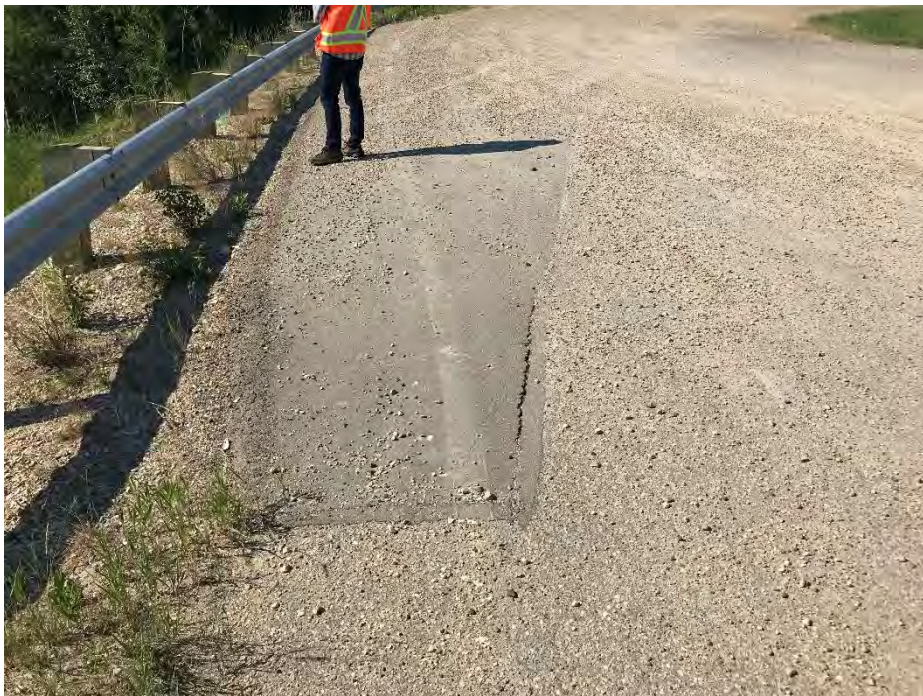
Photo 4: Separation of new and old pavement west of pile wall. Looking south.

- Pavement cracks should be sealed to reduce surface water infiltration into the slope.
- Site inspections should continue annually.
- Instrumentation readings should continue to be read annually in the spring.
