<b>SITE NUMBER AND NAME:</b> NC086 – Poplar Creek Slide	<b>HIGHWAY AND KM:</b> 39:06, km 4.915	<b>PREVIOUS INSPECTION:</b> June 29, 2021	<b>CURRENT INSPECTION:</b> June 15, 2022
<b>LEGAL DESCRIPTION:</b> SW 11-49-06-W5	<b>NAD83 COORDINATES:</b> UTM11U 5897673N, 648158E		<b>RISK ASSESSMENT:</b> PF: 3 CF: 3 Total: 9
<b>AVERAGE ANNUAL DAILY TRAFFIC (AADT):</b> 3,510 (2021)		<b>CONTRACTOR MAINTENANCE AREA (CMA):</b> 509

2022 Site Inspection Photos at NC086

ALBERTA TRANSPORTATION  
GEOHAZARD MONITORING PROGRAM  
NC86 HWY 39 AND TWP RD 491A - NEAR DRAYTON VALLEY  
SITE PLAN

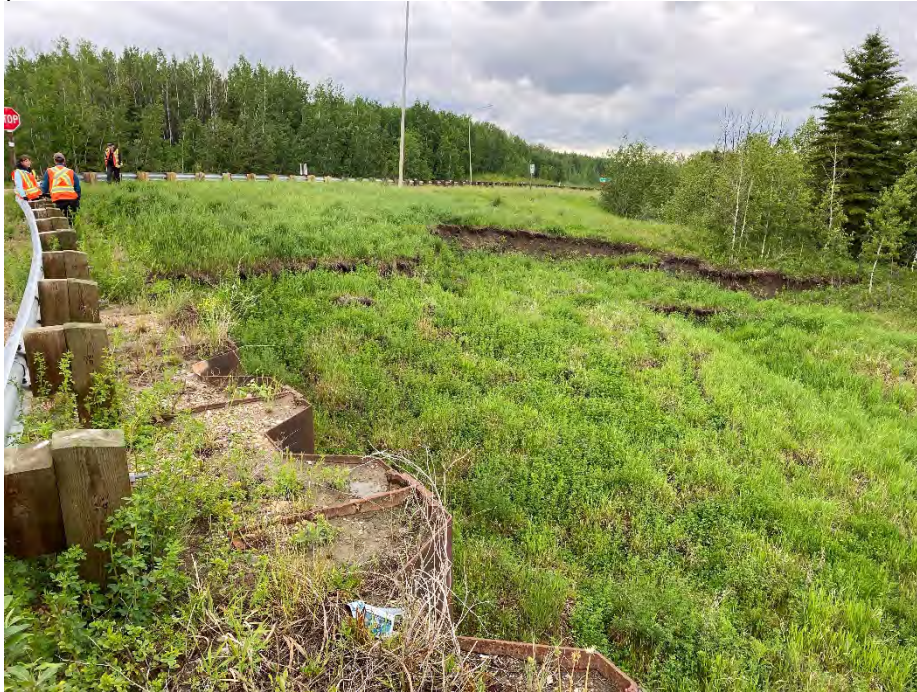
<b>COMMENTS</b>
<ul style="list-style-type: none"> <li>The landslide is progressing downslope of the wall (Photos 1 and 2). A measurement from the top of pile wall to the top of ground was taken between the 9<sup>th</sup> and 10<sup>th</sup> guardrail post south of the stop sign. The height was measured to be 3.5 m.</li> <li>The landslide mass appears to be extending further east beyond the limits of the pile wall. The current east limit is approximately 5.6 m east from the light standard. This is approximately in line with the east limit of the pile wall. The scarp is approximately 10.4 m south of the guardrail, meaning that the slide has retrogressed 1.6 m since the 2021 inspection.</li> <li>S11 showed a negligible cumulative movement of less than 1 mm at a depth of about 14 m in the clay shale since initialization in 2018.</li> <li>The light standard south of Highway 39 and about 20 m from the intersection had a 3° lean towards the slide mass (Photo 3). The MCI informed Stantec that many light standards in this area have a similar lean.</li> <li>The culvert and ditch across TWP RD 491A were flowing. The riprap at both ends of the culvert were cracked.</li> <li>The separation between the new and old pavement appeared unchanged (Photo 4).</li> <li>Longitudinal cracking of Highway 39 was observed and did not appear to have changed (Photo 5).</li> </ul>

**Photo 1:** Slope movement downslope of pile wall. Looking northeast.

- The site should be regularly monitored by the MCI. In particular, the landslide should be monitored for additional progression towards the light standard which would indicate the slide is beyond the extent of the pile wall. In addition, the depth of the landslide from the top of the pile wall should be checked to ensure that it does not exceed the design cantilever height of 6 m.

- Should the landslide progress beyond the east extent of the pile wall, the pile wall can be extended to protect the highway. The high-level cost of extending the pile wall by 20 m is \$300,000, excluding engineering. Conflicts with streetlight power and communications cable are expected if the pile wall is extended east.

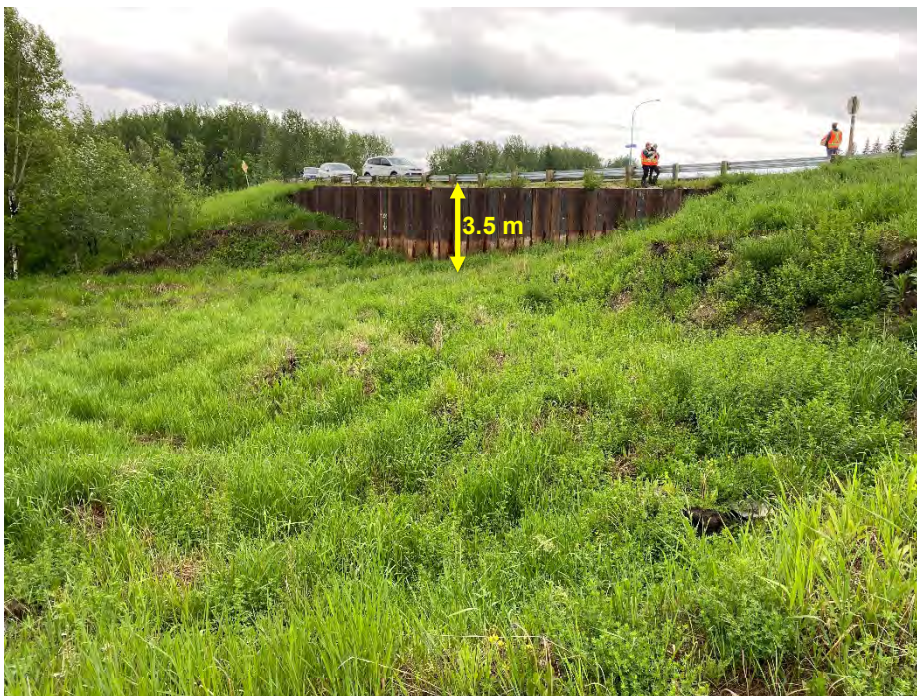
**Photo 2:** Slope movement downslope of pile wall. Looking southwest.

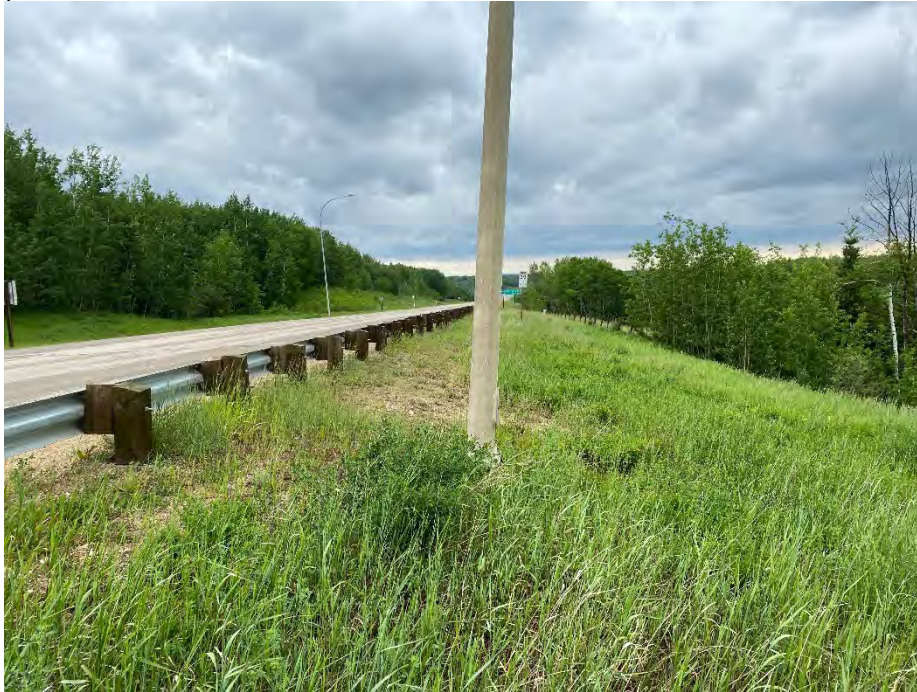
**Photo 3:** Leaning light standard. Looking northeast.

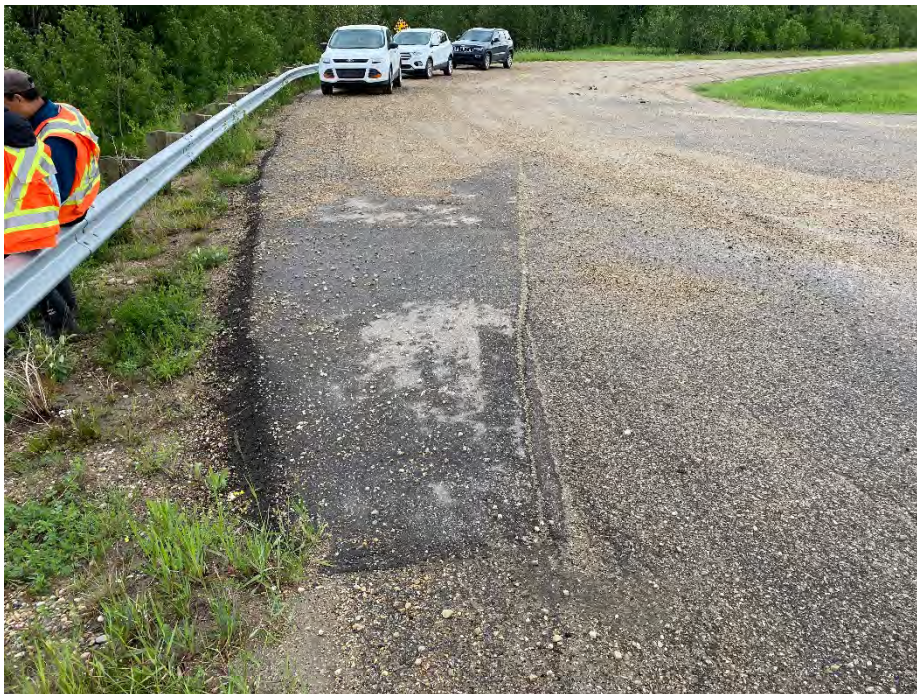
**Photo 4:** Separation of new and old pavement west of pile wall. Looking south.

- Pavement cracks should be sealed to reduce surface water infiltration into the slope.
- The ditch on the north side of Highway 39 should be regraded for water flow. Additional check dams or other structures should be installed to reduce surface water flow velocity.

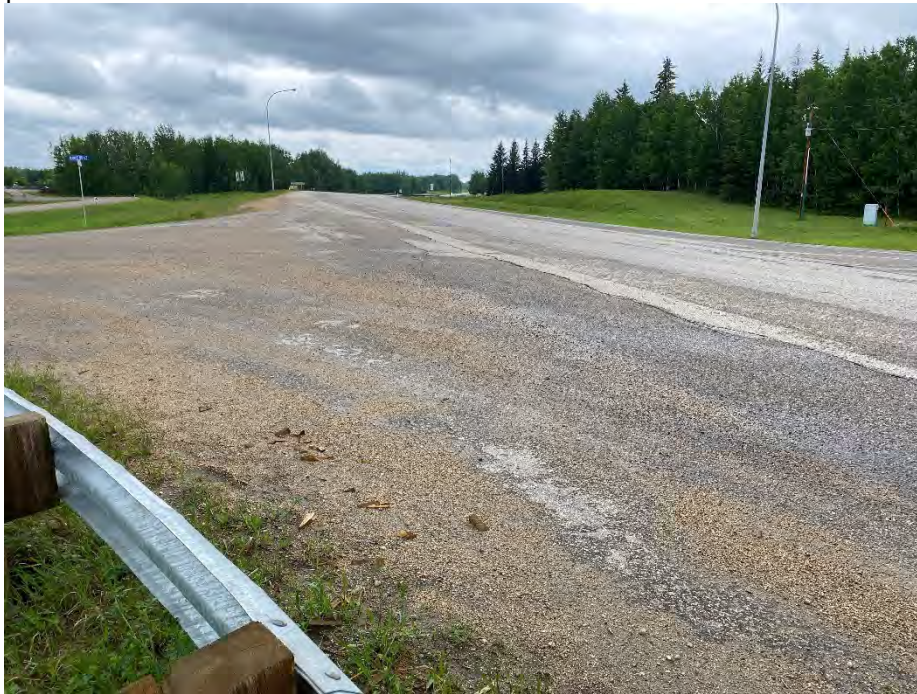
**Photo 5:** Pavement condition at intersection. Looking southwest.

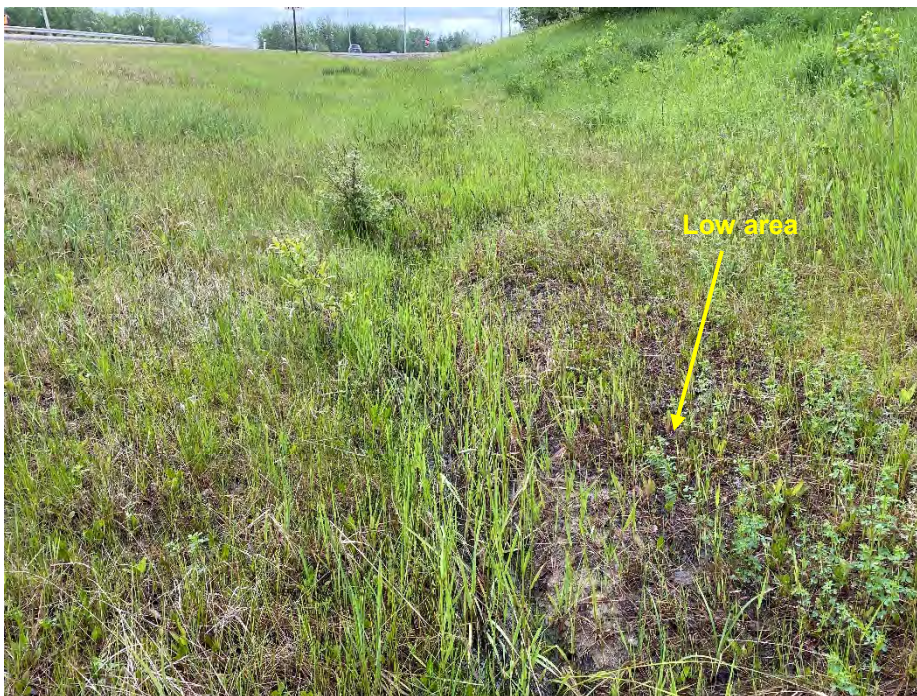
- The north ditch of Highway 39 was wet. It was noted that there is only one check dam, located on the east side of the light standard. It is possible that the rock check dam may have been grown over with vegetation.
- An erosion gully approximately 400 mm wide and 200 mm deep has formed on the west side of the light standard in the north ditch, and water is ponding in a low spot near the light standard (Photo 6).

**Photo 6:** Ditch on north side of Hwy 39. Looking southwest.
