<b>SITE NUMBER AND NAME:</b> NC086 – Poplar Creek Slide	<b>HIGHWAY AND KM:</b> 39:06, km 4.915	<b>PREVIOUS INSPECTION:</b> June 15, 2022	<b>CURRENT INSPECTION:</b> June 2, 2023
<b>LEGAL DESCRIPTION:</b> SW 11-49-06-W5	<b>NAD83 COORDINATES:</b> UTM11U 5897673N, 648158E		<b>RISK ASSESSMENT:</b> PF: 9 CF: 3 Total: 27
<b>AVERAGE ANNUAL DAILY TRAFFIC (AADT):</b> 3,520 (2022)		<b>CONTRACTOR MAINTENANCE AREA (CMA):</b> 509

2023 Site Inspection Photos at NC086

TRANSPORTATION AND ECONOMIC CORRIDORS  
GEOHAZARD MONITORING PROGRAM  
NC86 HWY 39 AND TWP RD 491A - NEAR DRAYTON VALLEY  
SITE PLAN

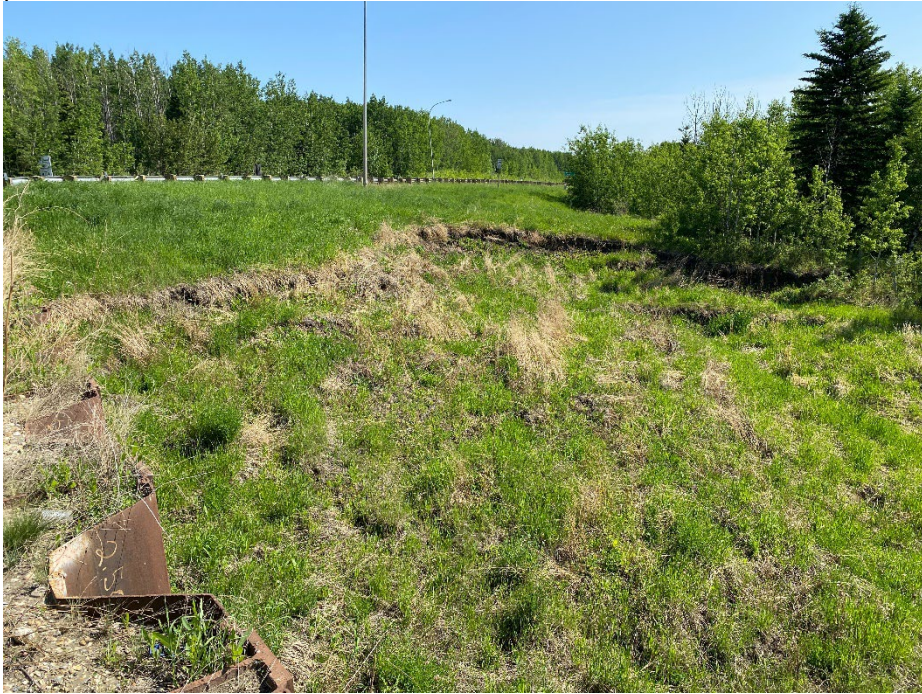
<b>COMMENTS</b>
<ul style="list-style-type: none"> <li>The landslide is progressing downslope of the wall (Photos 1 and 2). A measurement from the top of pile wall to the top of ground was taken between the 9<sup>th</sup> and 10<sup>th</sup> guardrail post south of the stop sign. The height was measured to be 3.6 m, 0.1 m greater than the previous inspection.</li> <li>The landslide mass appears to be extending further east beyond the limits of the pile wall. The current east limit is approximately 5.6 m east from the light standard. This is approximately in line with the east limit of the pile wall. The scarp is approximately 9.5 m south of the guardrail, meaning that the slide has retrogressed 0.9 m since the 2022 inspection.</li> <li>Tension cracks were observed in the ground near the current landslide scarp (Photo 3).</li> <li>S11 showed a negligible cumulative movement of less than 1 mm at a depth of about 14 m in the clay shale since initialization in 2018.</li> </ul>

**Photo 1:** Slope movement downslope of pile wall. Looking northeast.

- The site should be regularly monitored by the MCI. In particular, the landslide should be monitored for additional progression towards the light standard which would indicate the slide is beyond the extent of the pile wall. In addition, the depth of the landslide from the top of the pile wall should be checked to ensure that it does not exceed the design cantilever height of 6 m.

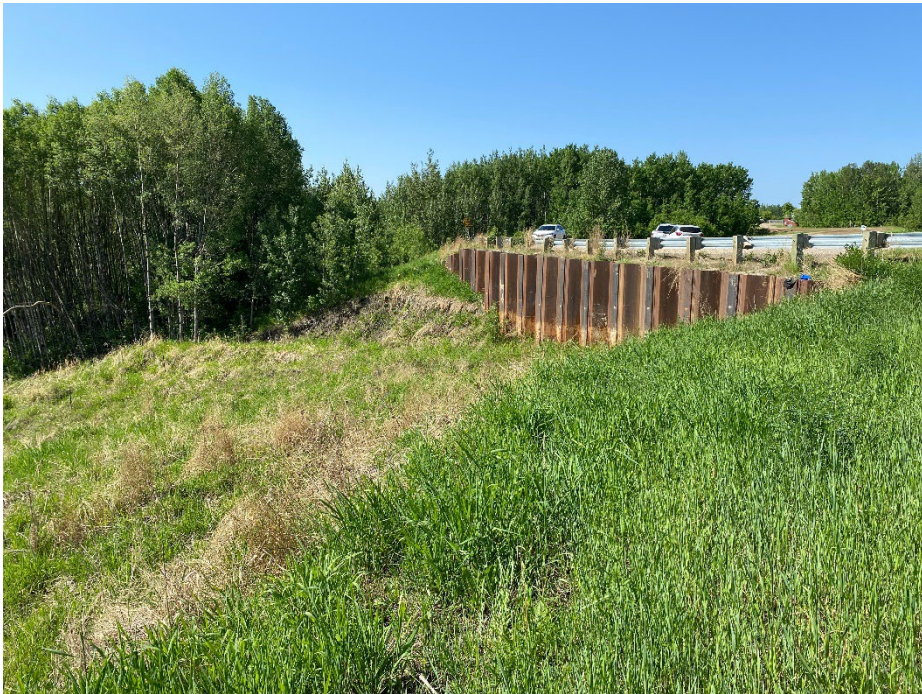
**Photo 2:** Slope movement downslope of pile wall. Looking southwest.

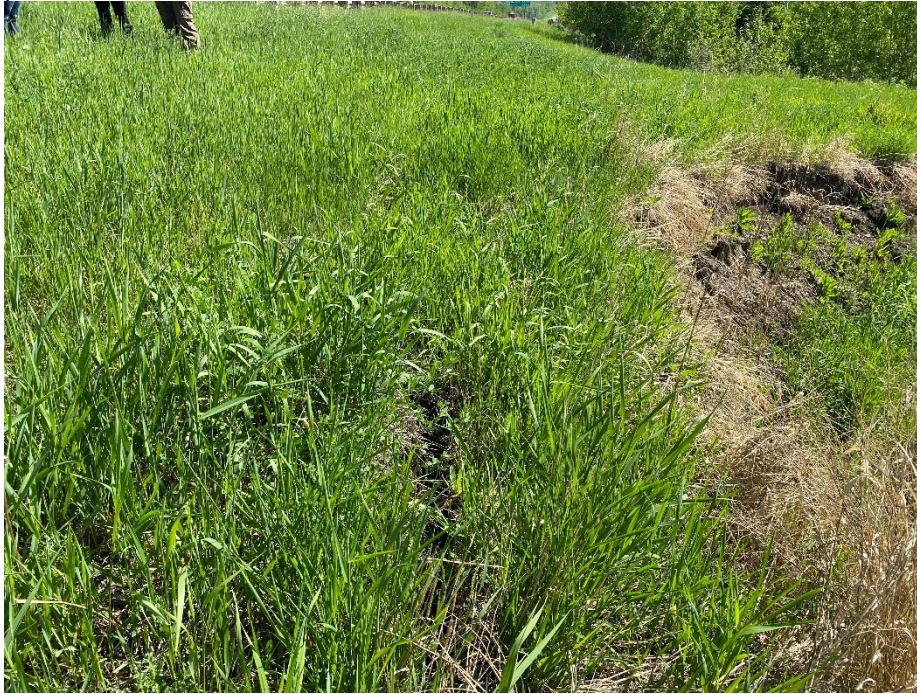
**Photo 3:** Tension crack upslope of the current scarp. Looking northeast.

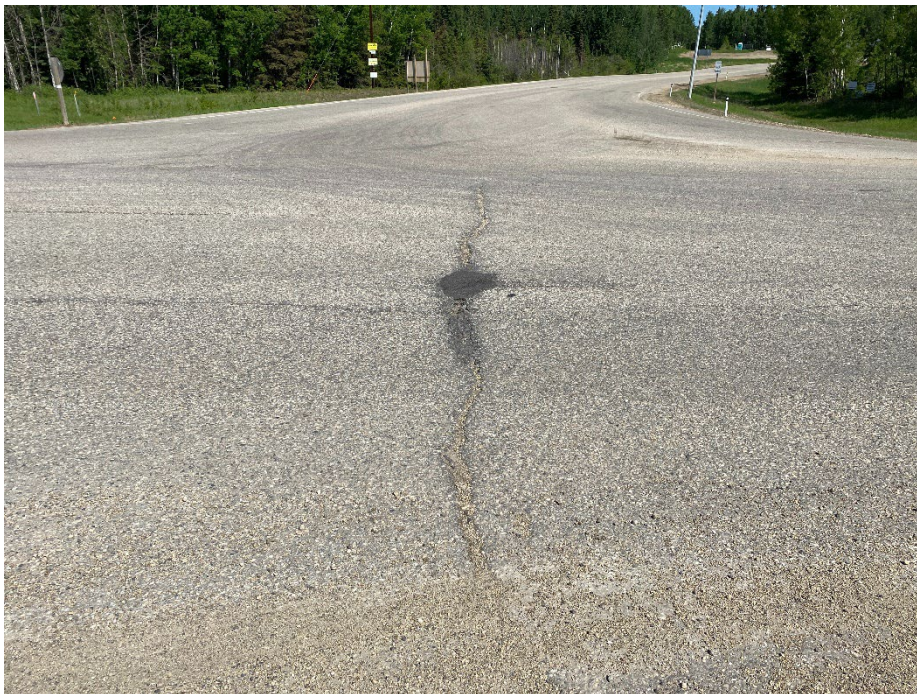
- Transverse pavement cracks up to 50 mm wide were observed east of the intersection (Photo 4). Longitudinal cracking of Highway 39 was observed and did not appear to have changed (Photo 5). The observed cracking does not appear to be related to landslide activity.

**Photo 4:** Crack on east side of intersection. Looking north.

- Pavement cracks should be sealed to reduce surface water infiltration into the slope.
- The ditch on the north side of Highway 39 should be regraded for water flow. Additional check dams or other structures should be installed to reduce surface water flow velocity.

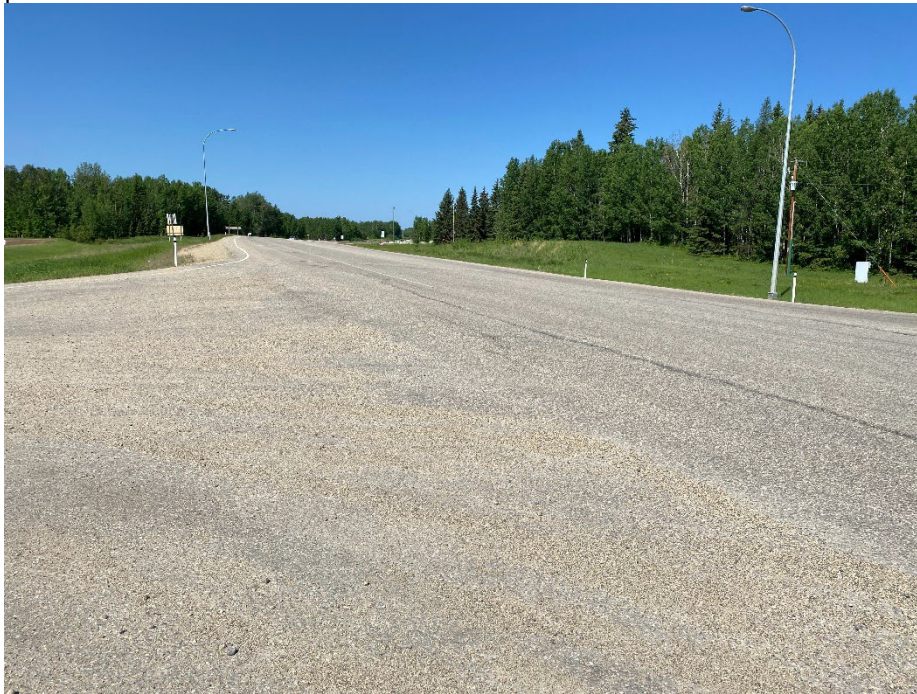
**Photo 5:** Pavement condition at intersection. Looking southwest.

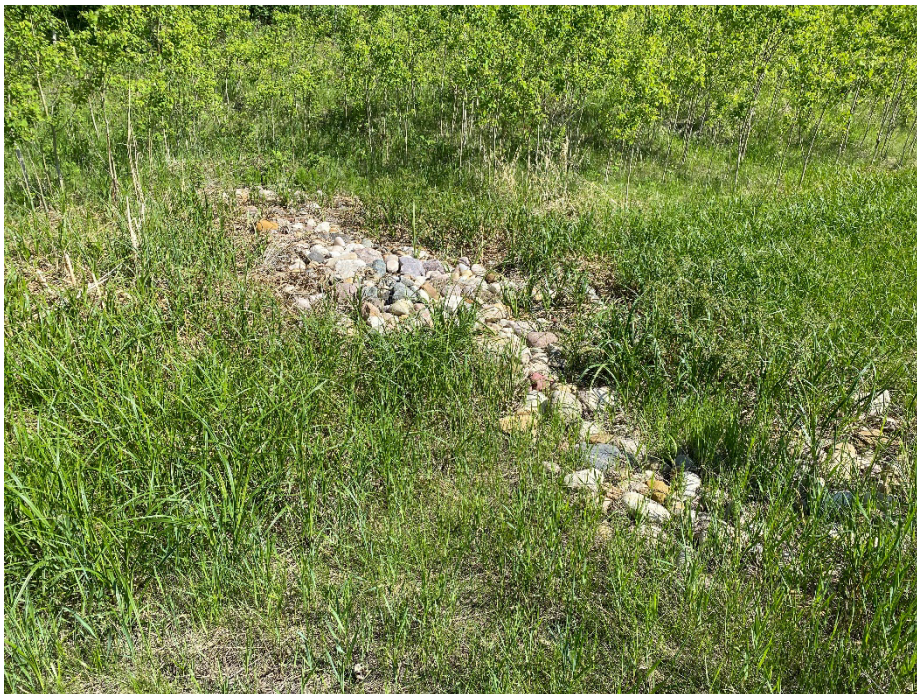
- The north ditch of Highway 39 was wet. Both check dams were observed to the east of the light standard, with the check dam furthest west having been obscured by vegetation (Photo 6).

**Photo 6:** West most rock check dam in north ditch partially obscured by vegetation. Looking northeast.
