SITE NUMBER AND NAME: NC086 – Poplar Creek Slide	HIGHWAY AND KM: 39:06, km 4.915	PREVIOUS INSPECTION: June 2, 2023	CURRENT INSPECTION: June 14, 2024
LEGAL DESCRIPTION: SW 11-49-06-W5	NAD83 COORDINATES: UTM11U 5897673N, 648158E		RISK ASSESSMENT: PF: 9 CF: 3 Total: 27
AVERAGE ANNUAL DAILY TRAFFIC (AADT): 3,530 (2023)		CONTRACTOR MAINTENANCE AREA (CMA): 509

TRANSPORTATION AND ECONOMIC CORRIDORS
GEOHAZARD MONITORING PROGRAM
NC86 HWY 39:06 POPLAR CREEK SLIDE
CROSS SECTION A & B

2024 Site Inspection Photos at NC086

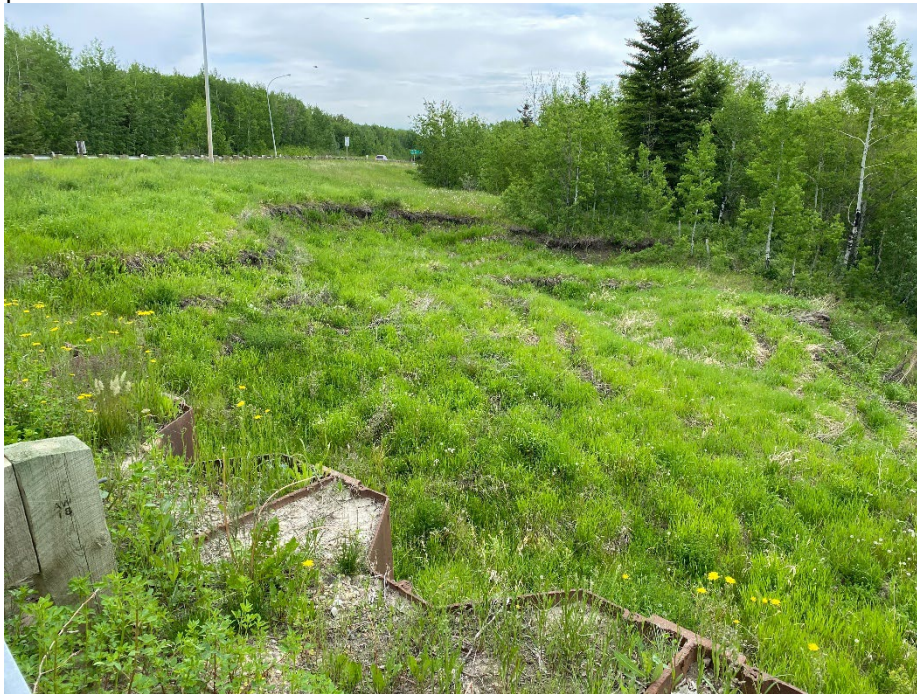
COMMENTS
<ul style="list-style-type: none"> The landslide downslope of the wall is progressing (Photos 1 to 3). A measurement from the top of pile wall to the top of ground was taken between the 9th and 10th guardrail post south of the stop sign. The height was measured to be 3.6 m, same as the previous inspection. The landslide mass appears to have extended east beyond the limits of the pile wall. The current east limit is approximately 5.6 m east from the light standard. This is approximately in line with the east limit of the pile wall. The scarp is approximately 8.7 m south of the guardrail, meaning that the slide has retrogressed 0.8 m since the 2023 inspection. The scarp has also increased in height, varying between about 2 and 3 m high. The southeast extent of the scarp has also extended into the tree line. The tension cracks above the current landslide scarp observed during the previous inspection were not seen, possibly due to vegetation. SI1 showed a negligible cumulative movement of less than 1 mm at a depth of about 14 m in the clay shale since initialization in 2018.

Photo 1: Slope movement downslope of pile wall. Looking northeast.

- The site should be regularly monitored by the MCI. In particular, the landslide should be monitored for additional progression towards the light standard which would indicate the slide is beyond the extent of the pile wall. In addition, the depth of the landslide from the top of the pile wall should be checked to ensure that it does not exceed the design cantilever height of 6 m.

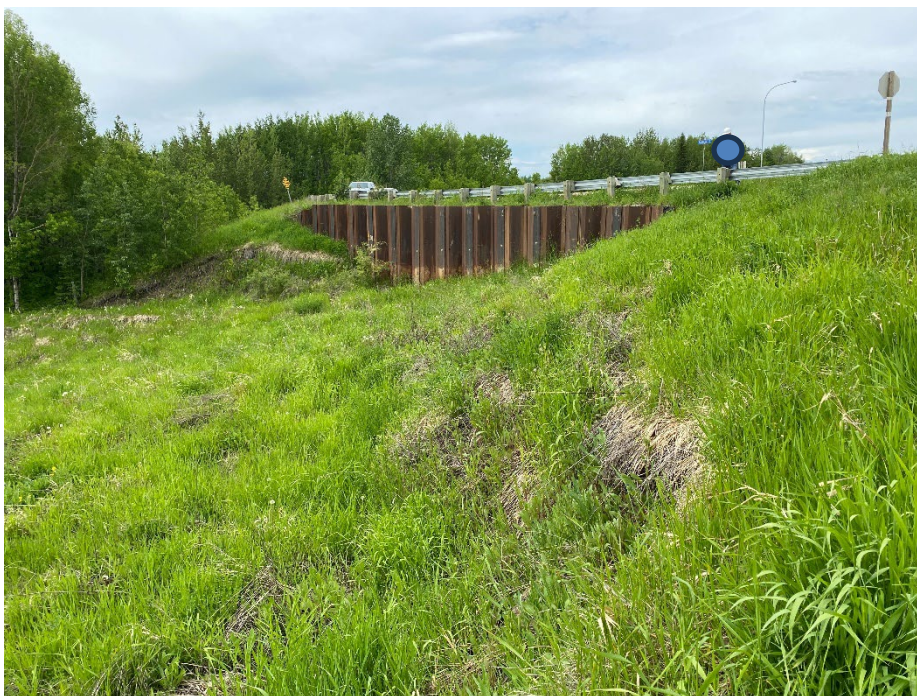
Photo 2: Slope movement downslope of pile wall. Looking southwest.

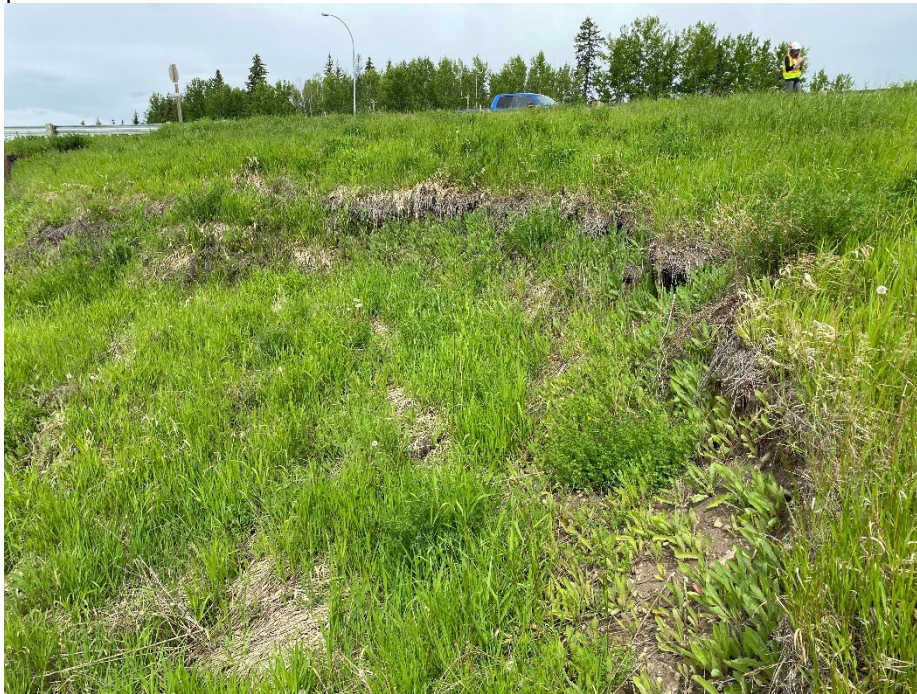
Photo 3: Vegetated scarp. Looking northeast.

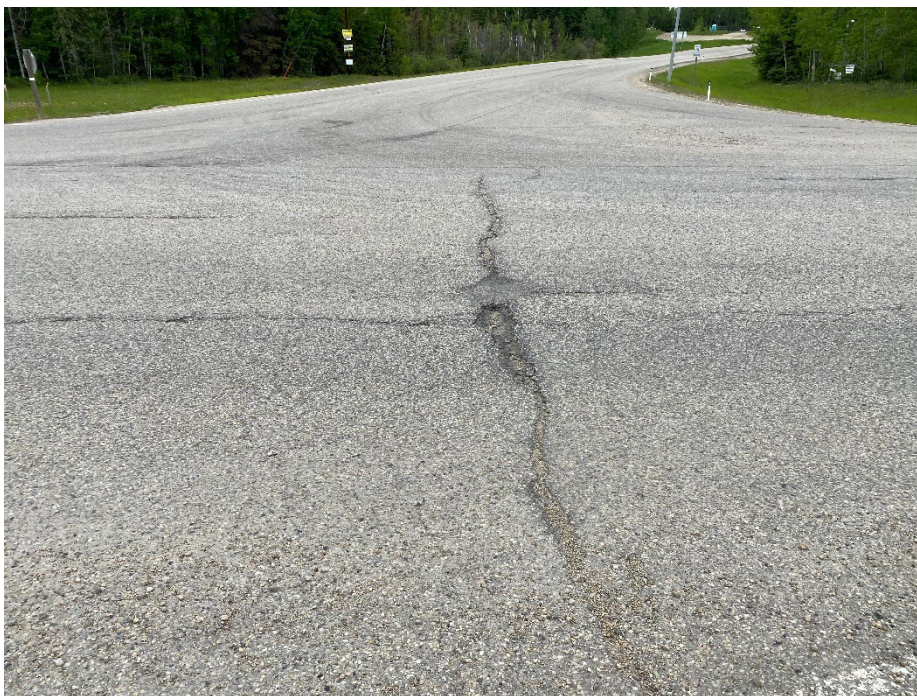
- Transverse pavement cracks up to 60 mm wide were observed east of the intersection (Photo 4). A pothole around 0.1 m diameter and 50 mm deep was observed within one of the cracks. Longitudinal cracking of Highway 39 was observed and appeared to have widened, with cracks up to 10 mm wide (Photo 5). The observed cracking does not appear to be related to landslide activity.

Photo 4: Crack on east side of intersection. Looking north.

- Pavement cracks should be sealed to reduce surface water infiltration into the slope.
- The ditch on the north side of Highway 39 should be regraded for water flow. Additional check dams or other structures should be installed to reduce surface water flow velocity.

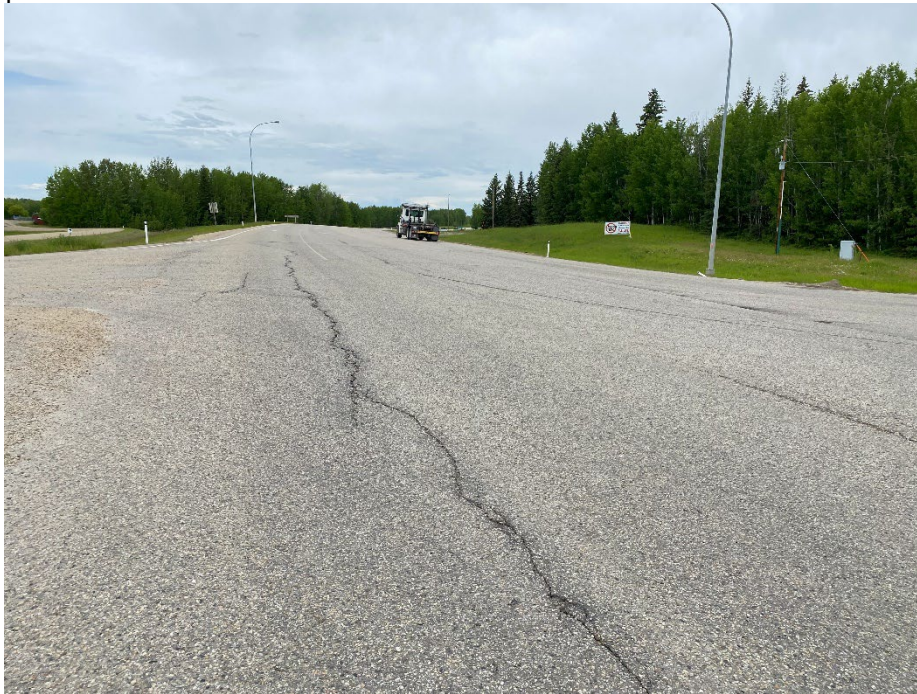
Photo 5: Pavement condition at intersection. Looking west.

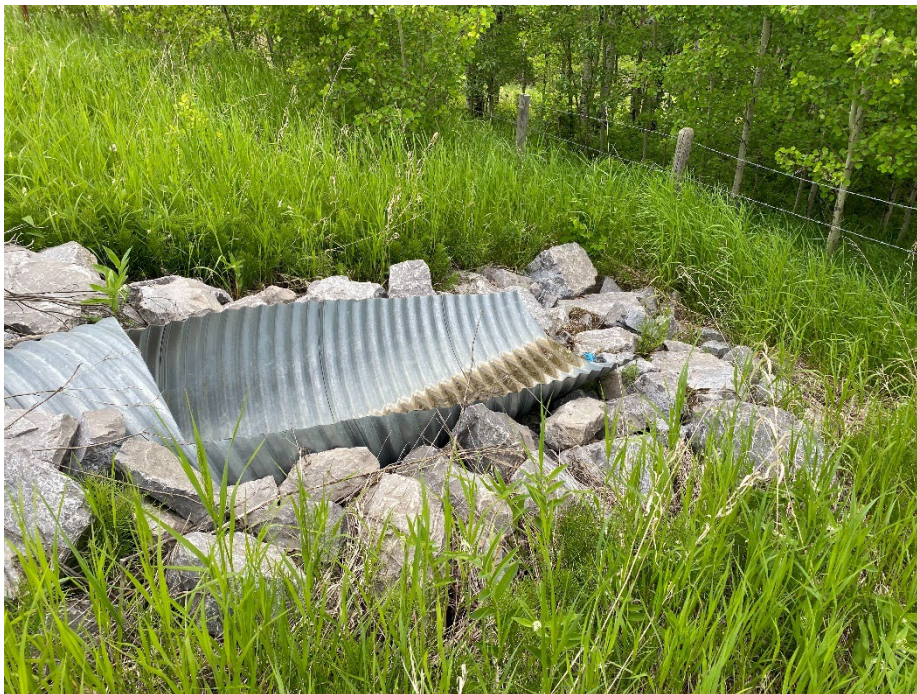
- The culvert and ditch across TWP RD 491A were dry. The riprap at both ends of the culvert was cracked (Photo 6).
- The separation between the new and old pavement could not be observed as the area was covered in dirt and gravel.

Photo 6: Culvert outlet south of the pile wall. Looking northeast.
