SITE NUMBER AND NAME: NC067 – Anthony Henday Bridge	HIGHWAY AND KM: 216:06, km 10.528	PREVIOUS INSPECTION: May 21, 2020	CURRENT INSPECTION: June 28, 2021
LEGAL DESCRIPTION: SE 4-52-25-W4	NAD83 COORDINATES: UTM12U 5926734N 326219E		RISK ASSESSMENT: PF: 4 CF: 10 Total: 40
AVERAGE ANNUAL DAILY TRAFFIC (AADT): 70,690 (2020)		CONTRACTOR MAINTENANCE AREA (CMA): AHD

2021 Site Inspection Photos at NC067

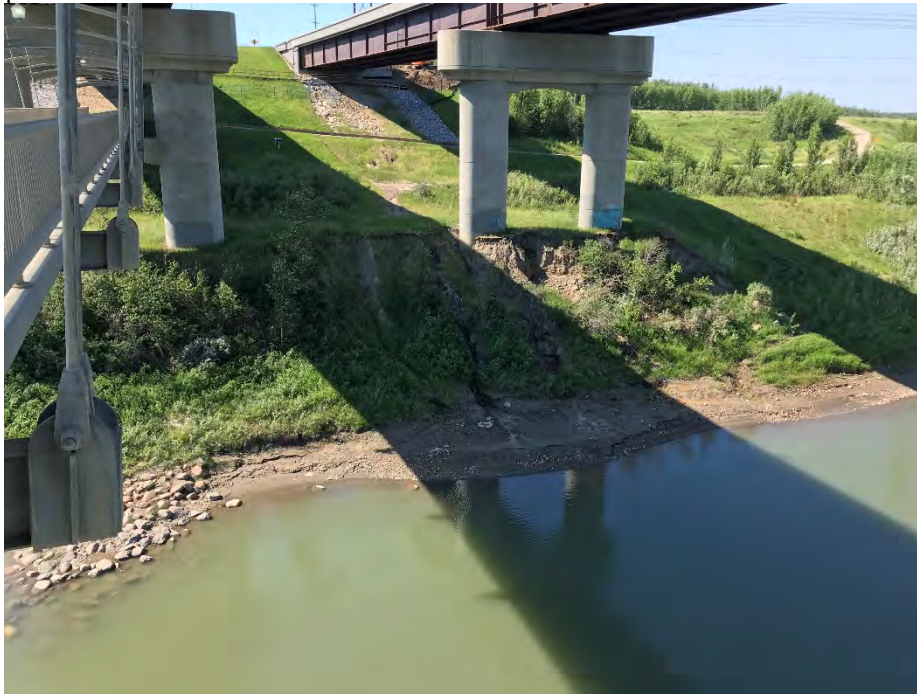
COMMENTS
<ul style="list-style-type: none"> Aside from ongoing erosion at the north abutment piers, the site appeared mostly unchanged. Significant erosion/slumping was observed at the land piers of the north bank. Ongoing erosion/slumping may be due to river scour. The extent of erosion appears to have increased resulting in additional loss of soil support around the piers. In discussion with AT, the bridge group is not concerned with loss of soil support at its current elevation since some loss of lateral soil support was assumed in the original design. SI2 and SI7 continue to show movement in the fill. SI2 is installed in the pile wall and shows an average rate of movement of about 3 mm/yr since 2014. SI7 shows a similar rate of movement for the middle movement zone (~7 m depth) since 2009 and a slightly higher rate of movement for the upper zone (4 mm/yr at about 3

Photo 1: Erosion of land piers at the north bank. Looking north.

- Stantec submitted two tender packages for site remediation
 - North abutment slope: remediation includes flattening the slope to 2.5H:1V and armoring the slope with riprap. Additional surface drainage improvements will also be constructed. The estimated cost for construction is approximately \$1,200,000, excluding engineering costs. Construction is scheduled for 2024.

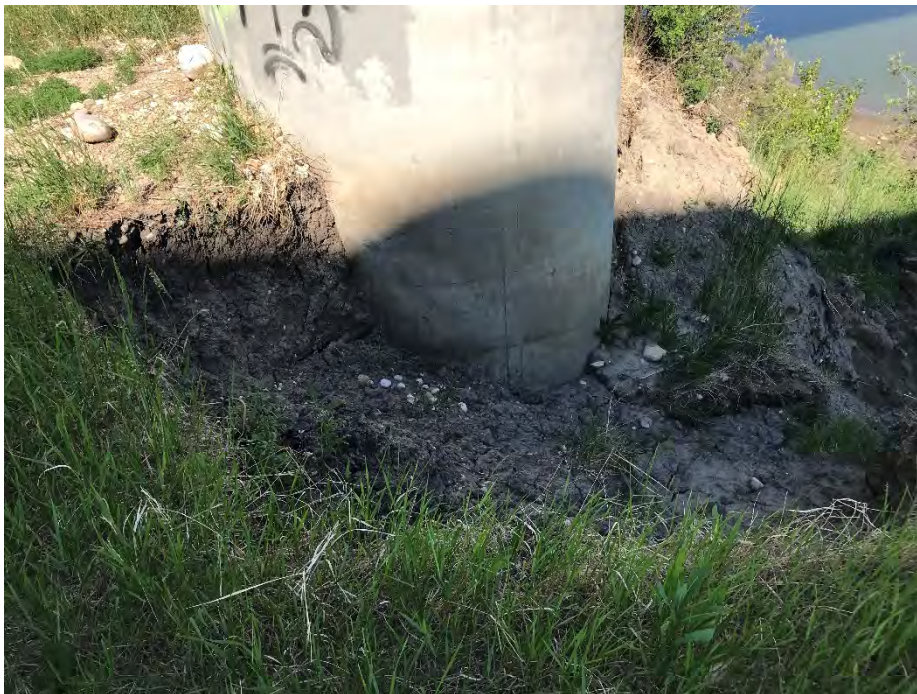
Photo 2: Loss of soil support at pier. Looking northeast.

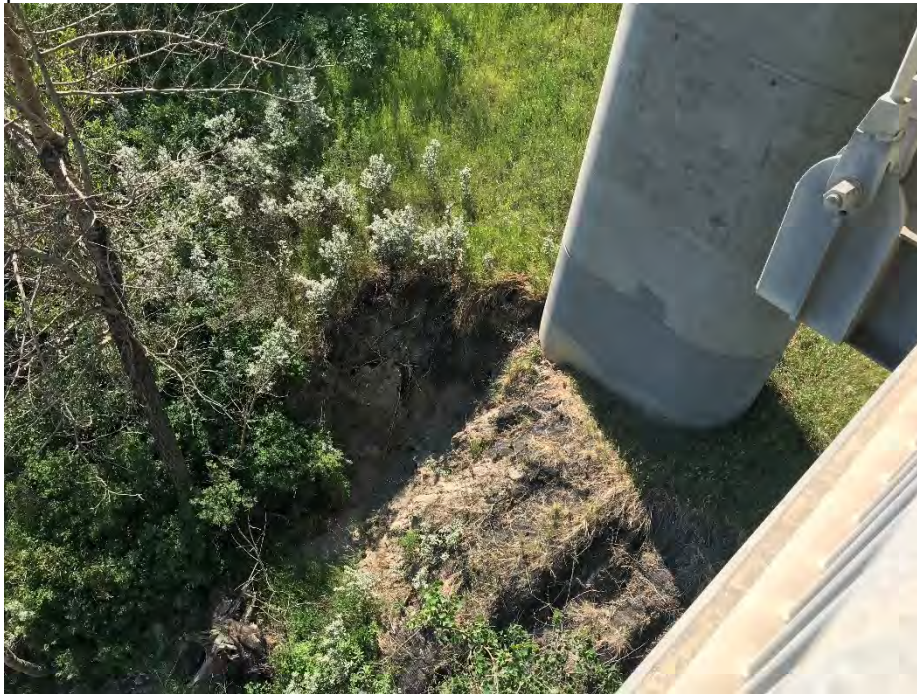
Photo 3: Erosion at outermost pier of southbound lane. Looking northwest.

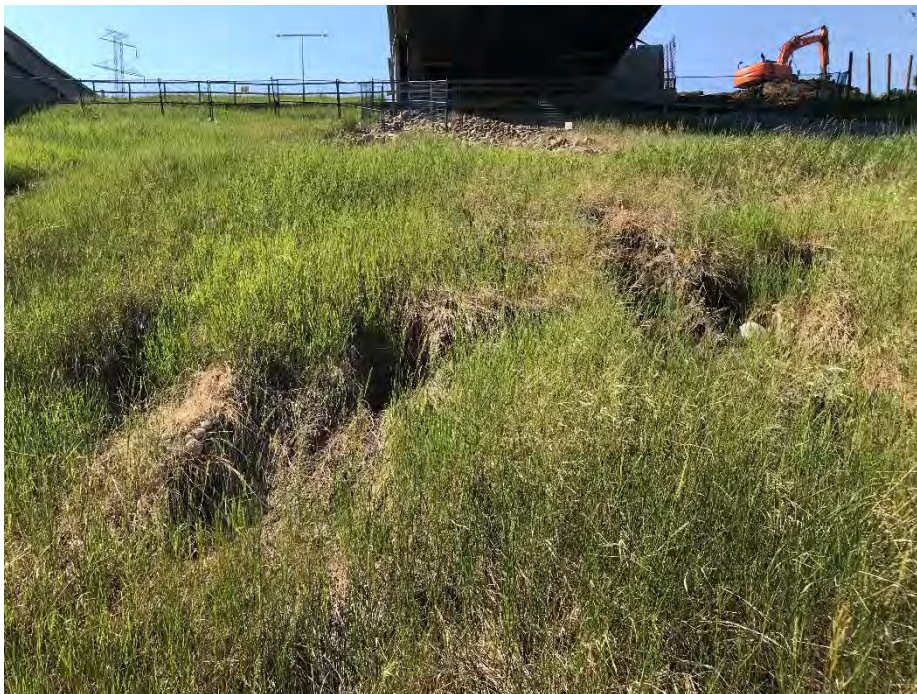
- Four erosion gullies were observed under the NBL downslope from the pedestrian trail at the north abutment. The gullies were up to 1 m deep and 0.9 m wide. Minor loss of trail observed upslope from the gullies.
- The erosion/slumping adjacent to the outfall at the south abutment appeared relatively unchanged. The scarp height decreased from 2 m to 1.2 m suggesting additional loss of ground upslope. Vegetation growth in this slump obscured site observations.
- The separation of the concrete pipe and the separation at the beveled end appeared similar to 2020. Slight water ponding was observed under the separated pipe.
- A perforated PVC pipe was exposed at the south end of the tapered wall at the south abutment. The pipe appeared damaged and filled with soil.

Photo 4: Four scour holes downslope of pedestrian trail under NBL. Looking northwest.

- Pavement cracks along the pedestrian trail should be sealed to reduce surface water infiltration into the slope.
- The erosion gullies should be regraded and reseeded to improve erosion protection and reduce the risk of additional loss of trail.

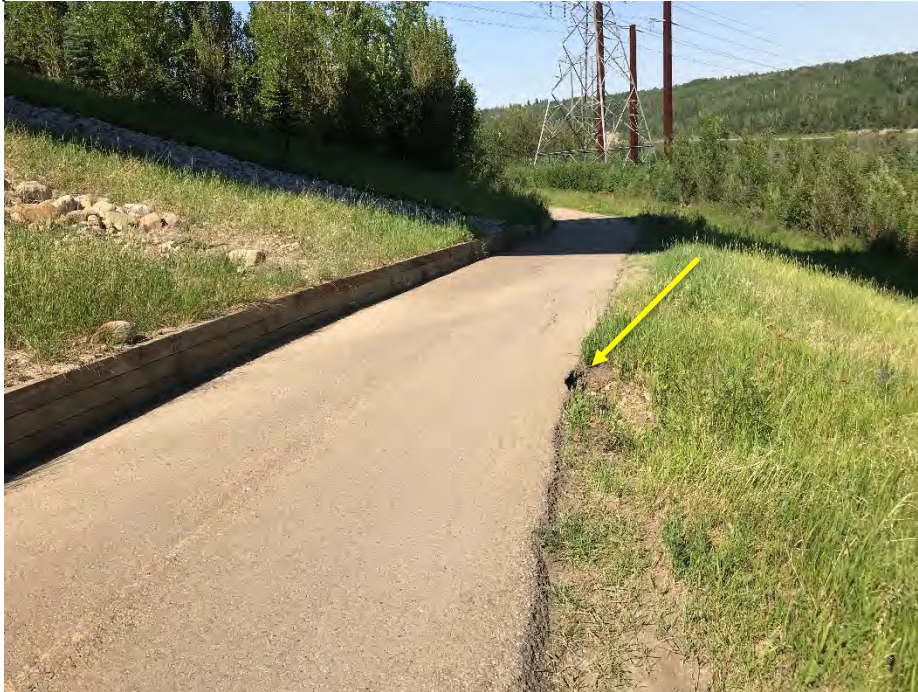
Photo 5: No change to trail crack pattern. Minor loss of trail. Looking northeast.

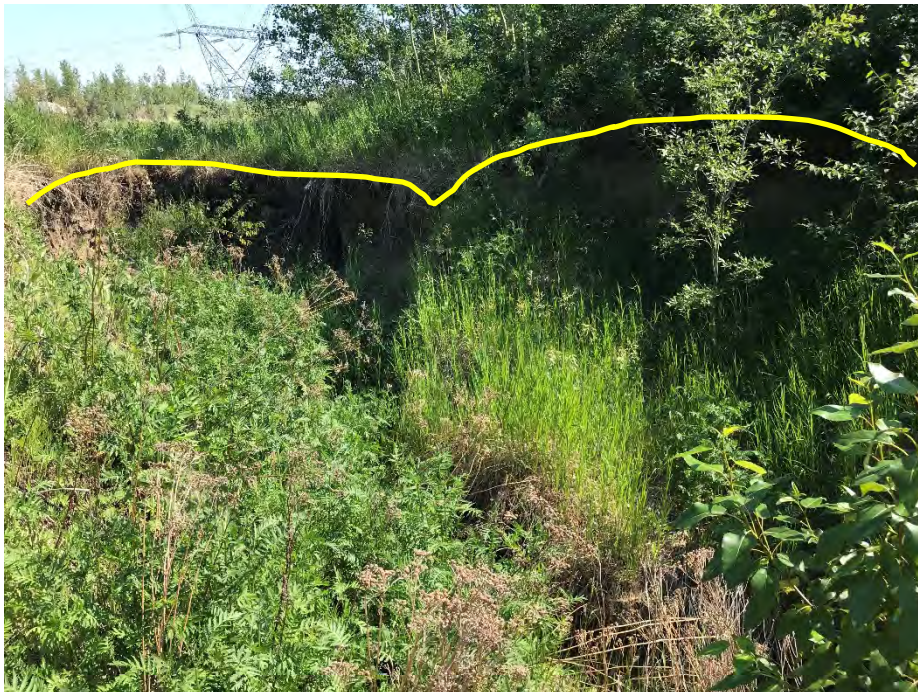
Photo 6: Two bowl shaped slumps adjacent and behind the outfall on the south bank of the river. Looking southeast.

- Outfall remediation as part of NC79 work: Replace separated sections of pipe with 750 mm reinforced concrete pipe. Reline storm sewer with cured-in-place pipe installed at 5% slope. The estimated cost for construction is approximately \$800,000, excluding engineering costs. Construction is scheduled for 2024.

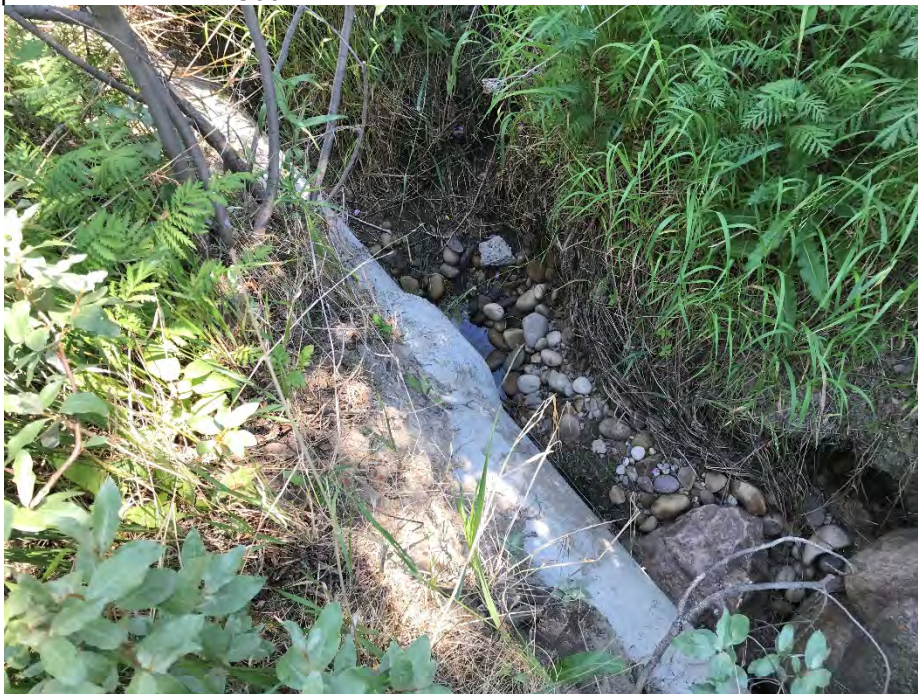
Photo 7: Water ponding below the separated pipe at the outfall. Looking down.

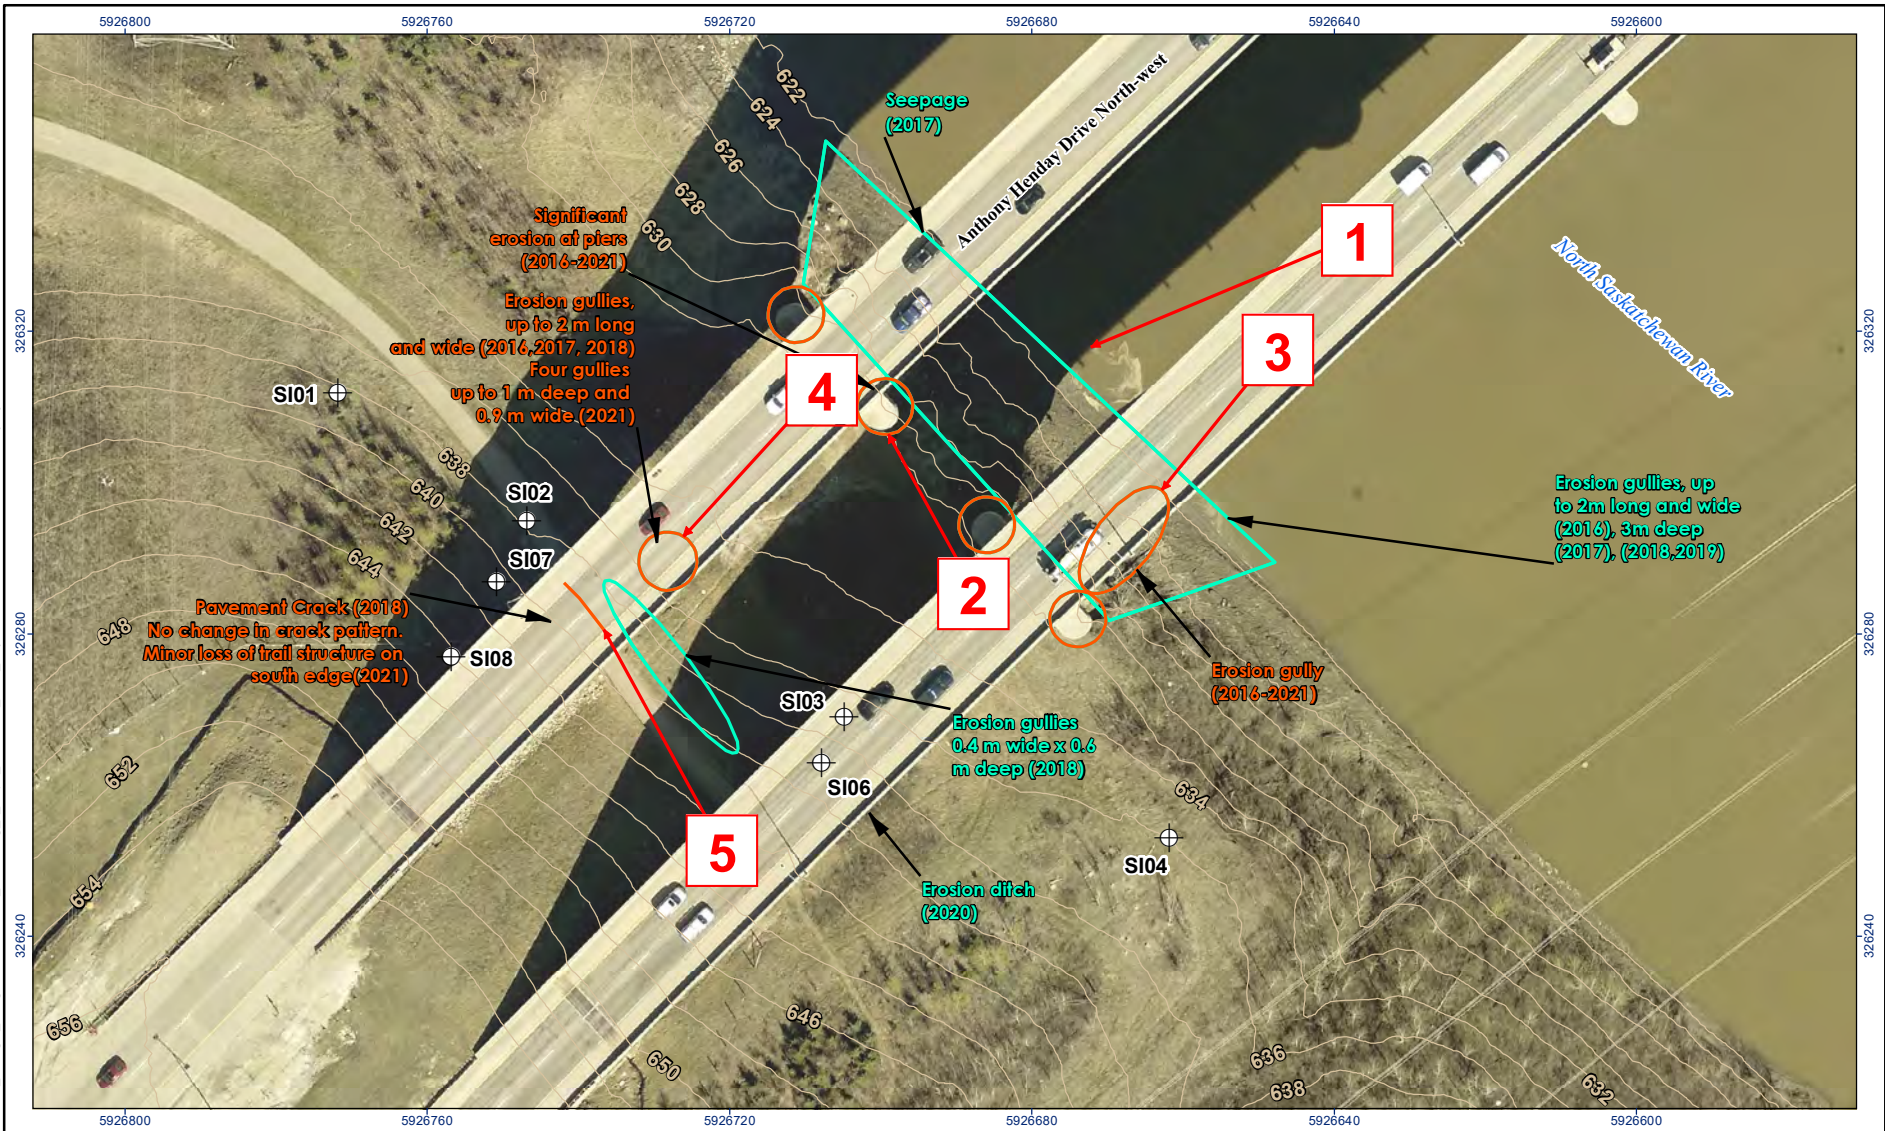
Figure No.: **2**
 Title: **Slope Inclinometer Locations**

m depth). SI7 is installed upslope of SI2. The other SIs installed in the pile wall (SI1 and SI3) suggests the observed movement is related to the deformation of the pile wall. It is surmised that the observed movement in SI2 and SI7 are also related to pile wall deformation and not a slope failure. Approximate SI locations are shown on Figure 2.
