<b>SITE NUMBER AND NAME:</b> NC067 – Anthony Henday Bridge	<b>HIGHWAY AND KM:</b> 216:06, km 10.528	<b>PREVIOUS INSPECTION:</b> June 28, 2021	<b>CURRENT INSPECTION:</b> June 15, 2022
<b>LEGAL DESCRIPTION:</b> SE 4-52-25-W4	<b>NAD83 COORDINATES:</b> UTM12U 5926734N 326219E		<b>RISK ASSESSMENT:</b> PF: 5 CF: 10 Total: 50
<b>AVERAGE ANNUAL DAILY TRAFFIC (AADT):</b> 69,010 (2021)		<b>CONTRACTOR MAINTENANCE AREA (CMA):</b> AHD

2022 Site Inspection Photos at NC067

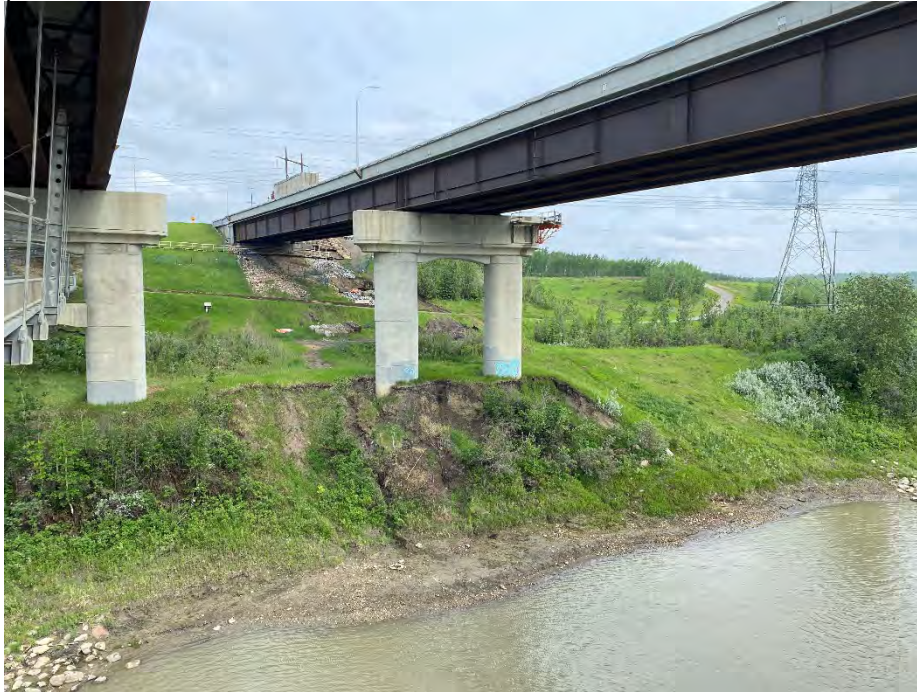
<b>COMMENTS</b>
<ul style="list-style-type: none"> <li>Aside from ongoing erosion and slumping at the north abutment piers, the site appeared mostly unchanged.</li> <li>Significant erosion/slumping was observed at the land piers of the north bank. Ongoing erosion/slumping may be due to river scour. The extent of erosion appears to have increased resulting in additional loss of soil support around the piers. In discussion with AT, the bridge group was not concerned with loss of soil support at its current elevation since some loss of lateral soil support was assumed in the original design.</li> <li>SI2 and SI7 continue to show movement in the fill. SI2 is installed in the pile wall and shows an average rate of movement of about 3 mm/yr since 2014. SI7 shows a similar rate of movement for the middle movement zone (~7 m depth) since 2009 and a slightly higher rate of movement for the upper zone (4 mm/yr at about 3</li> </ul>

**Photo 1:** Erosion of land piers at the north bank. Looking north.

- Stantec submitted two tender packages for site remediation
  - North abutment slope: remediation includes flattening the slope to 2.5H:1V and armoring the slope with riprap. Additional surface drainage improvements will also be constructed. The estimated cost for construction is approximately \$1,500,000, excluding engineering costs. Construction is scheduled for 2024.

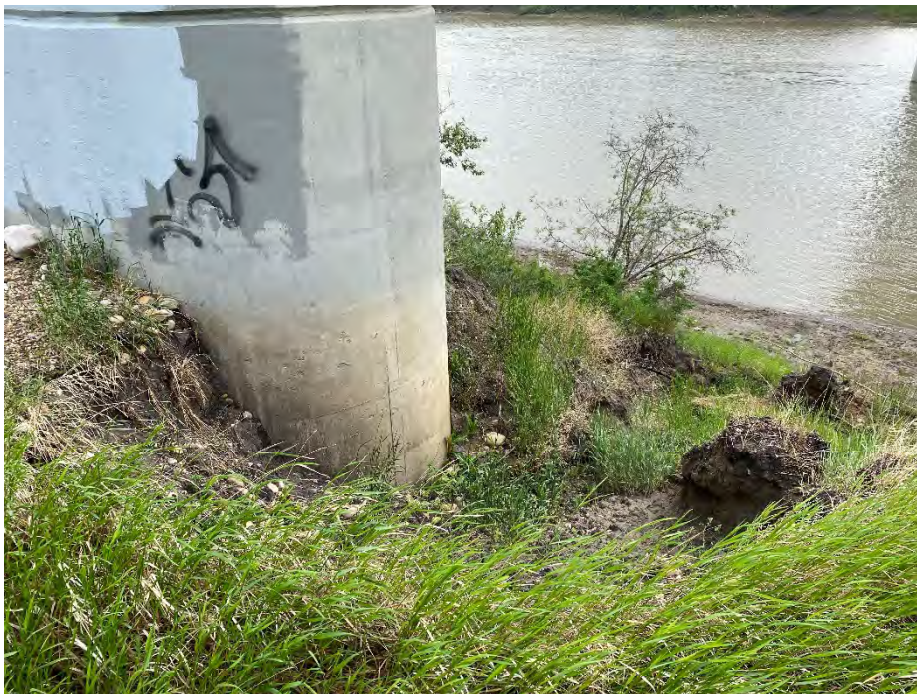
**Photo 2:** Loss of soil support at pier. Looking northeast.

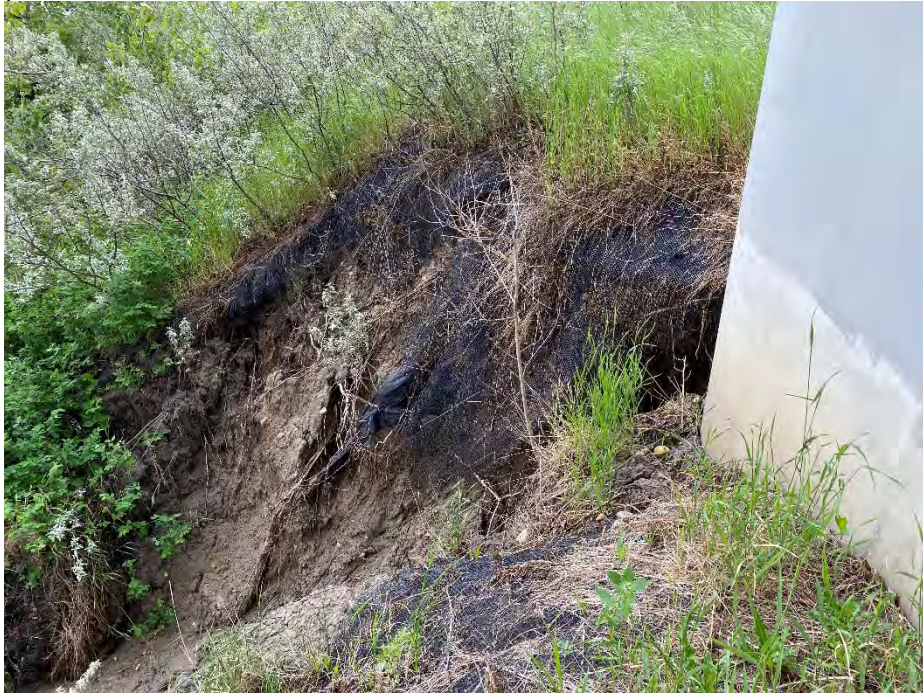
**Photo 3:** Erosion at outermost pier of southbound lane. Looking southwest.

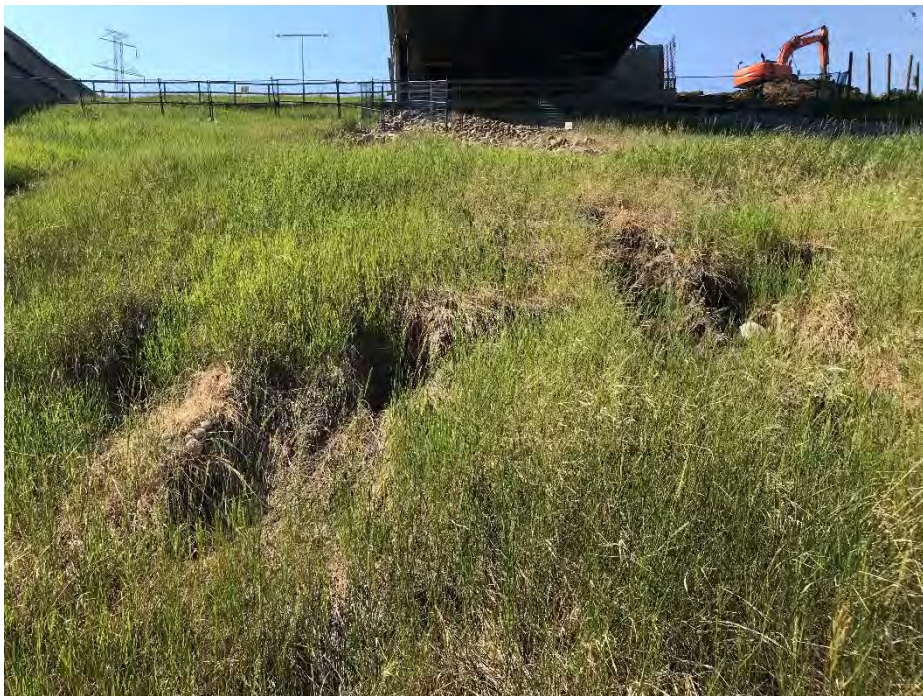
- Four erosion gullies were observed under the NBL downslope from the pedestrian trail at the north abutment. The gullies were up to 1 m deep and 0.9 m wide. Minor loss of trail observed upslope from the gullies.

**Photo 4:** Four scour holes downslope of pedestrian trail under NBL. Looking northwest.

- Pavement cracks along the pedestrian trail should be sealed to reduce surface water infiltration into the slope.
- The erosion gullies should be regraded and reseeded to improve erosion protection and reduce the risk of additional loss of trail.

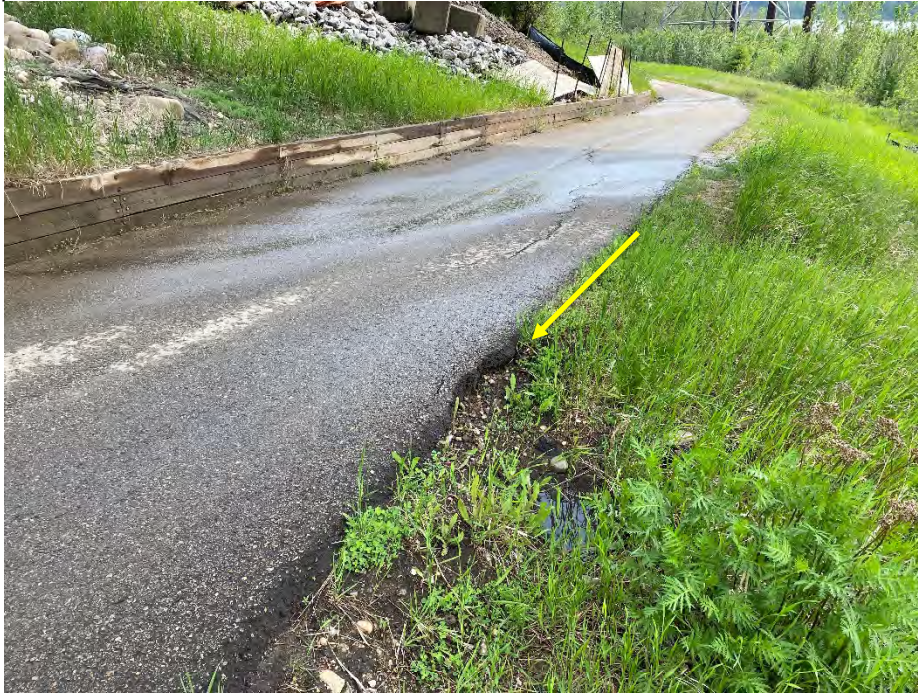
**Photo 5:** No change to trail crack pattern. Minor loss of trail. Looking northeast.

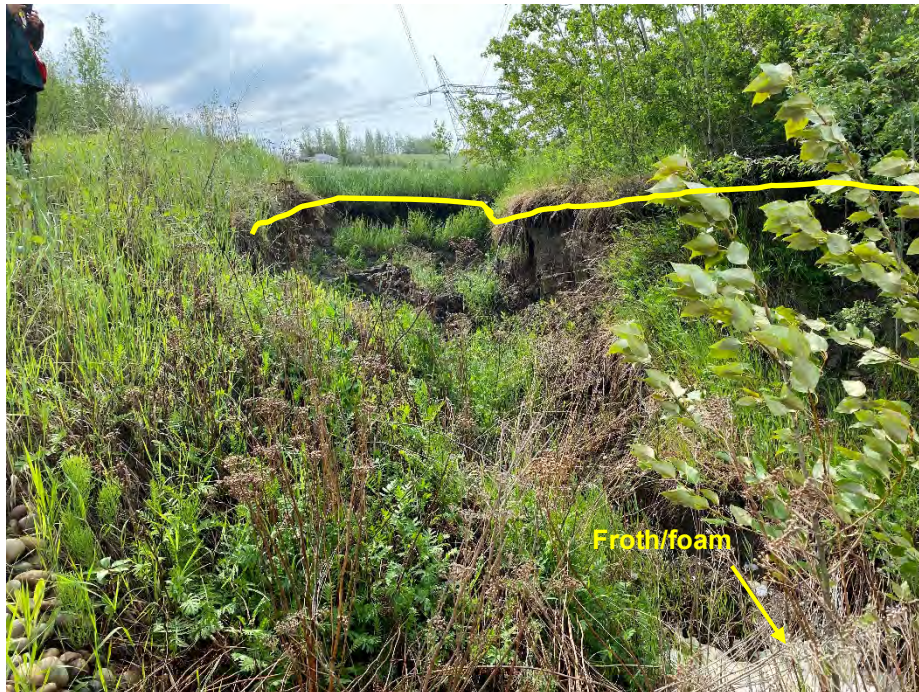
- The erosion/slumping adjacent to the outfall at the south abutment appeared to have progressed. The scarp is now 6 m wide and 6 m from the catch basin.

**Photo 6:** Two bowl shaped slumps adjacent and behind the outfall on the south bank of the river. Looking southeast.

- Outfall remediation as part of NC79 work: Replace separated sections of pipe with 750 mm reinforced concrete pipe. Reline storm sewer with cured-in-place pipe installed at 5% slope. The estimated cost for construction is approximately \$900,000, excluding engineering costs. Construction is scheduled for 2024.
