To:	Amy Driessen Alberta Transportation	From:	Leslie Cho and Carrie Murray Stantec Consulting Ltd.
File:	123315222	Date:	June 12, 2022

Reference: North Central Region, Stony Plain, Site NC067 - Highway 216:06 Anthony Henday Bridge, Spring 2022 Instrumentation Monitoring Report

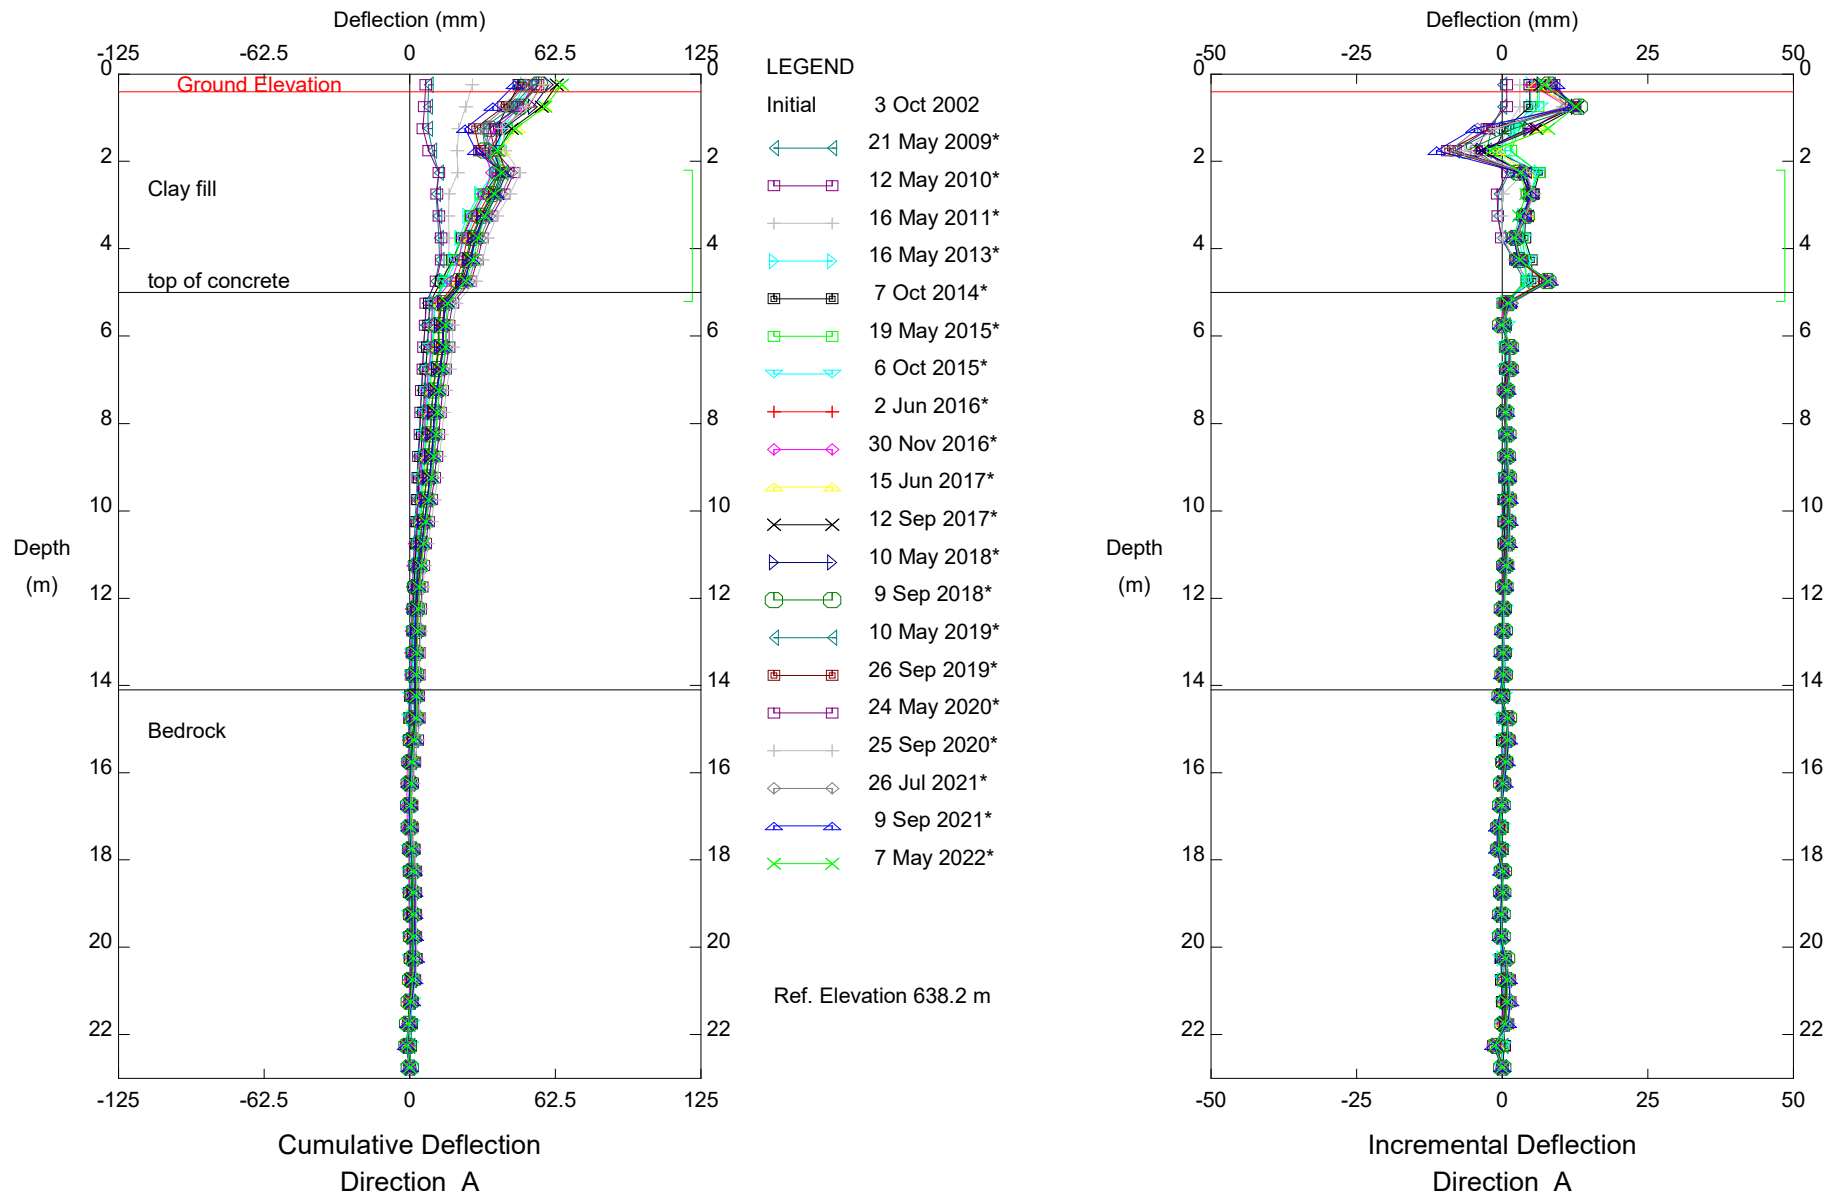
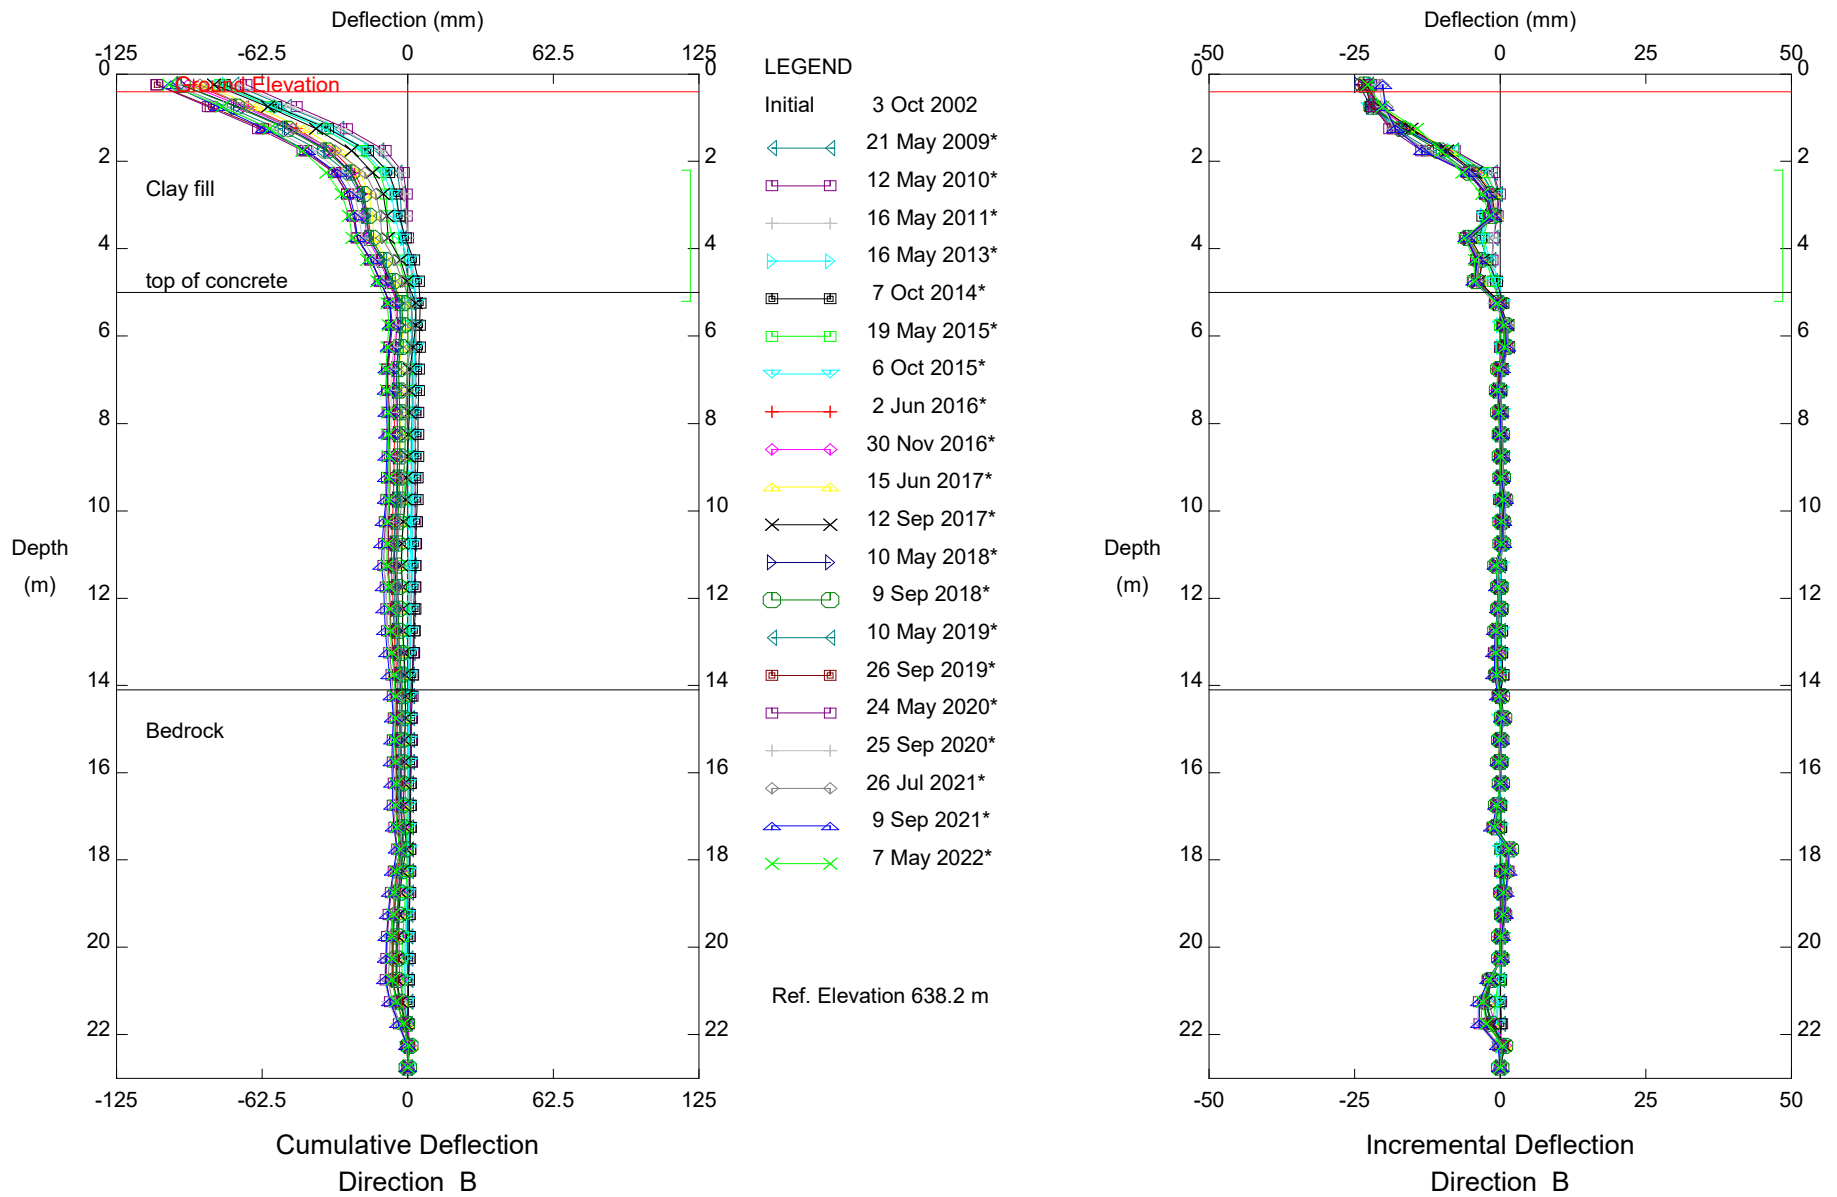
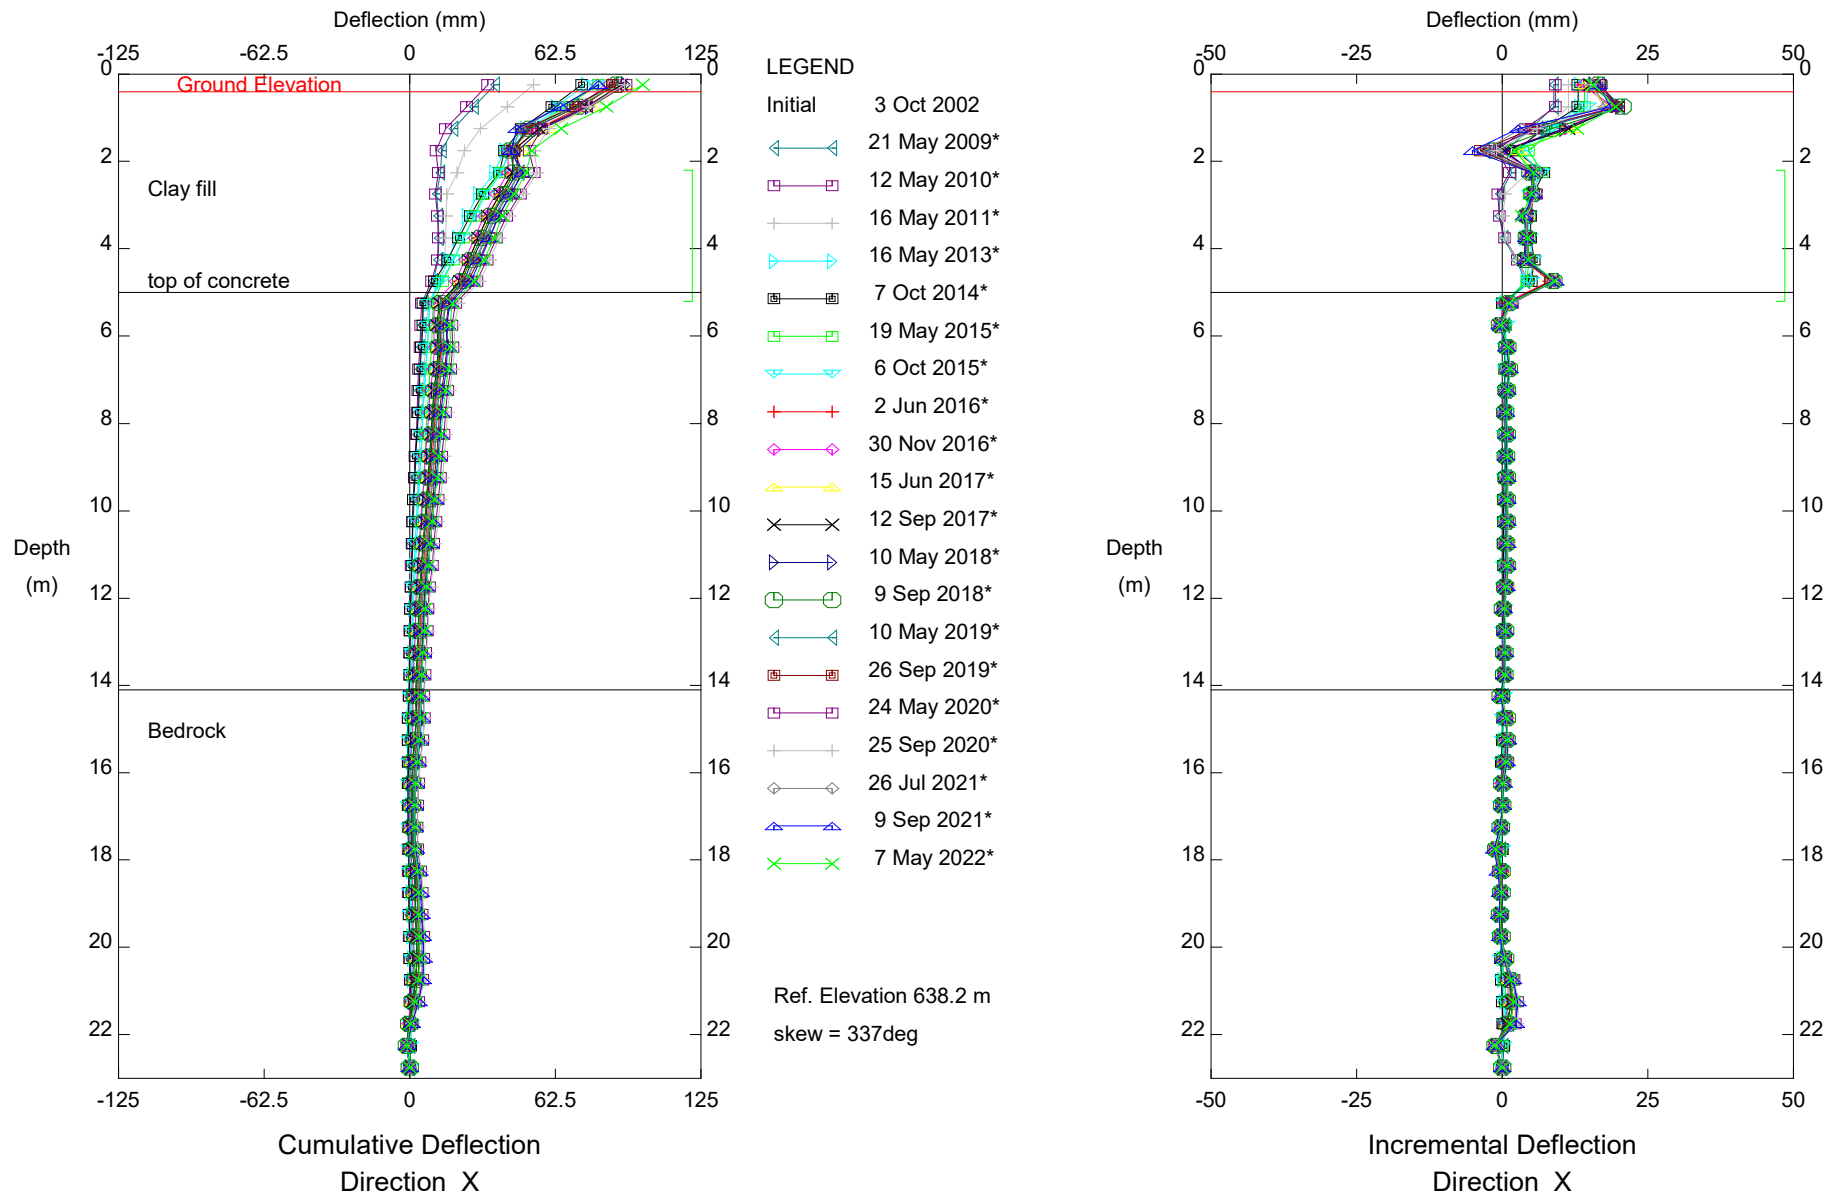
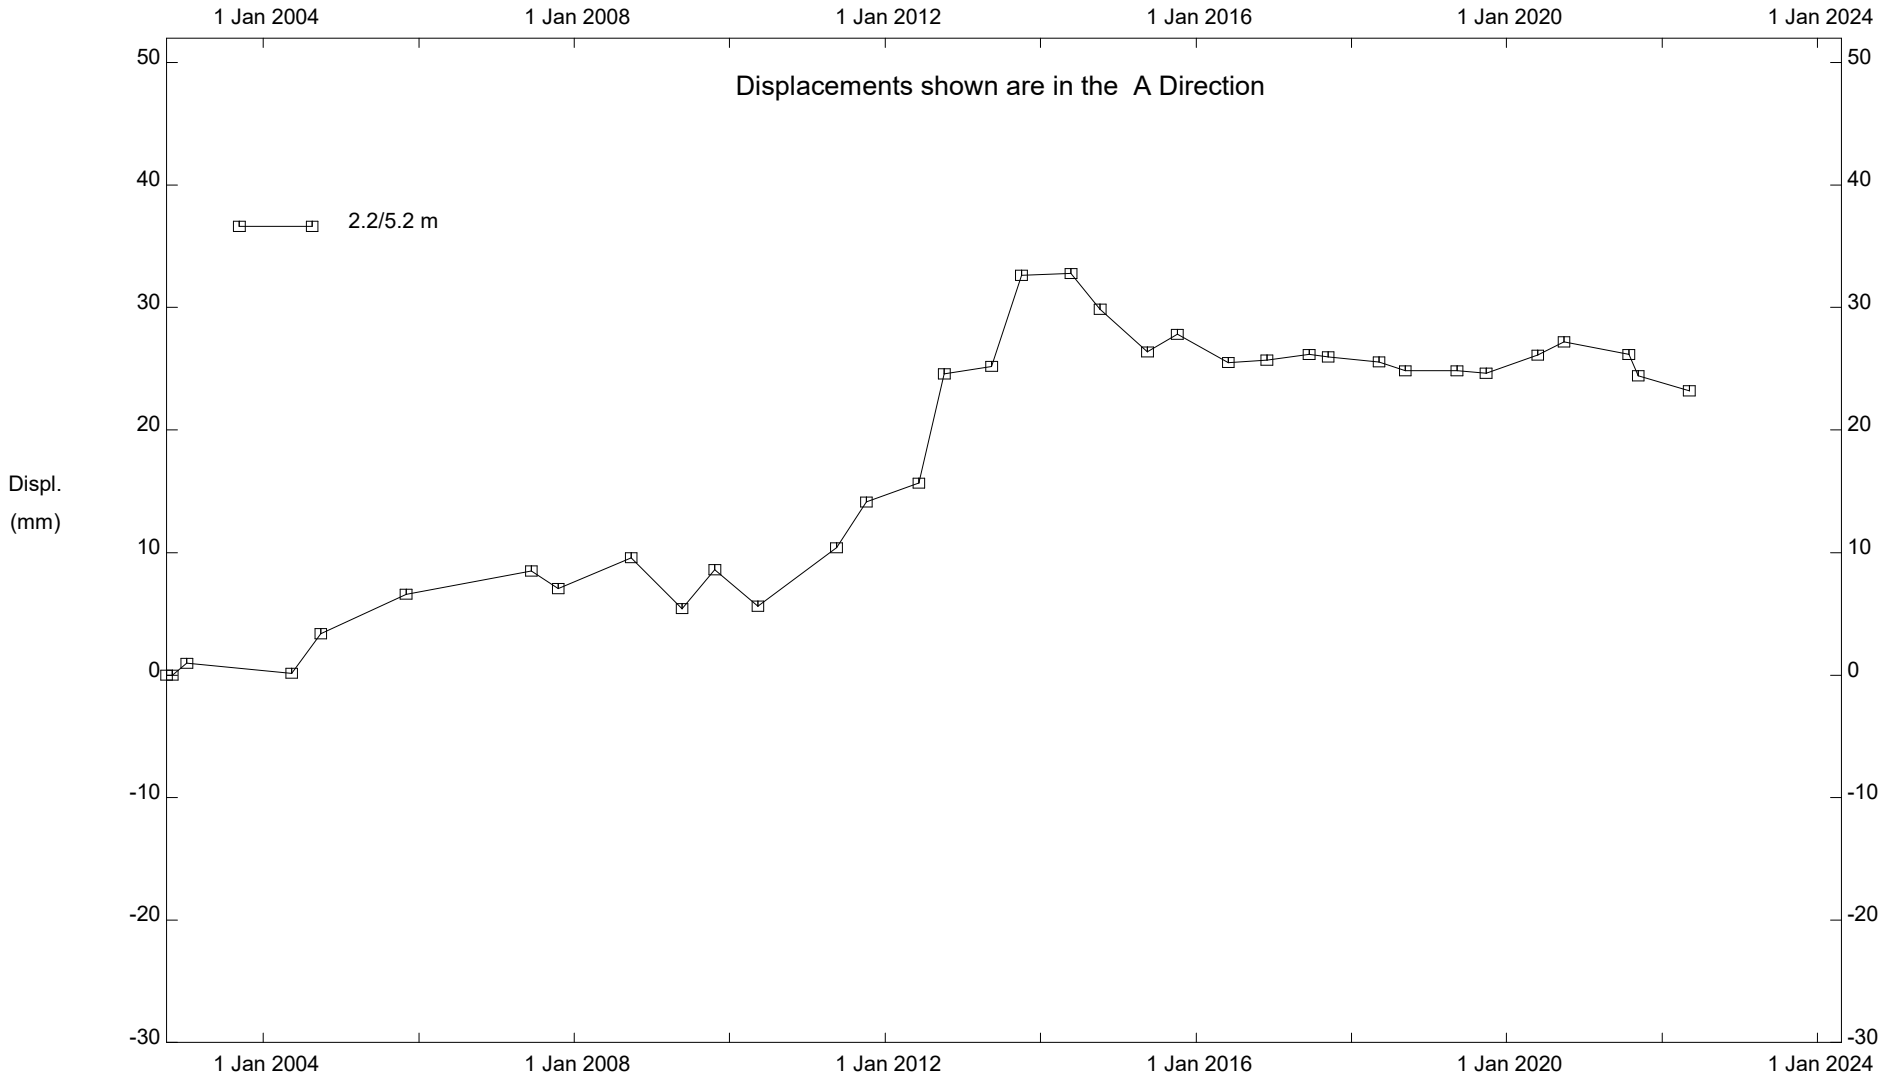
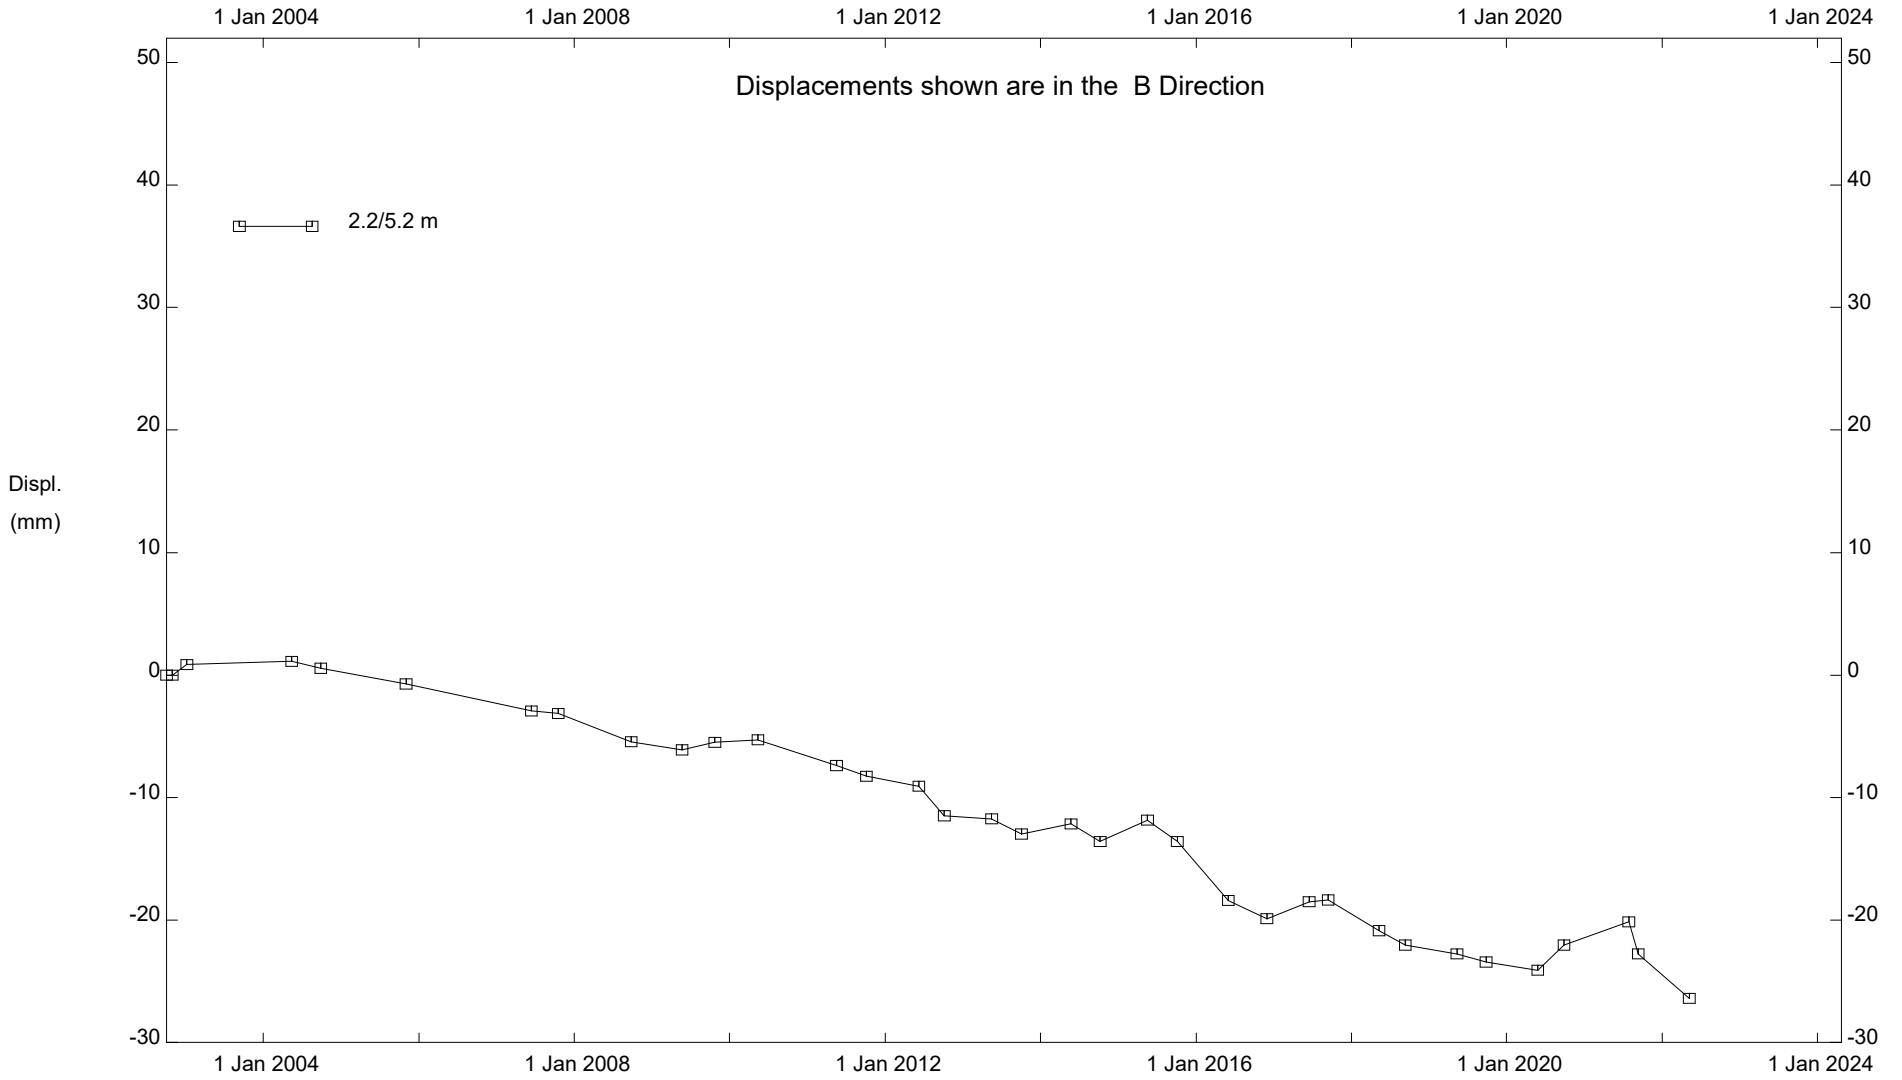
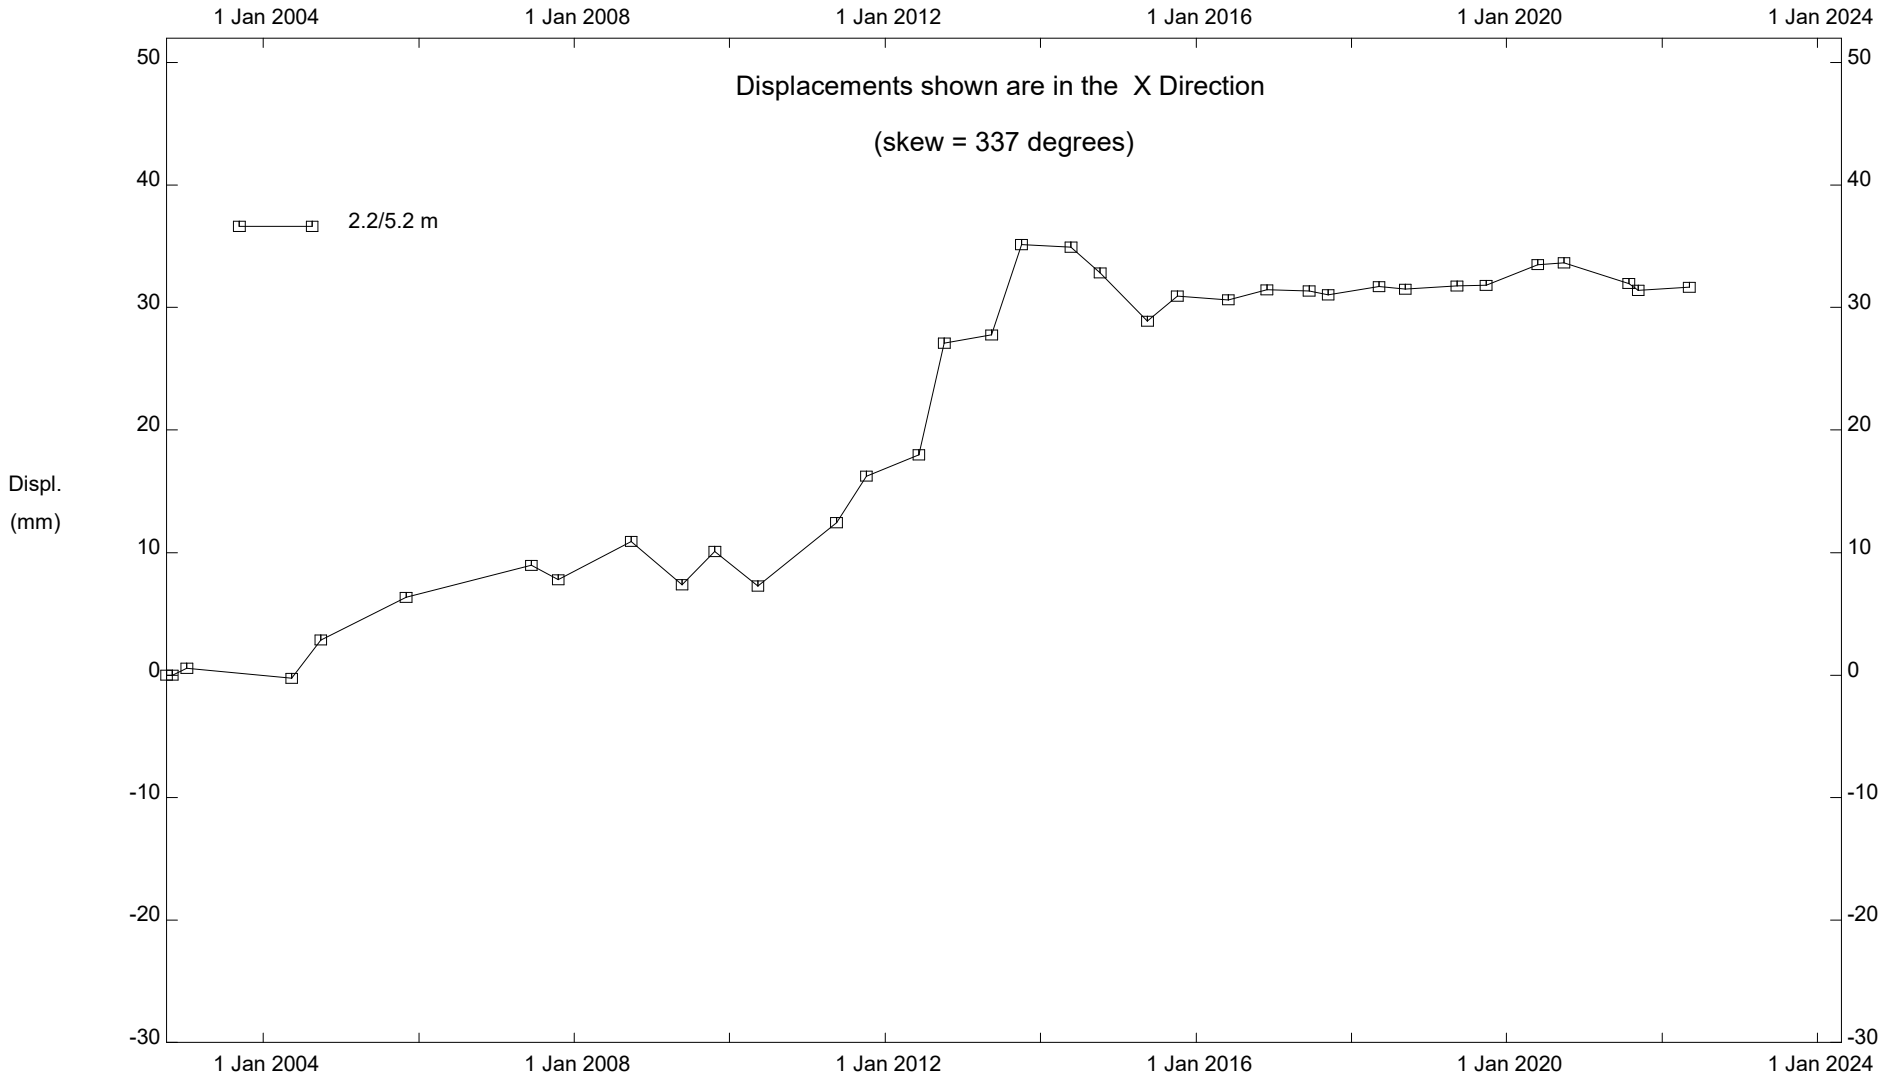
NC067, Inclinometer SI-01

- **SI-01** continues to show a negligible amount of incremental movement since about 2015. The total cumulative movement is about 32 mm.
- **SI-02** shows a current rate of movement of 4 mm/yr within the clay fill. The total cumulative movement is about 63 mm. An average movement rate of about 7 mm/yr was observed from Fall 2009 to Fall 2013 which decreased to an average rate of about 2 mm/yr to 3 mm/yr from 2014 on.
- **SI-03** is being monitored near surface and showed decreasing cumulative movement between 2018 and 2021. The cumulative movement increased to 106 mm during the Spring 2022 readings with the current rate of movement at 42 mm/yr.
- **SI-04** shows a rate of movement less than 1 mm/yr since 2015
