To:	Amy Driessen Alberta Transportation	From:	Leslie Cho and Carrie Murray Stantec Consulting Ltd.
File:	123315222	Date:	June 12, 2022

Reference: North Central Region, Stony Plain, Site NC067 - Highway 216:06 Anthony Henday Bridge, Spring 2022 Instrumentation Monitoring Report

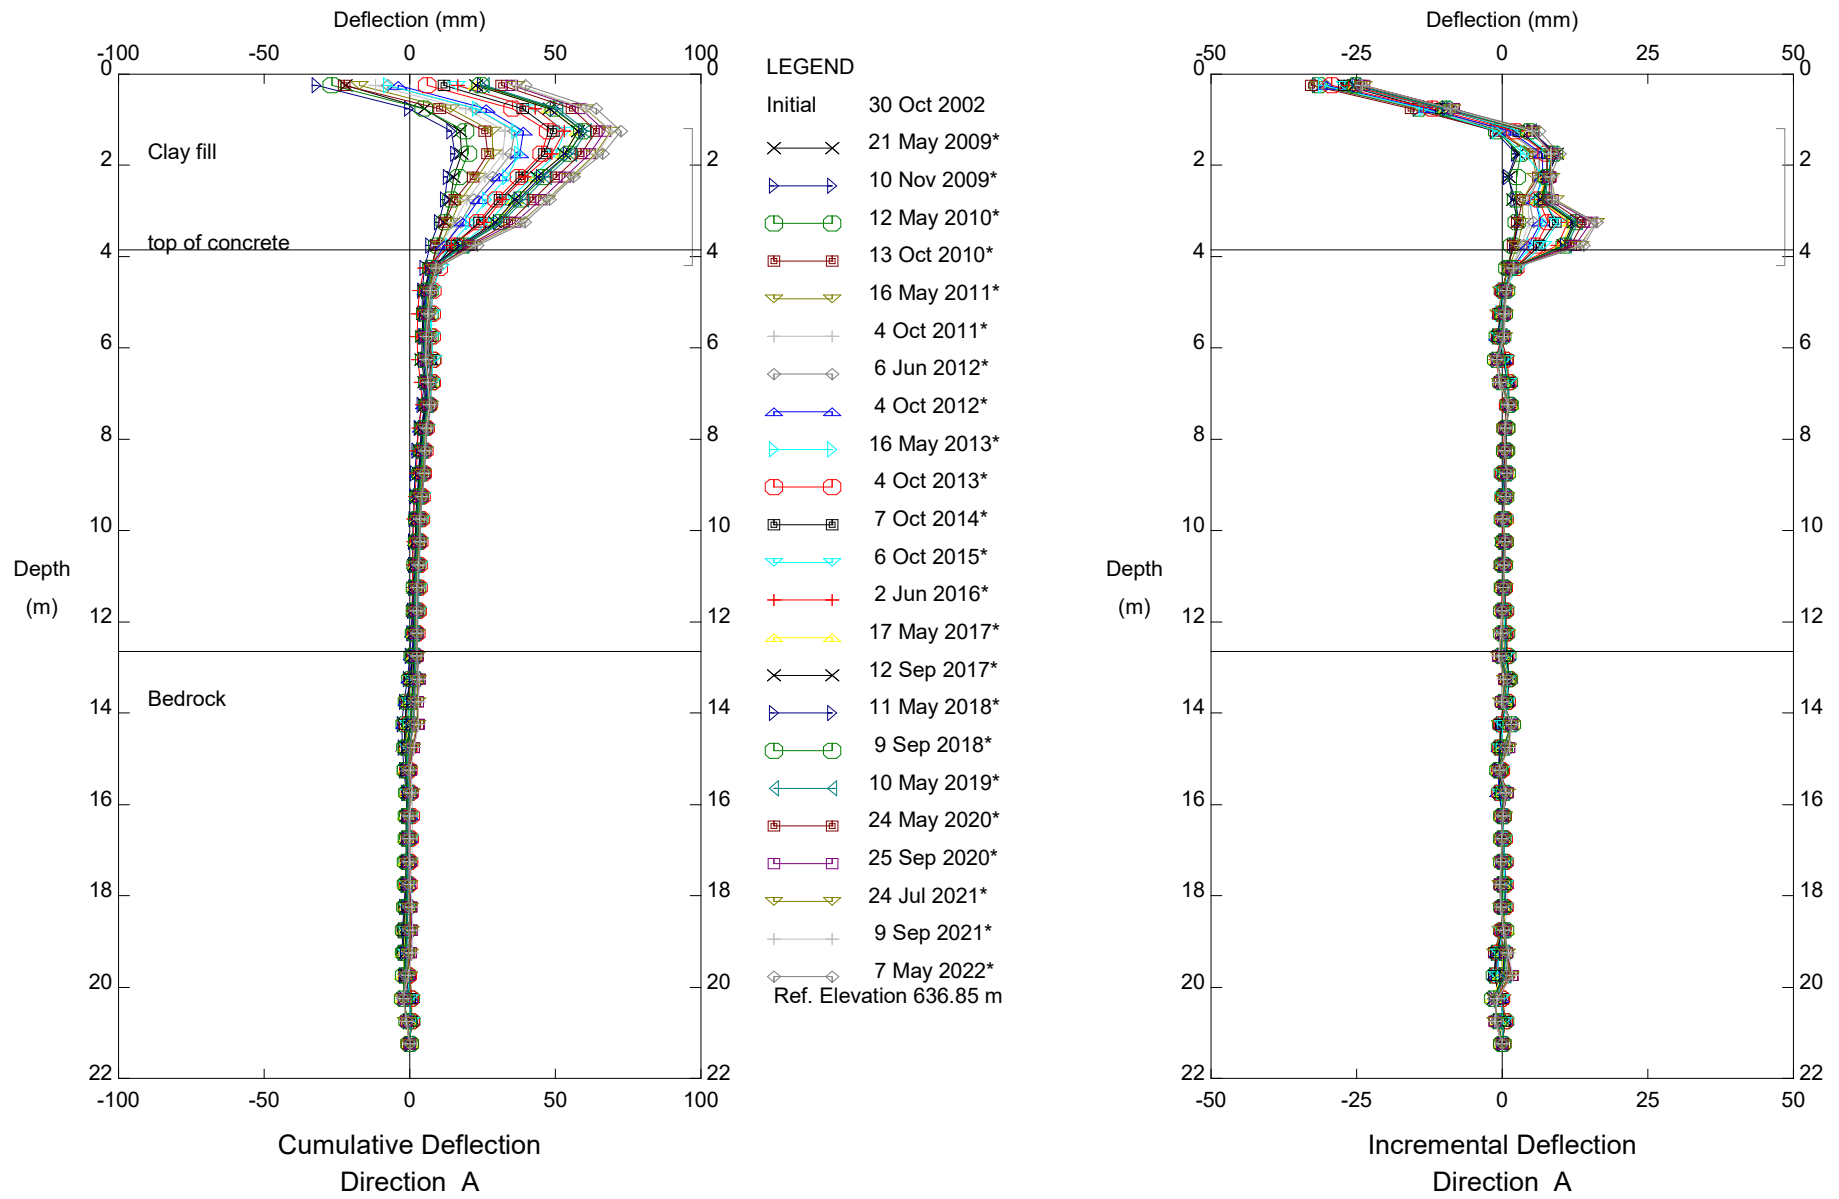
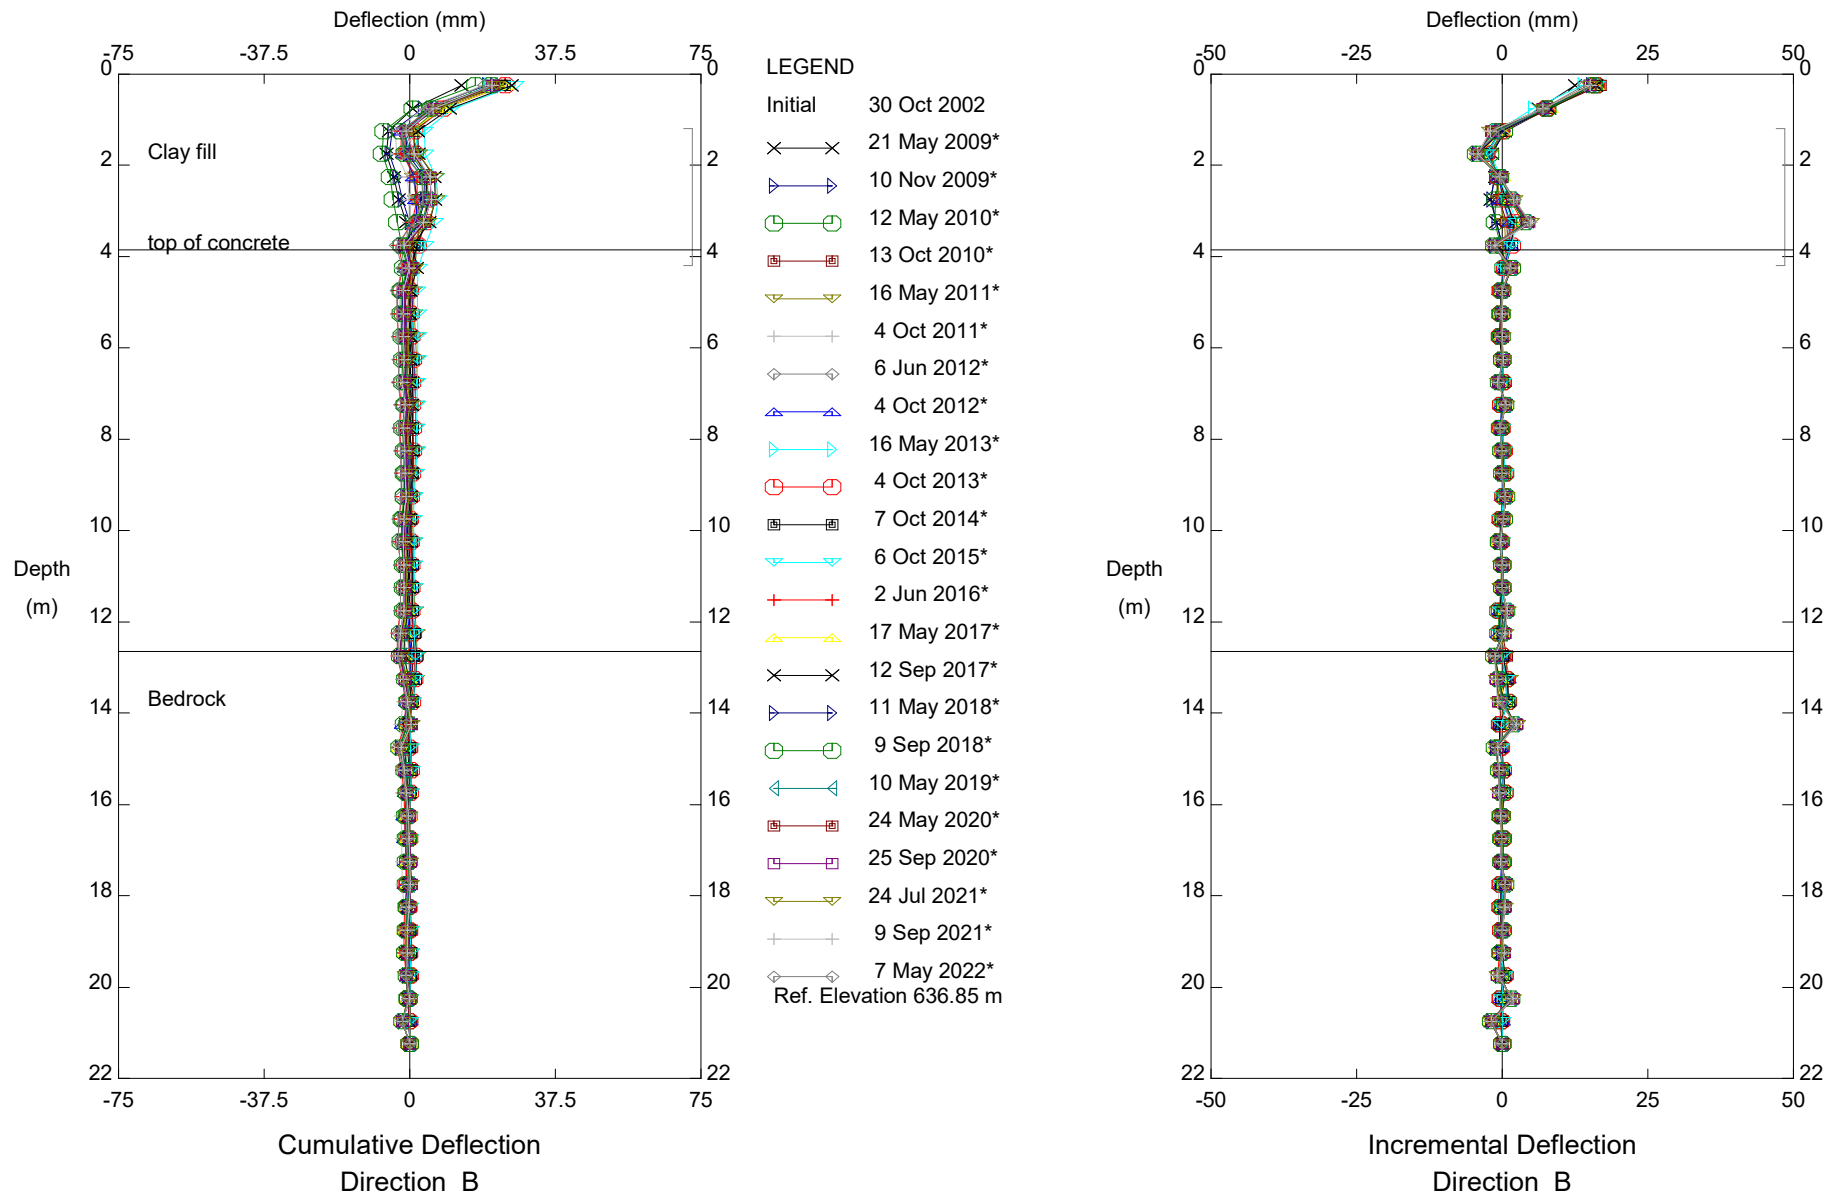
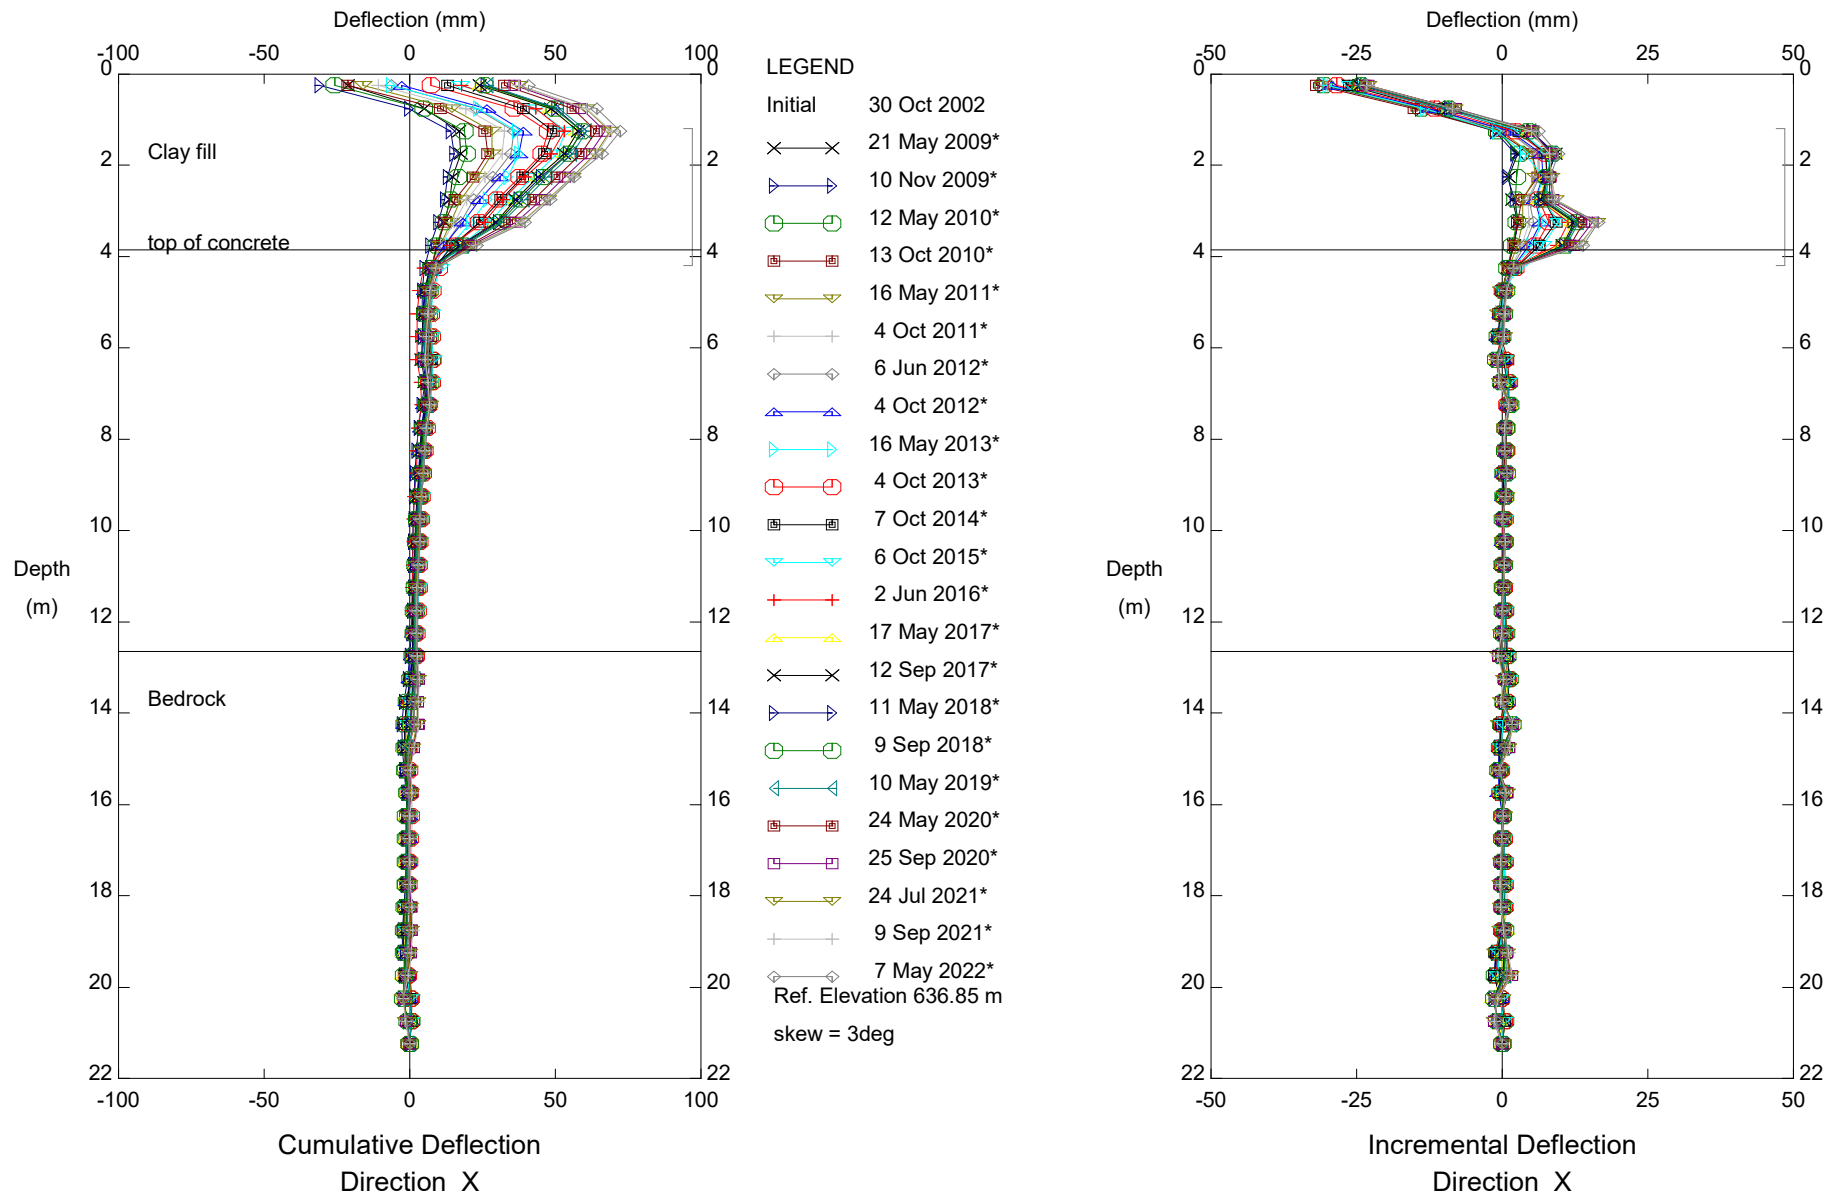
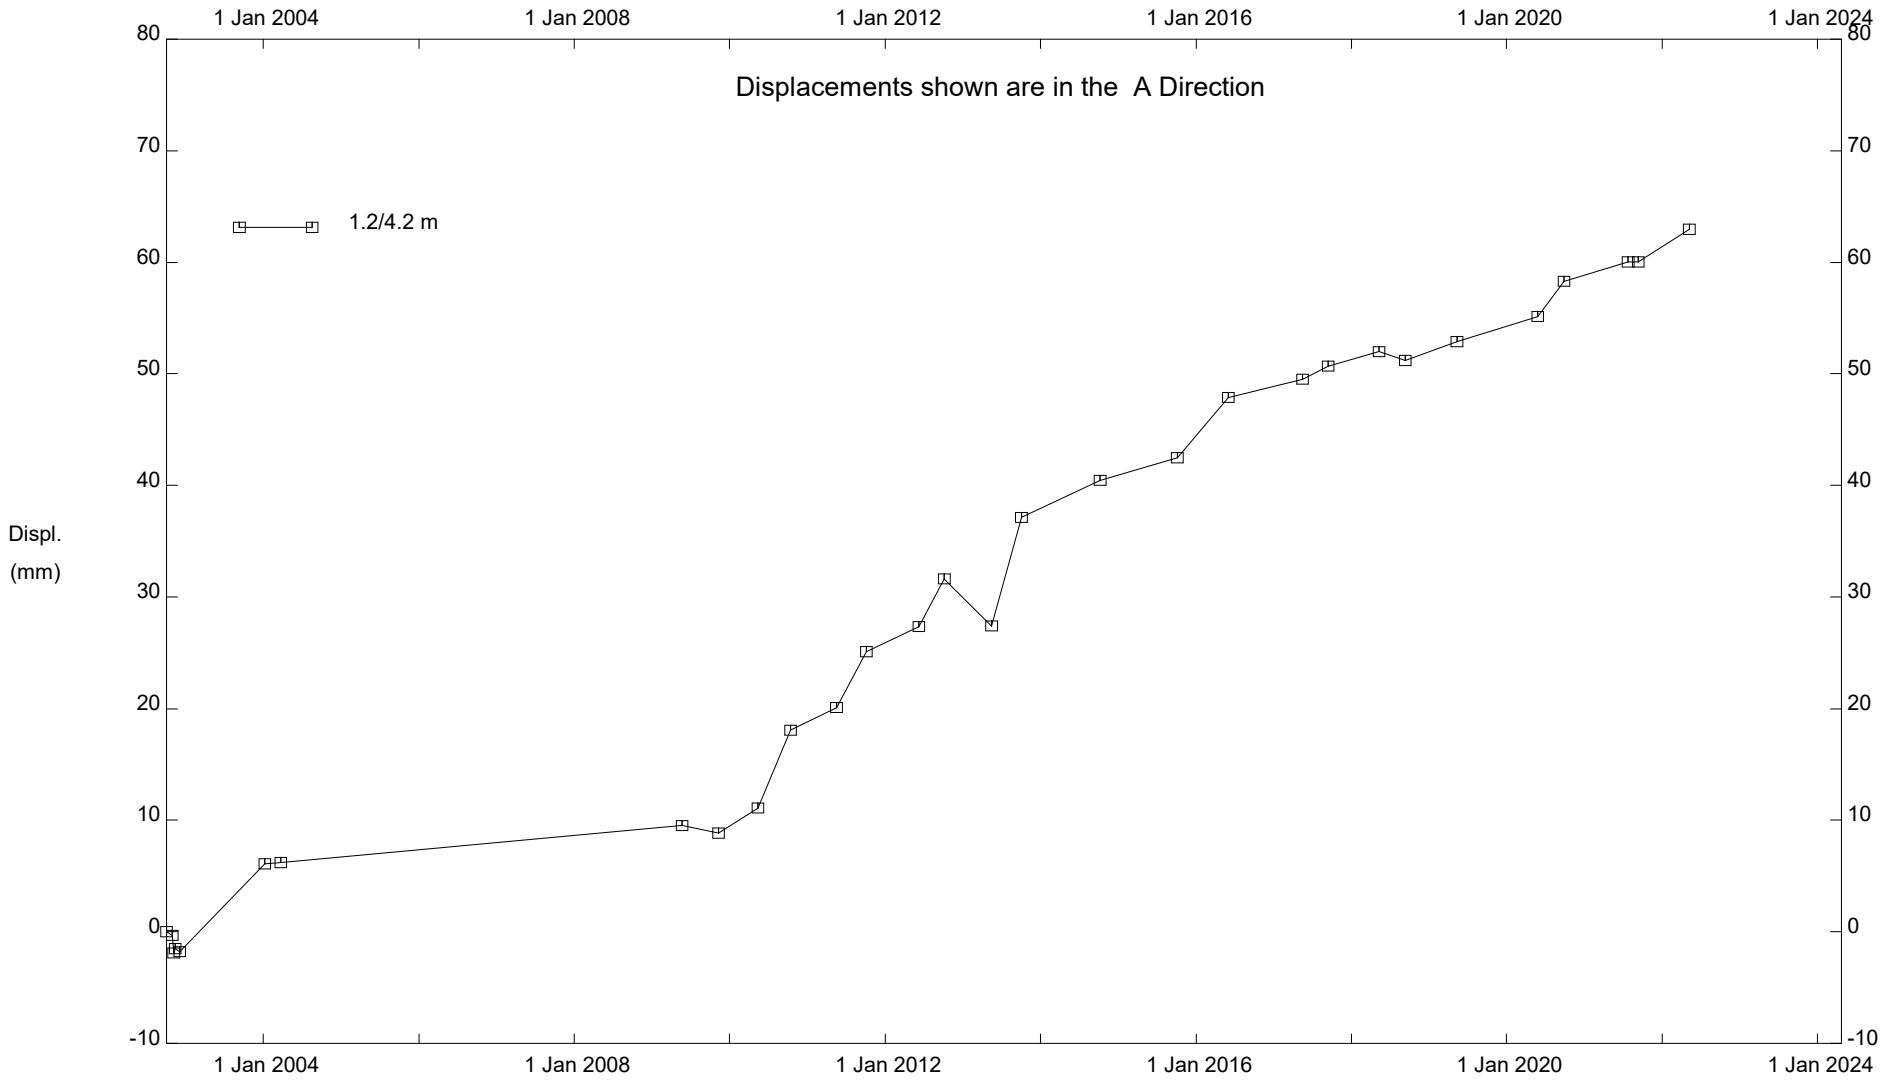
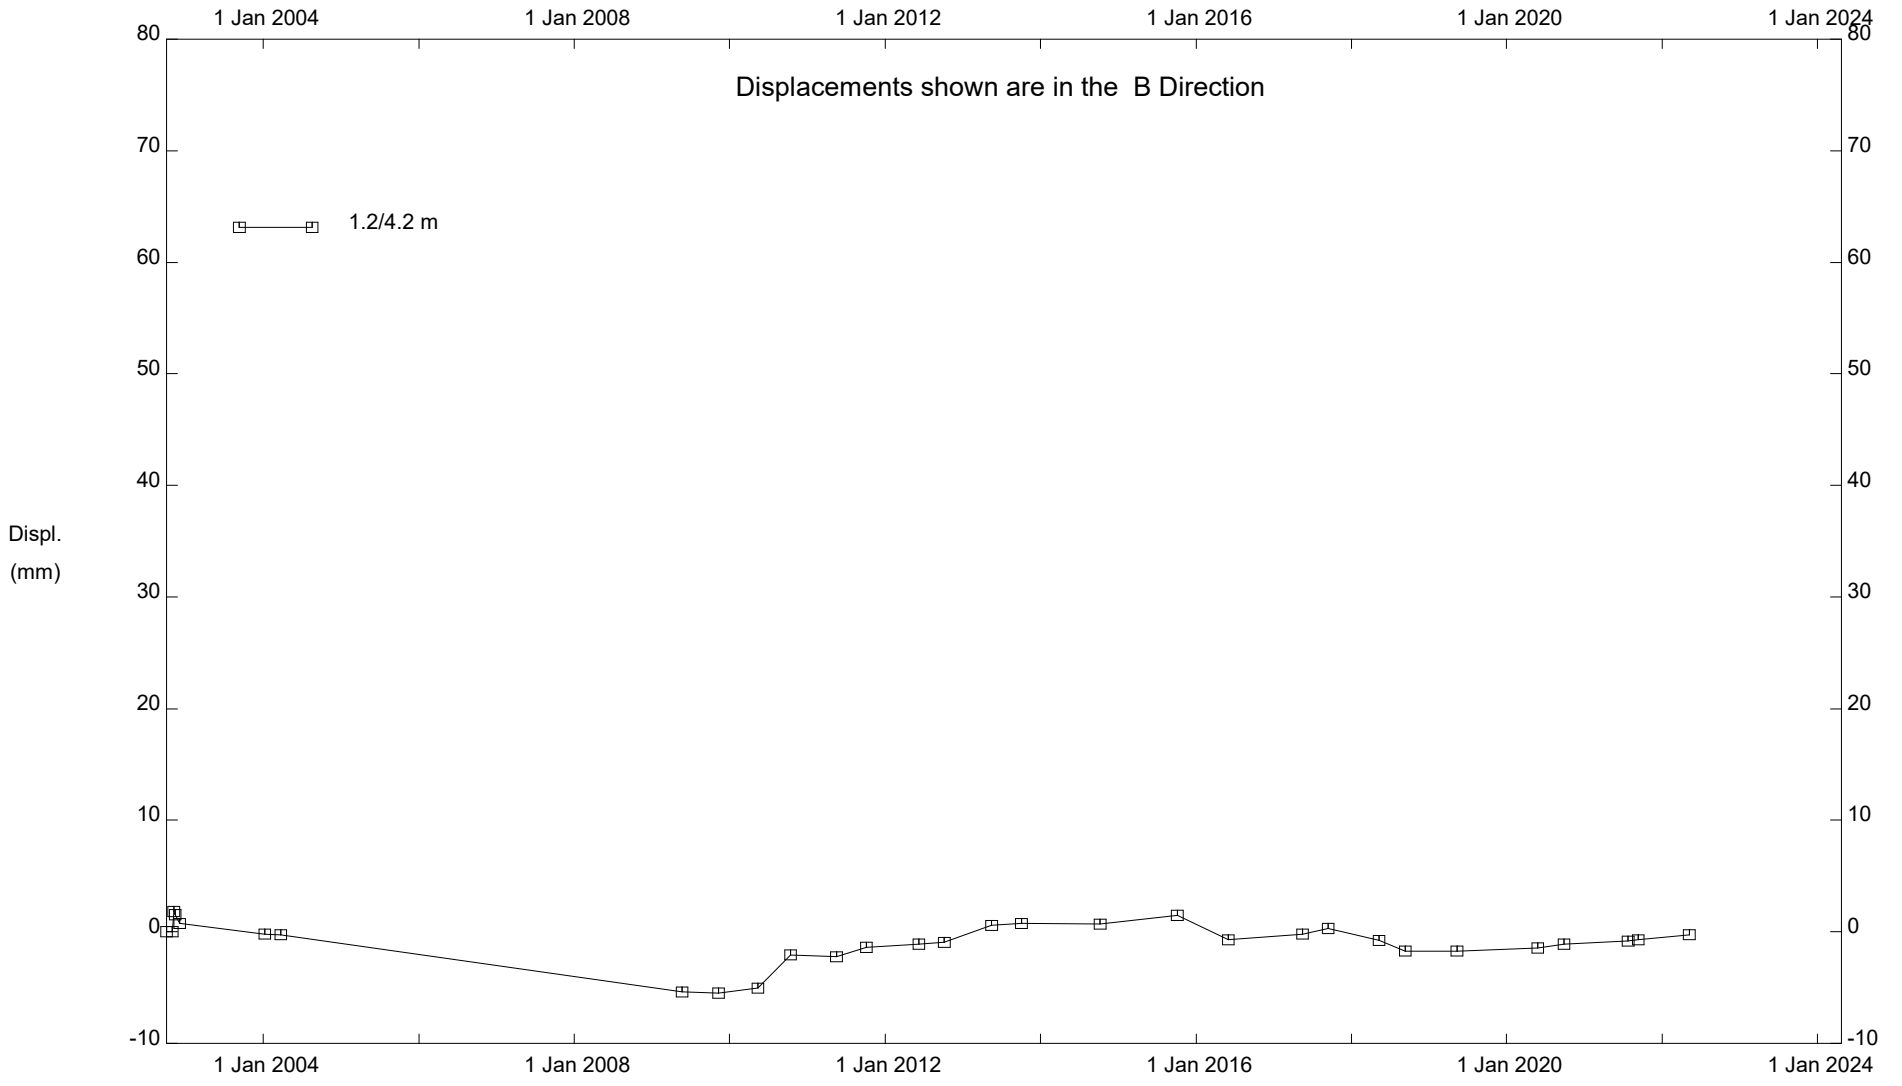
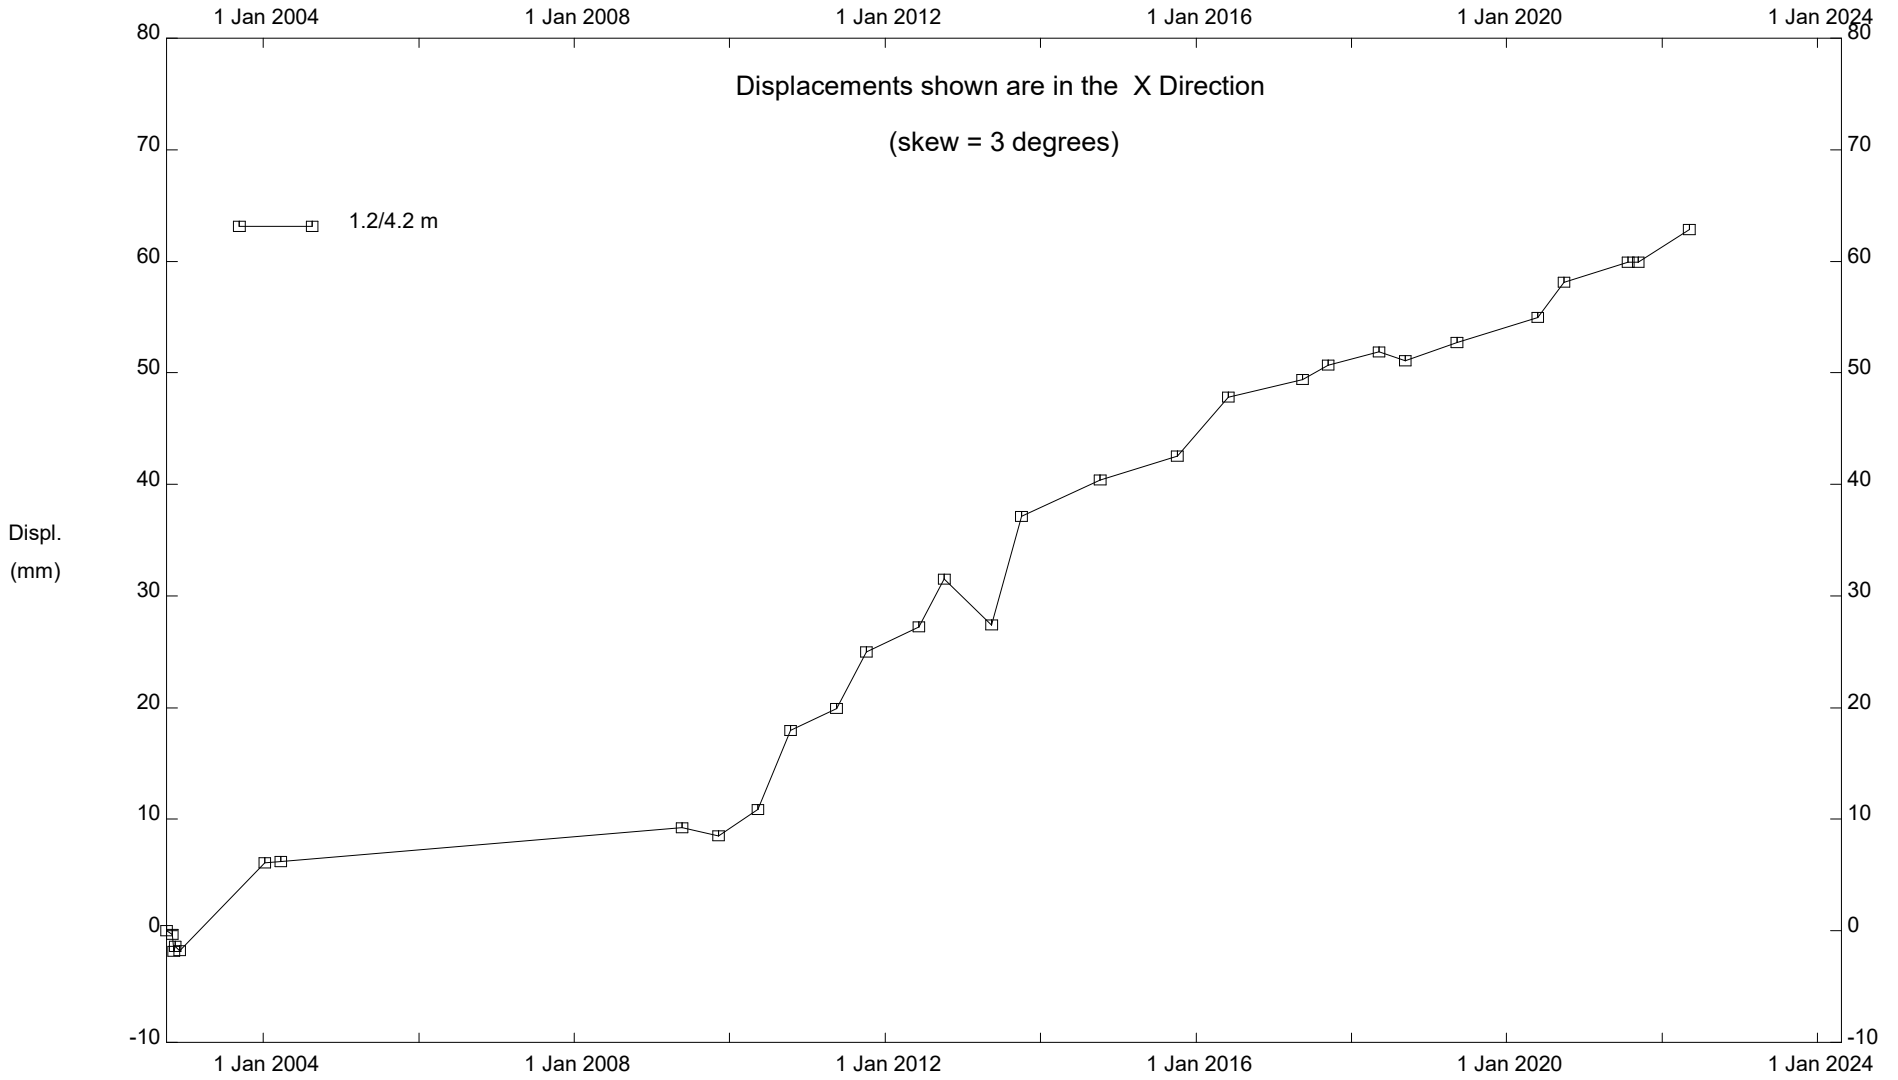
NC067, Inclinometer SI-02

- **SI-01** continues to show a negligible amount of incremental movement since about 2015. The total cumulative movement is about 32 mm.
- **SI-02** shows a current rate of movement of 4 mm/yr within the clay fill. The total cumulative movement is about 63 mm. An average movement rate of about 7 mm/yr was observed from Fall 2009 to Fall 2013 which decreased to an average rate of about 2 mm/yr to 3 mm/yr from 2014 on.
- **SI-03** is being monitored near surface and showed decreasing cumulative movement between 2018 and 2021. The cumulative movement increased to 106 mm during the Spring 2022 readings with the current rate of movement at 42 mm/yr.
- **SI-04** shows a rate of movement less than 1 mm/yr since 2015
