To:	Amy Driessen Alberta Transportation	From:	Leslie Cho and Carrie Murray Stantec Consulting Ltd.
File:	123315222	Date:	June 12, 2022

Reference: North Central Region, Stony Plain, Site NC067 - Highway 216:06 Anthony Henday Bridge, Spring 2022 Instrumentation Monitoring Report

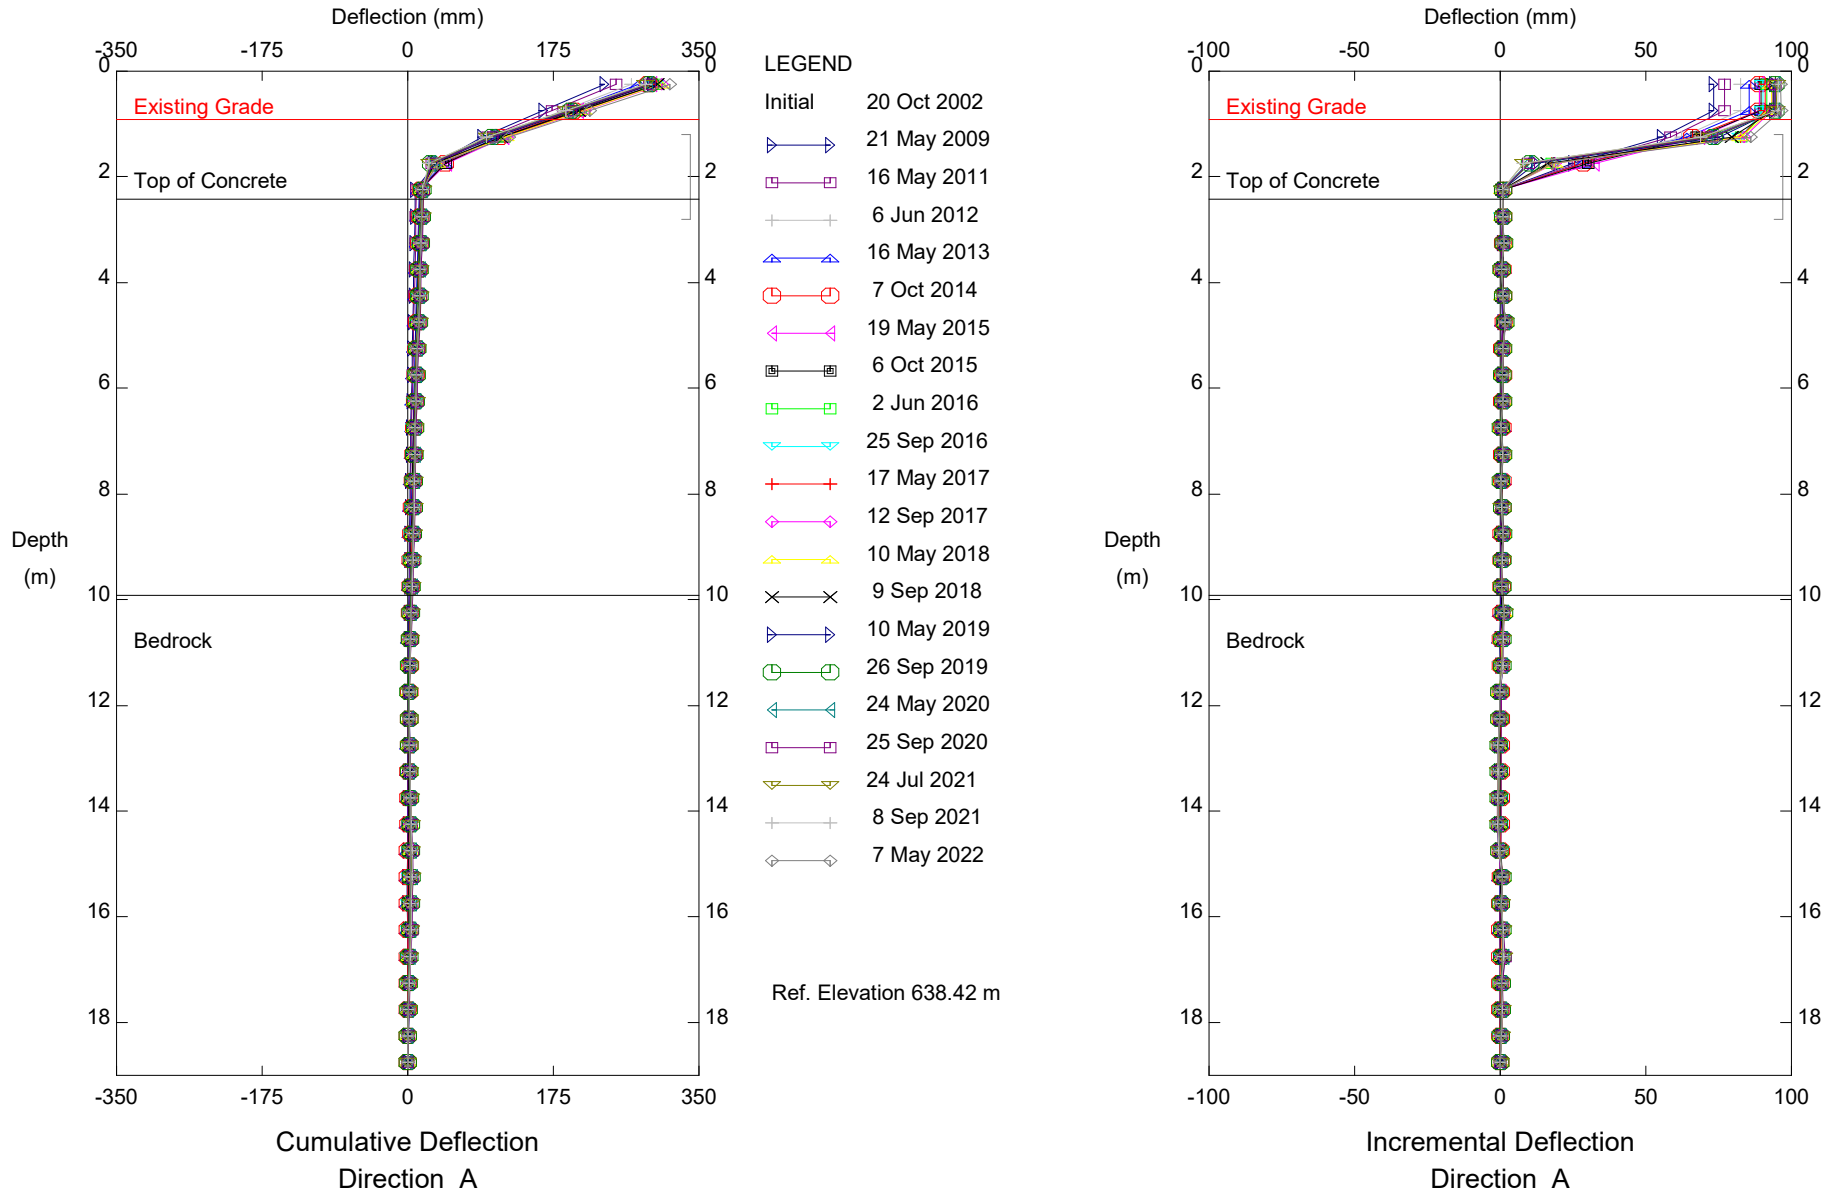
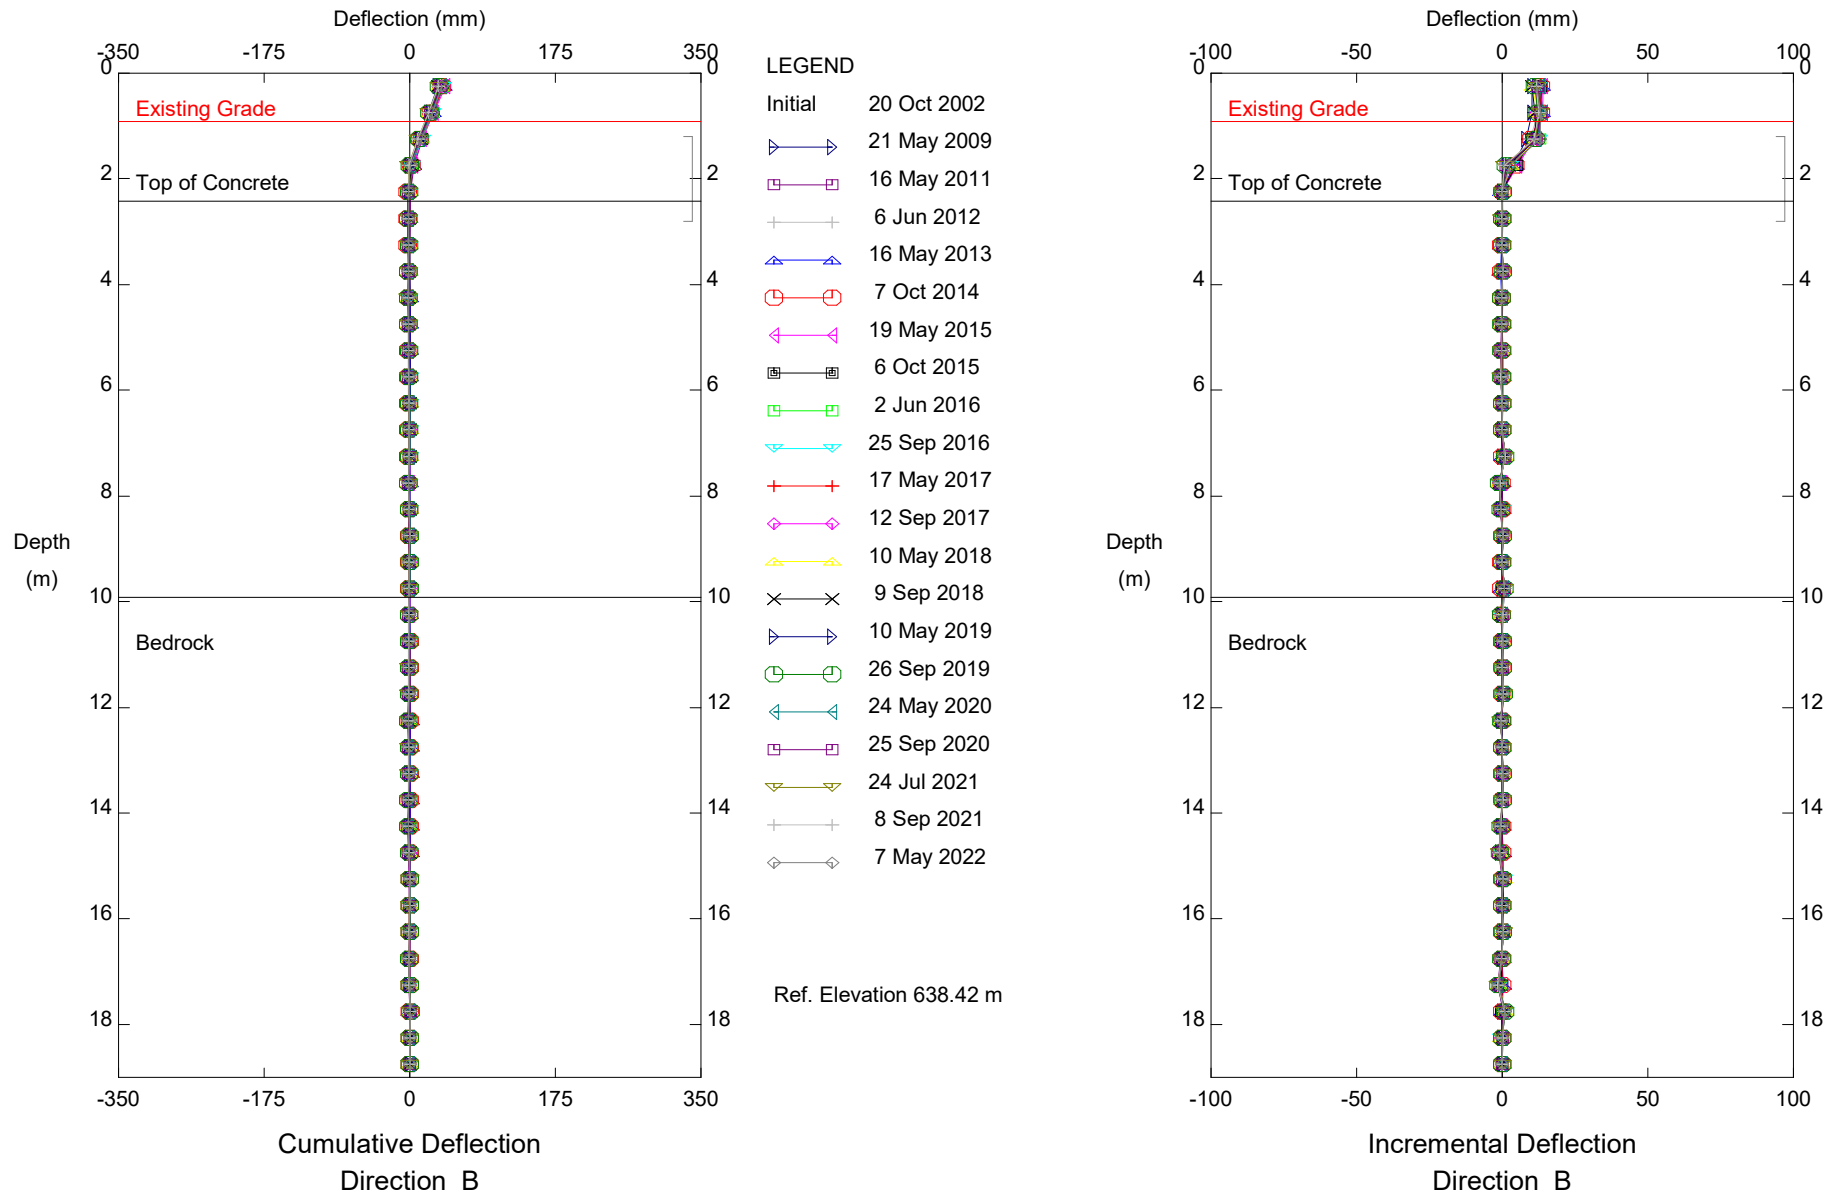
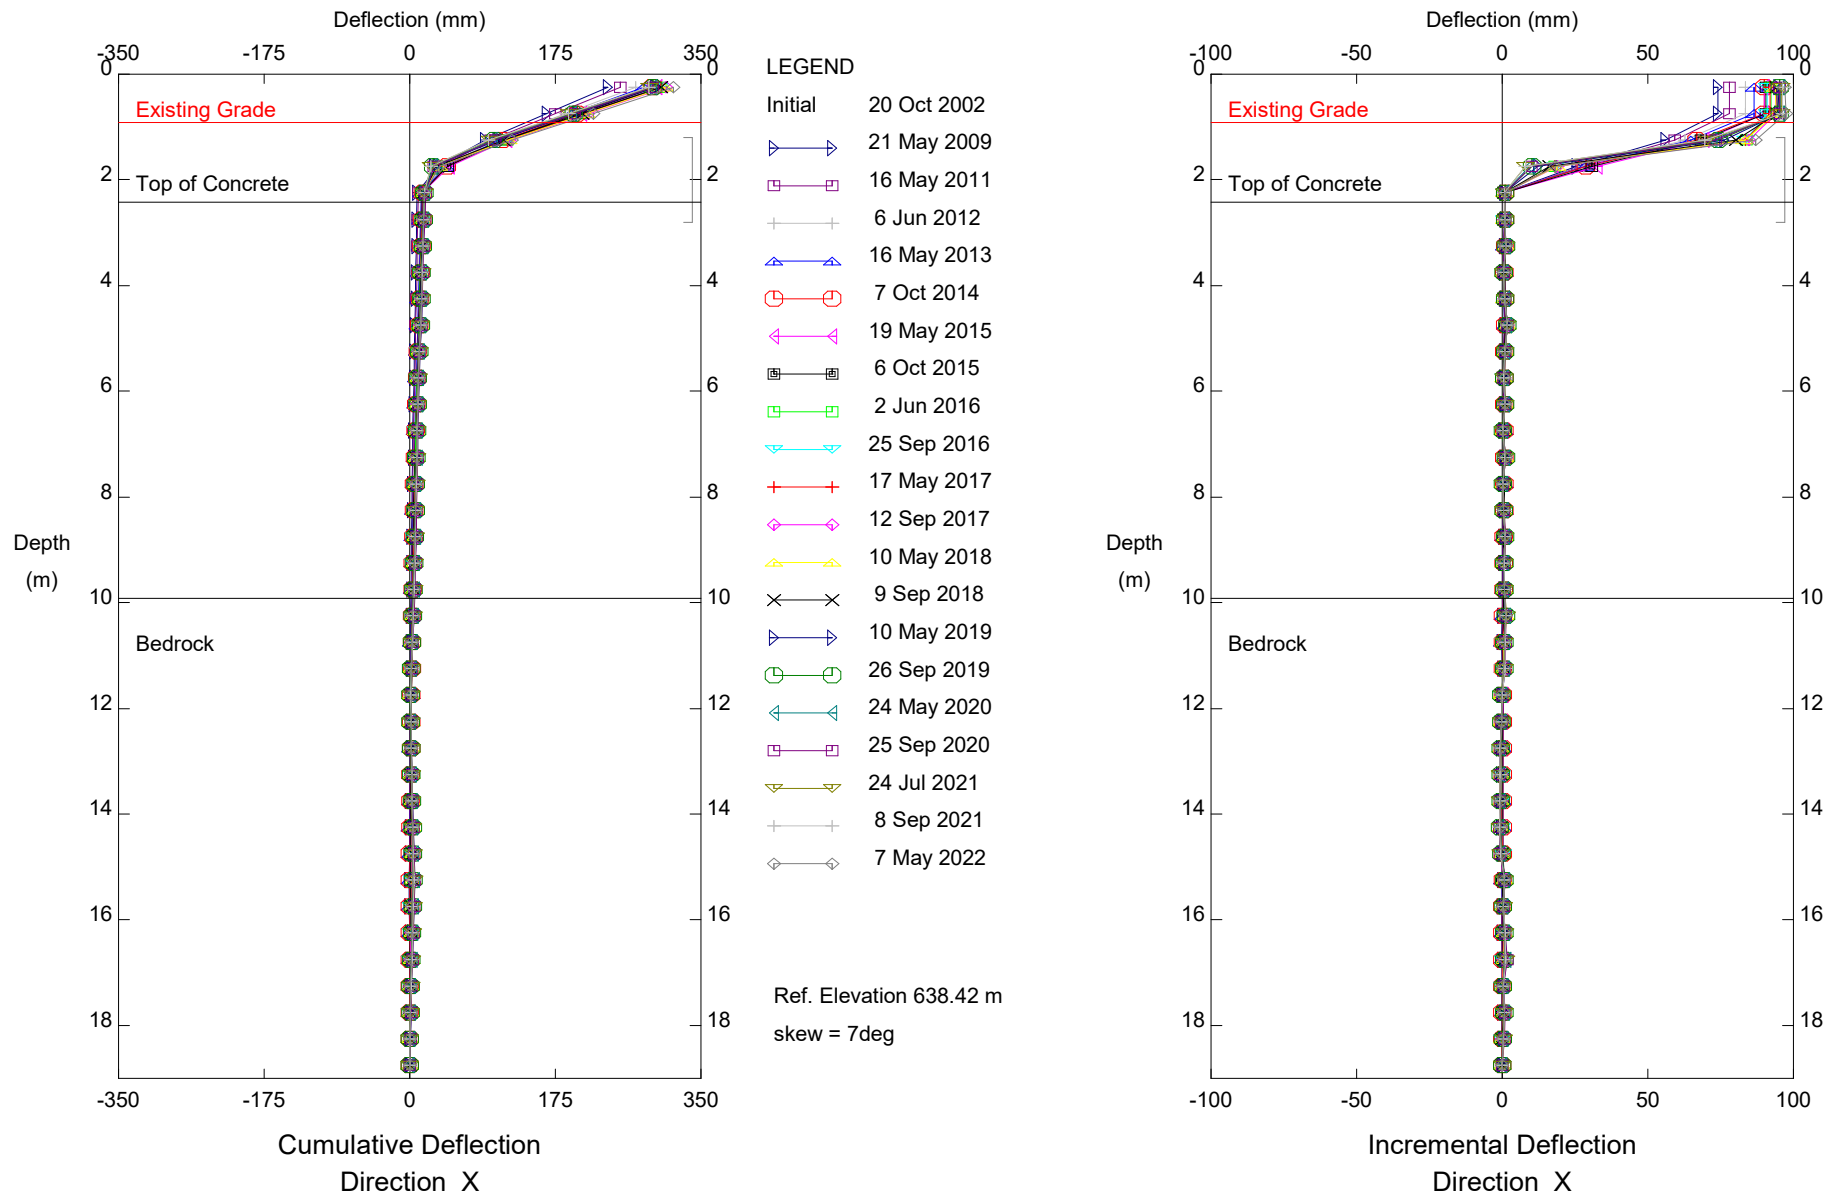
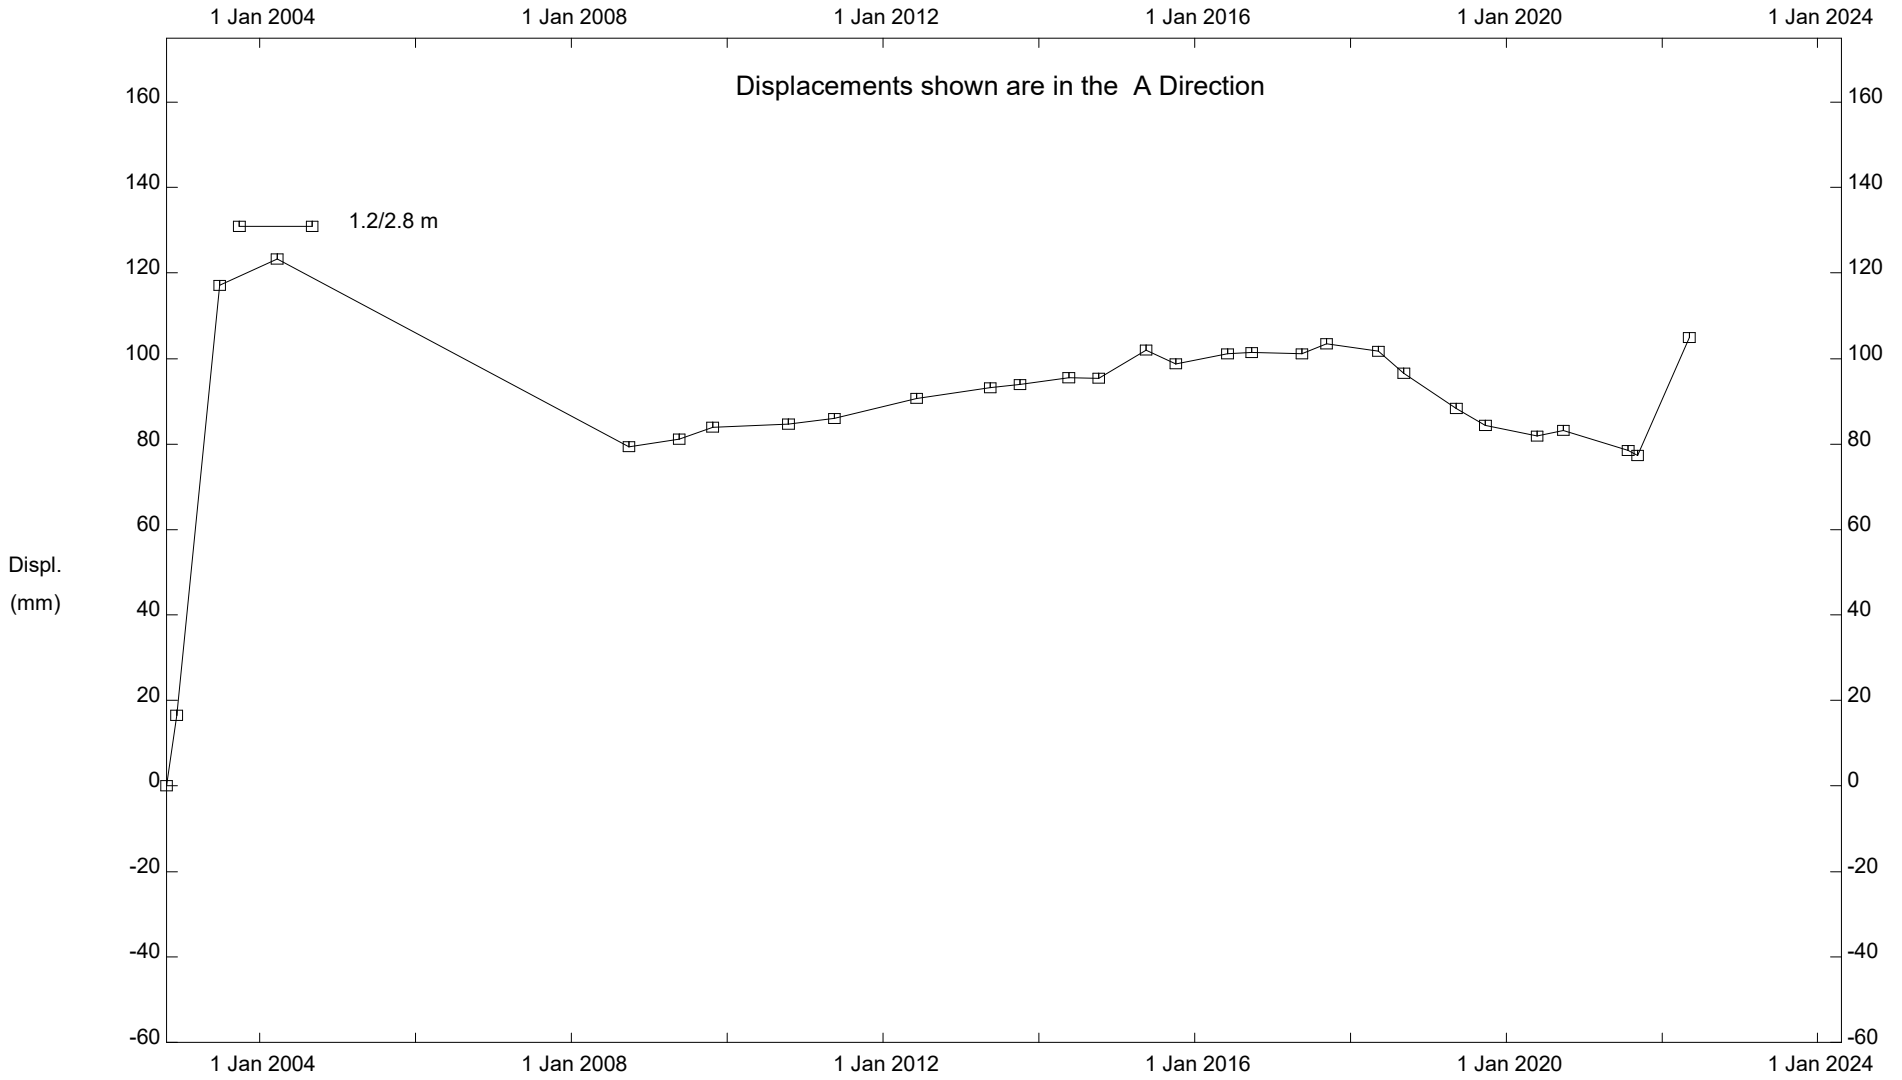
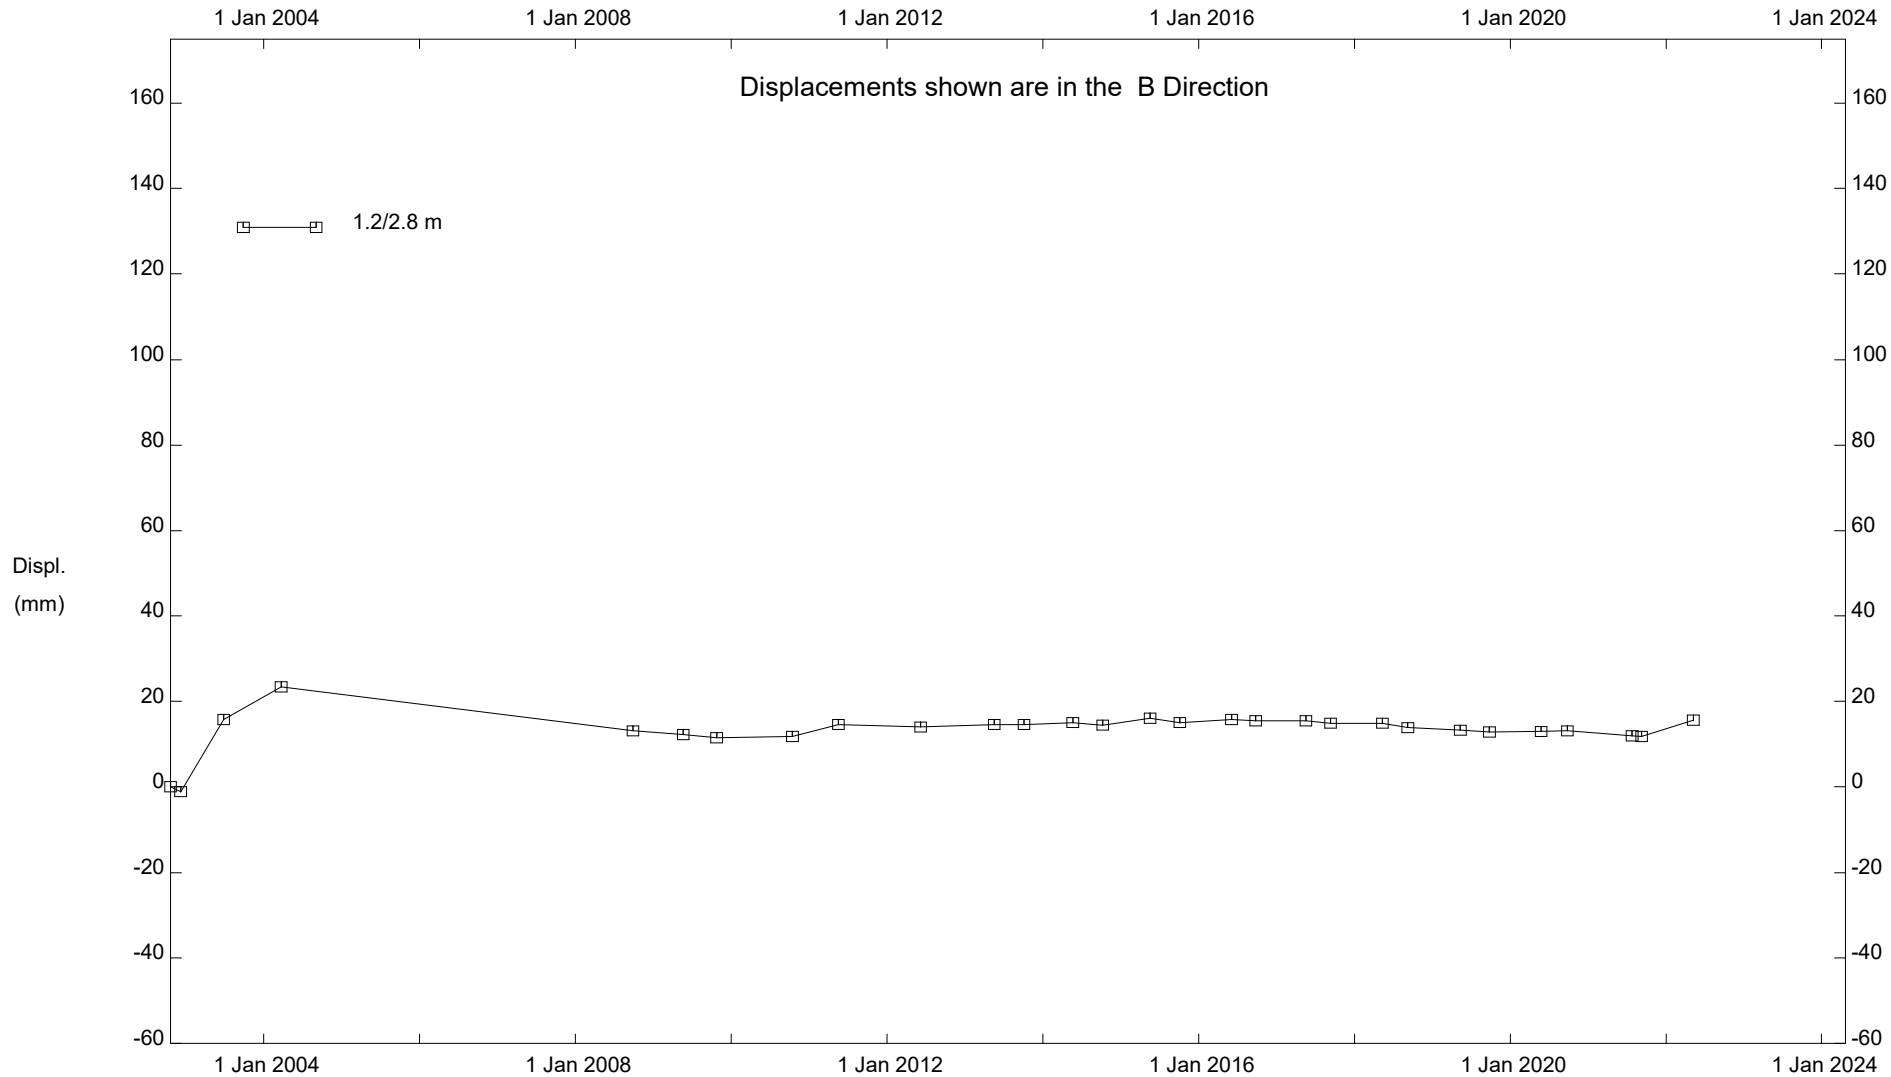
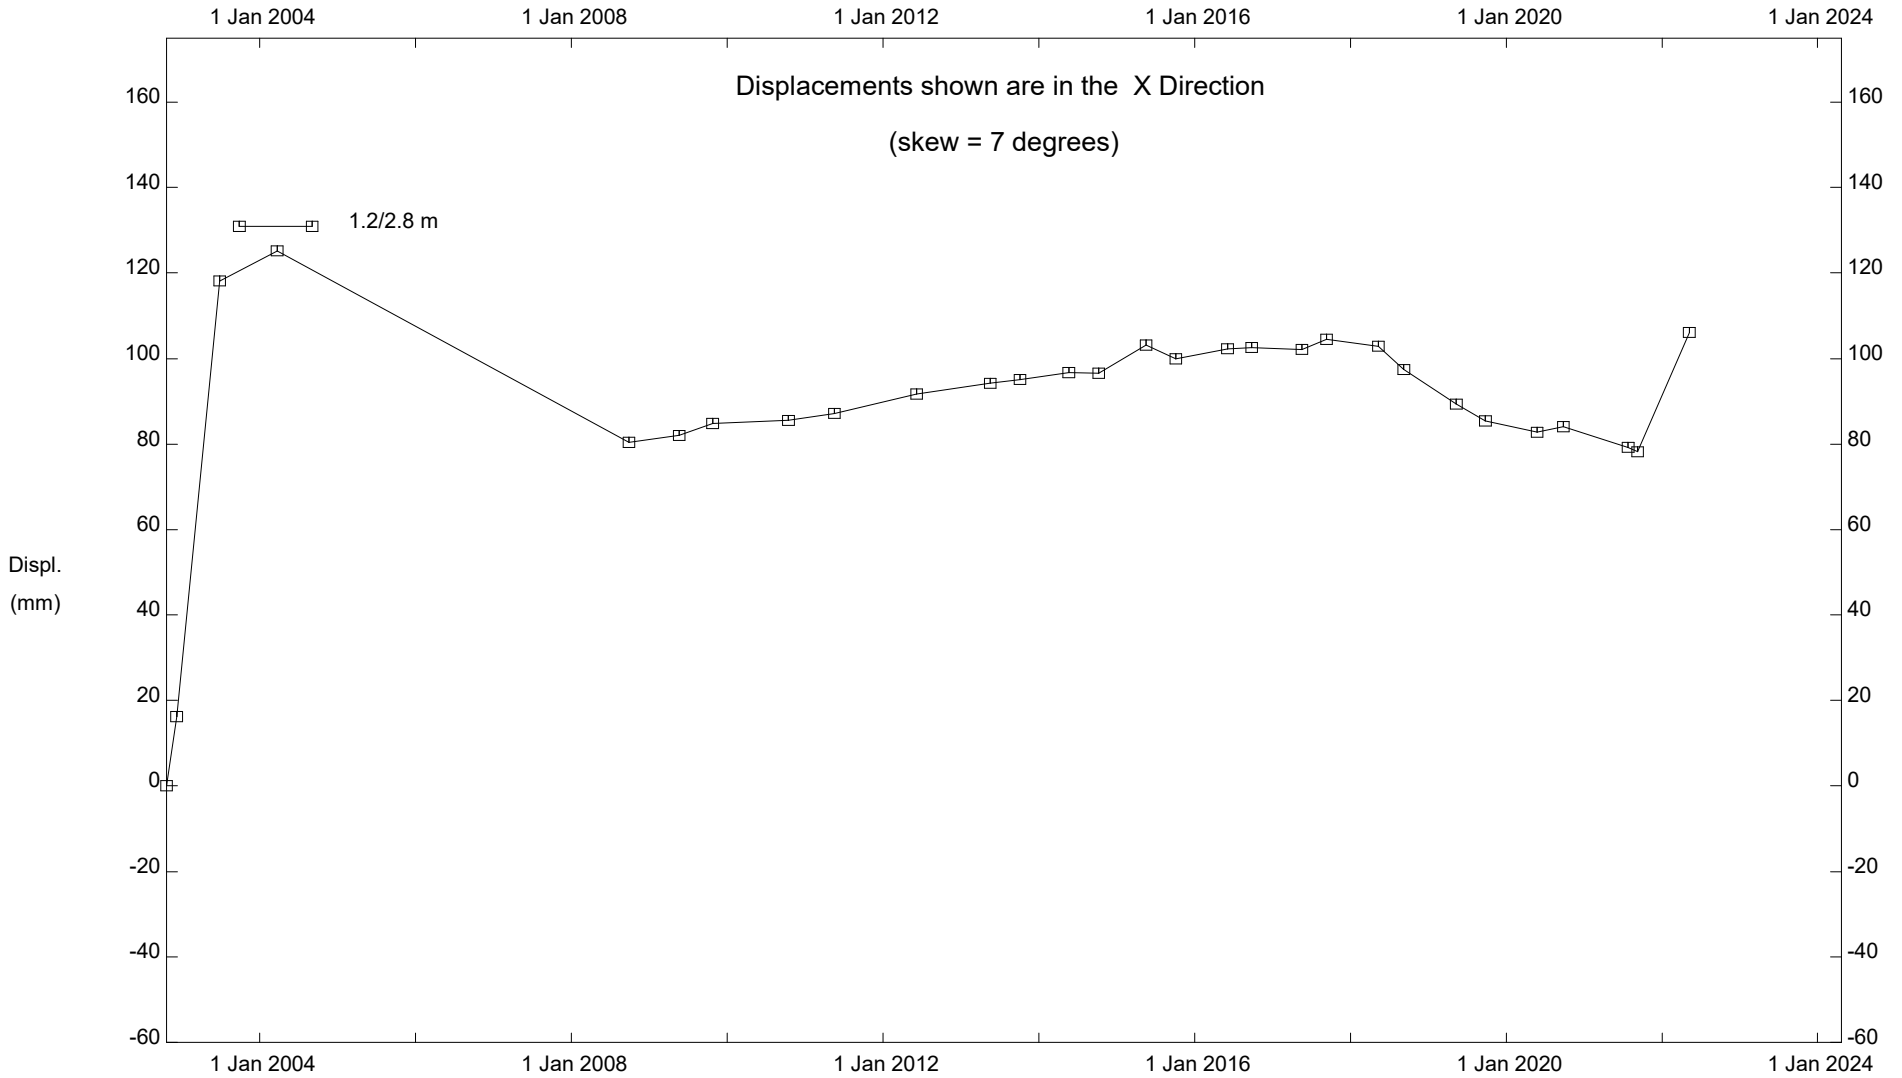
NC067, Inclinometer SI-03
 Alberta Transportation

- **SI-01** continues to show a negligible amount of incremental movement since about 2015. The total cumulative movement is about 32 mm.
- **SI-02** shows a current rate of movement of 4 mm/yr within the clay fill. The total cumulative movement is about 63 mm. An average movement rate of about 7 mm/yr was observed from Fall 2009 to Fall 2013 which decreased to an average rate of about 2 mm/yr to 3 mm/yr from 2014 on.
- **SI-03** is being monitored near surface and showed decreasing cumulative movement between 2018 and 2021. The cumulative movement increased to 106 mm during the Spring 2022 readings with the current rate of movement at 42 mm/yr.
- **SI-04** shows a rate of movement less than 1 mm/yr since 2015
