To:	Amy Driessen Alberta Transportation	From:	Leslie Cho and Carrie Murray Stantec Consulting Ltd.
File:	123315222	Date:	June 12, 2022

Reference: North Central Region, Stony Plain, Site NC067 - Highway 216:06 Anthony Henday Bridge, Spring 2022 Instrumentation Monitoring Report

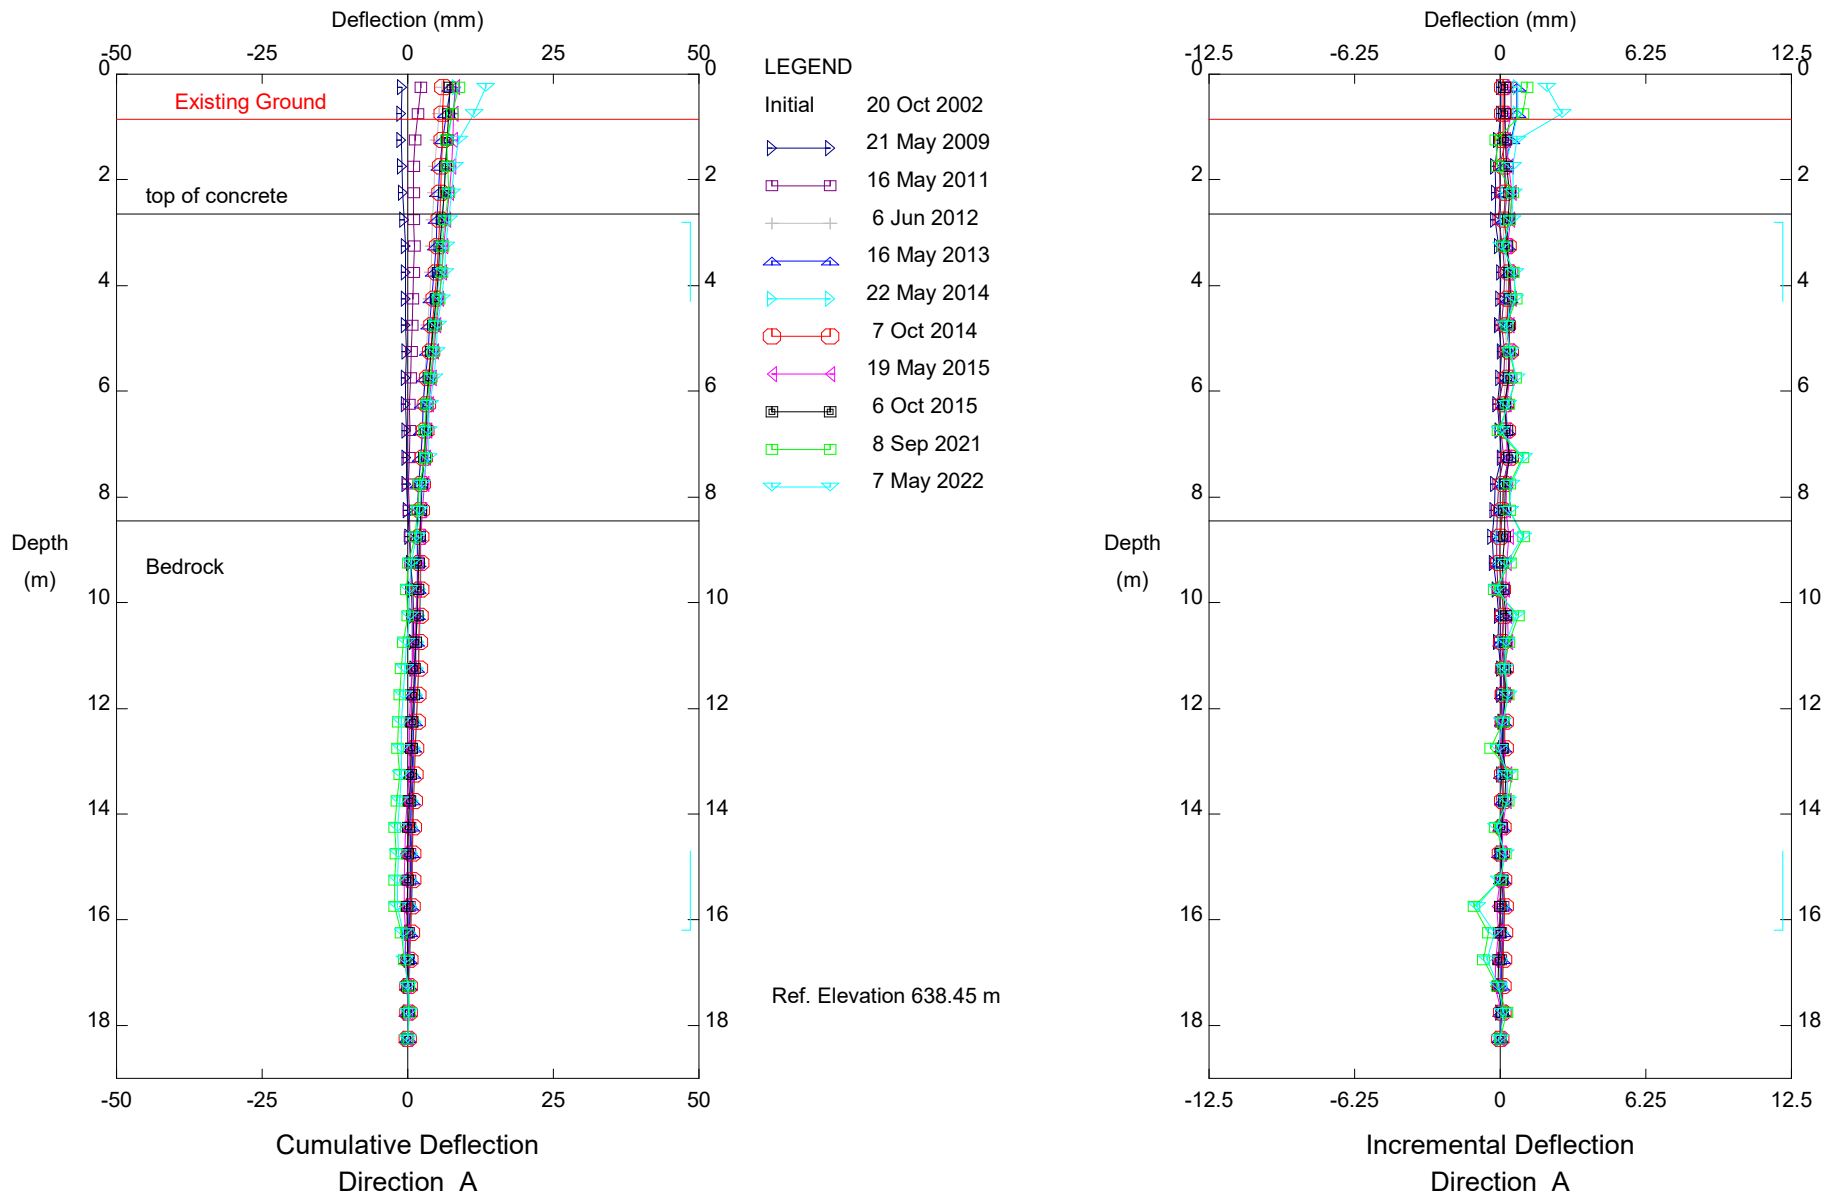
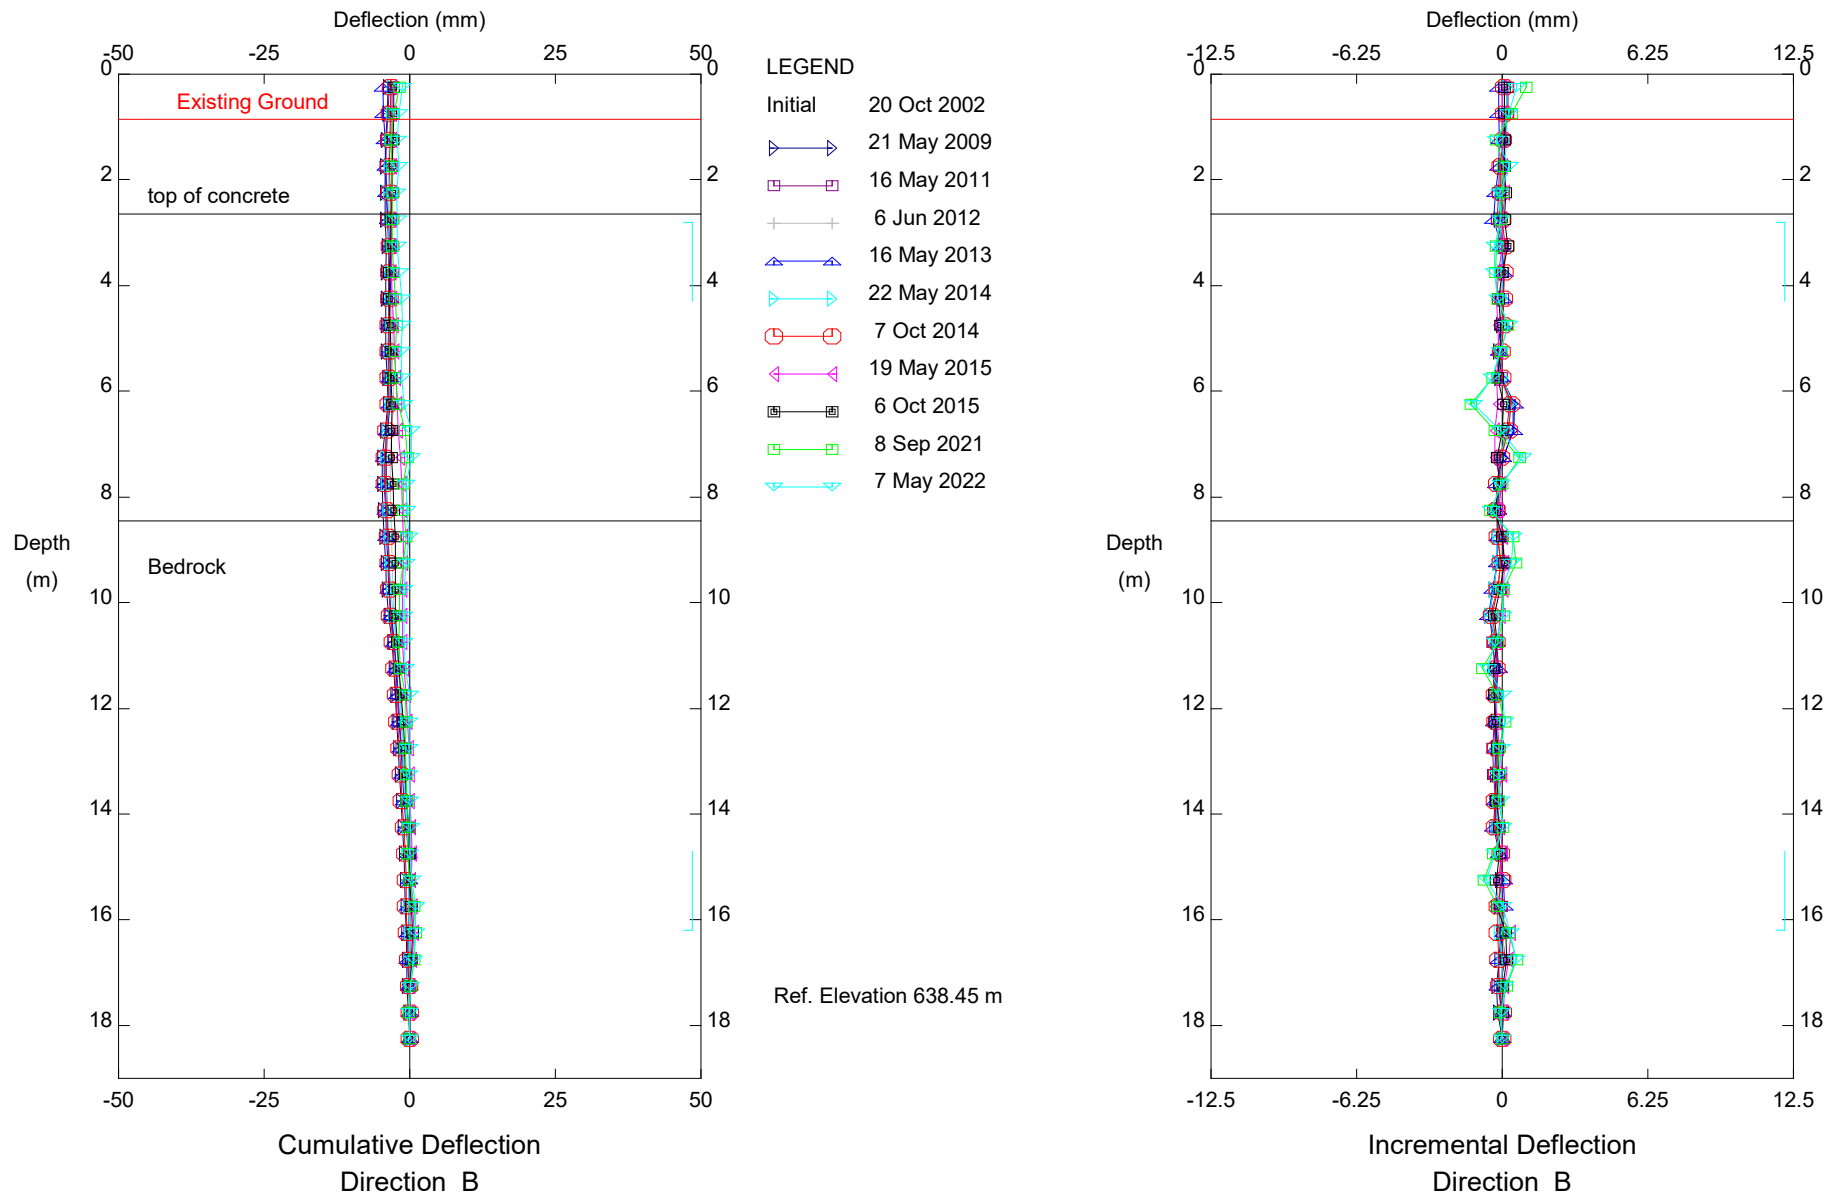
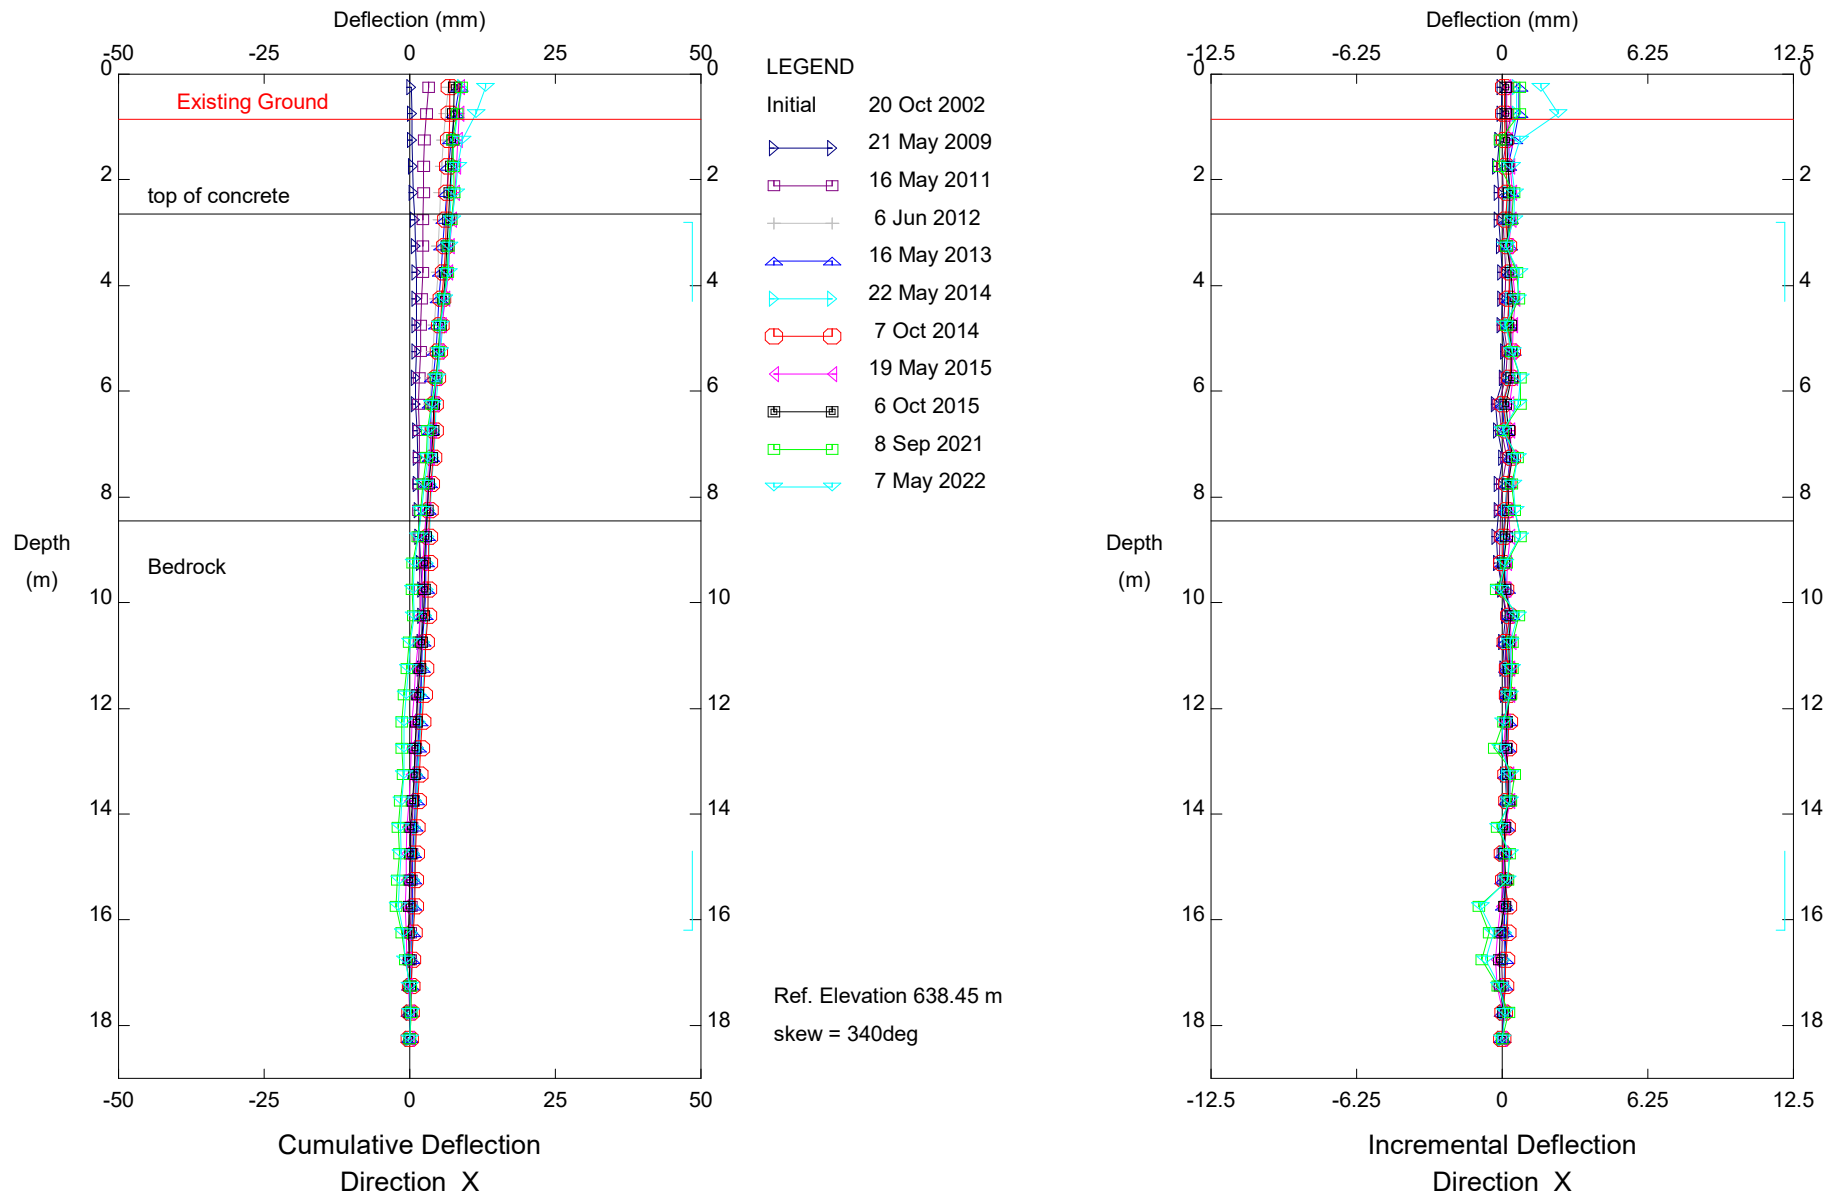
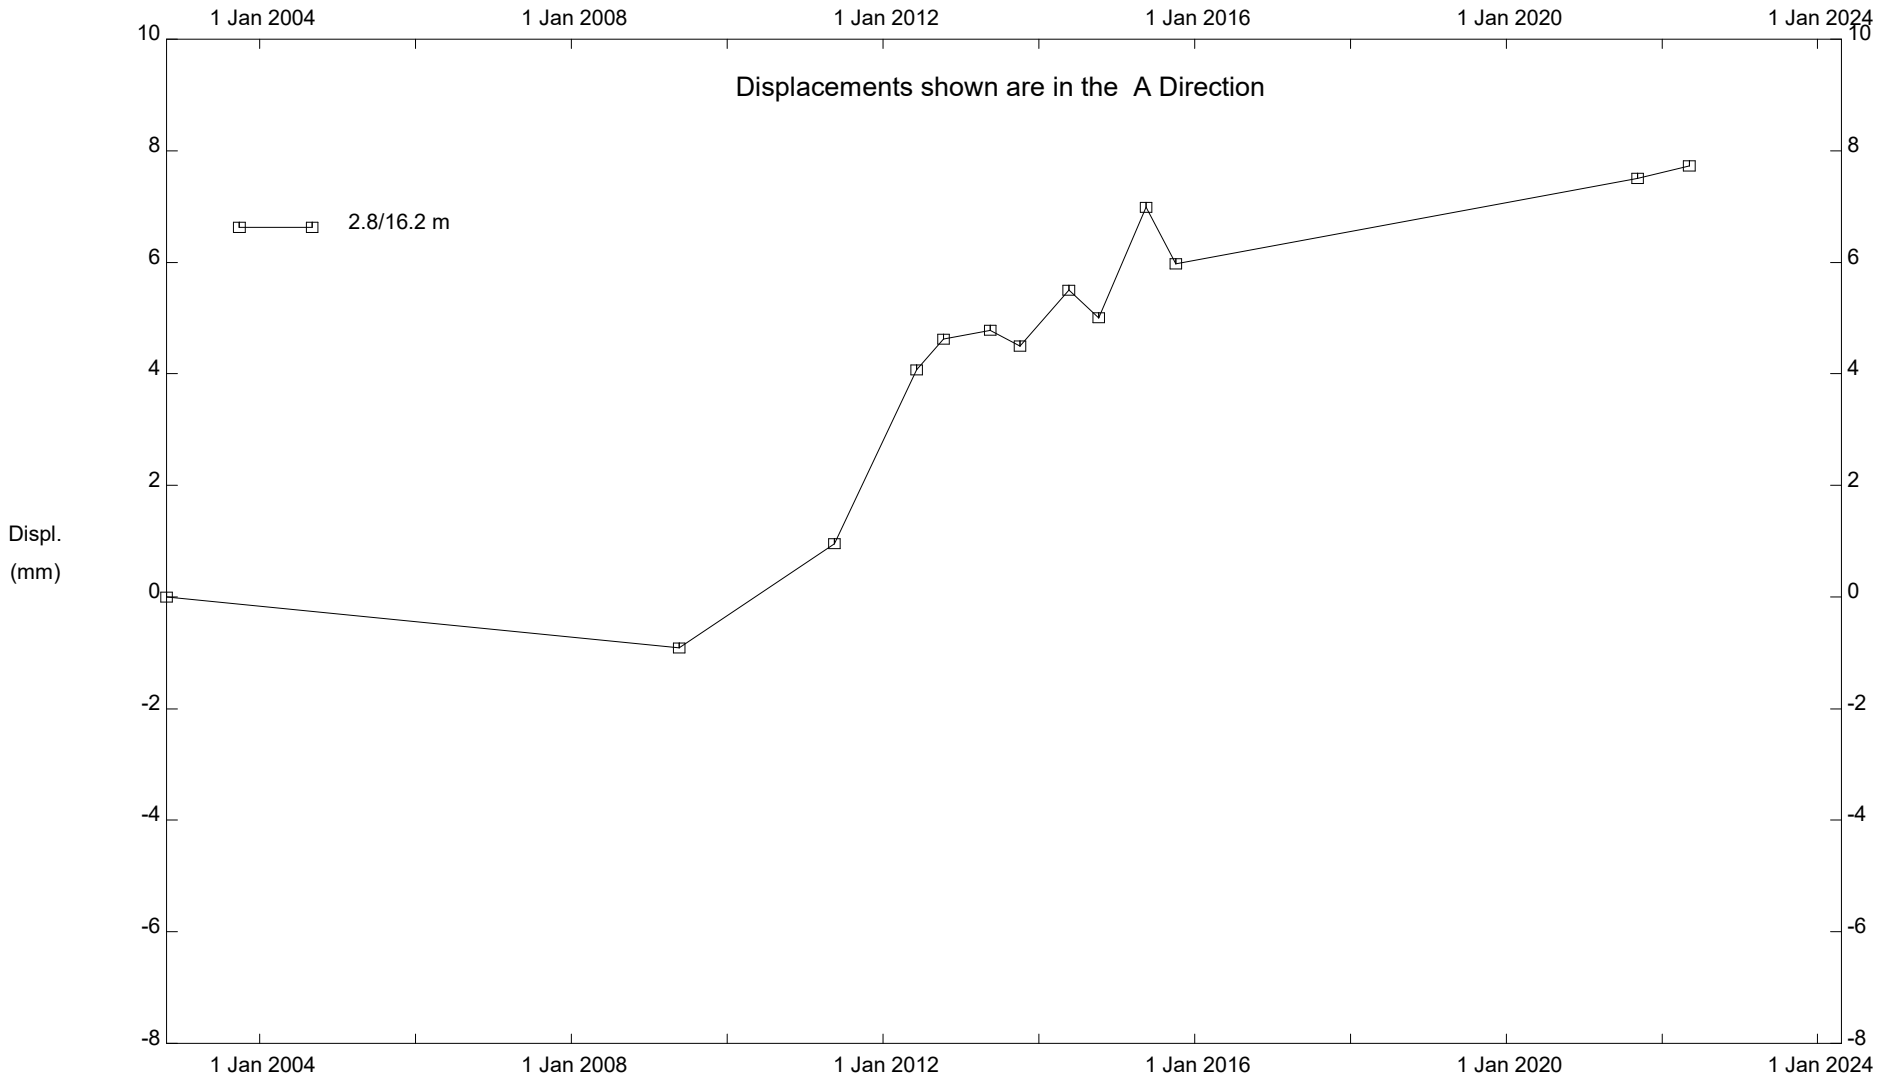
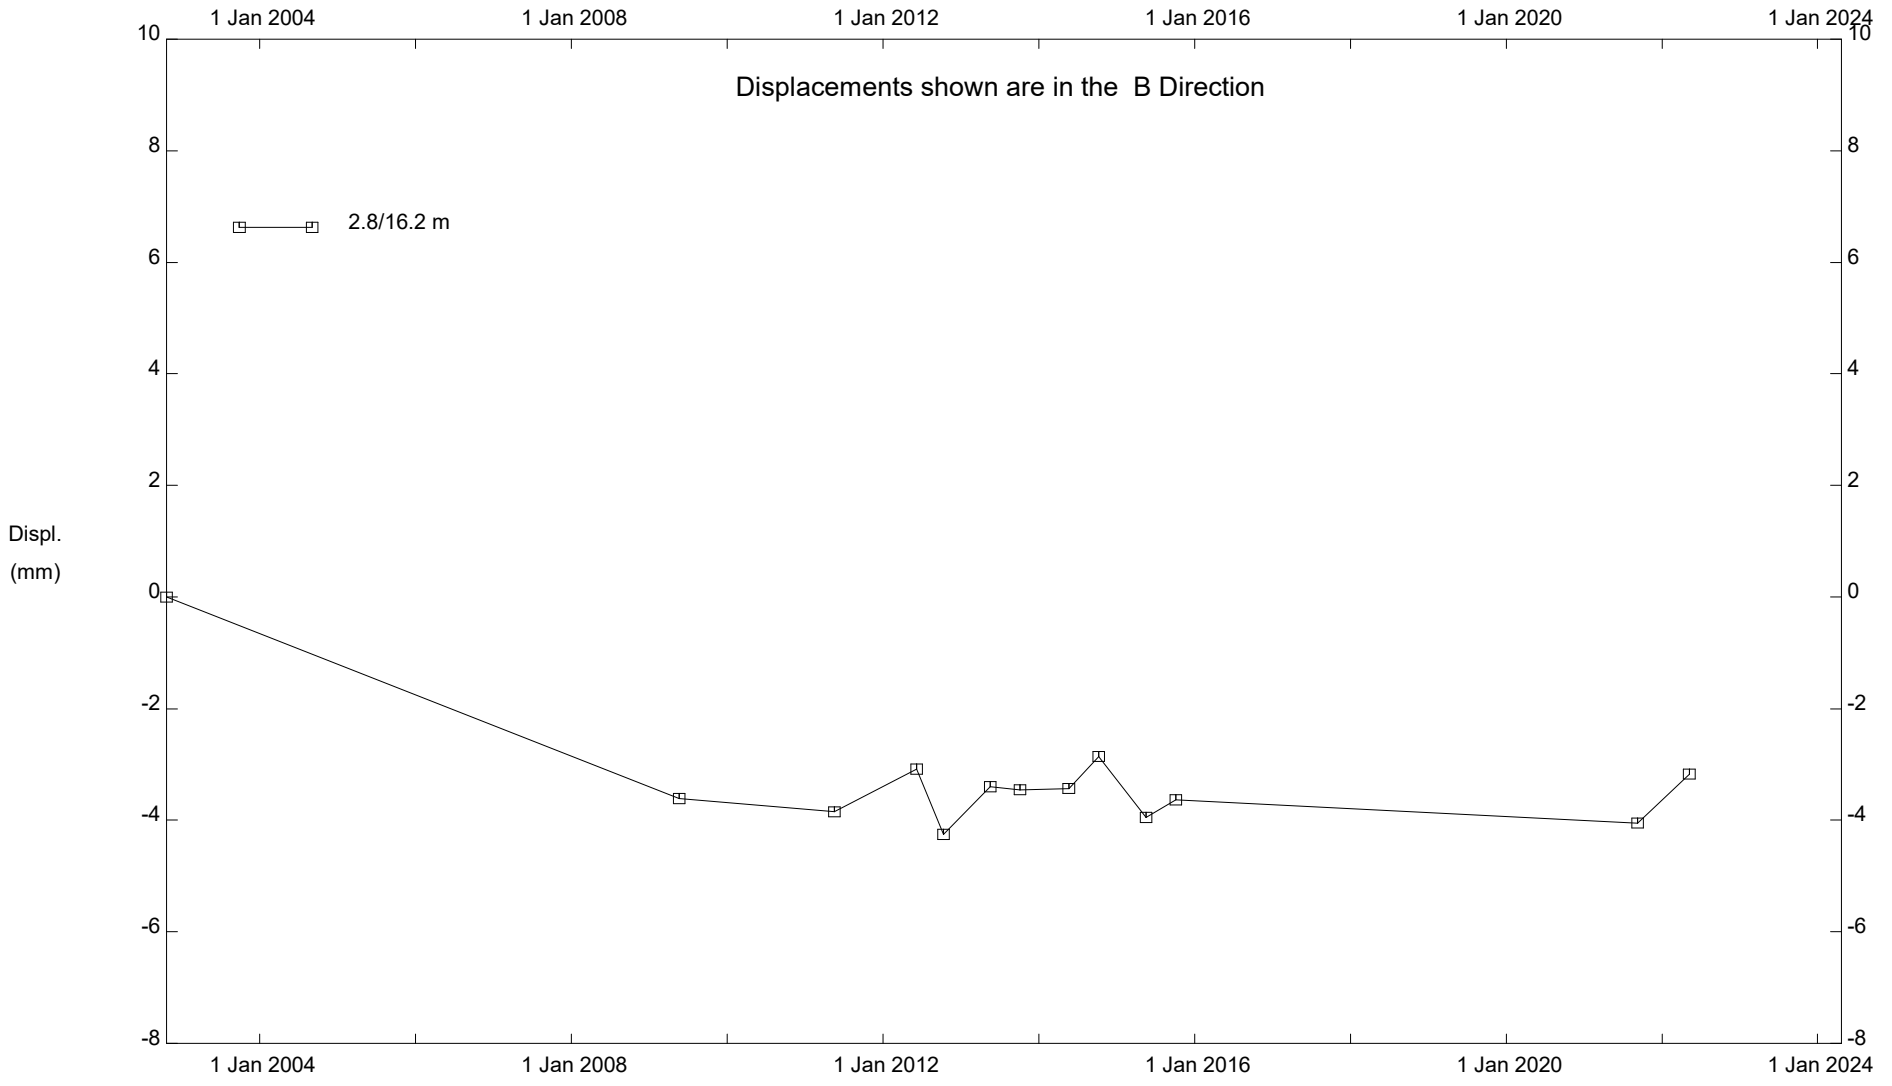
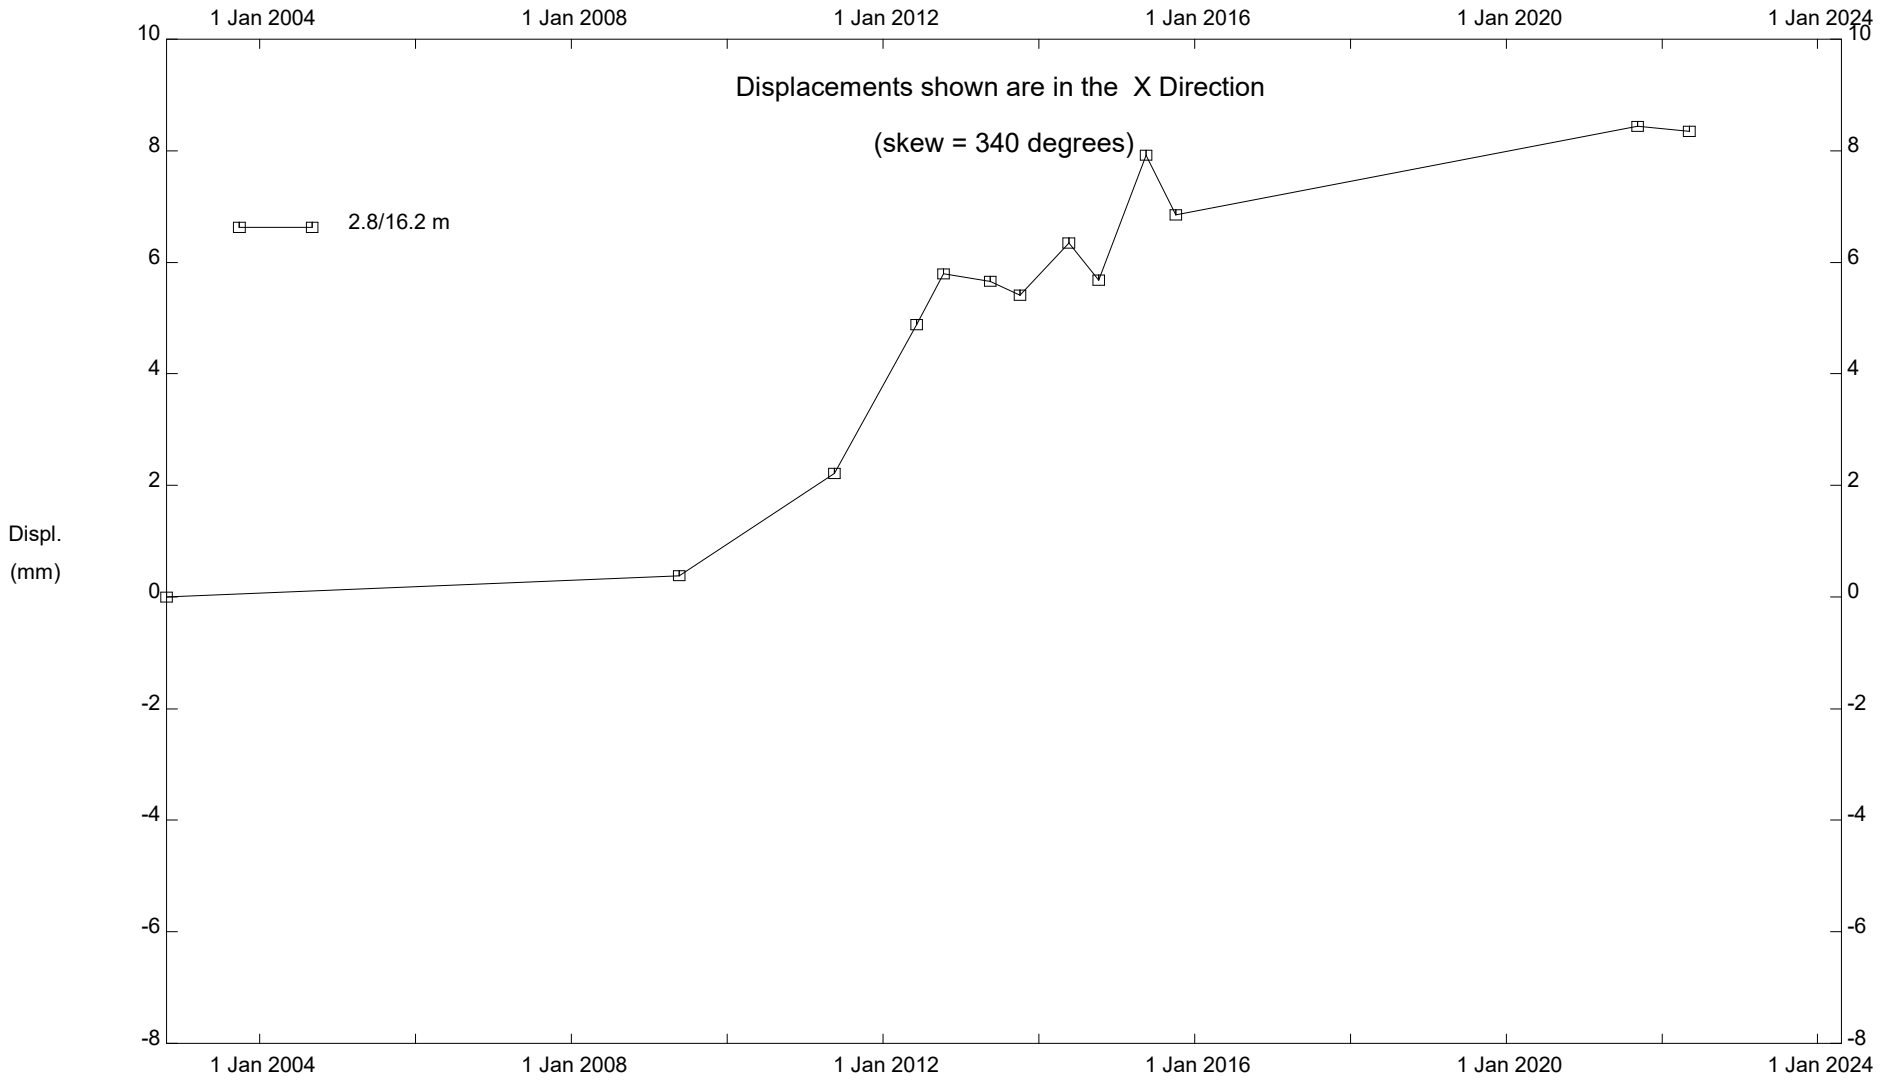
NC067, Inclinometer SI-04
 Alberta Transportation

- **SI-01** continues to show a negligible amount of incremental movement since about 2015. The total cumulative movement is about 32 mm.
- **SI-02** shows a current rate of movement of 4 mm/yr within the clay fill. The total cumulative movement is about 63 mm. An average movement rate of about 7 mm/yr was observed from Fall 2009 to Fall 2013 which decreased to an average rate of about 2 mm/yr to 3 mm/yr from 2014 on.
- **SI-03** is being monitored near surface and showed decreasing cumulative movement between 2018 and 2021. The cumulative movement increased to 106 mm during the Spring 2022 readings with the current rate of movement at 42 mm/yr.
- **SI-04** shows a rate of movement less than 1 mm/yr since 2015

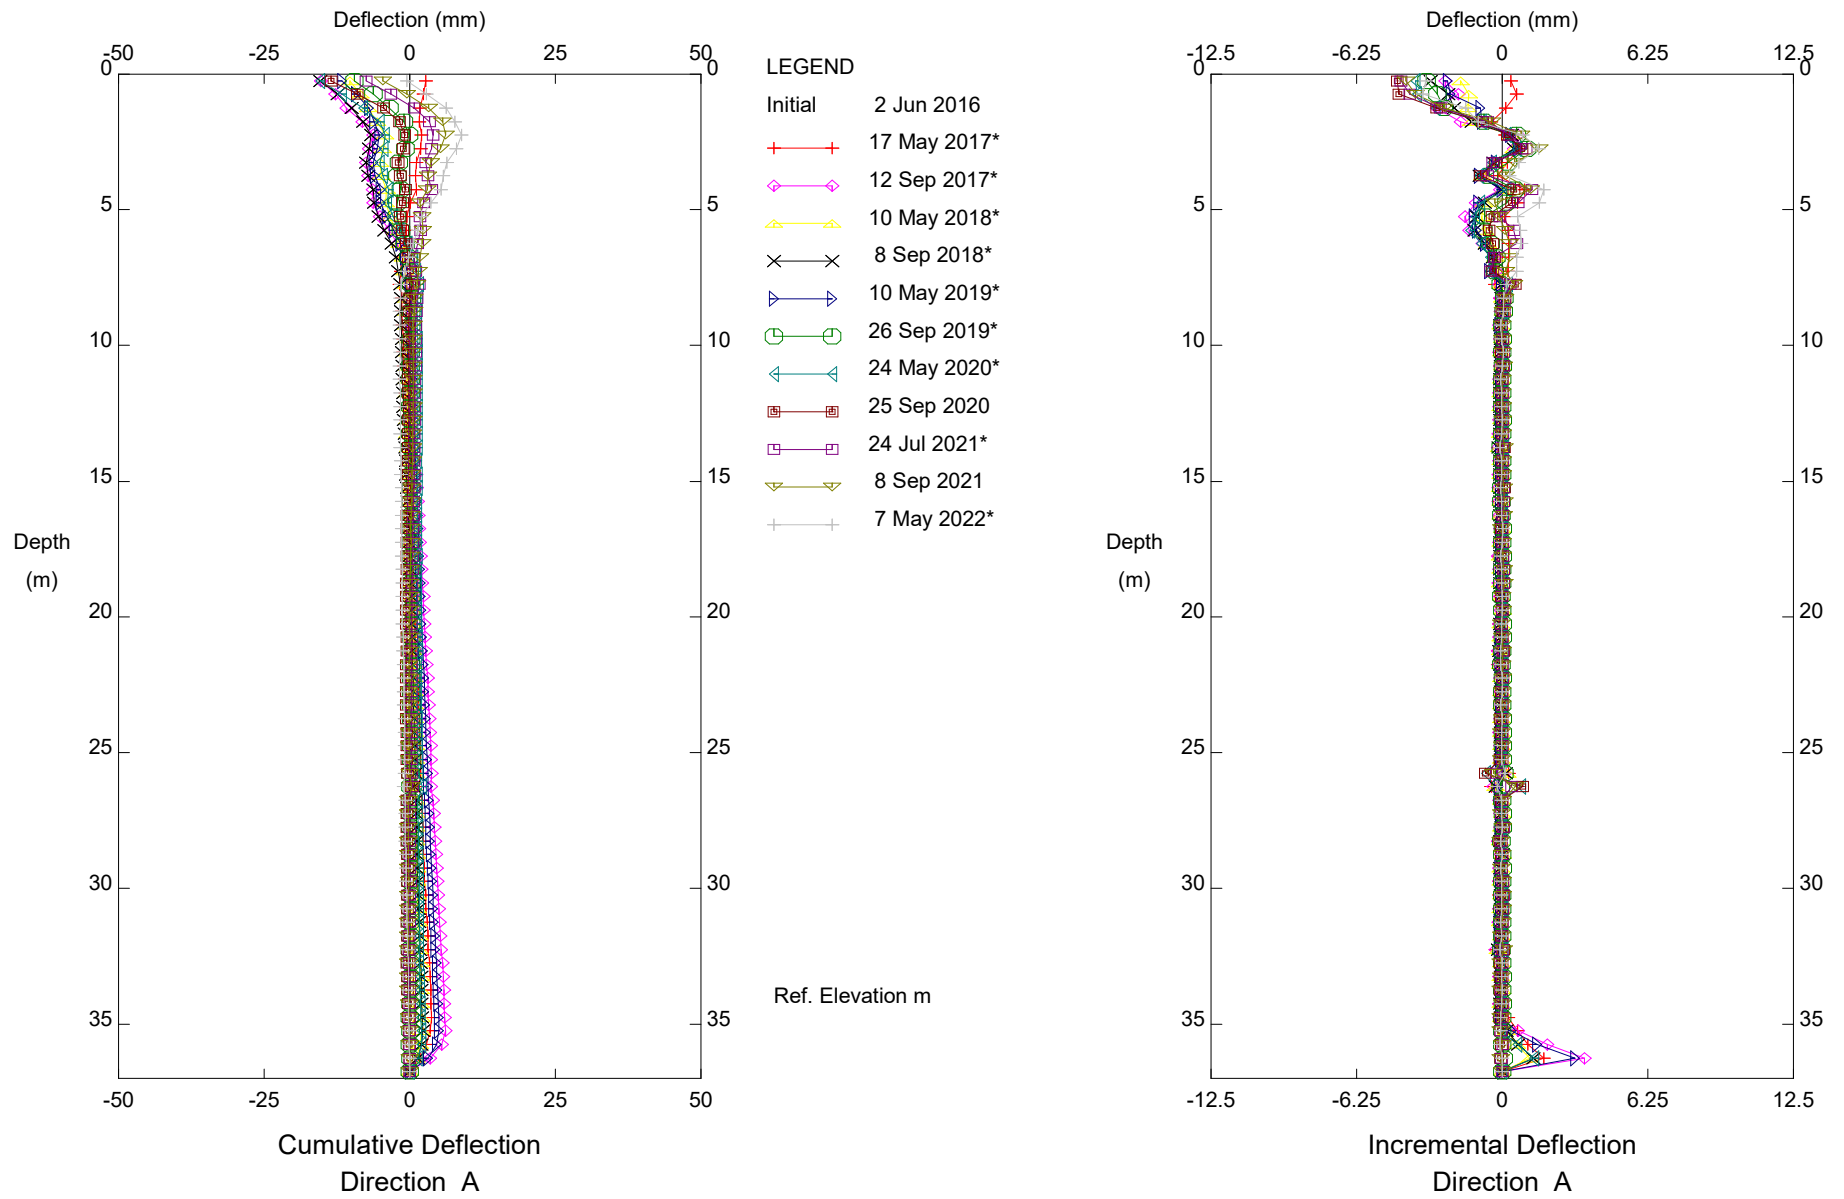
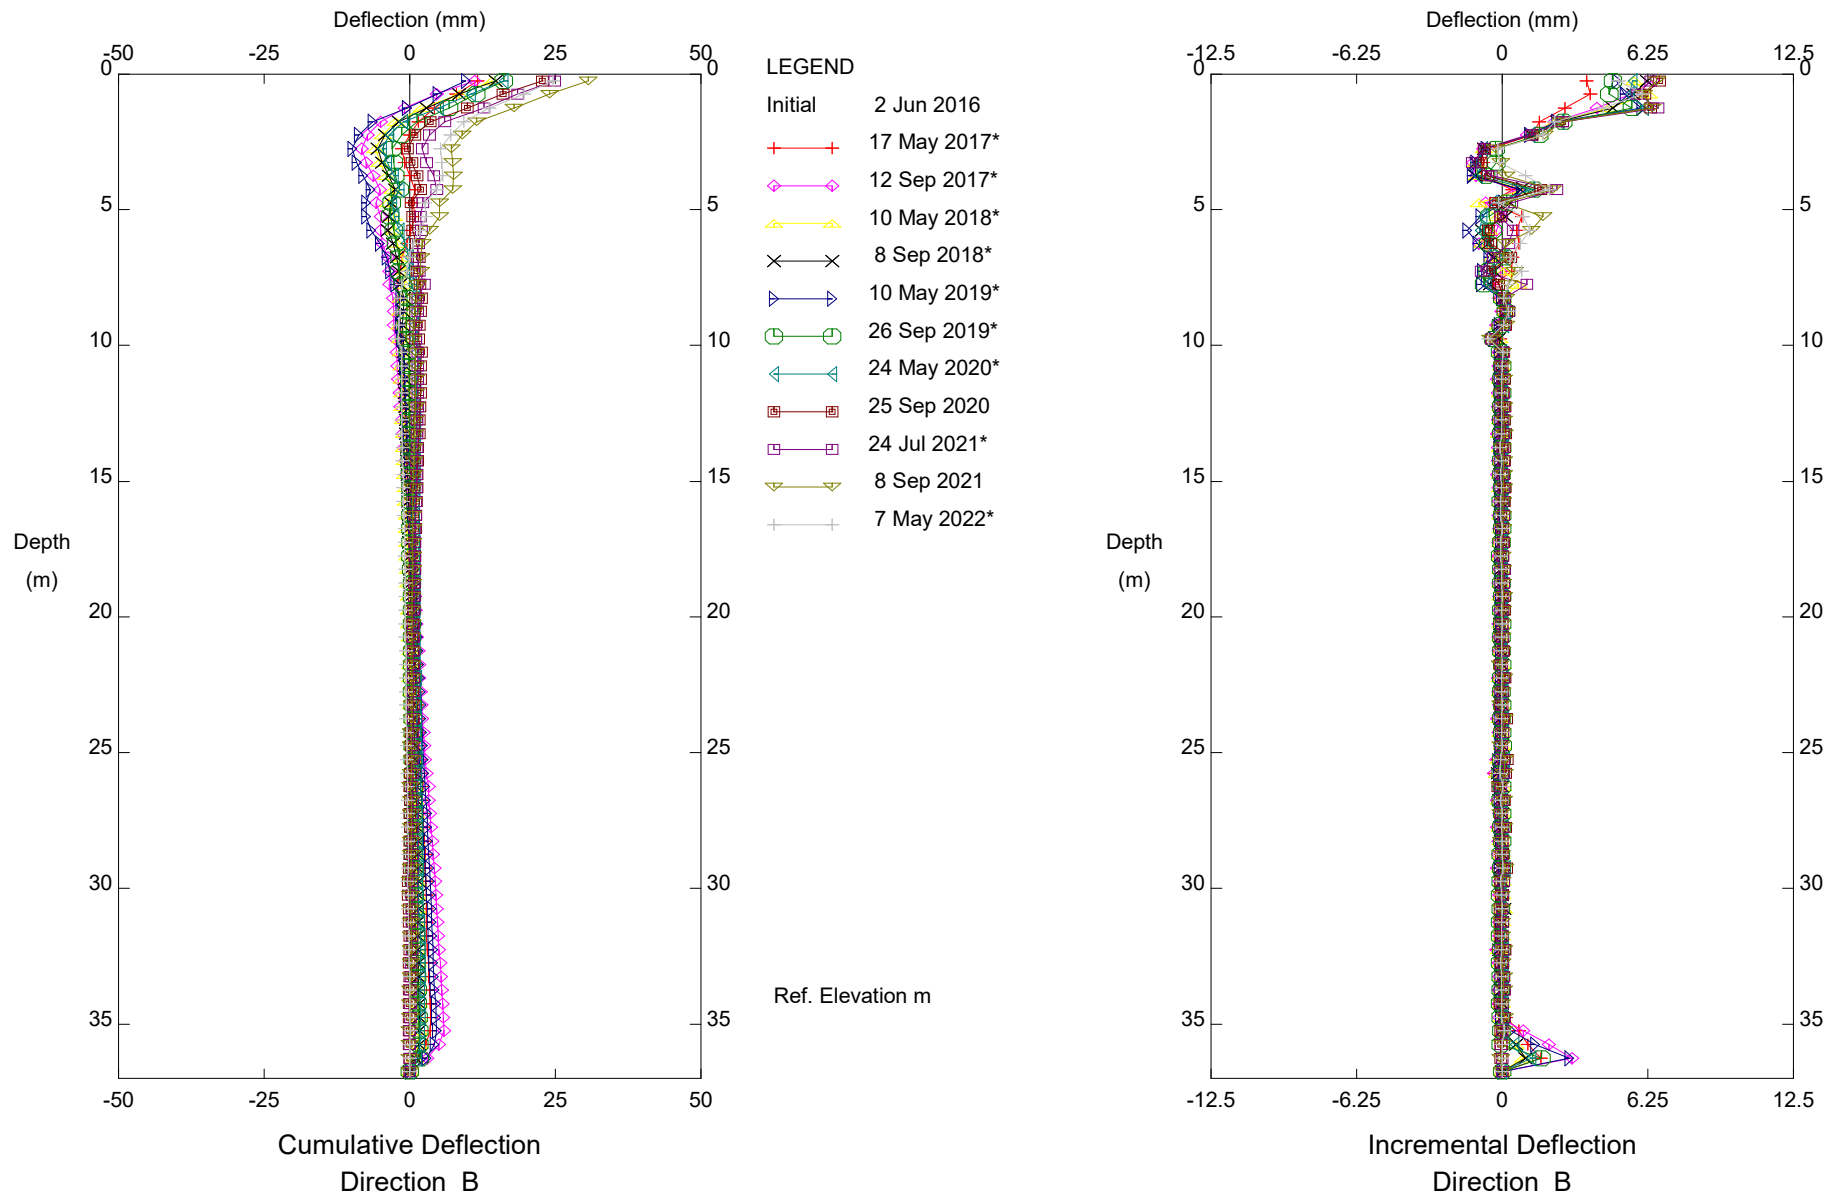
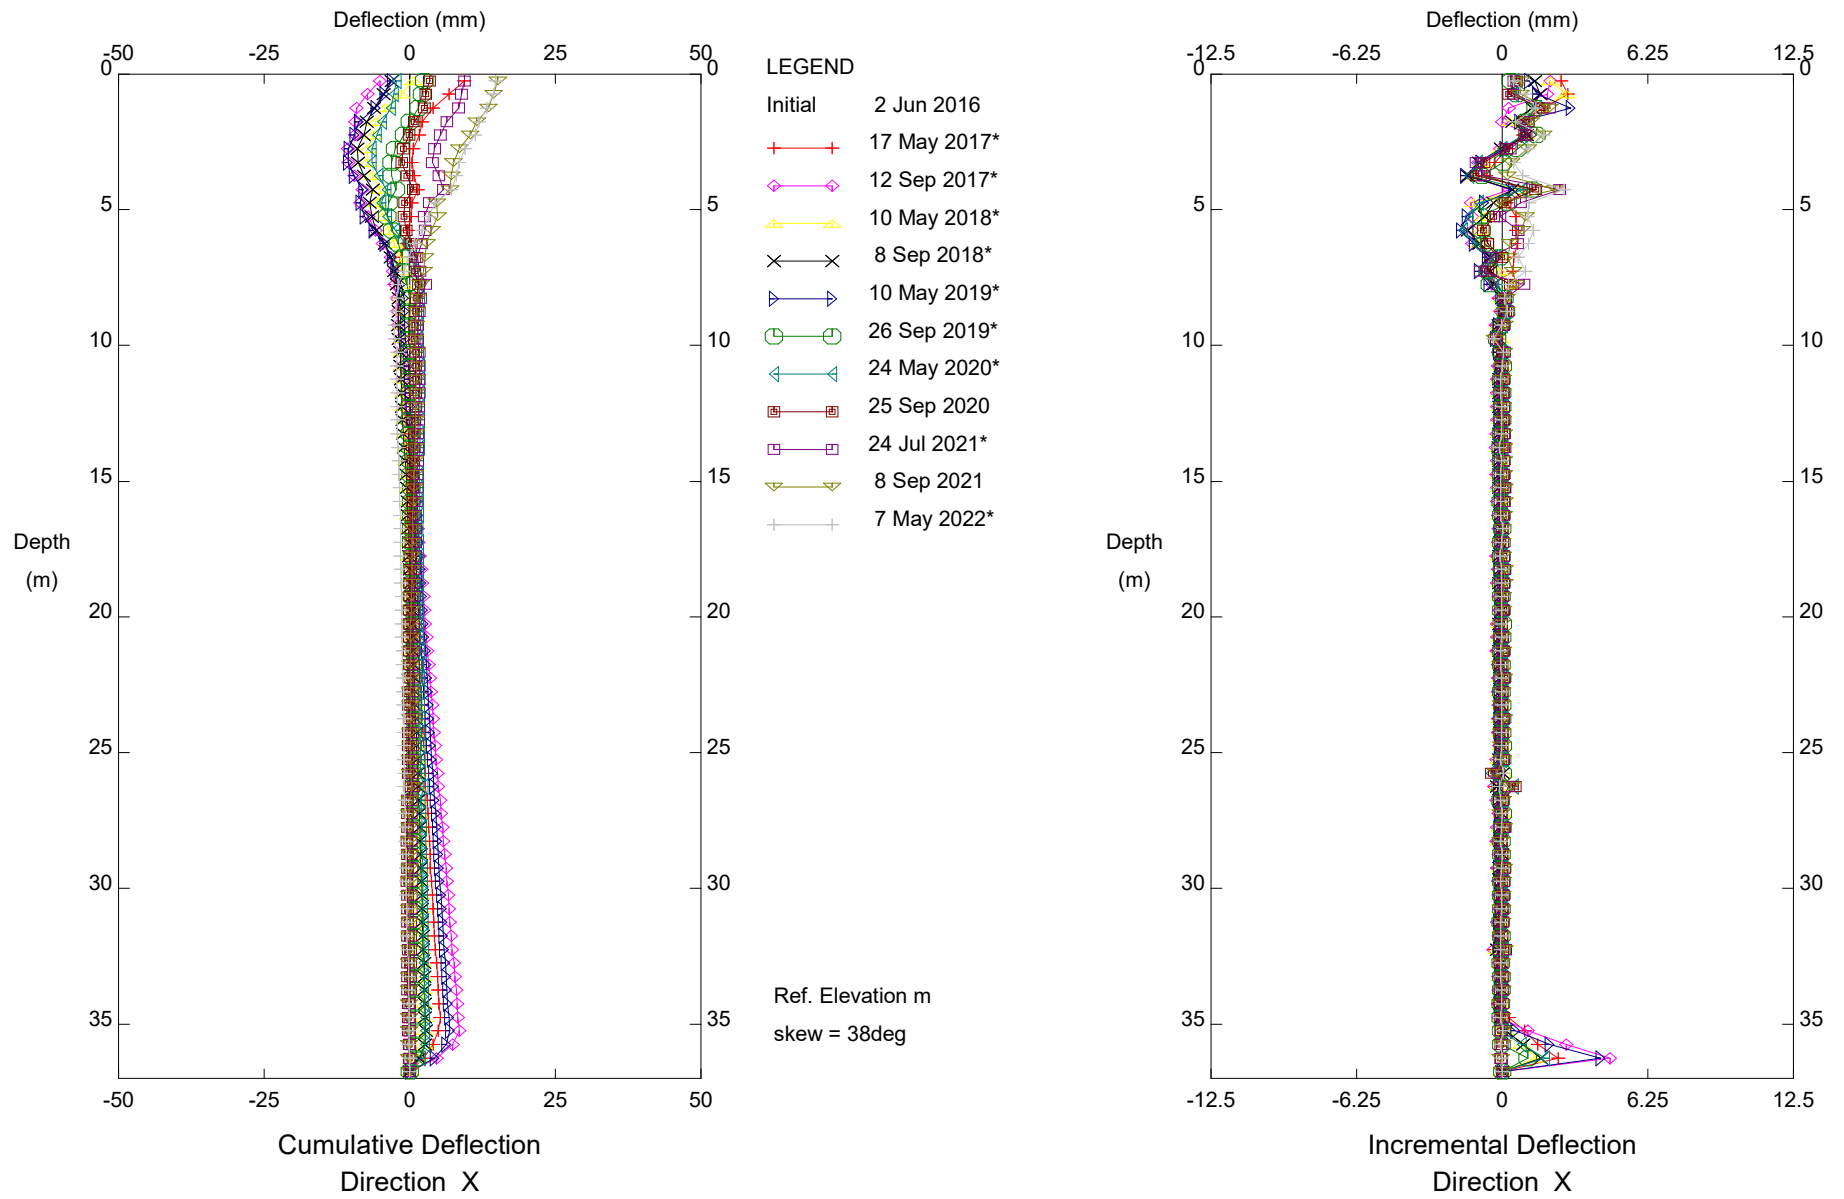
NC067, Inclinometer SI-06

SI-06 currently shows no discernable movement.
