To:	Amy Driessen Alberta Transportation	From:	Leslie Cho and Carrie Murray Stantec Consulting Ltd.
File:	123315222	Date:	June 12, 2022

Reference: North Central Region, Stony Plain, Site NC067 - Highway 216:06 Anthony Henday Bridge, Spring 2022 Instrumentation Monitoring Report

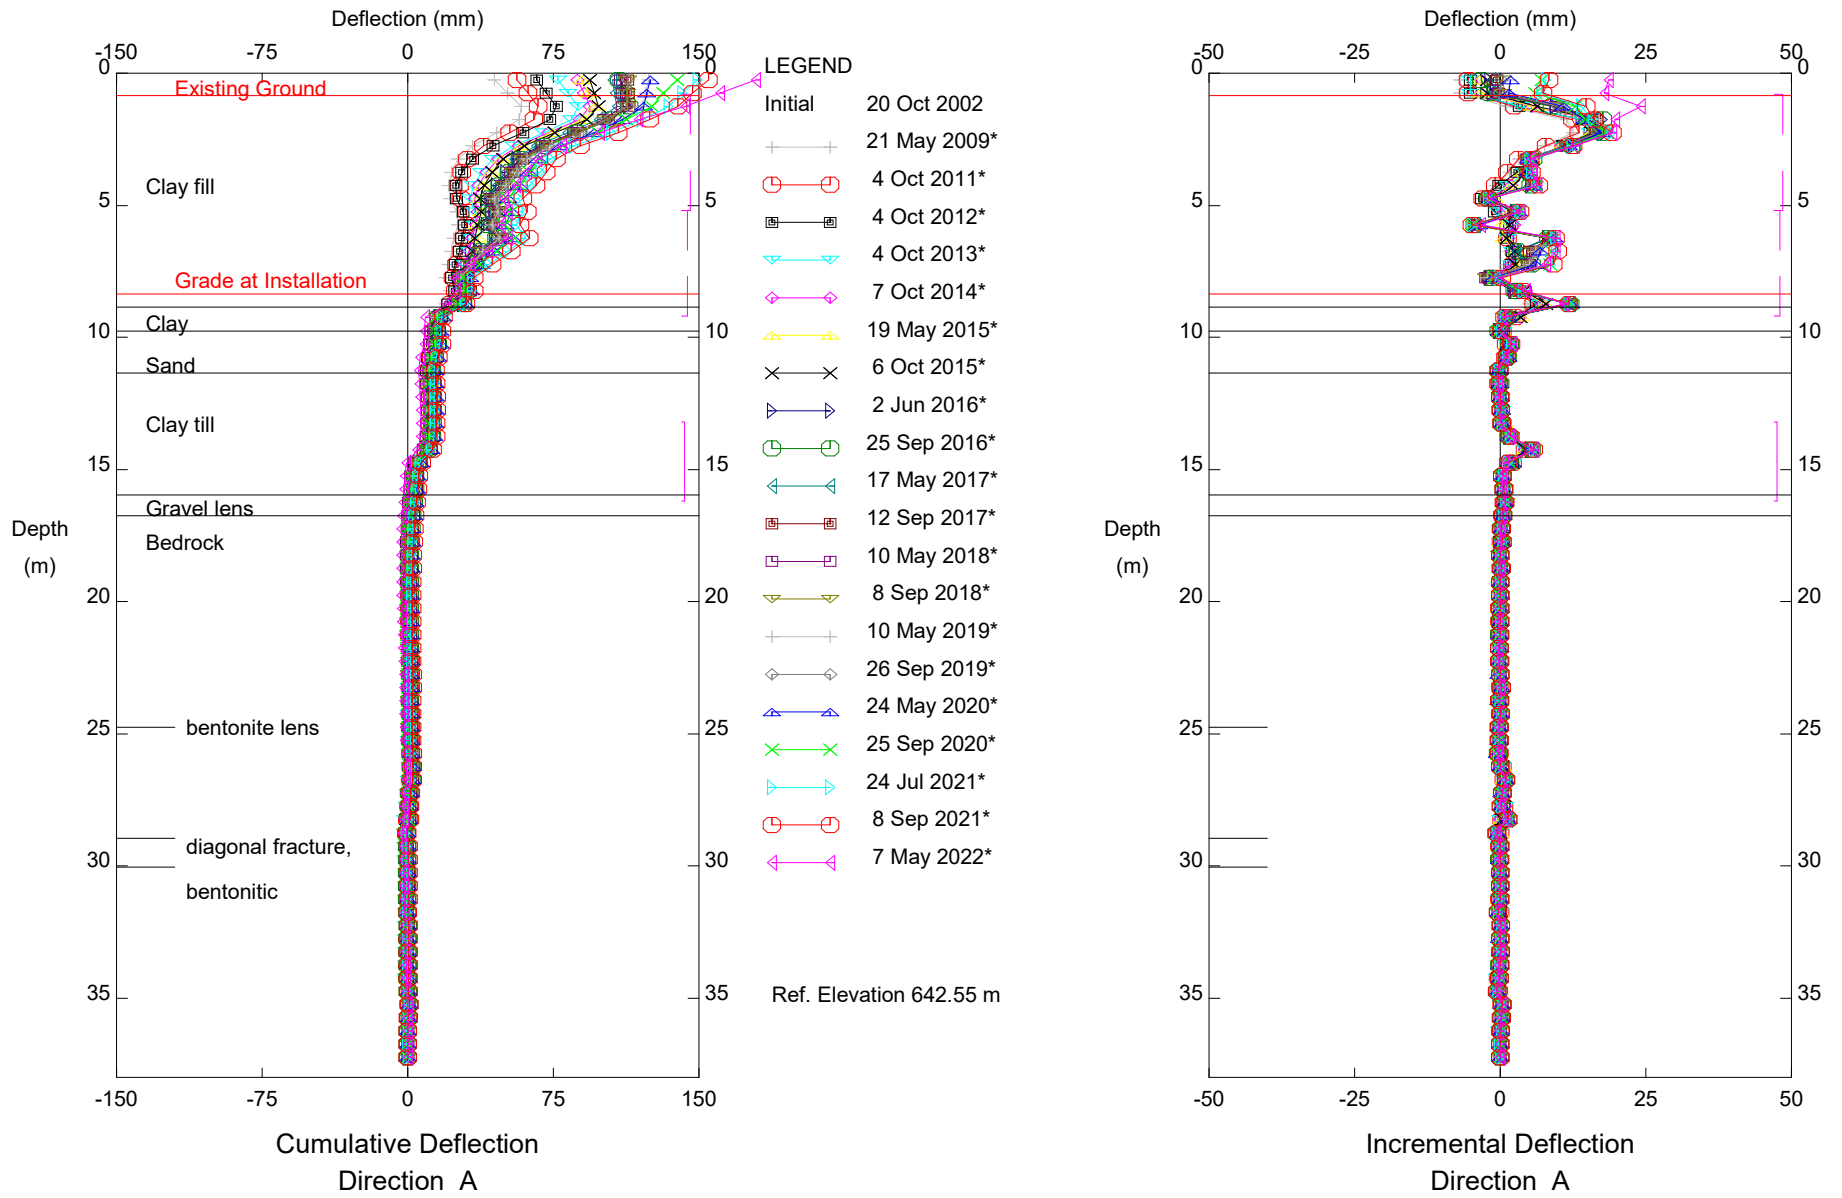
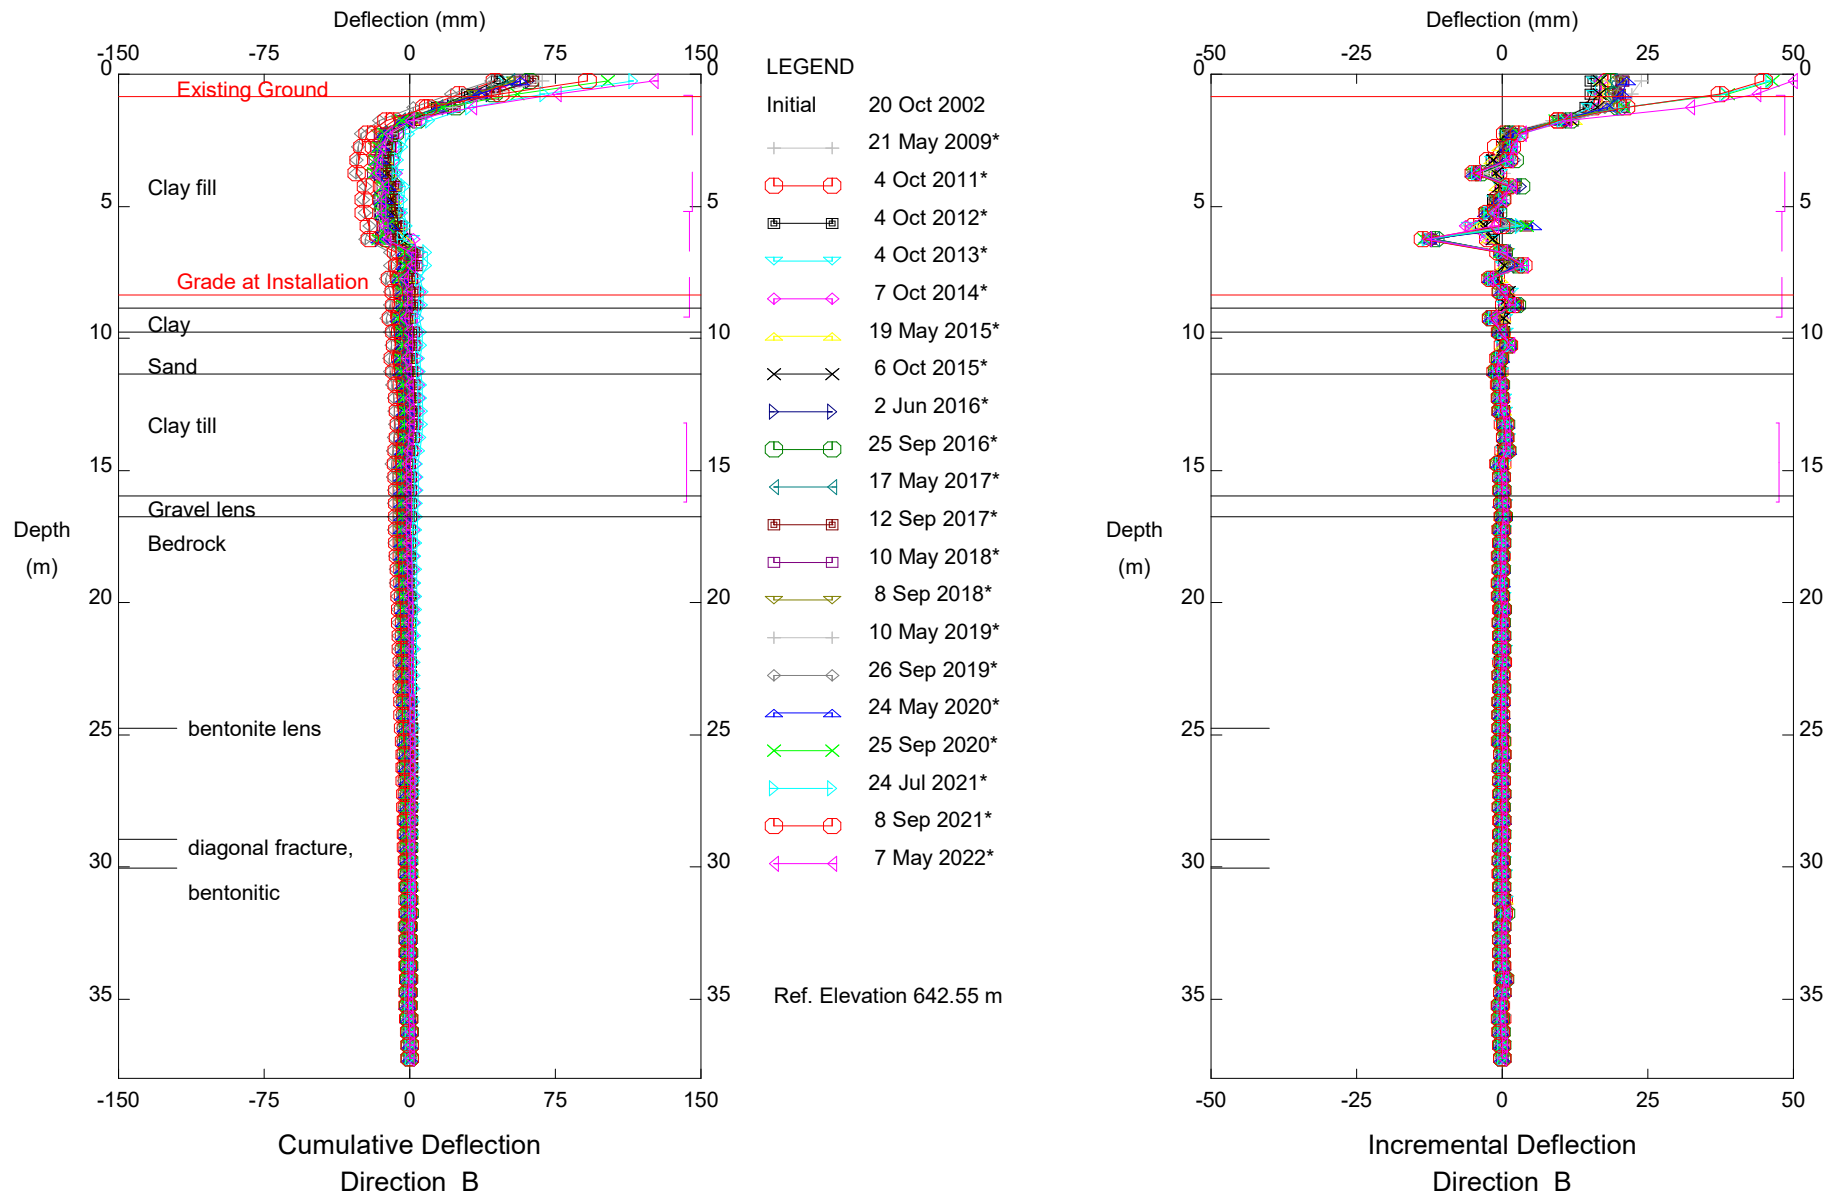
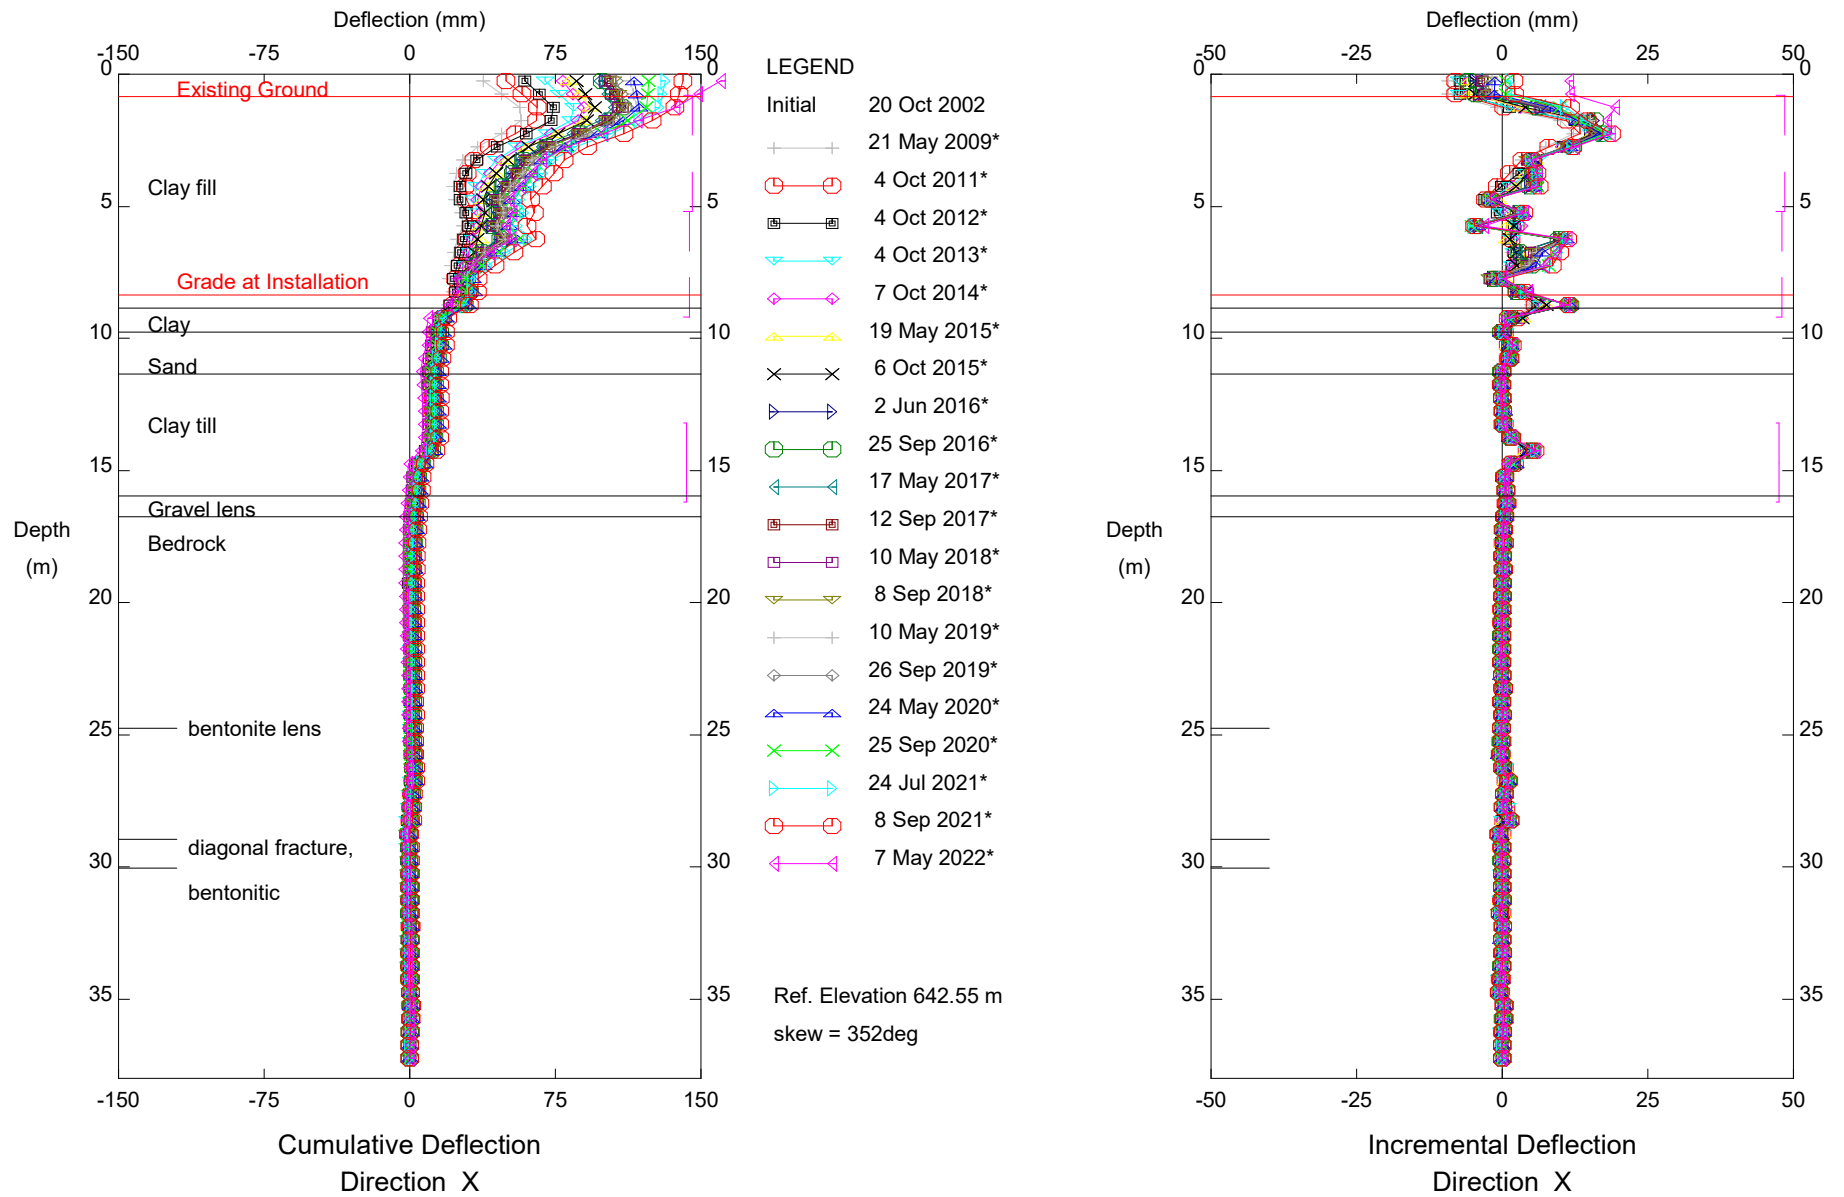
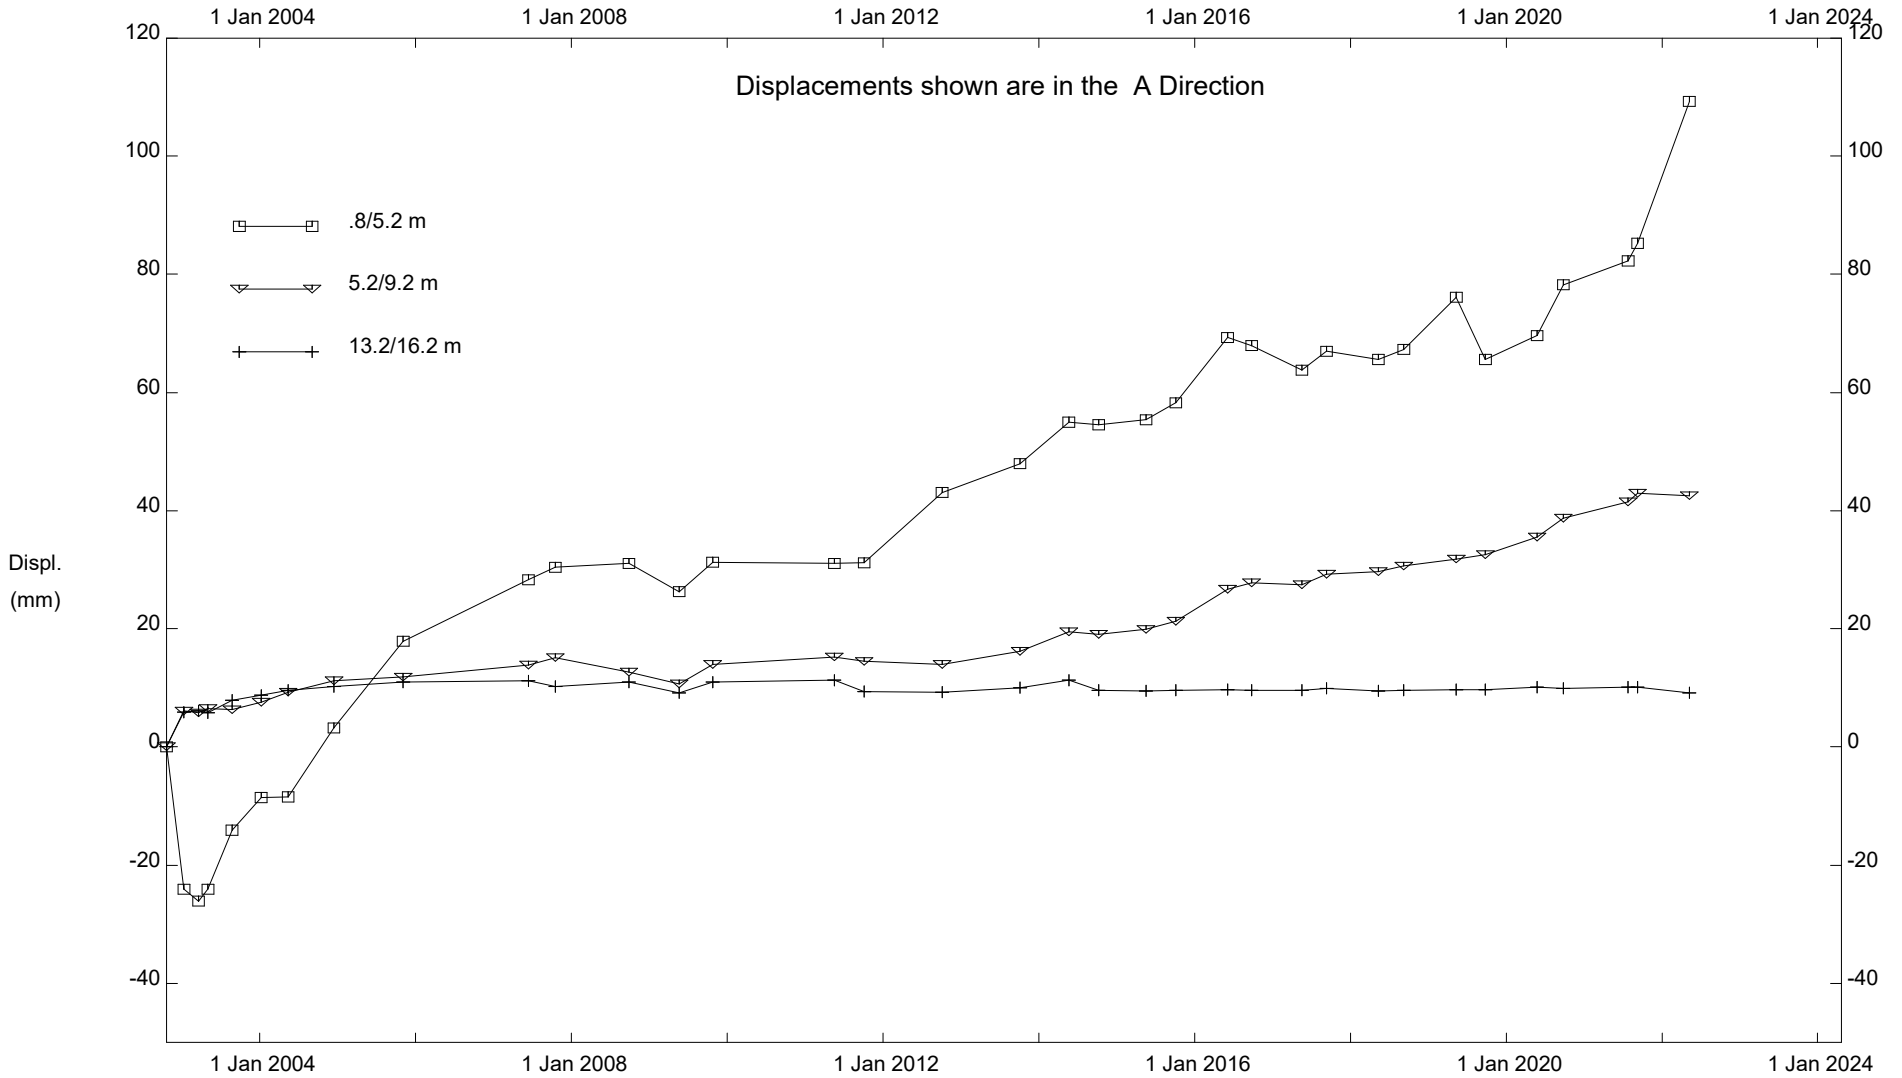
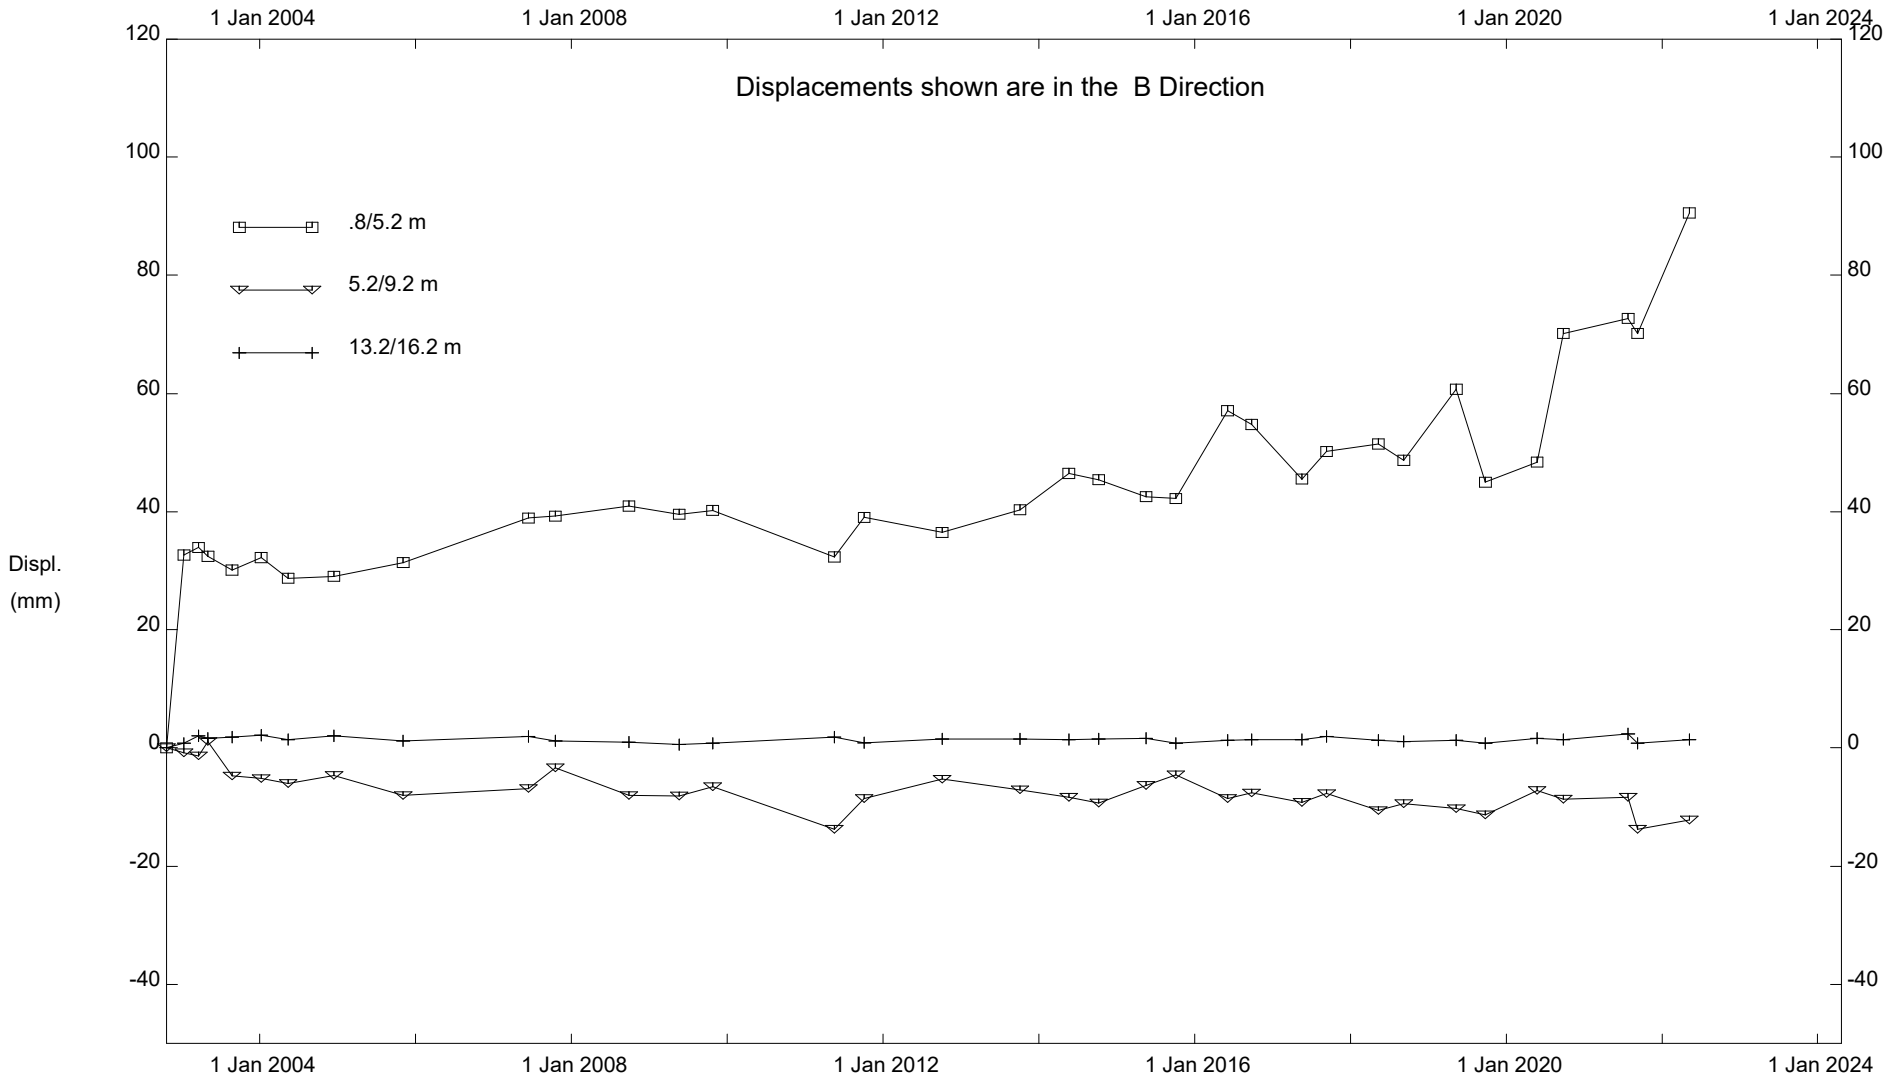
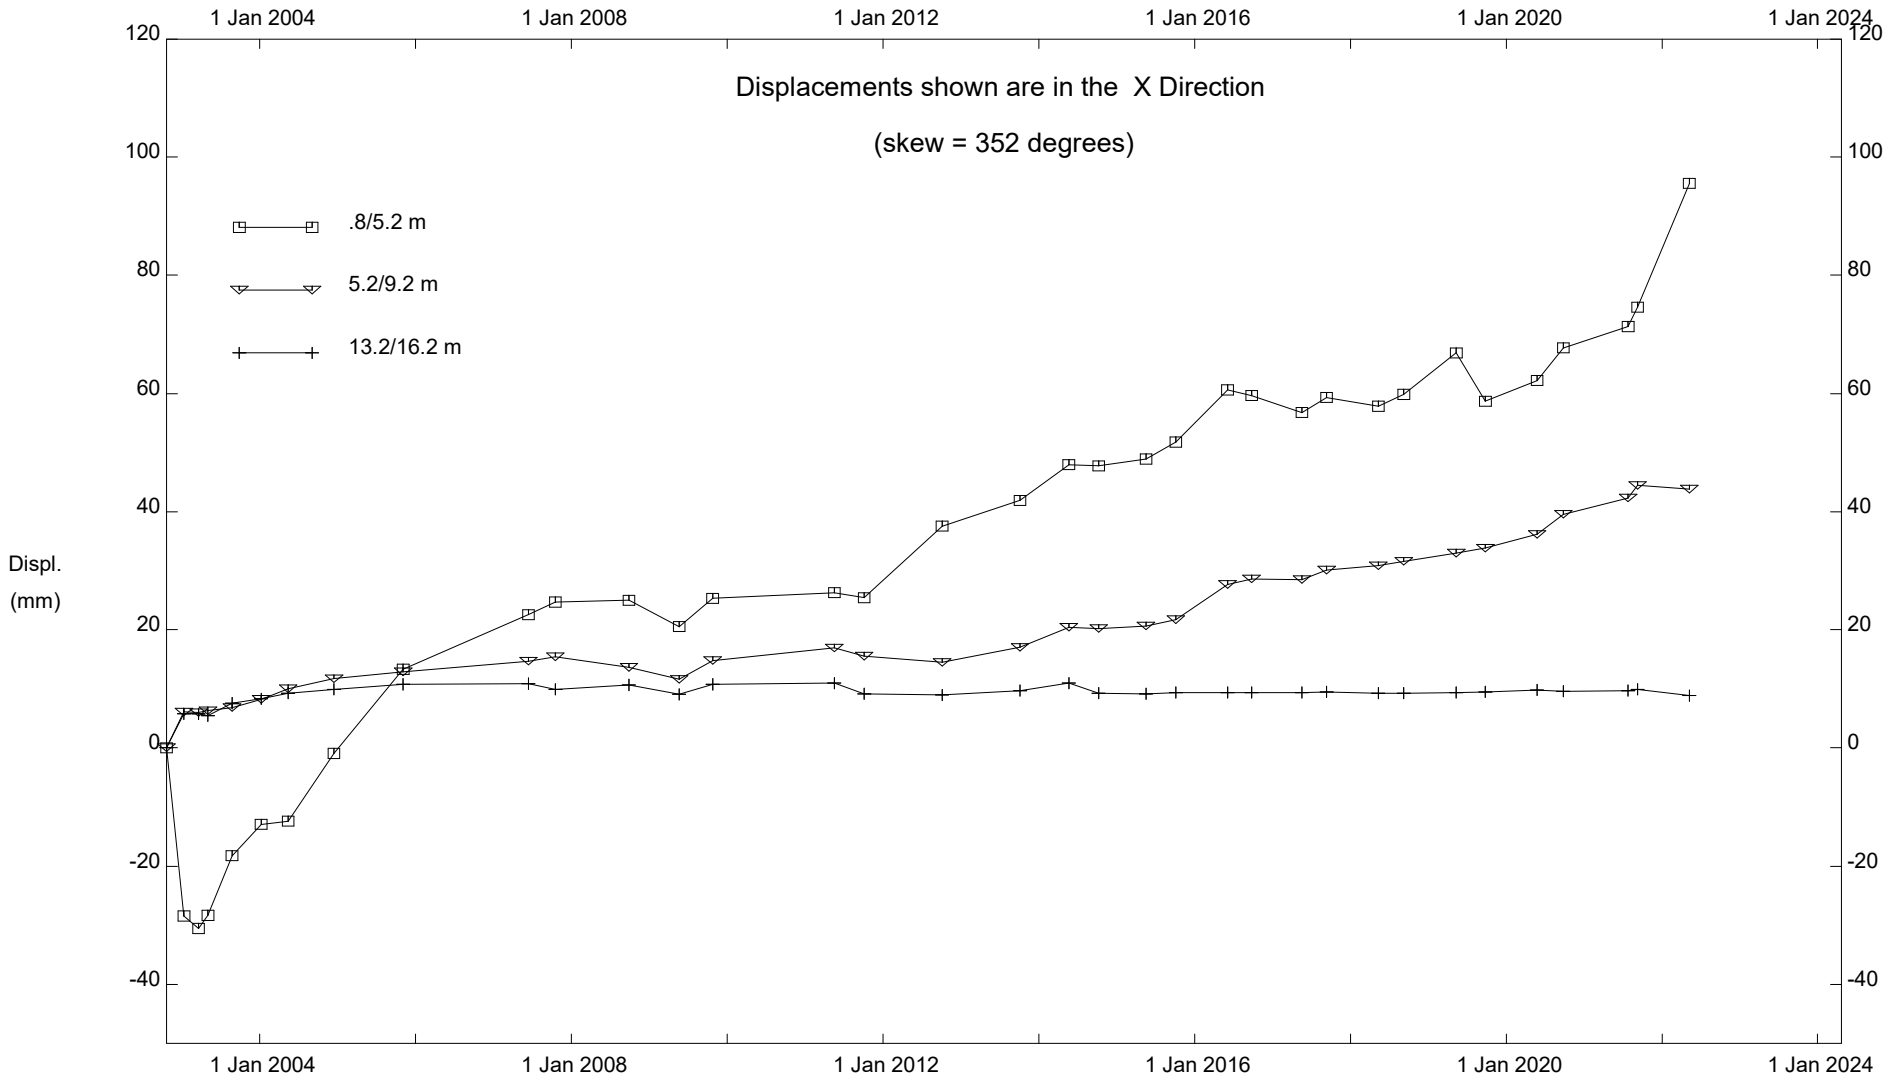
NC067, Inclinometer SI-07
 Alberta Transportation

SI-07 has three zones of movement observed at around 3 m, 7 m, and 15 m depths. The current rate of movement is about 32 mm/yr in the upper zone corresponding to an increase in the movement rate of 6 mm/yr since Fall 2021, and about 1 mm/yr in the middle zone. The lower shear zone remains stable since about 2004 with little to no change in cumulative movement observed.

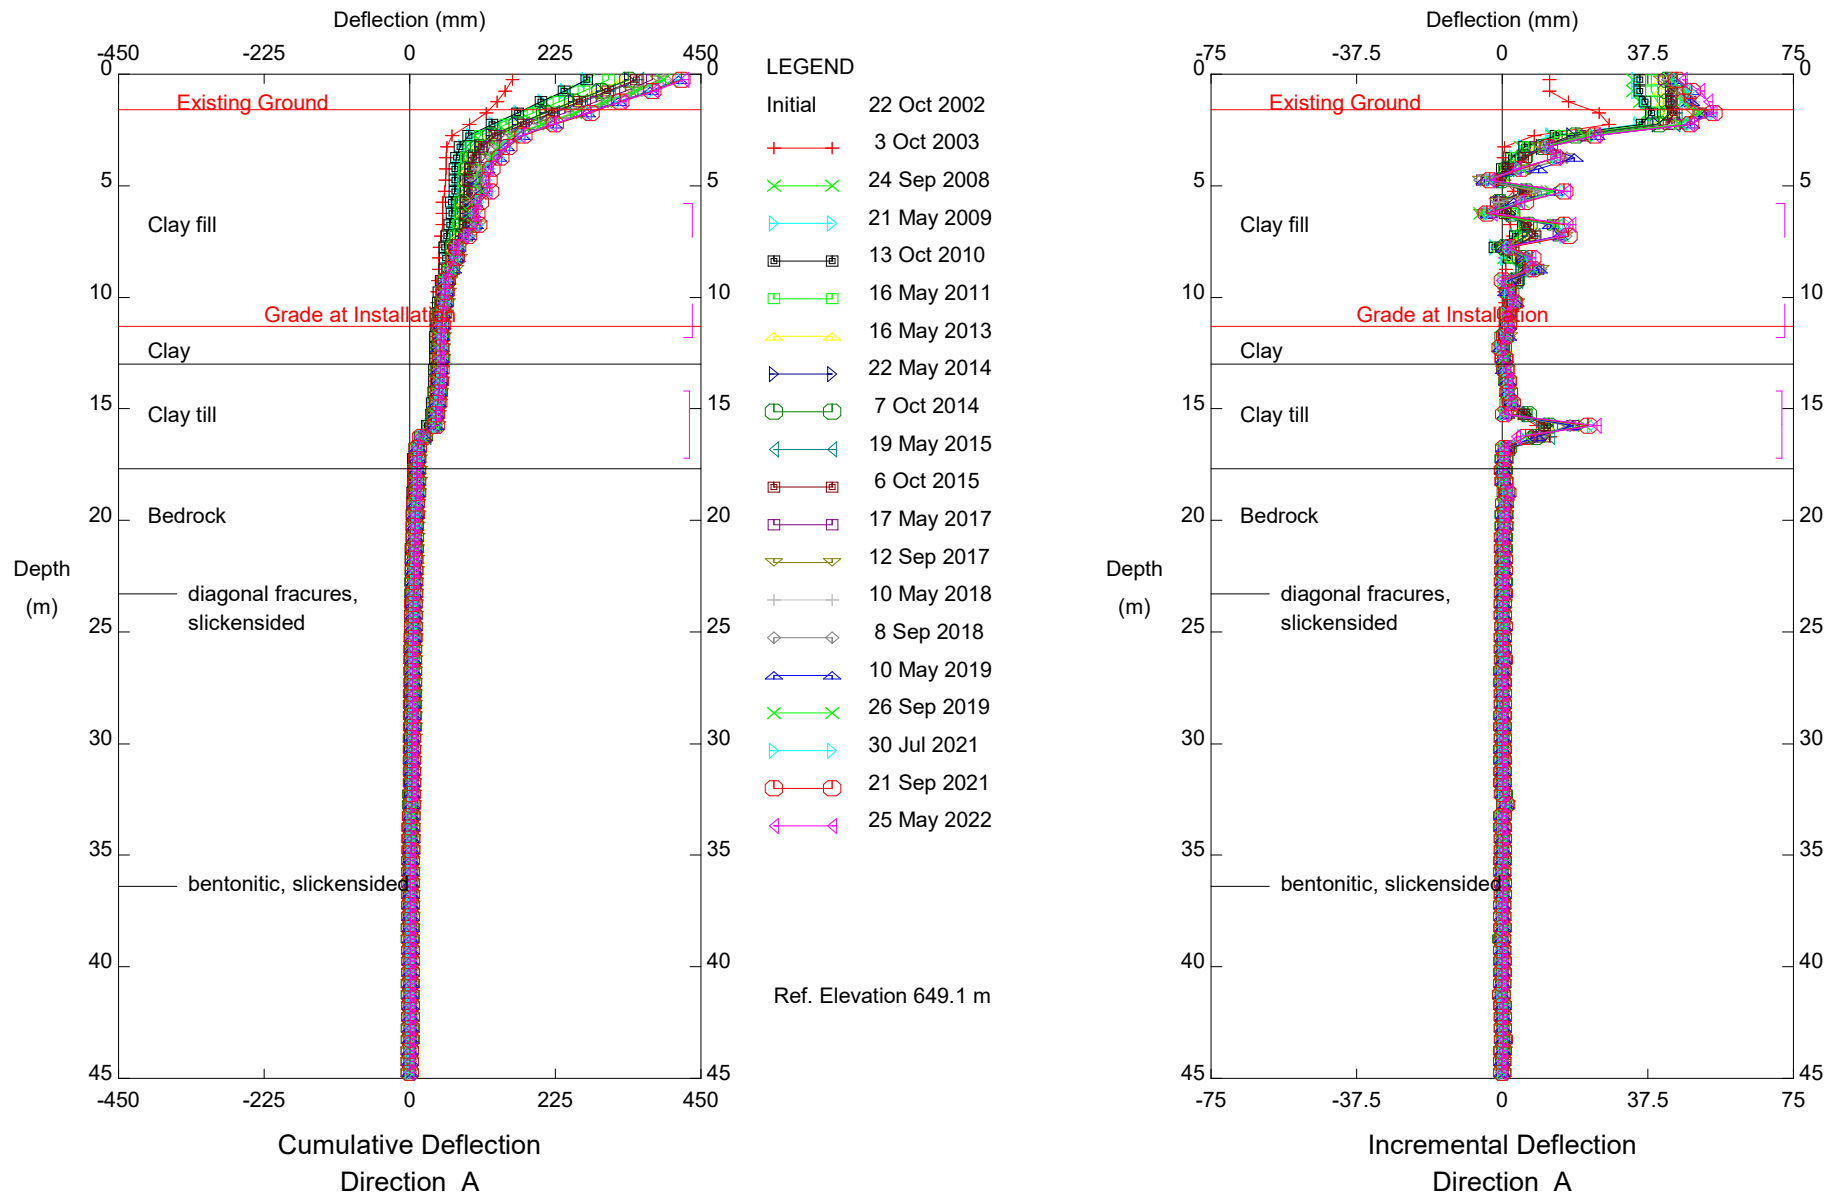
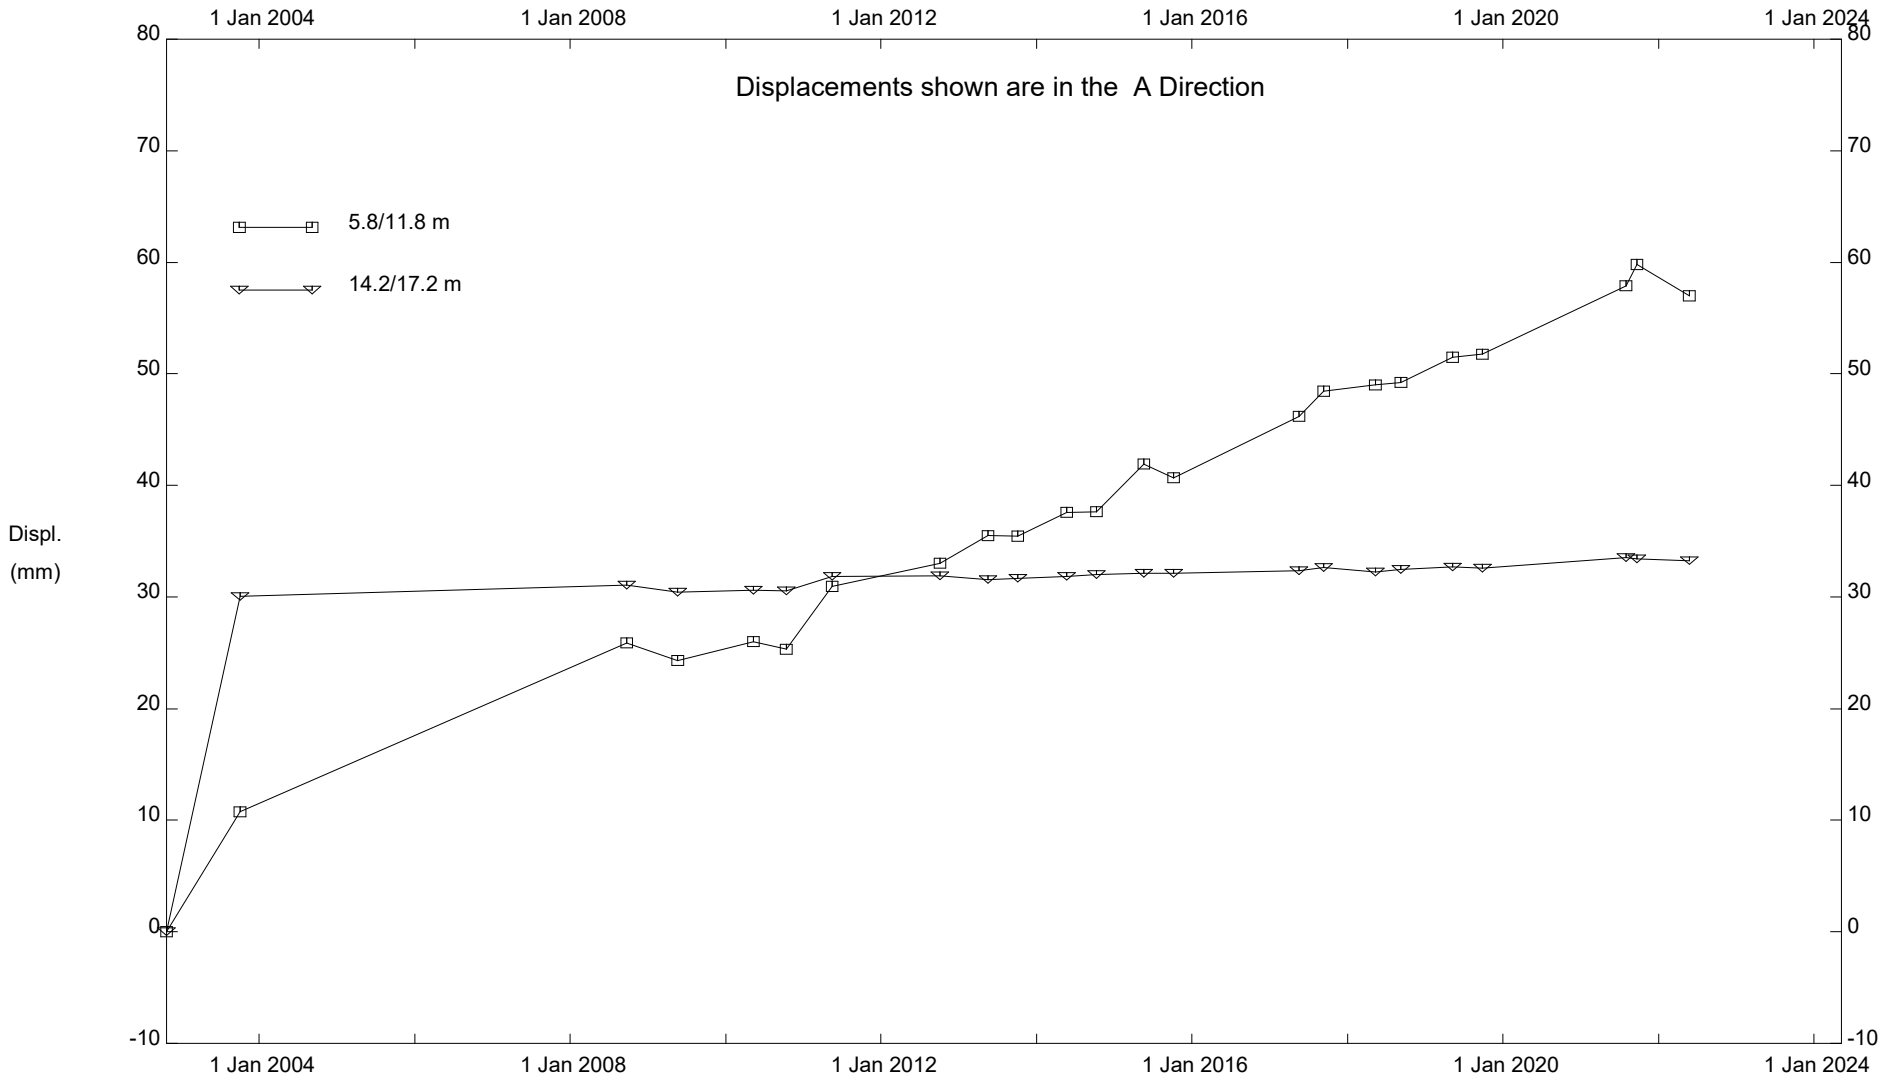
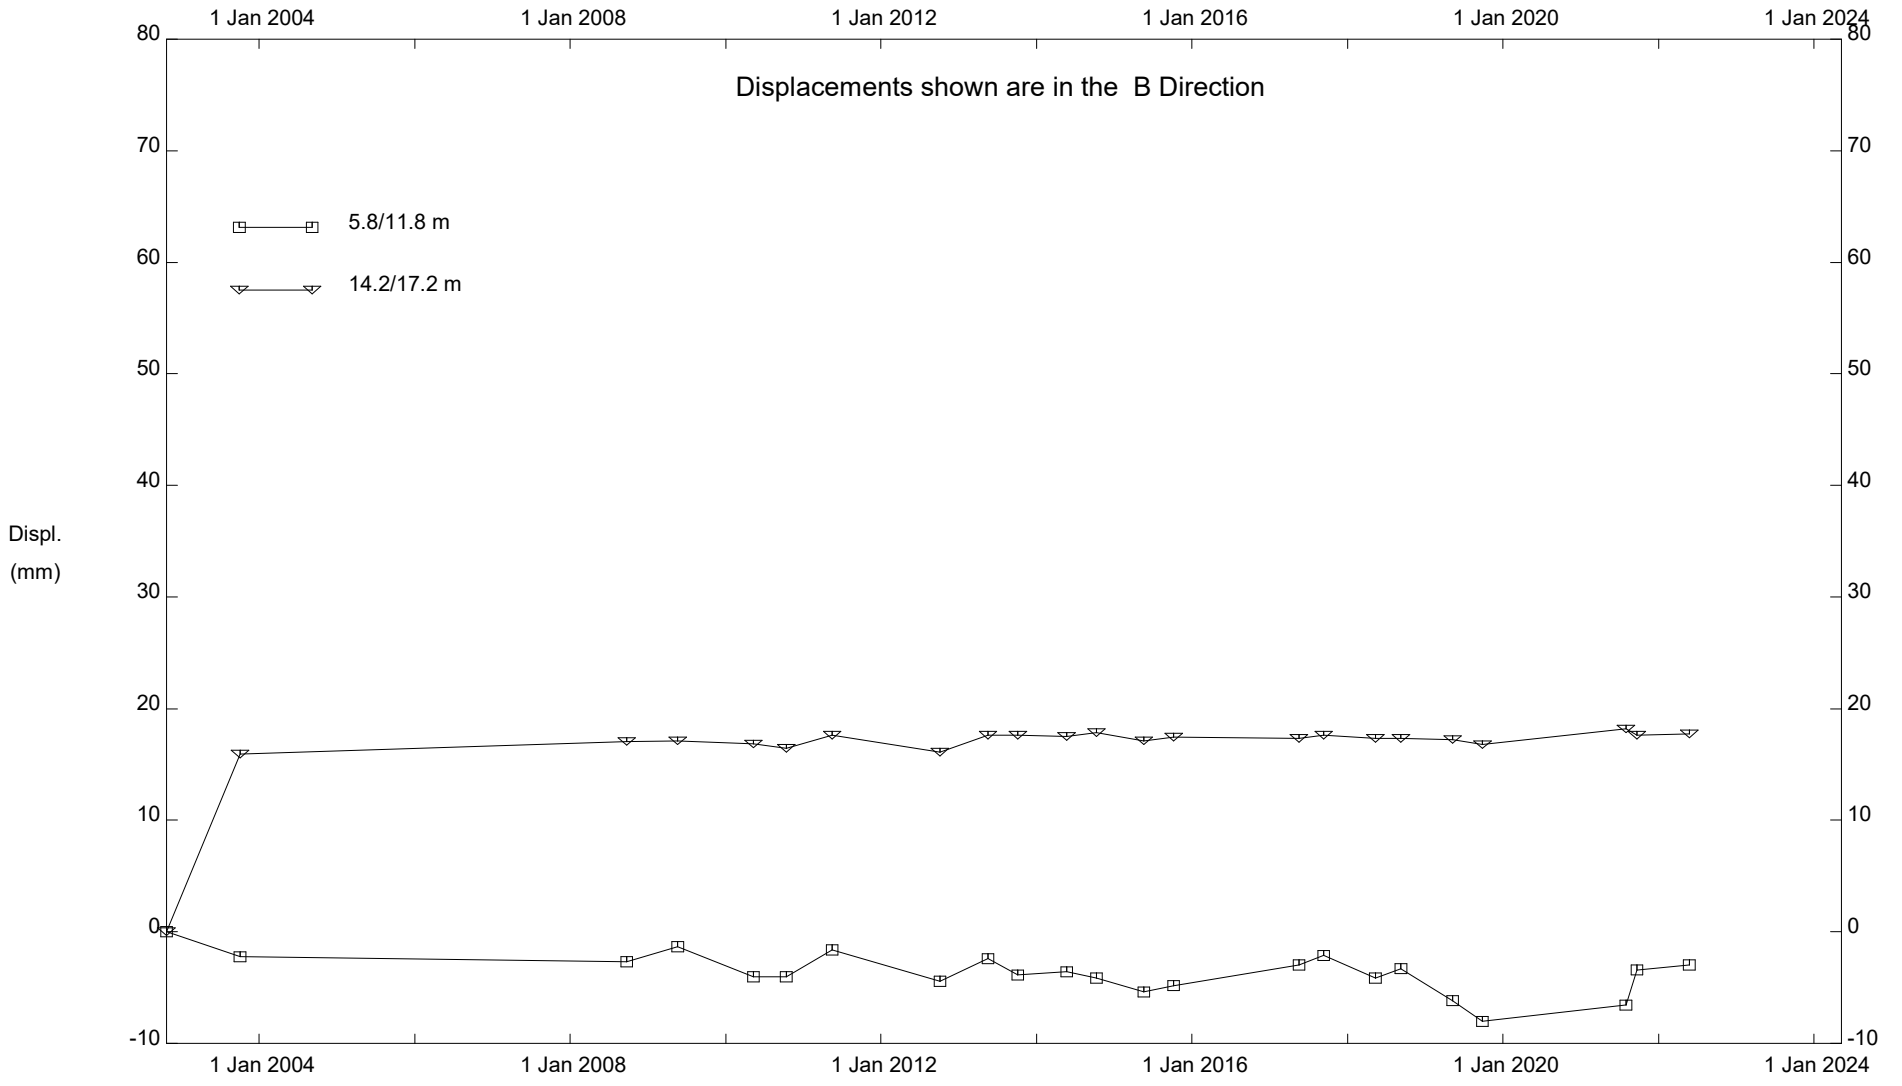
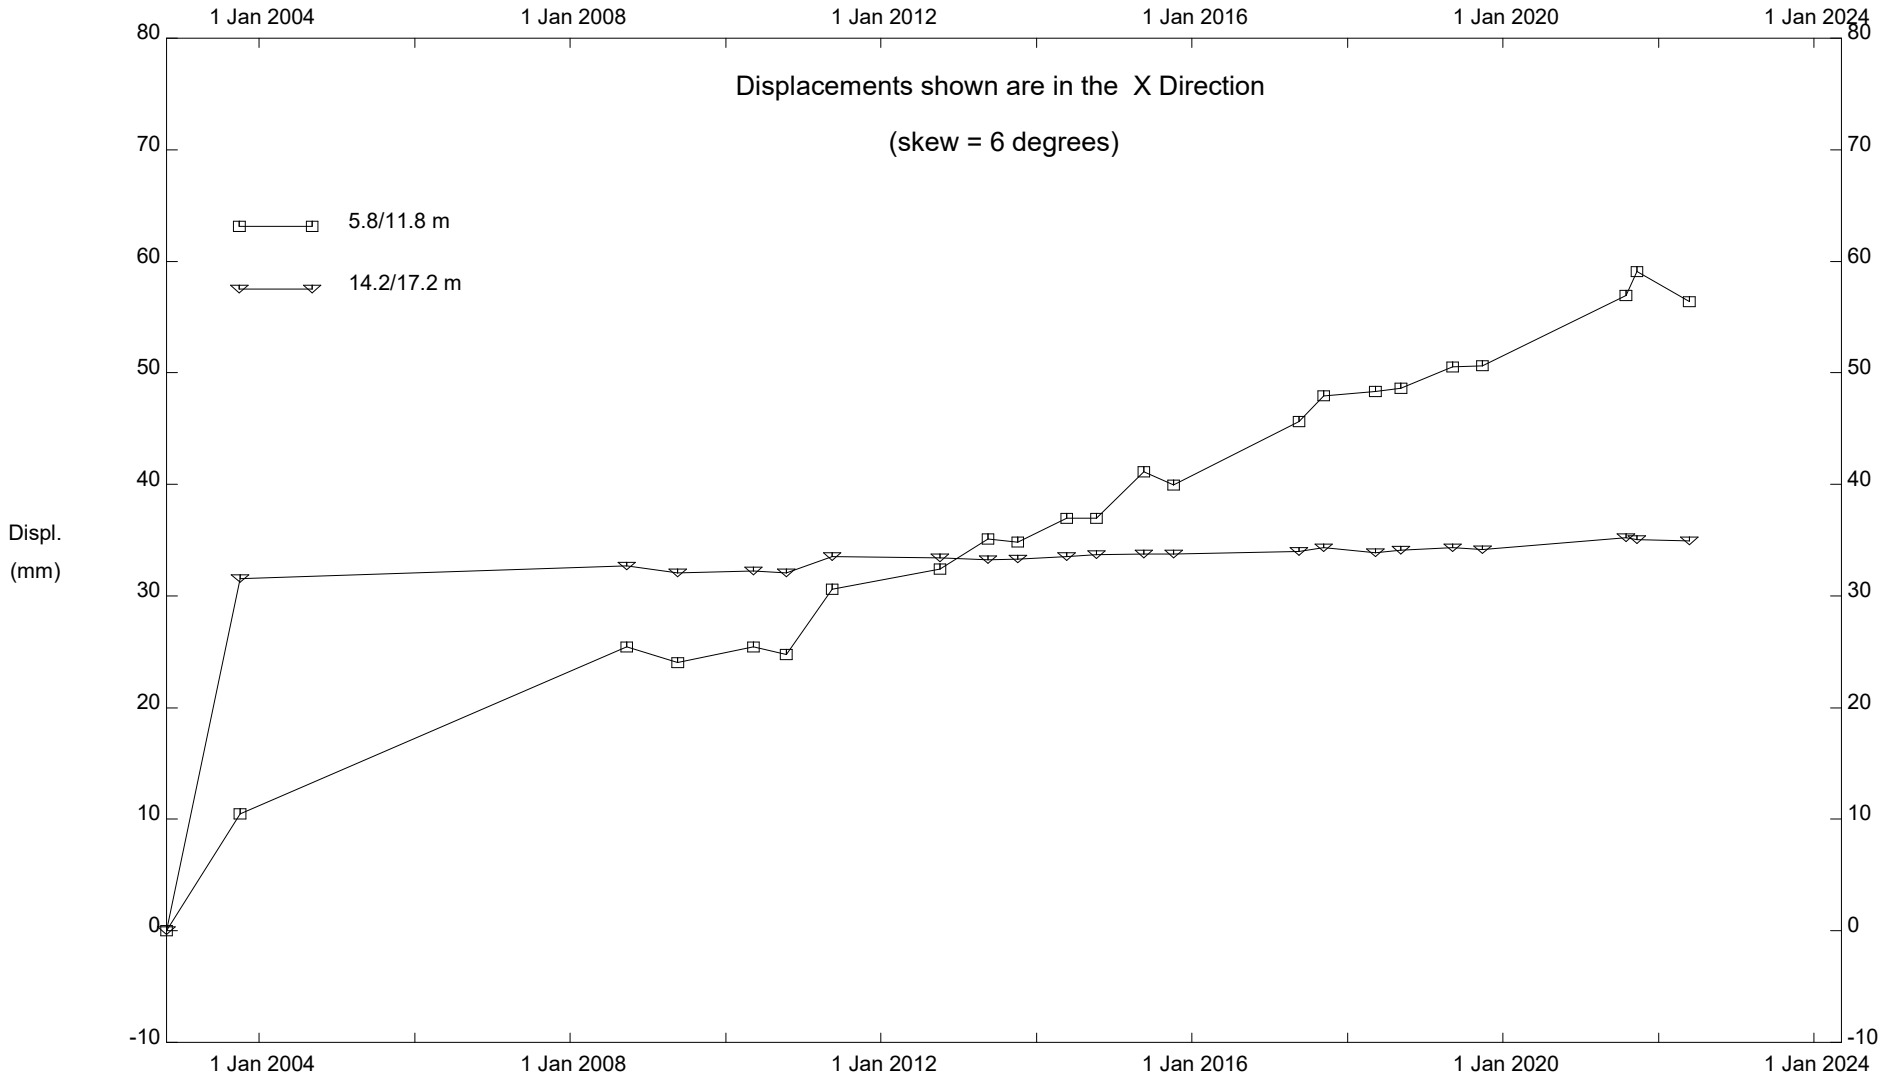
NC067, Inclinometer SI-08
Alberta Transportation

SI-08 has two zones of movement observed at around 8 m and 16 m depth. The average rate of movement in the upper zone was about 3 mm/yr since 2003. The current rate of movement is 5 mm/yr with a total cumulative movement of about 56 mm. The lower movement zone appears to be creeping at a rate of less than 1 mm/yr since 2003.
