To:	Amy Driessen Alberta Transportation	From:	Leslie Cho and Carrie Murray Stantec Consulting Ltd.
File:	123315222	Date:	June 12, 2022

Reference: North Central Region, Stony Plain, Site NC067 - Highway 216:06 Anthony Henday Bridge, Spring 2022 Instrumentation Monitoring Report

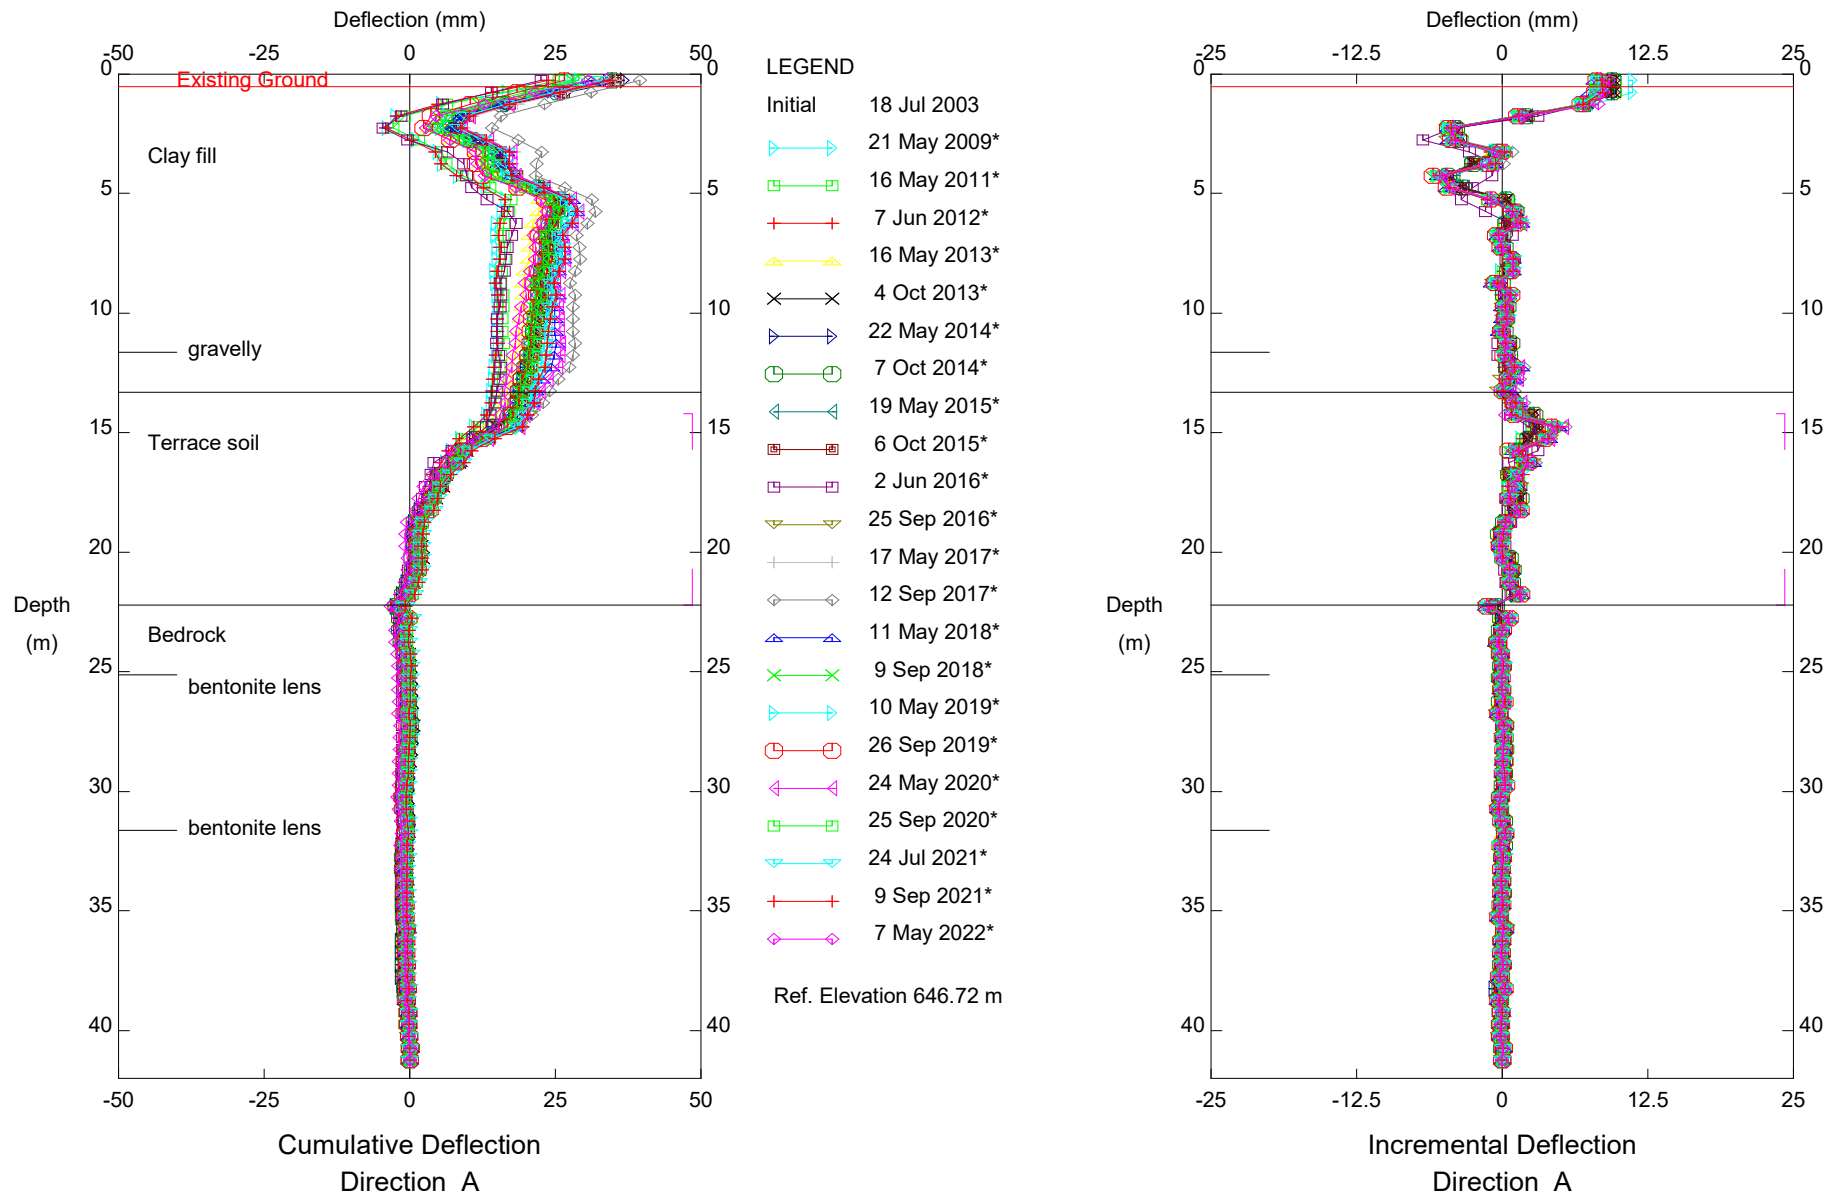
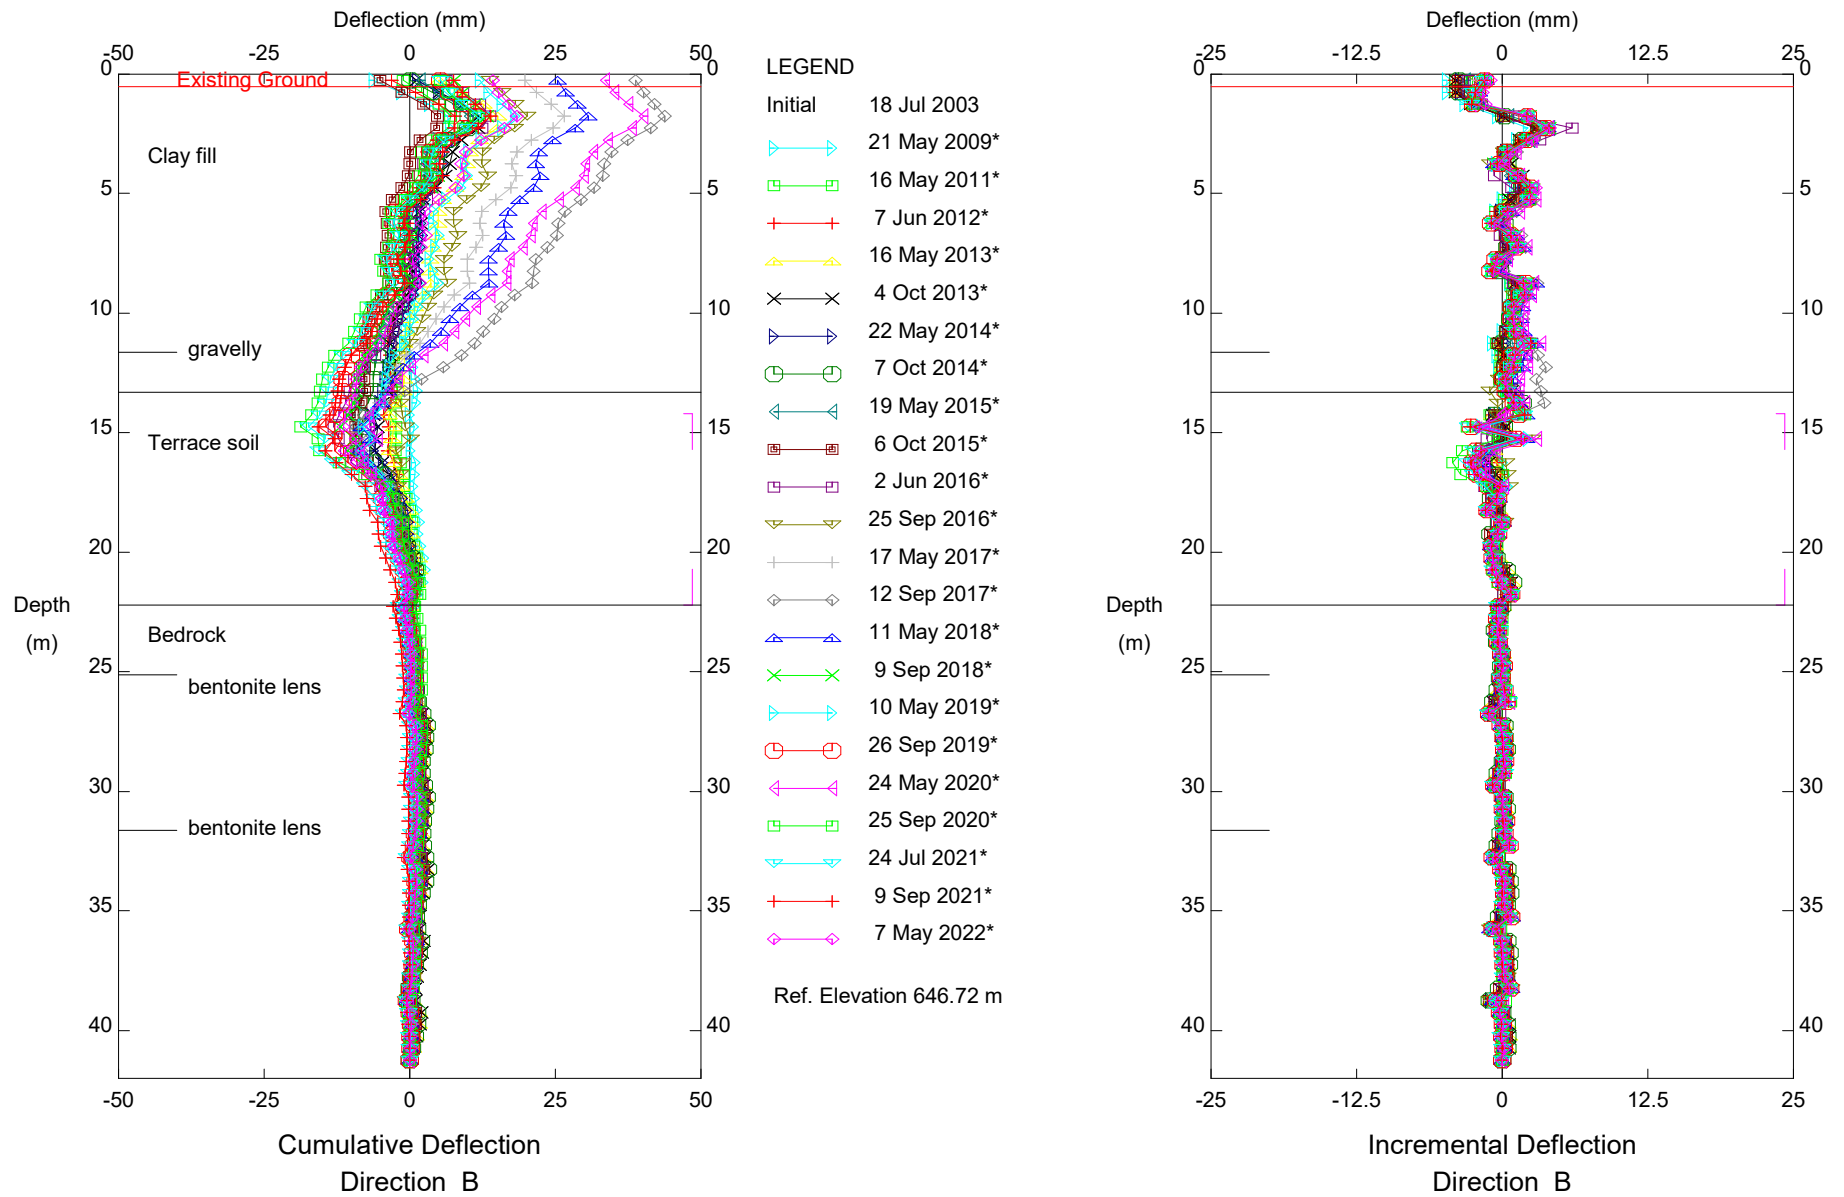
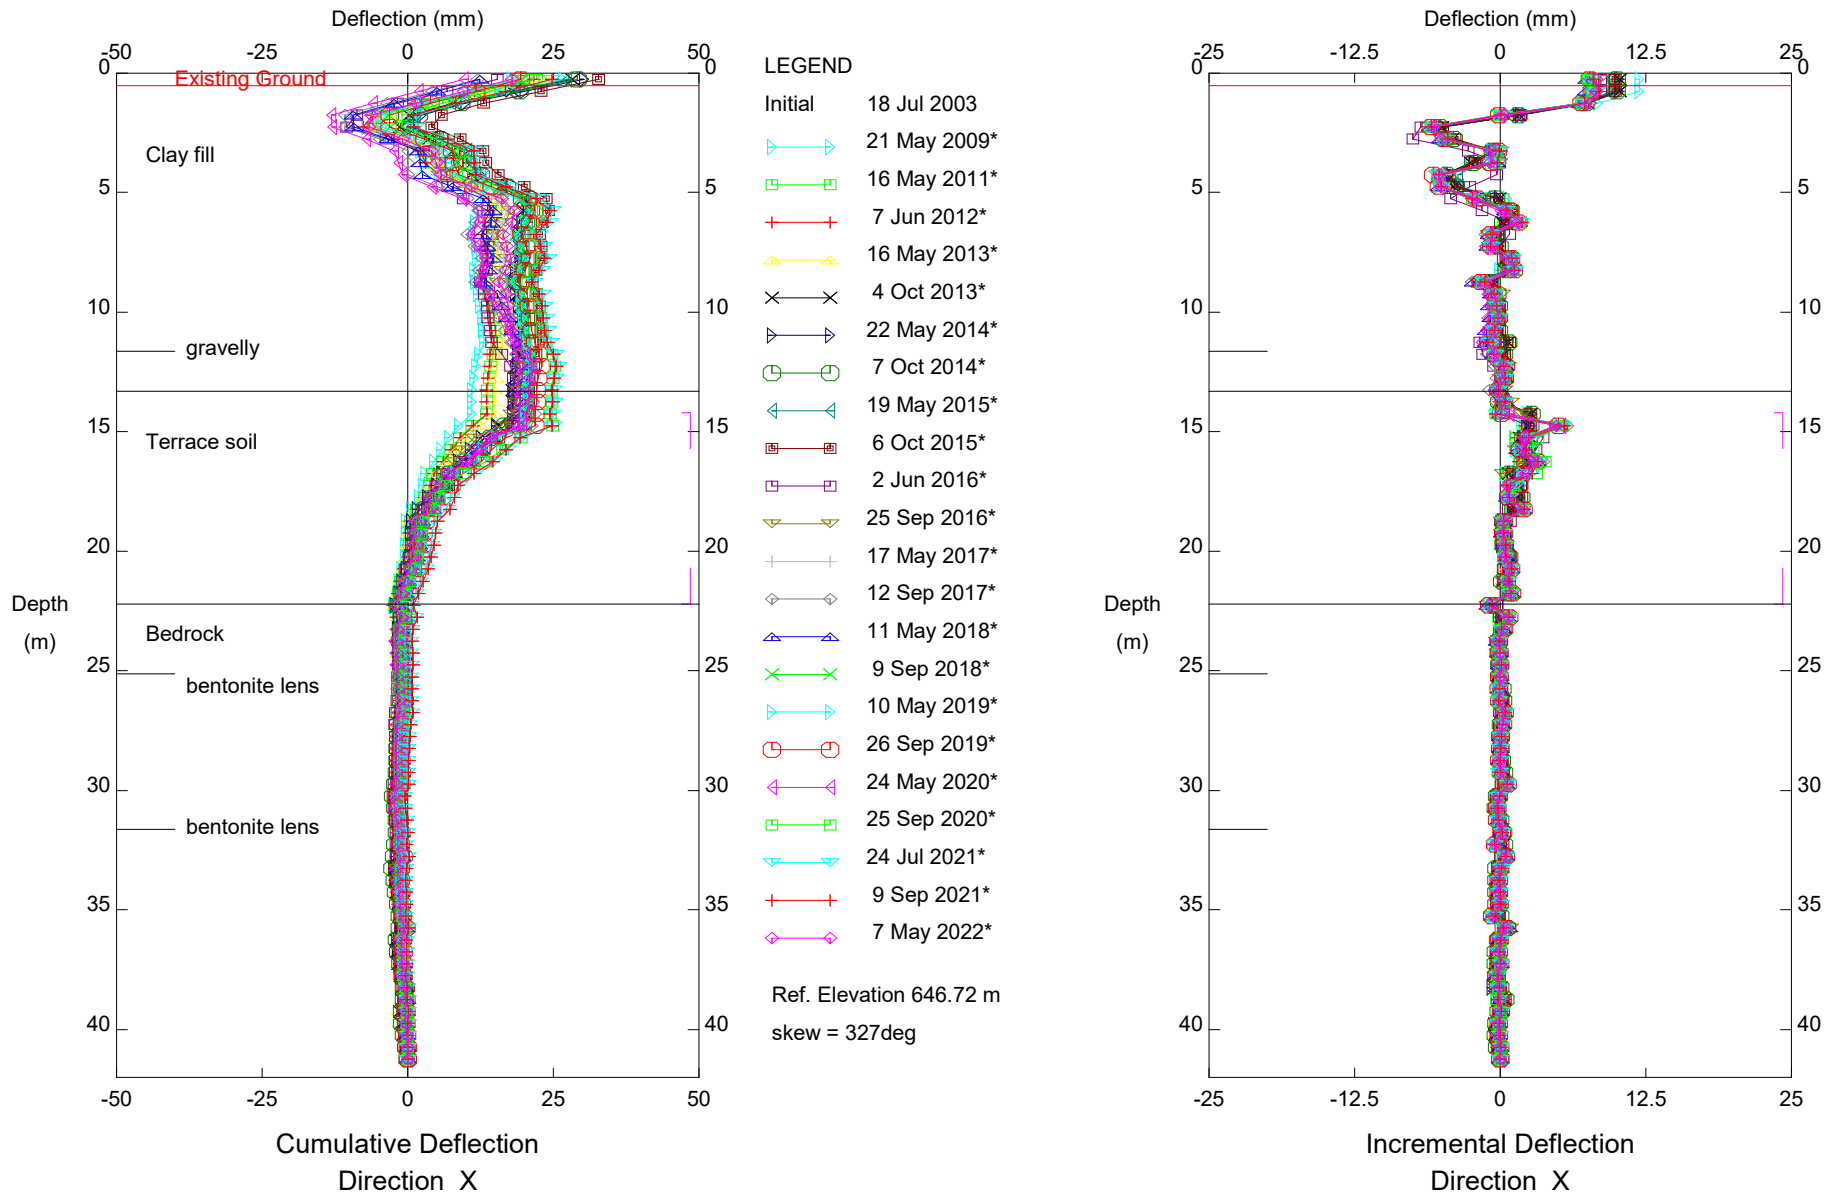
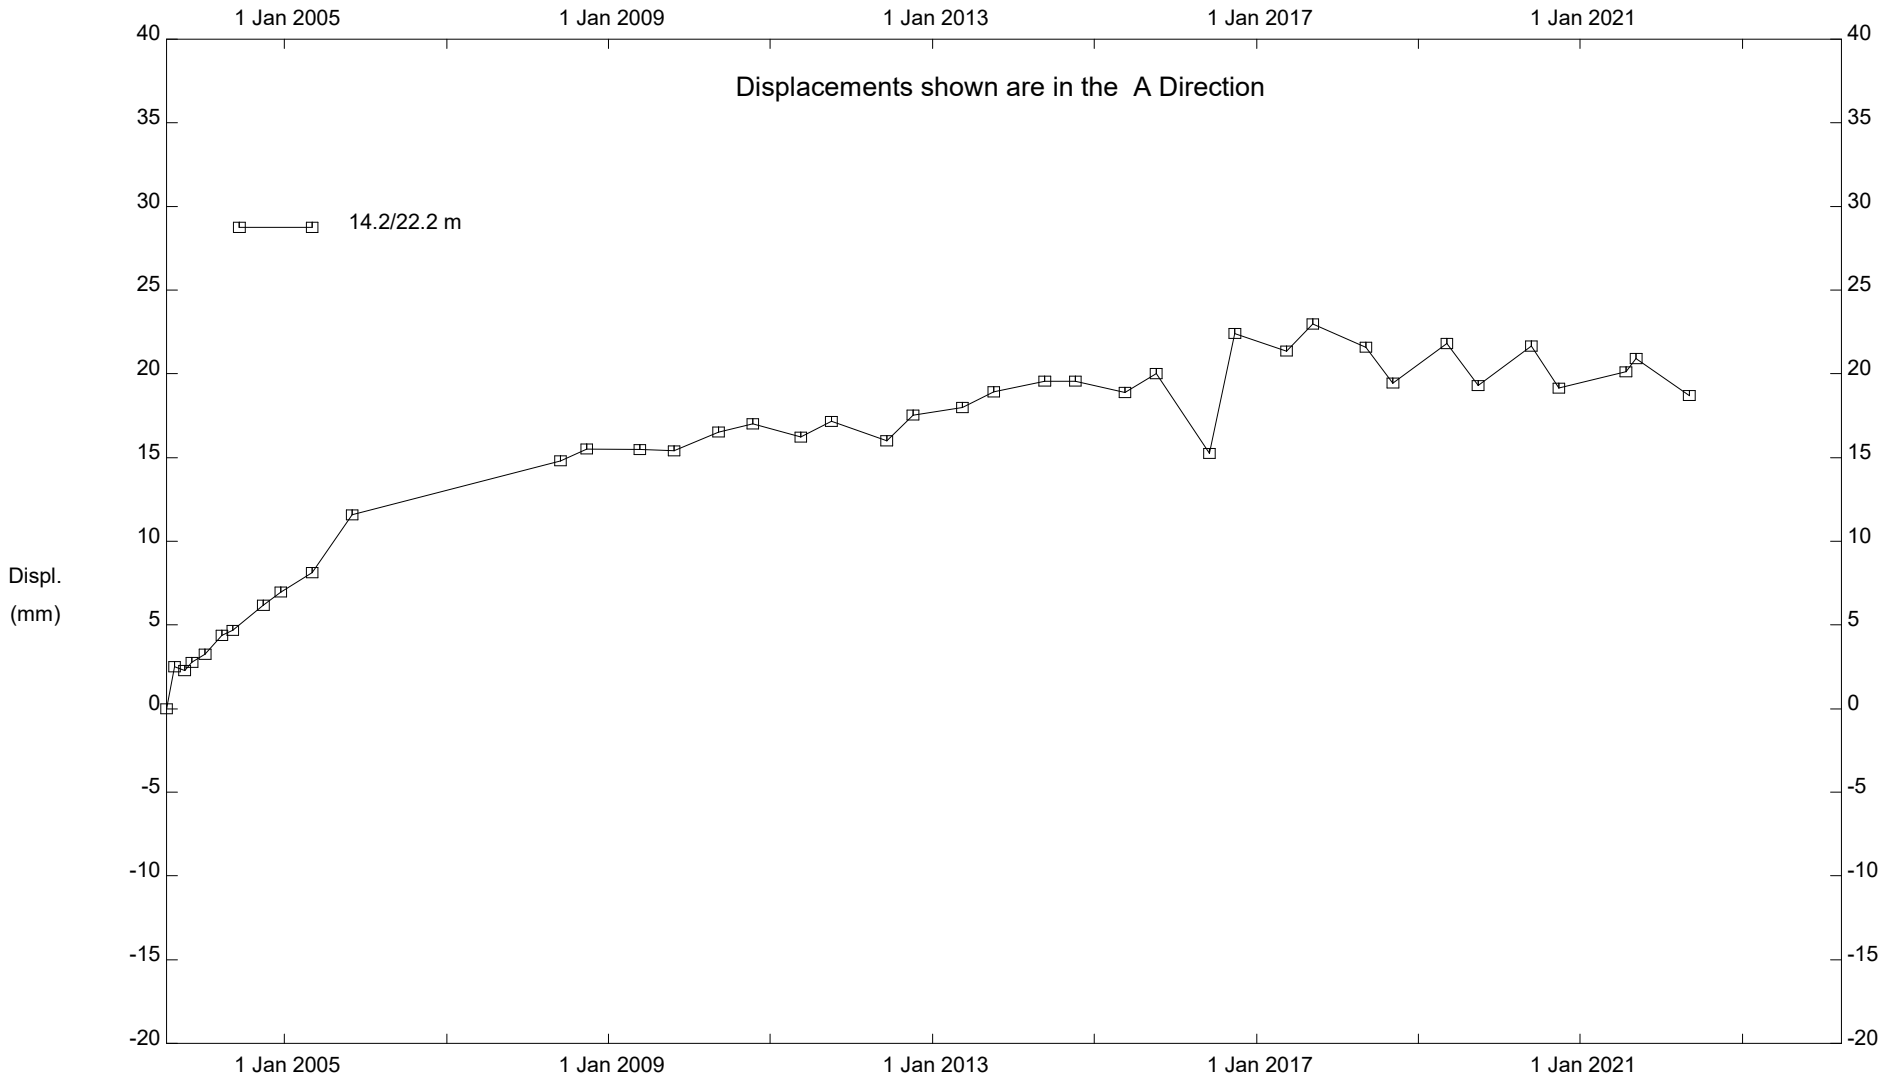
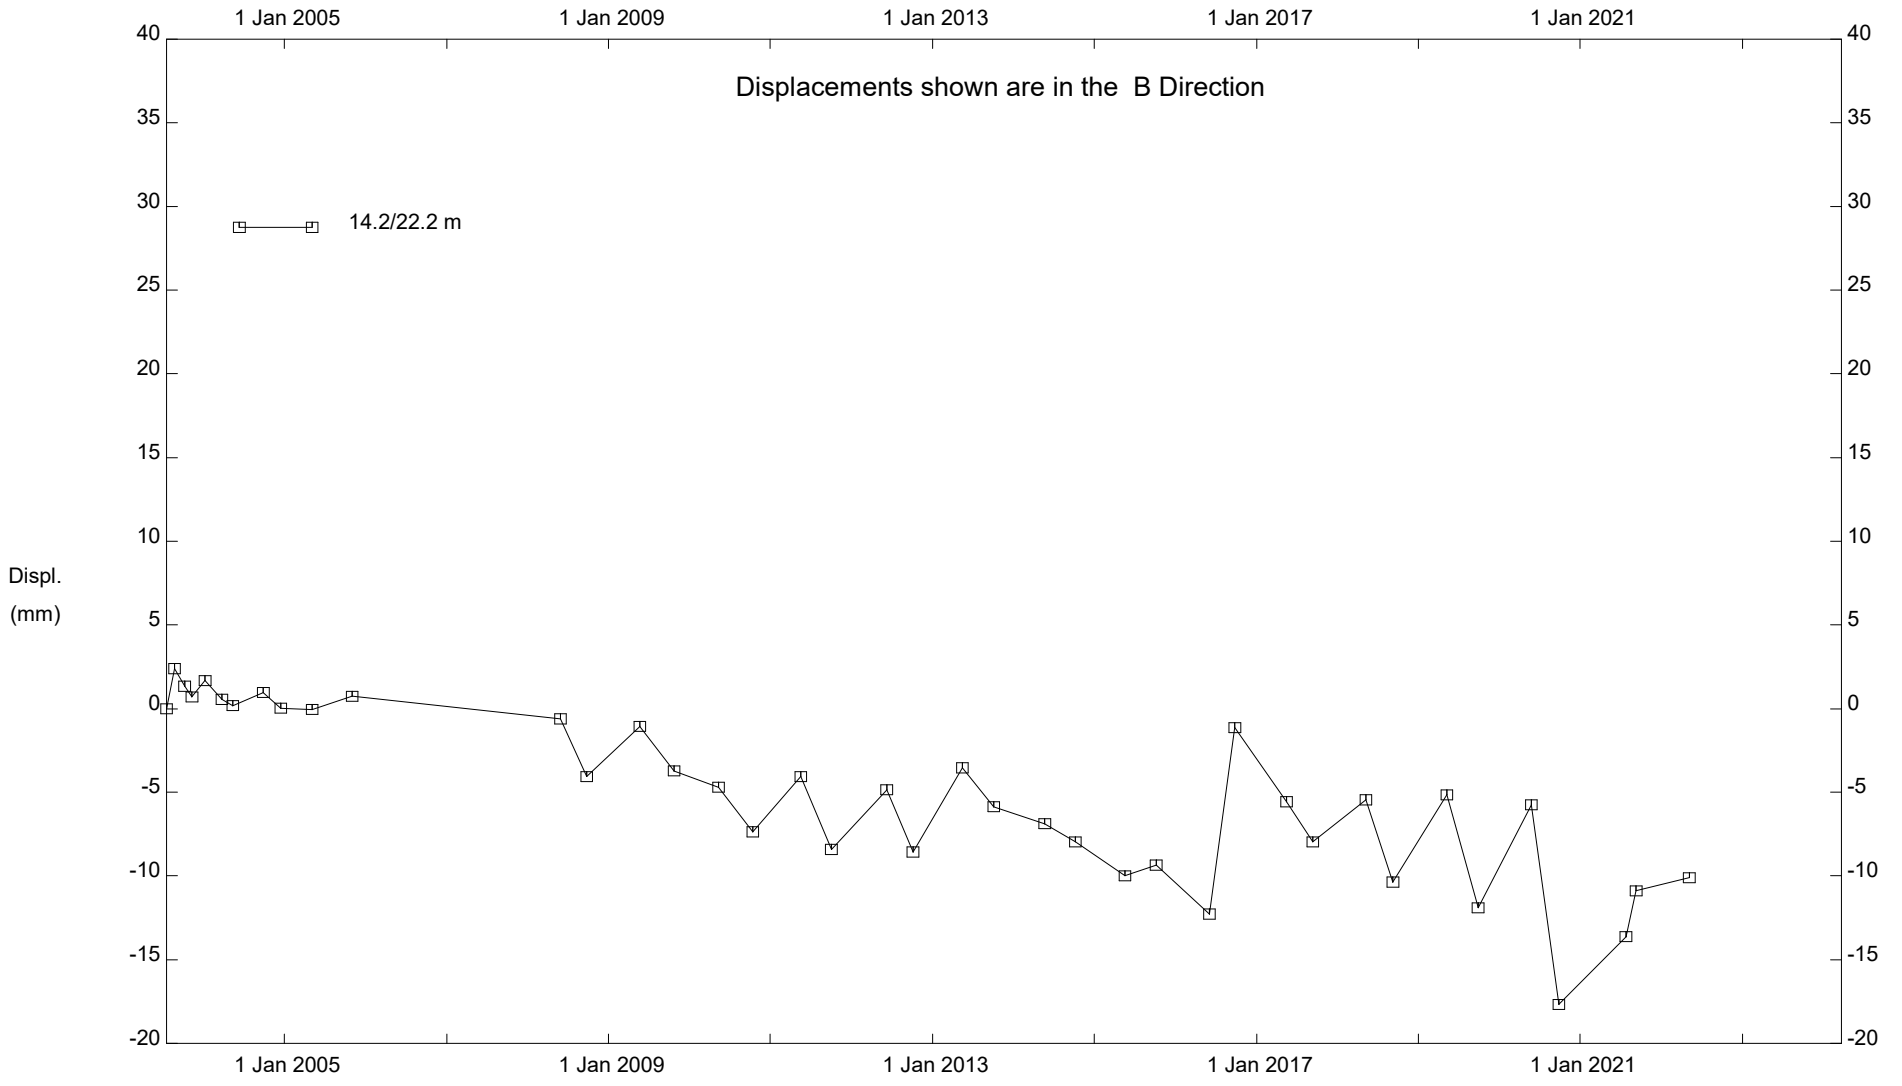
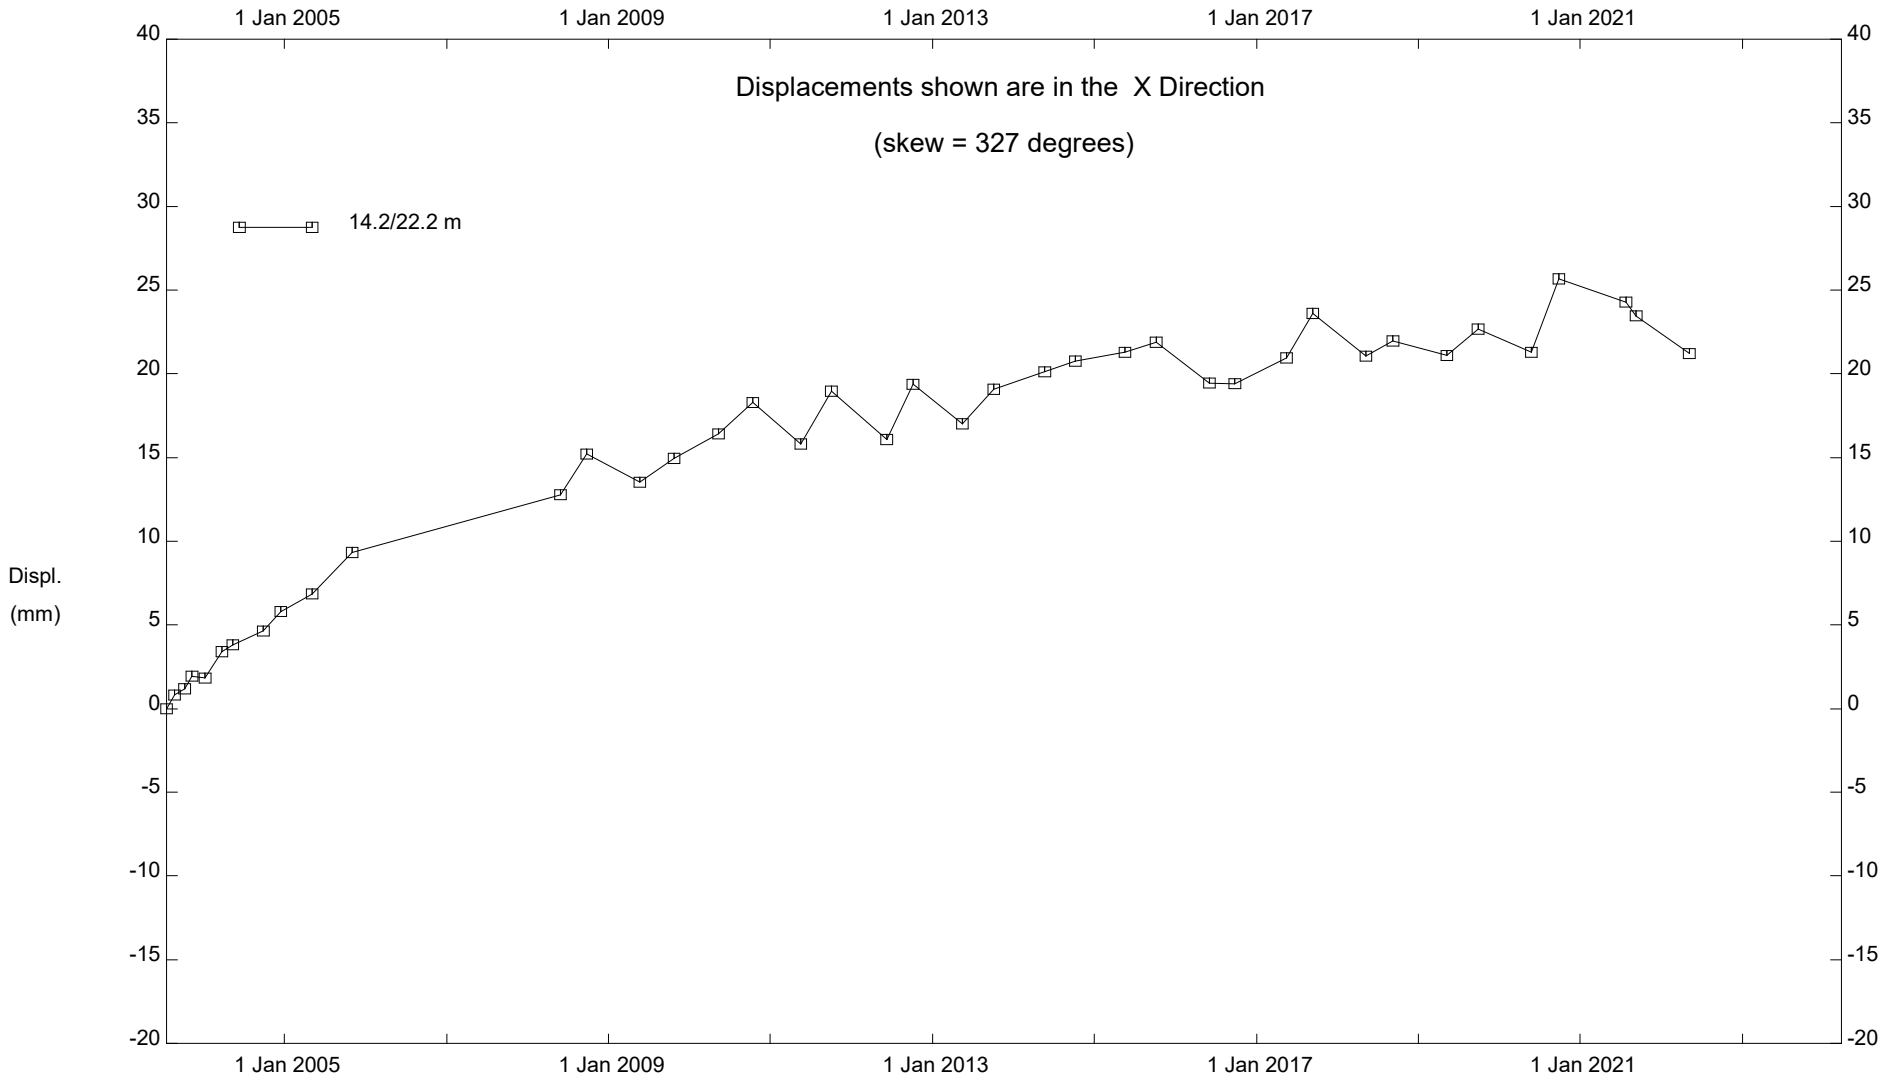
NC067, Inclinometer SI-10

SI-10 shows a current rate of movement of about 3 mm/yr corresponding to an increase of 1 mm/yr from the previous reading cycle. The average rate of movement since 2006 is about 2 mm/yr. The total cumulative movement is about 21 mm.
