To:	Amy Driessen Alberta Transportation	From:	Leslie Cho and Carrie Murray Stantec Consulting Ltd.
File:	123315222	Date:	June 12, 2022

Reference: North Central Region, Stony Plain, Site NC067 - Highway 216:06 Anthony Henday Bridge, Spring 2022 Instrumentation Monitoring Report

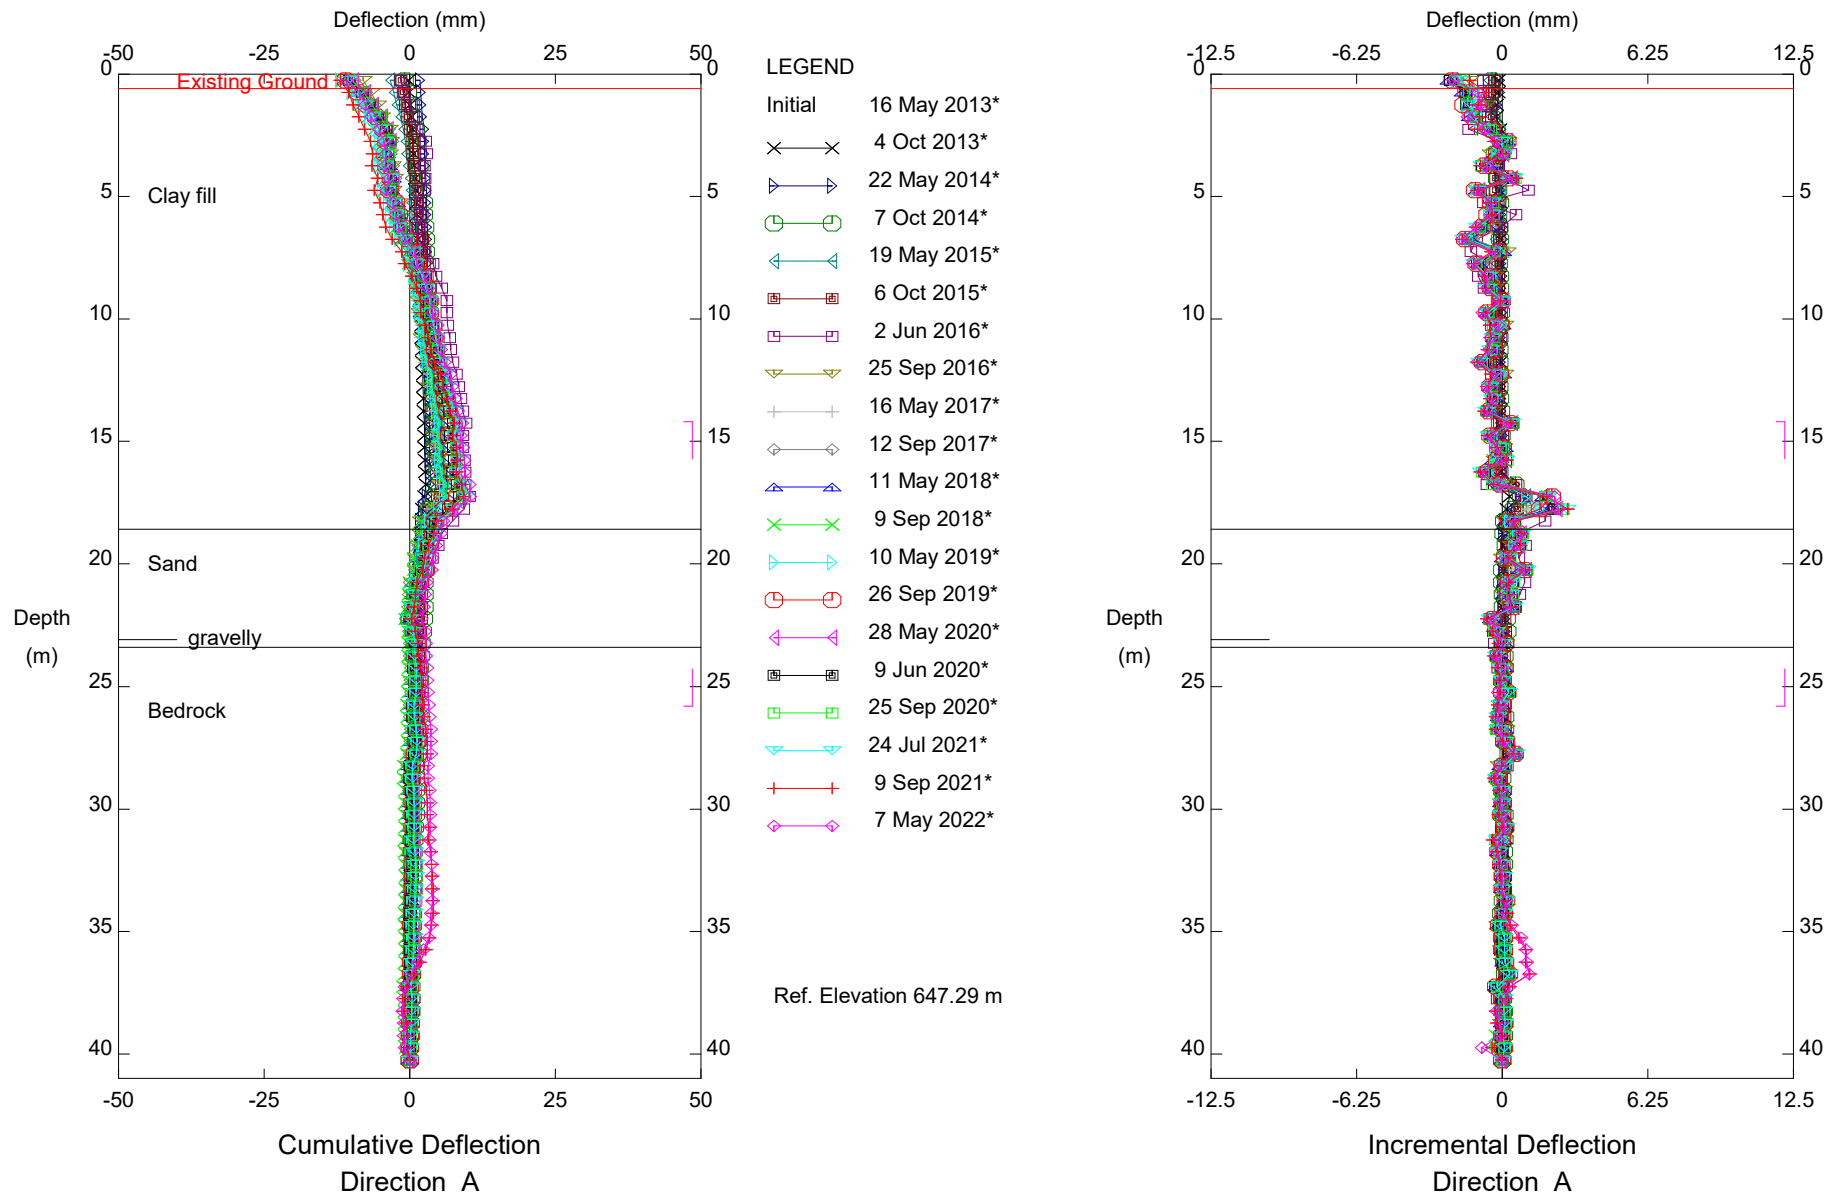
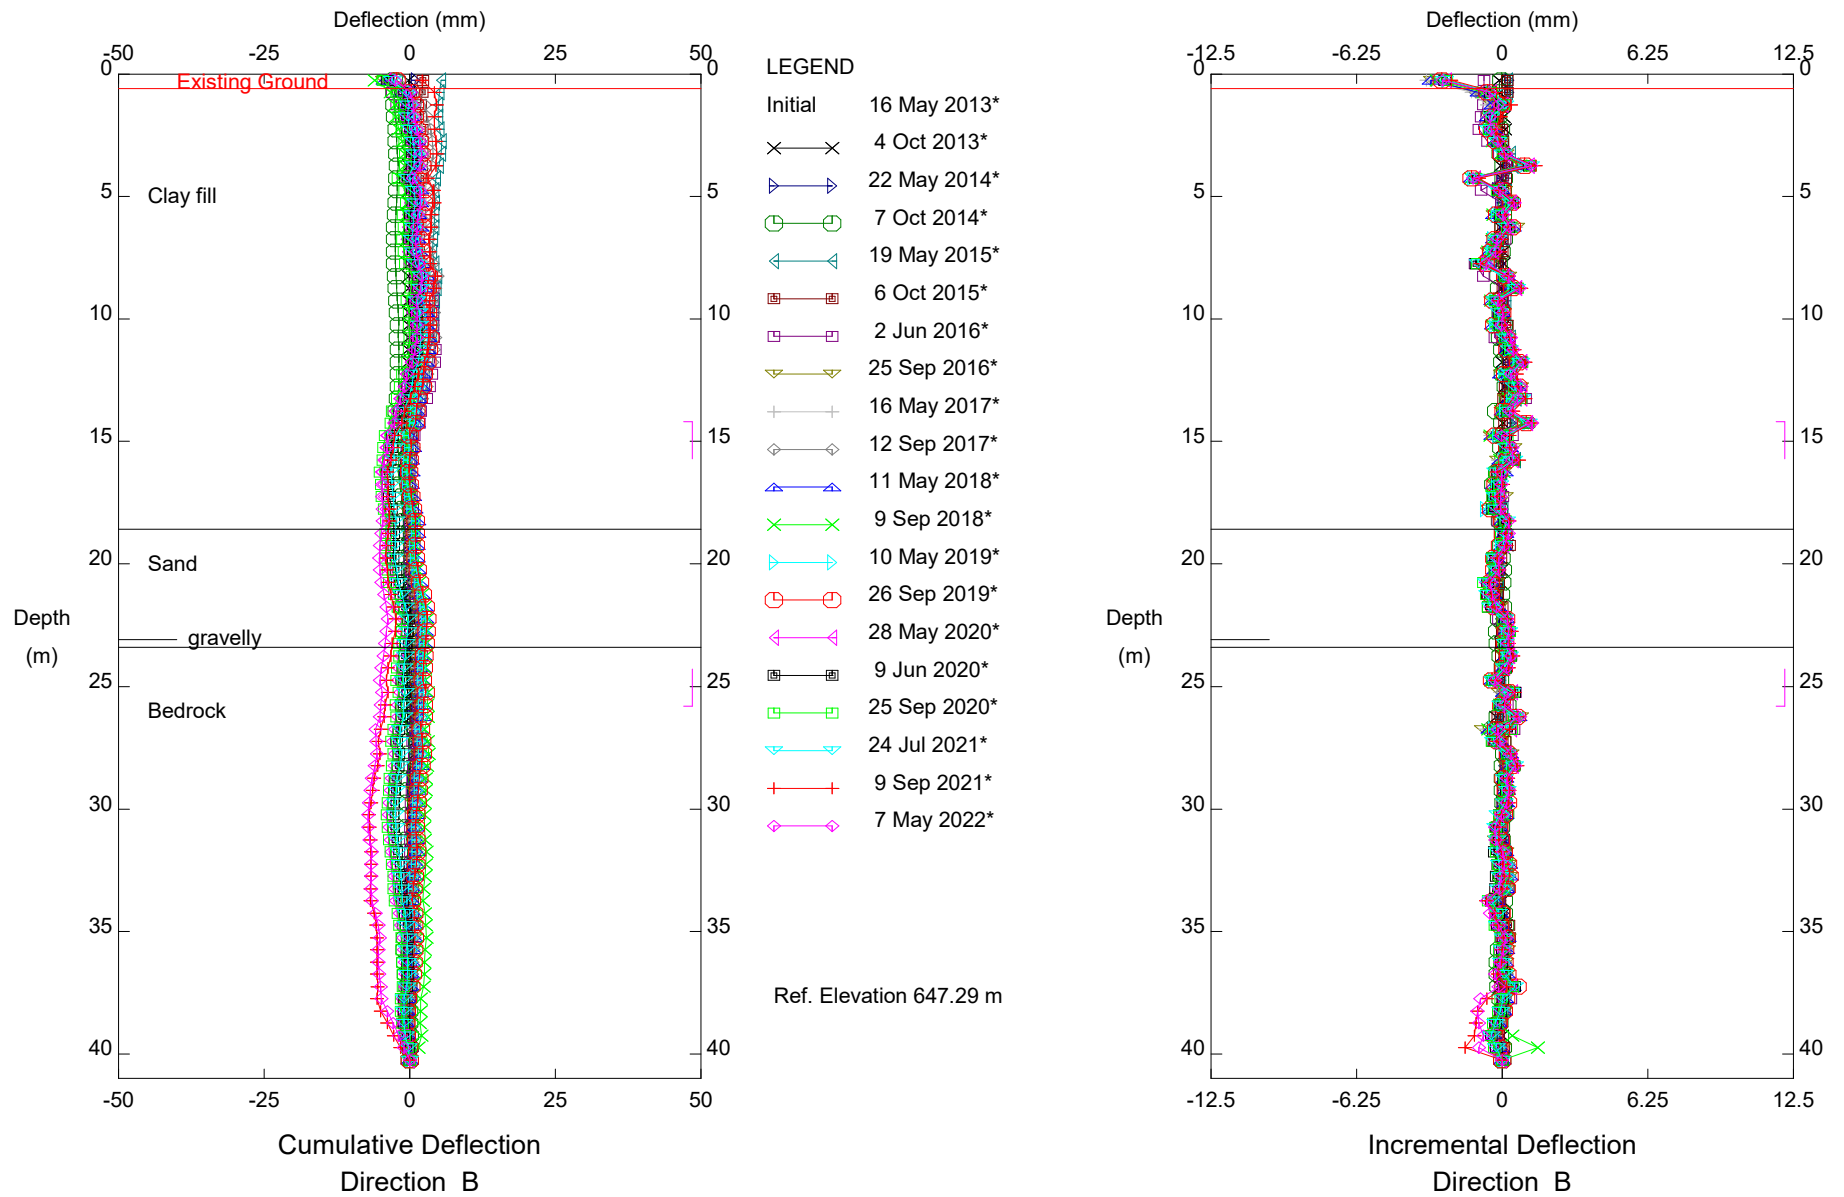
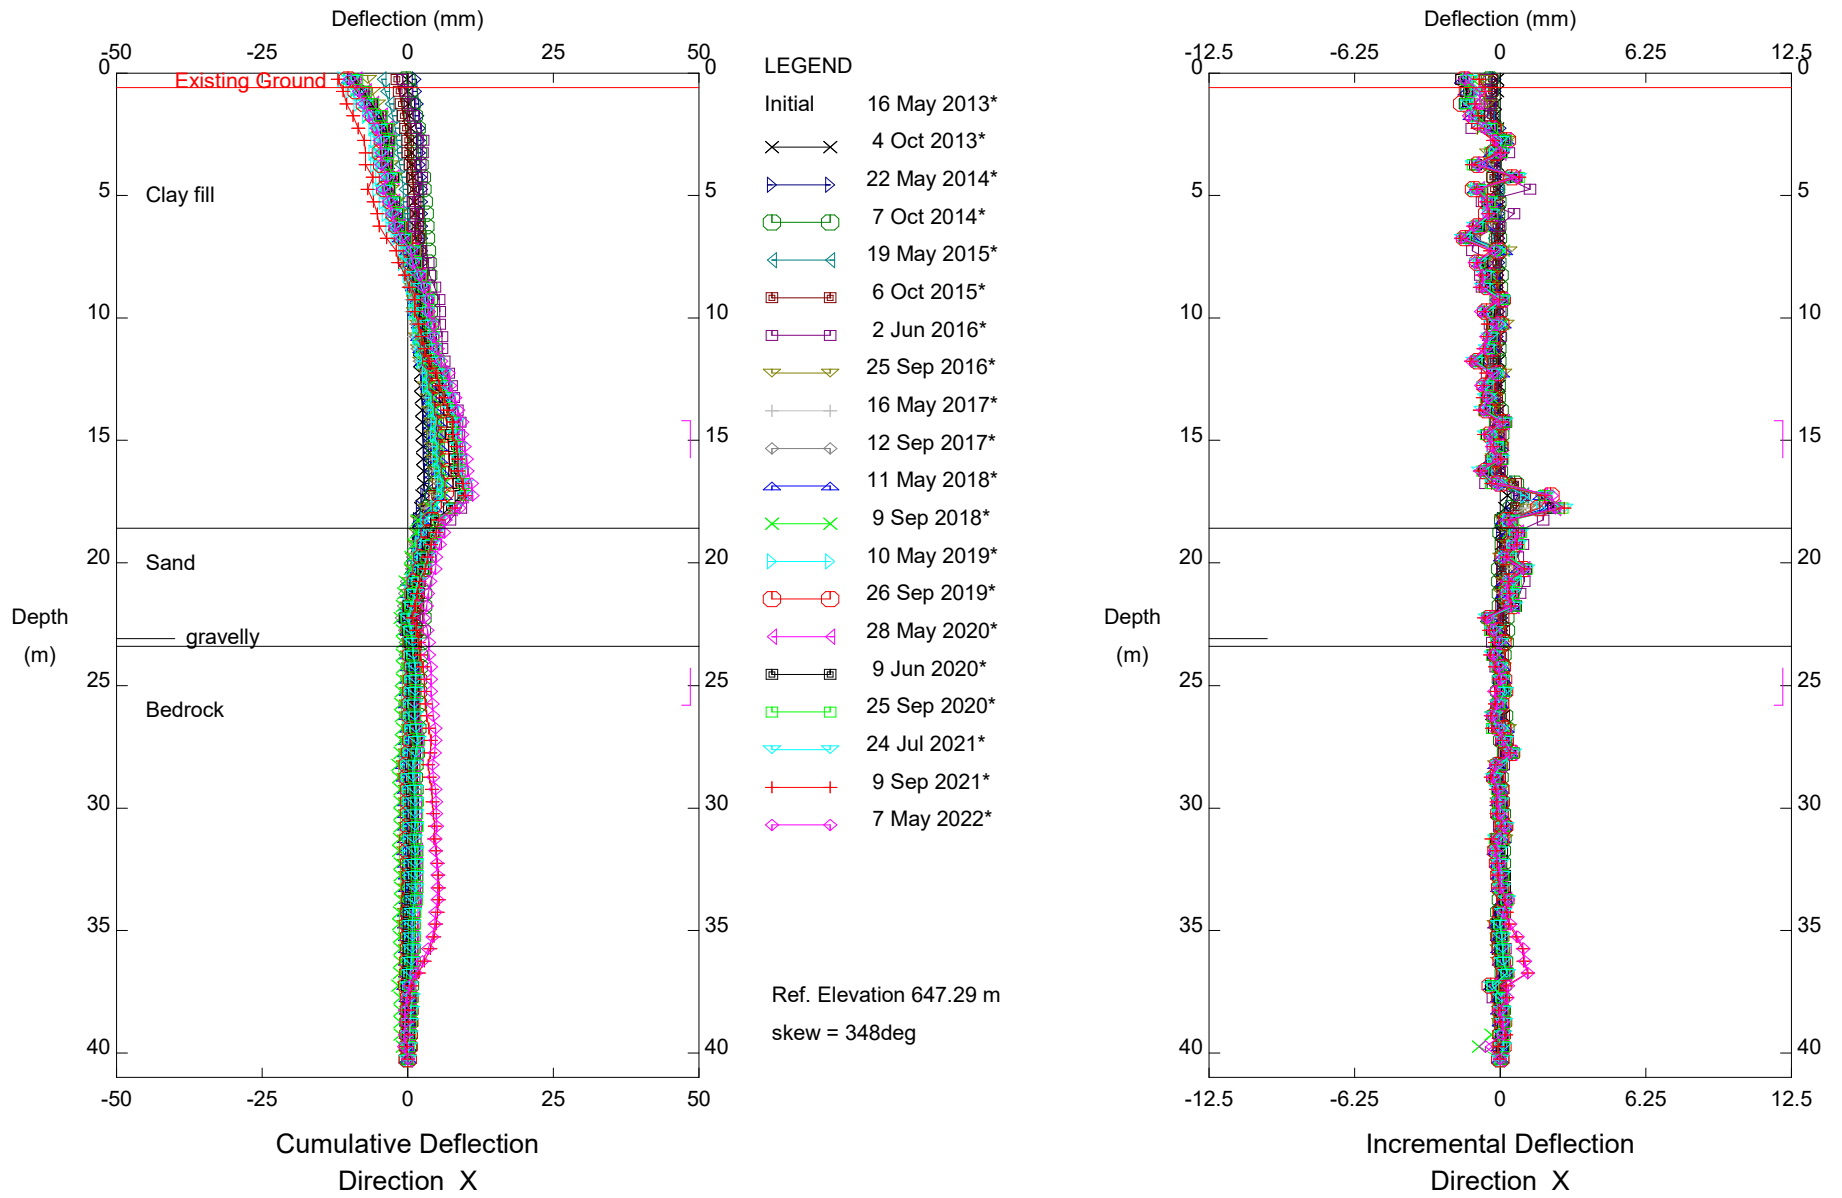
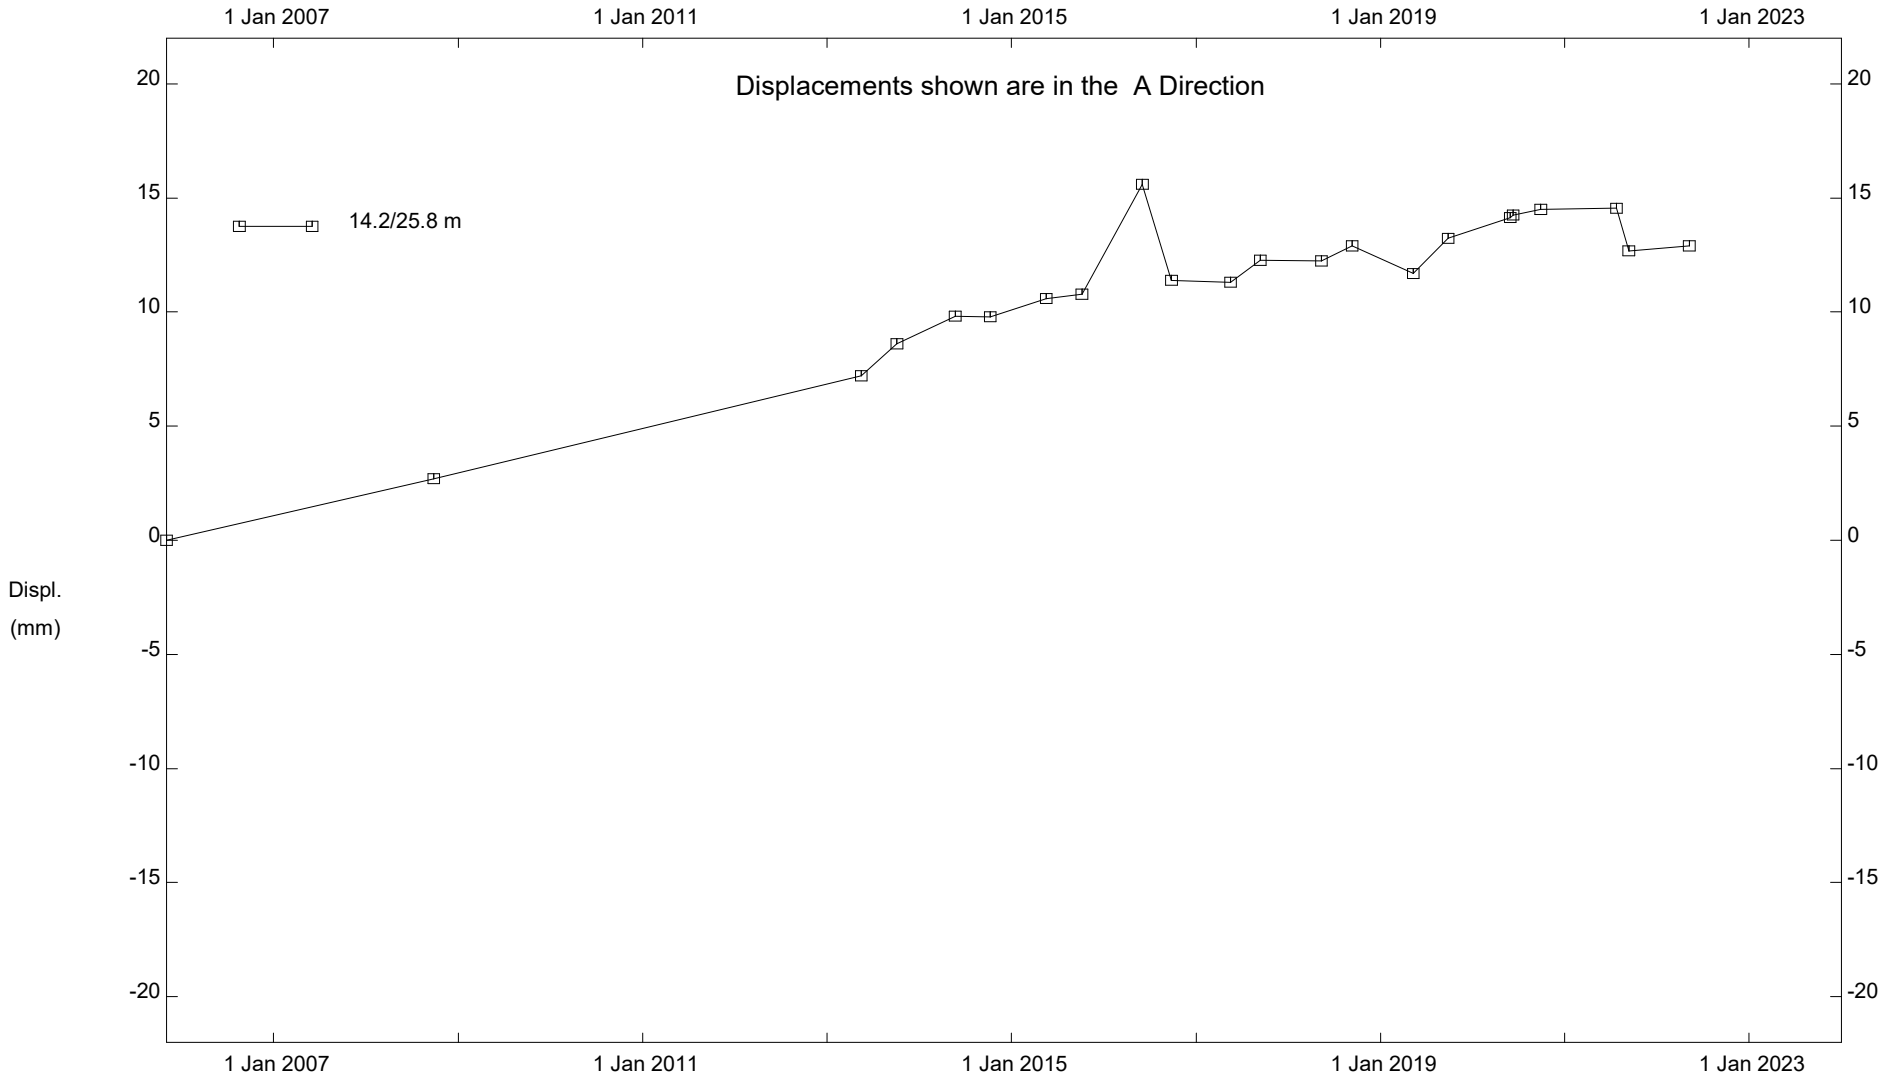
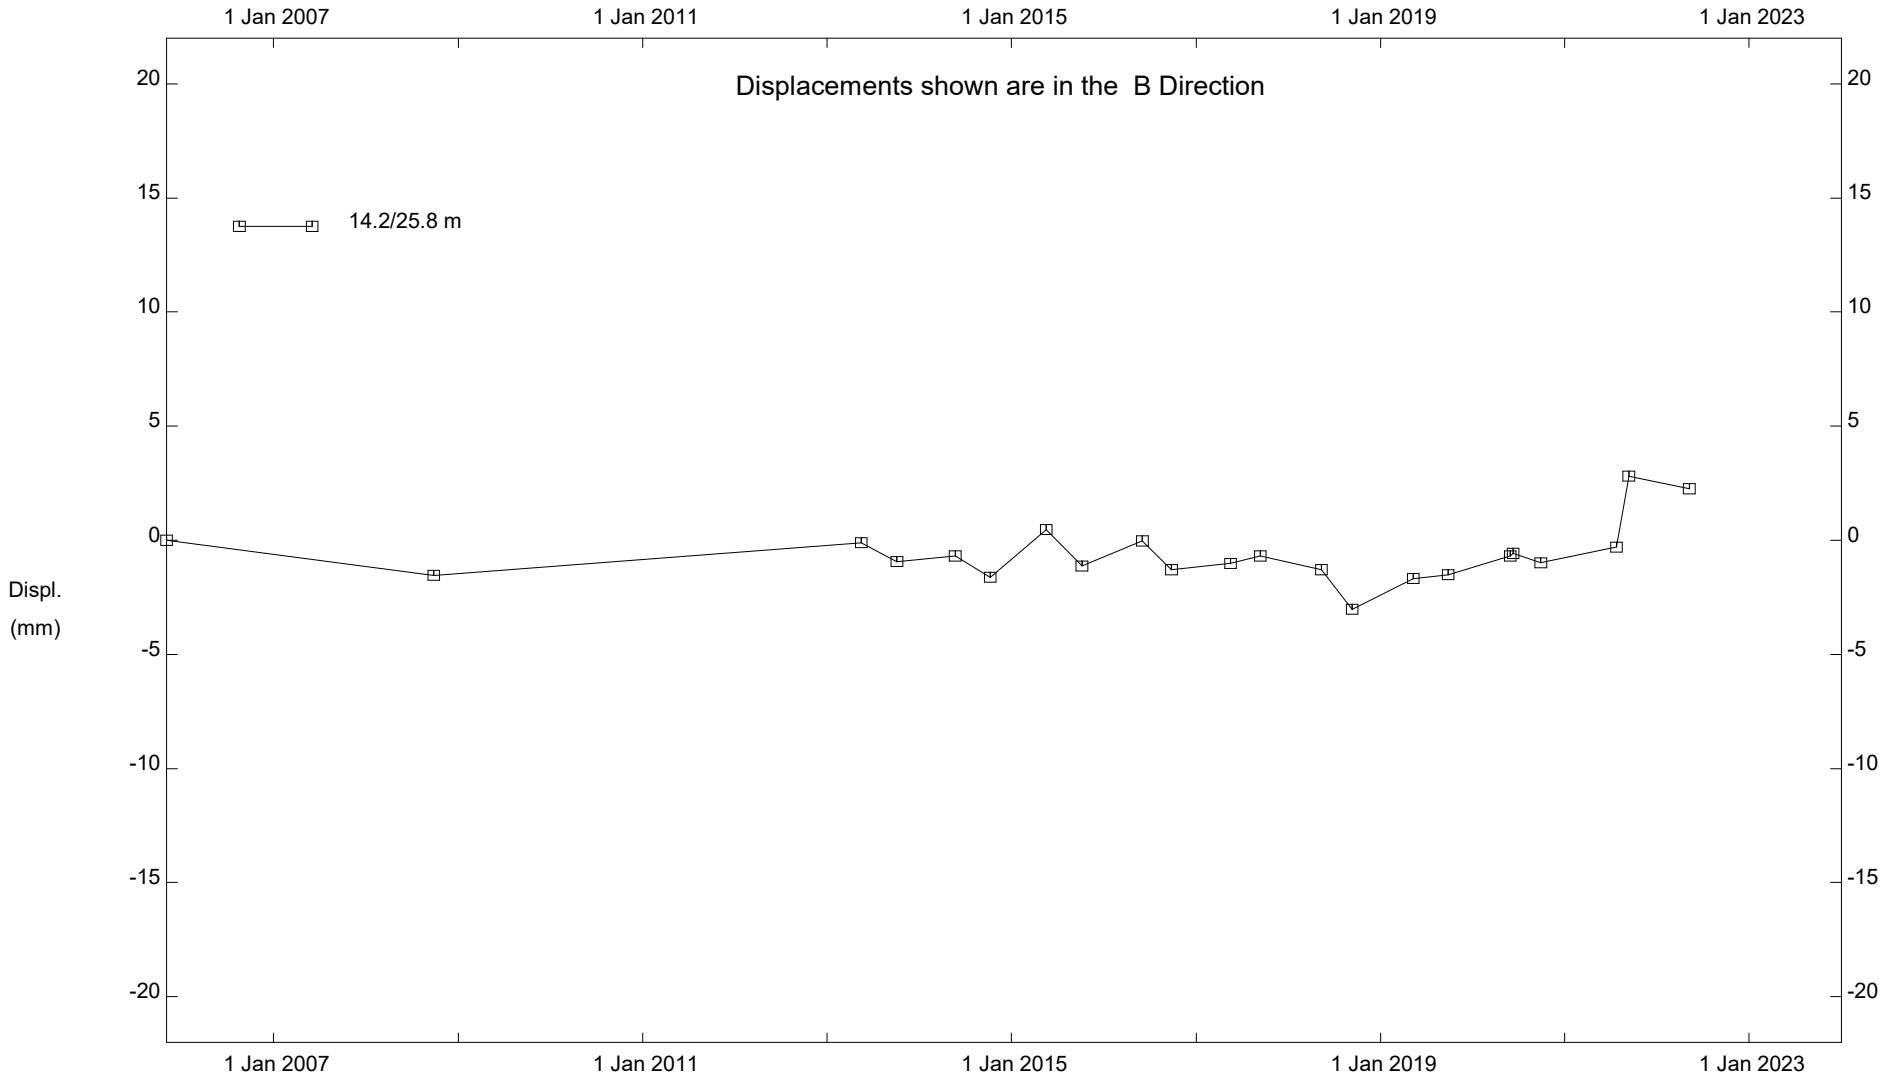
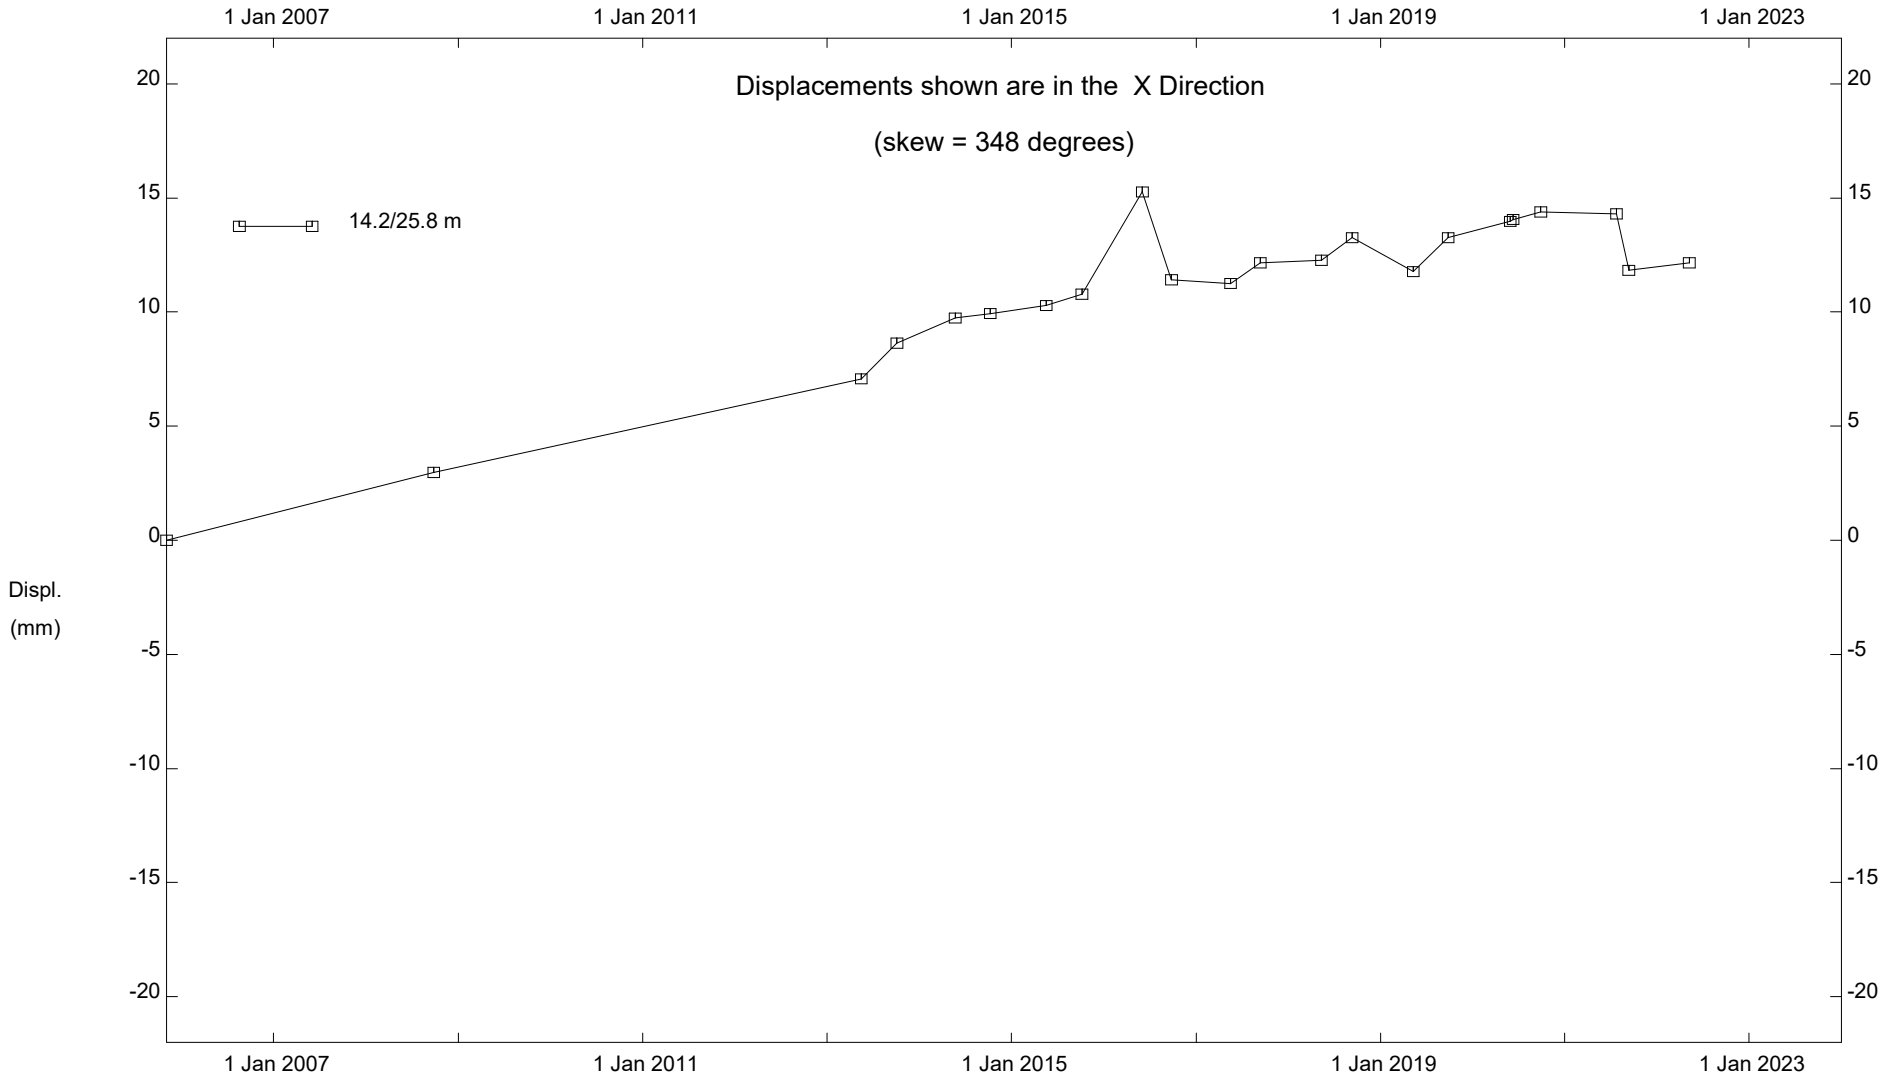
NC067, Inclinometer SI-11

SI-11 has a zone of movement being monitored from 14.2 m to 25.8 m with approximately 12 mm of cumulative movement recorded since 2006. The movement zone appears to be creeping at an overall rate of less than 1 mm/yr.
