To:	Amy Driessen Alberta Transportation	From:	Leslie Cho and Carrie Murray Stantec Consulting Ltd.
File:	123315222	Date:	June 12, 2022

Reference: North Central Region, Stony Plain, Site NC067 - Highway 216:06 Anthony Henday Bridge, Spring 2022 Instrumentation Monitoring Report

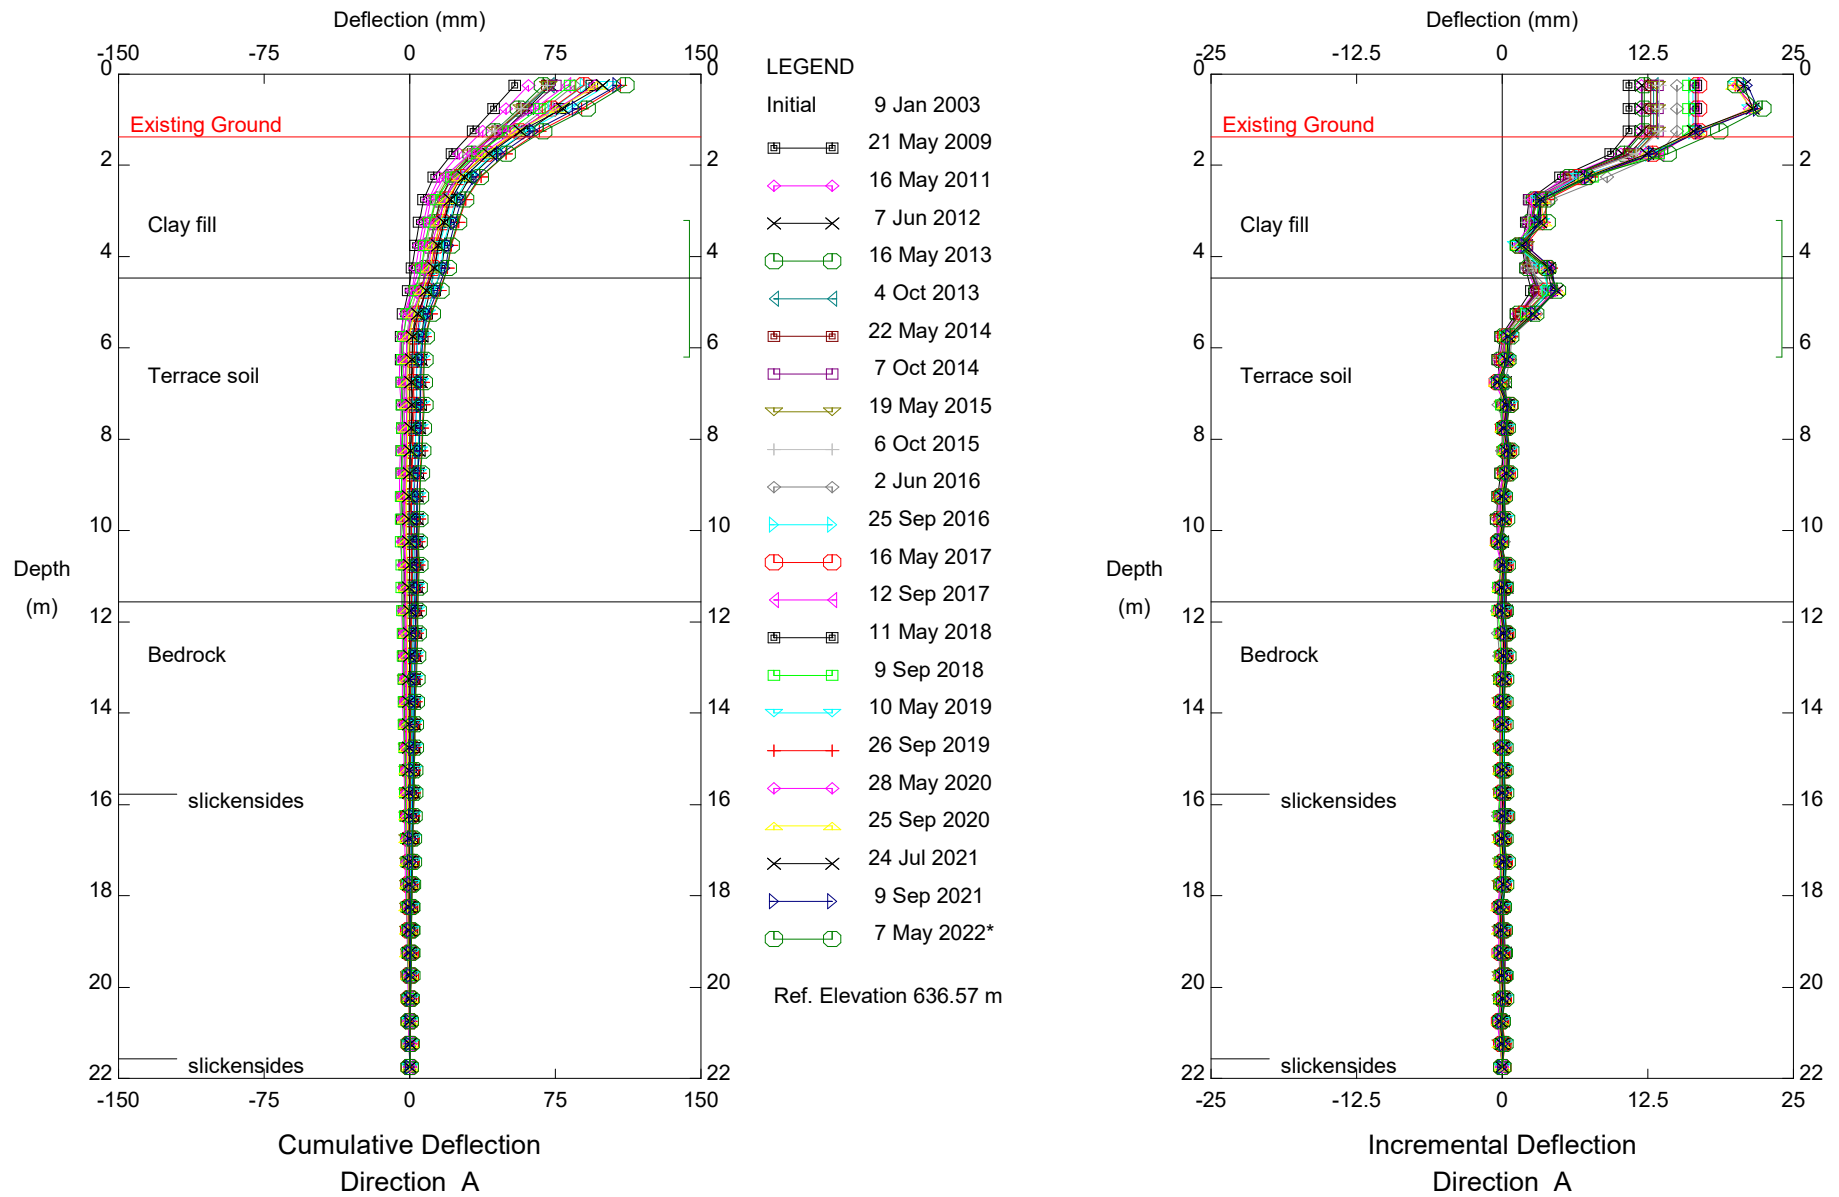
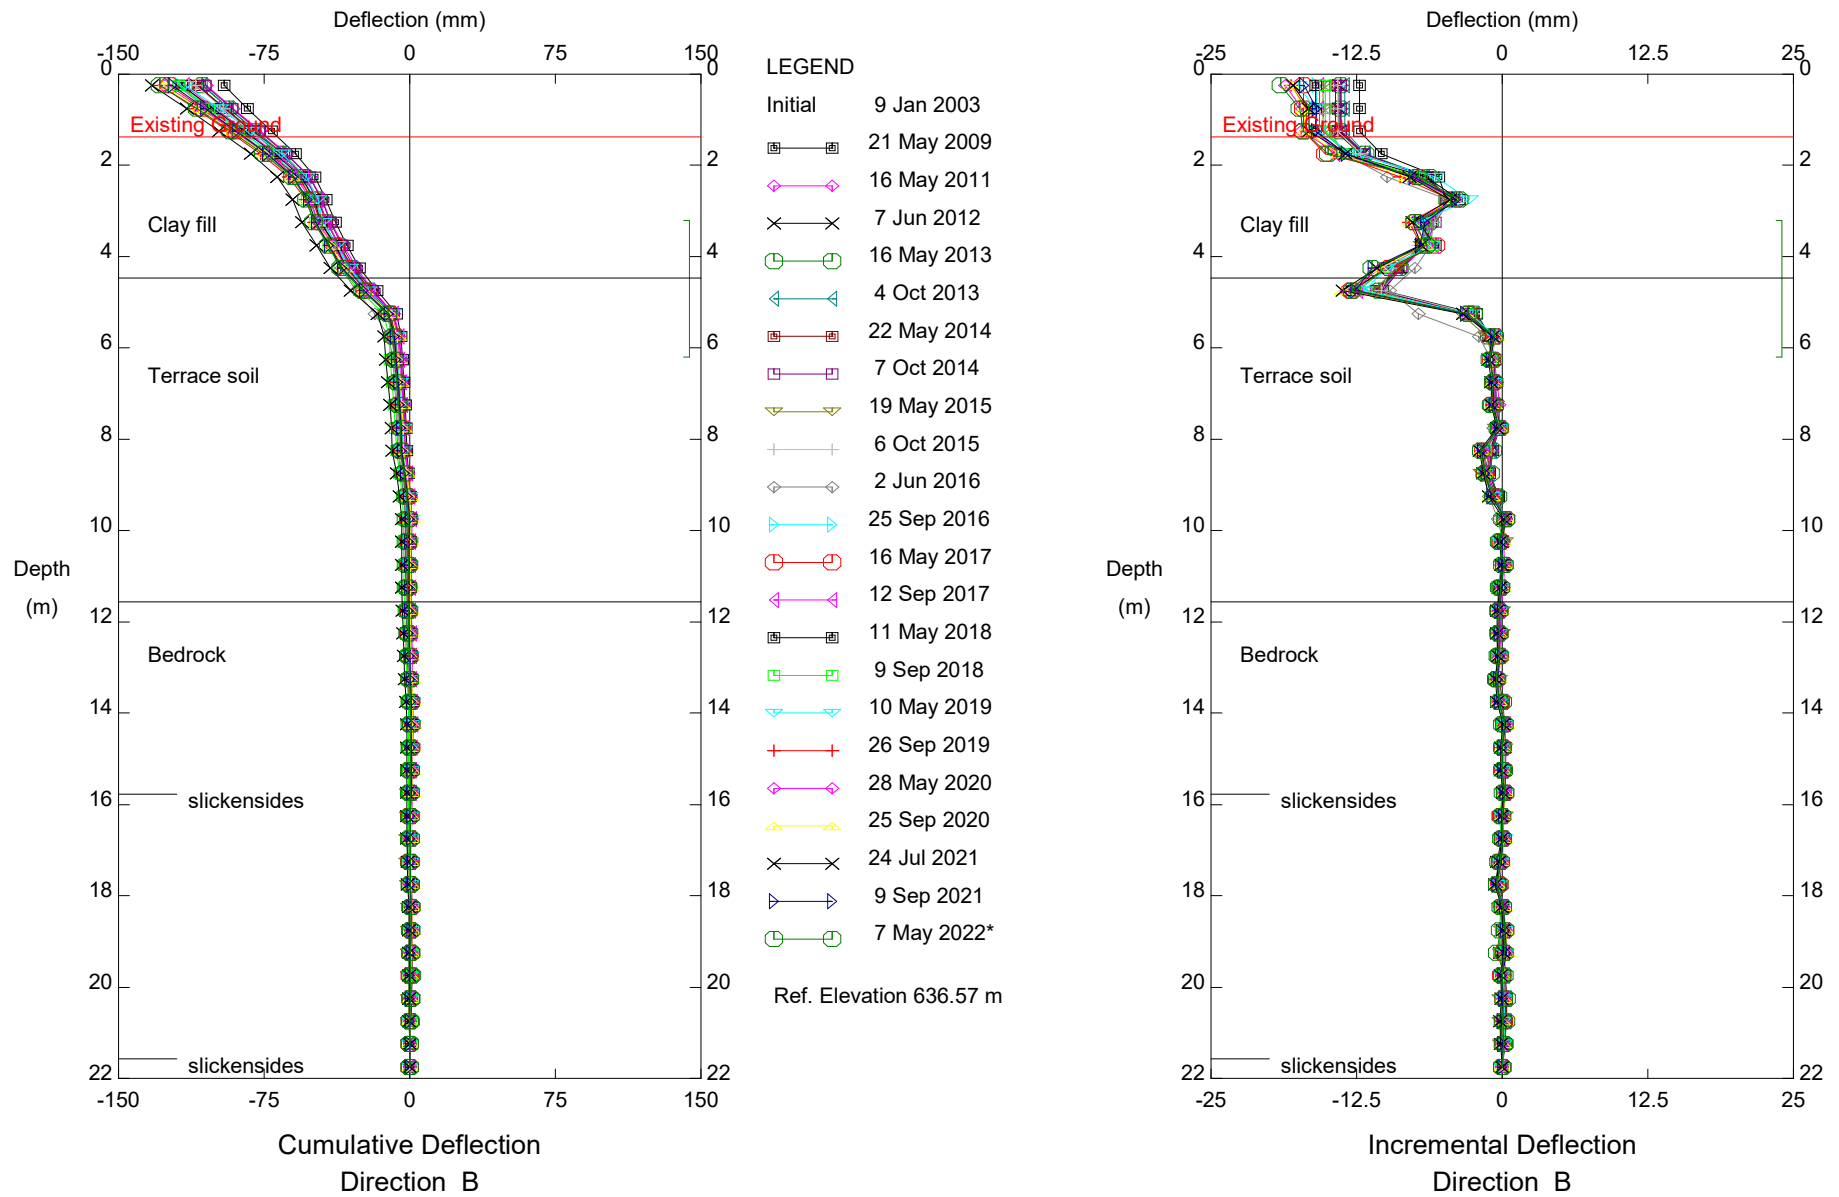
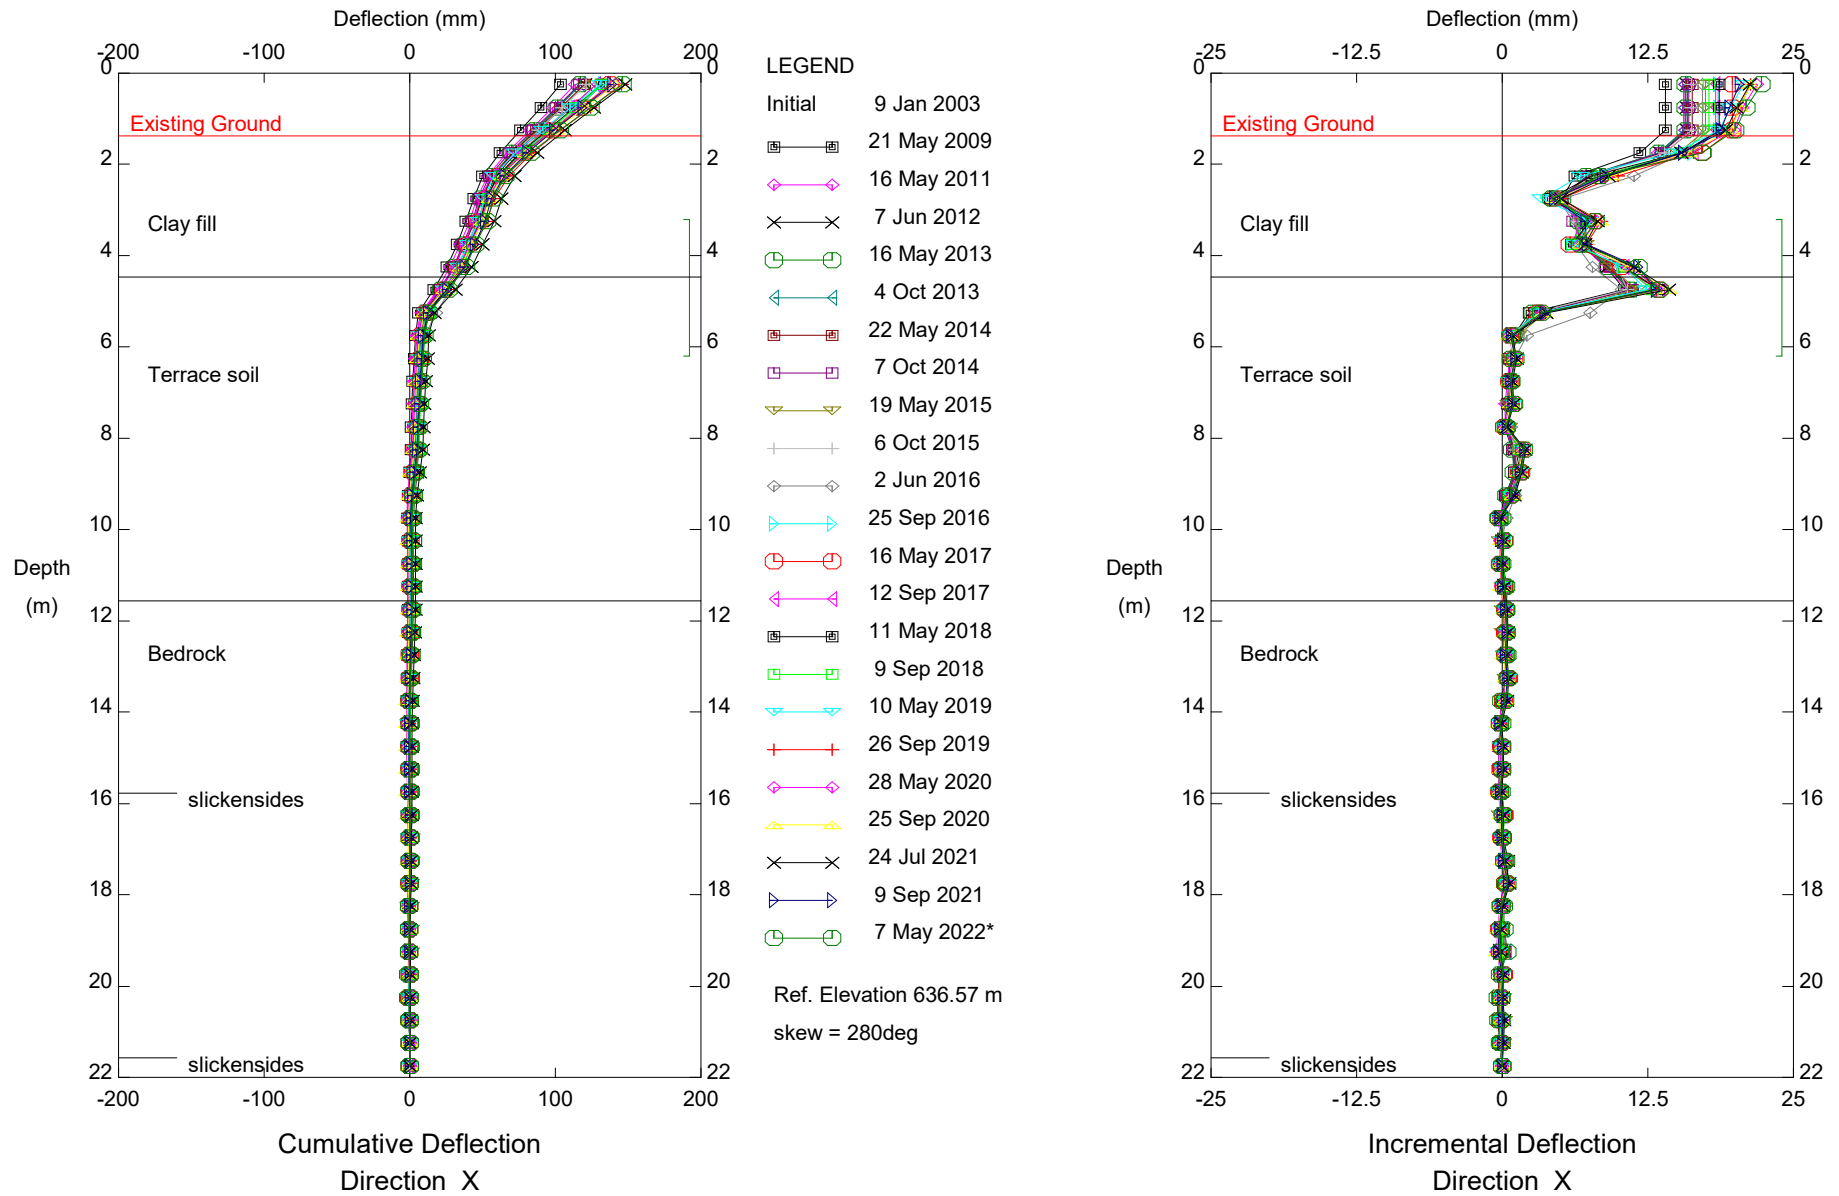
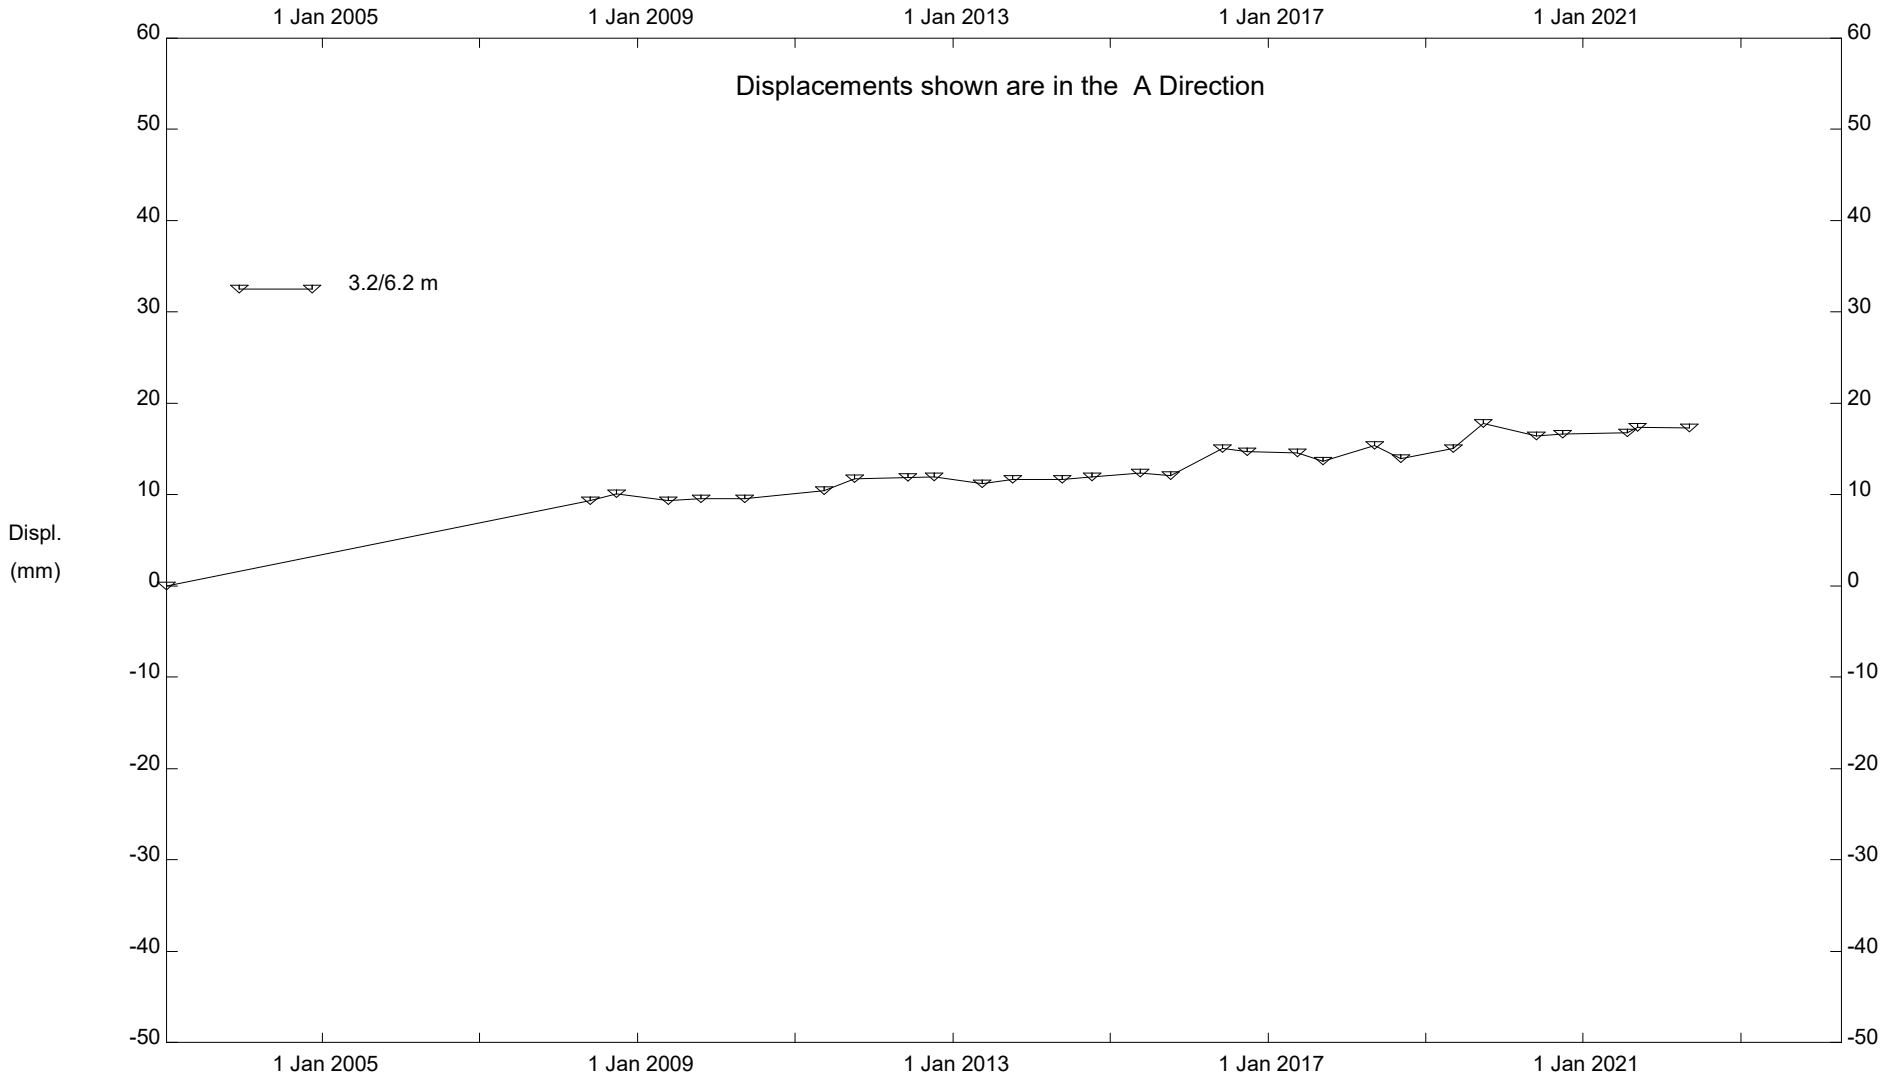
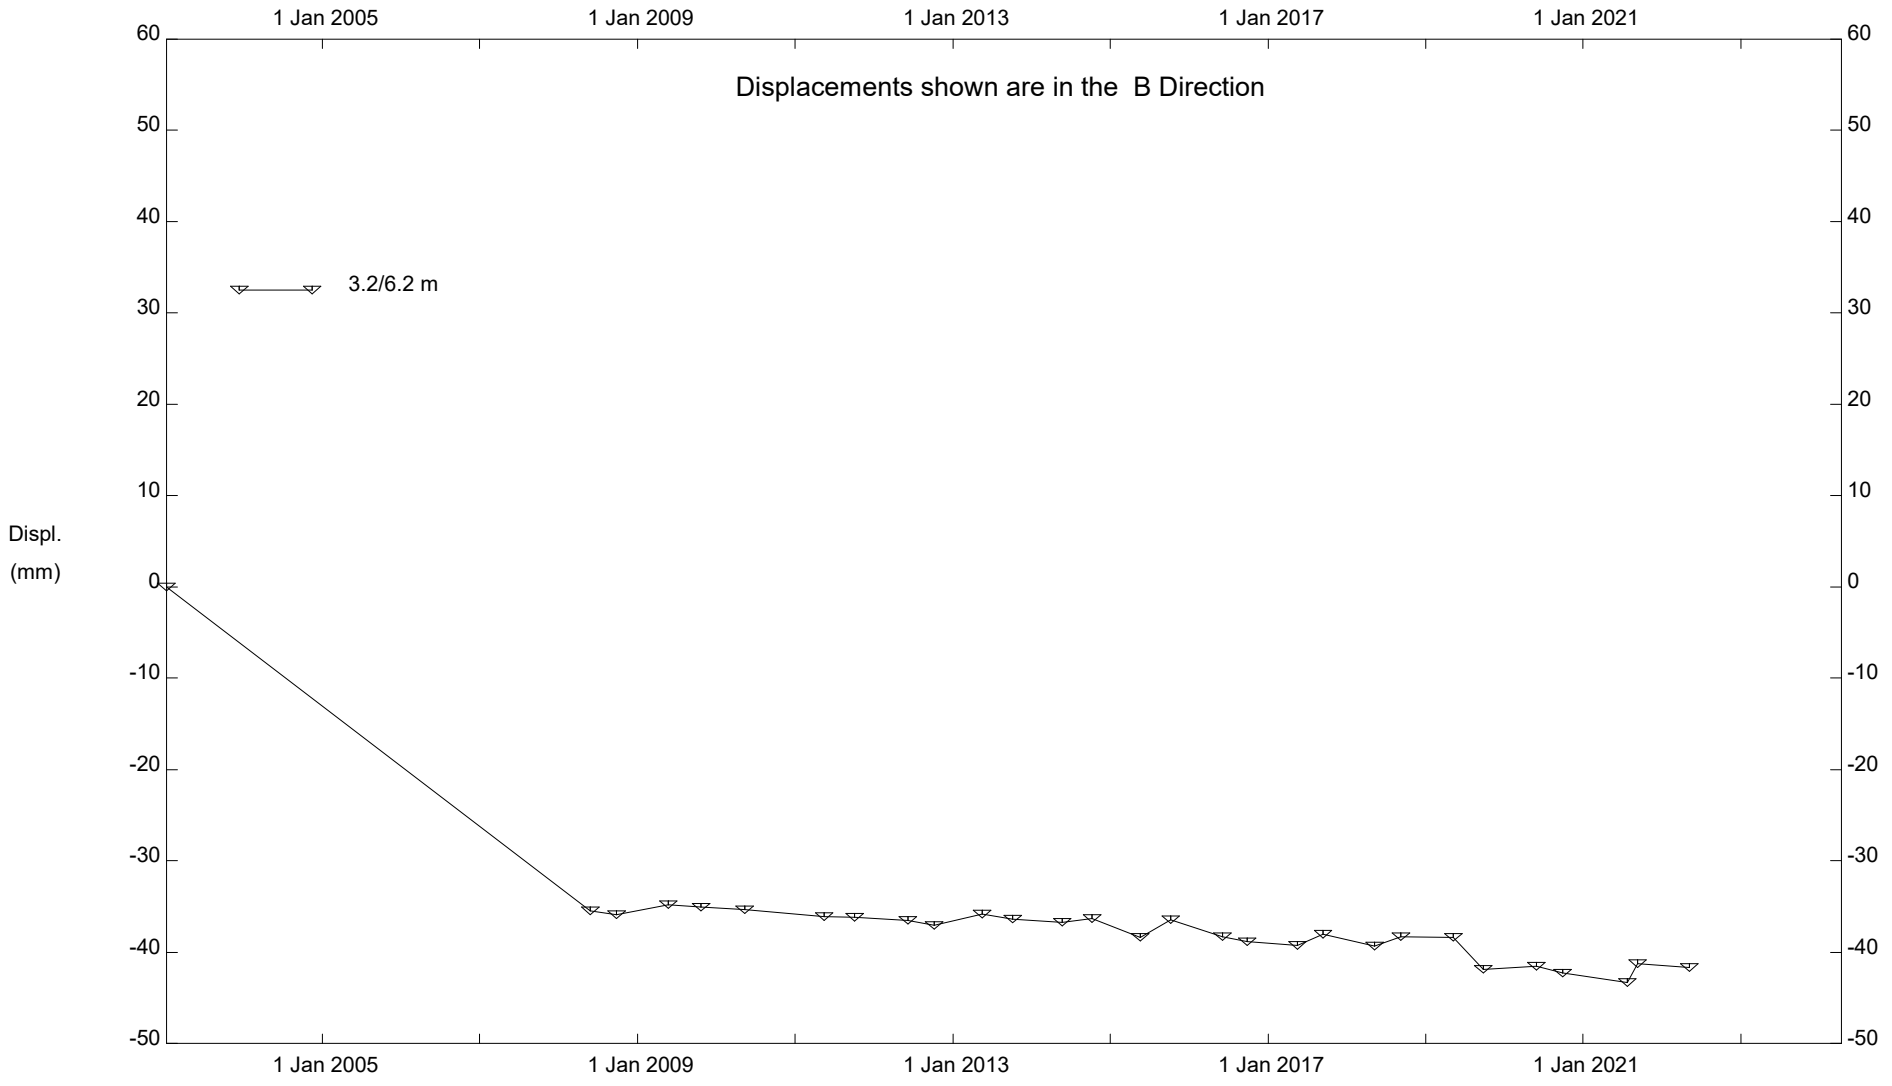
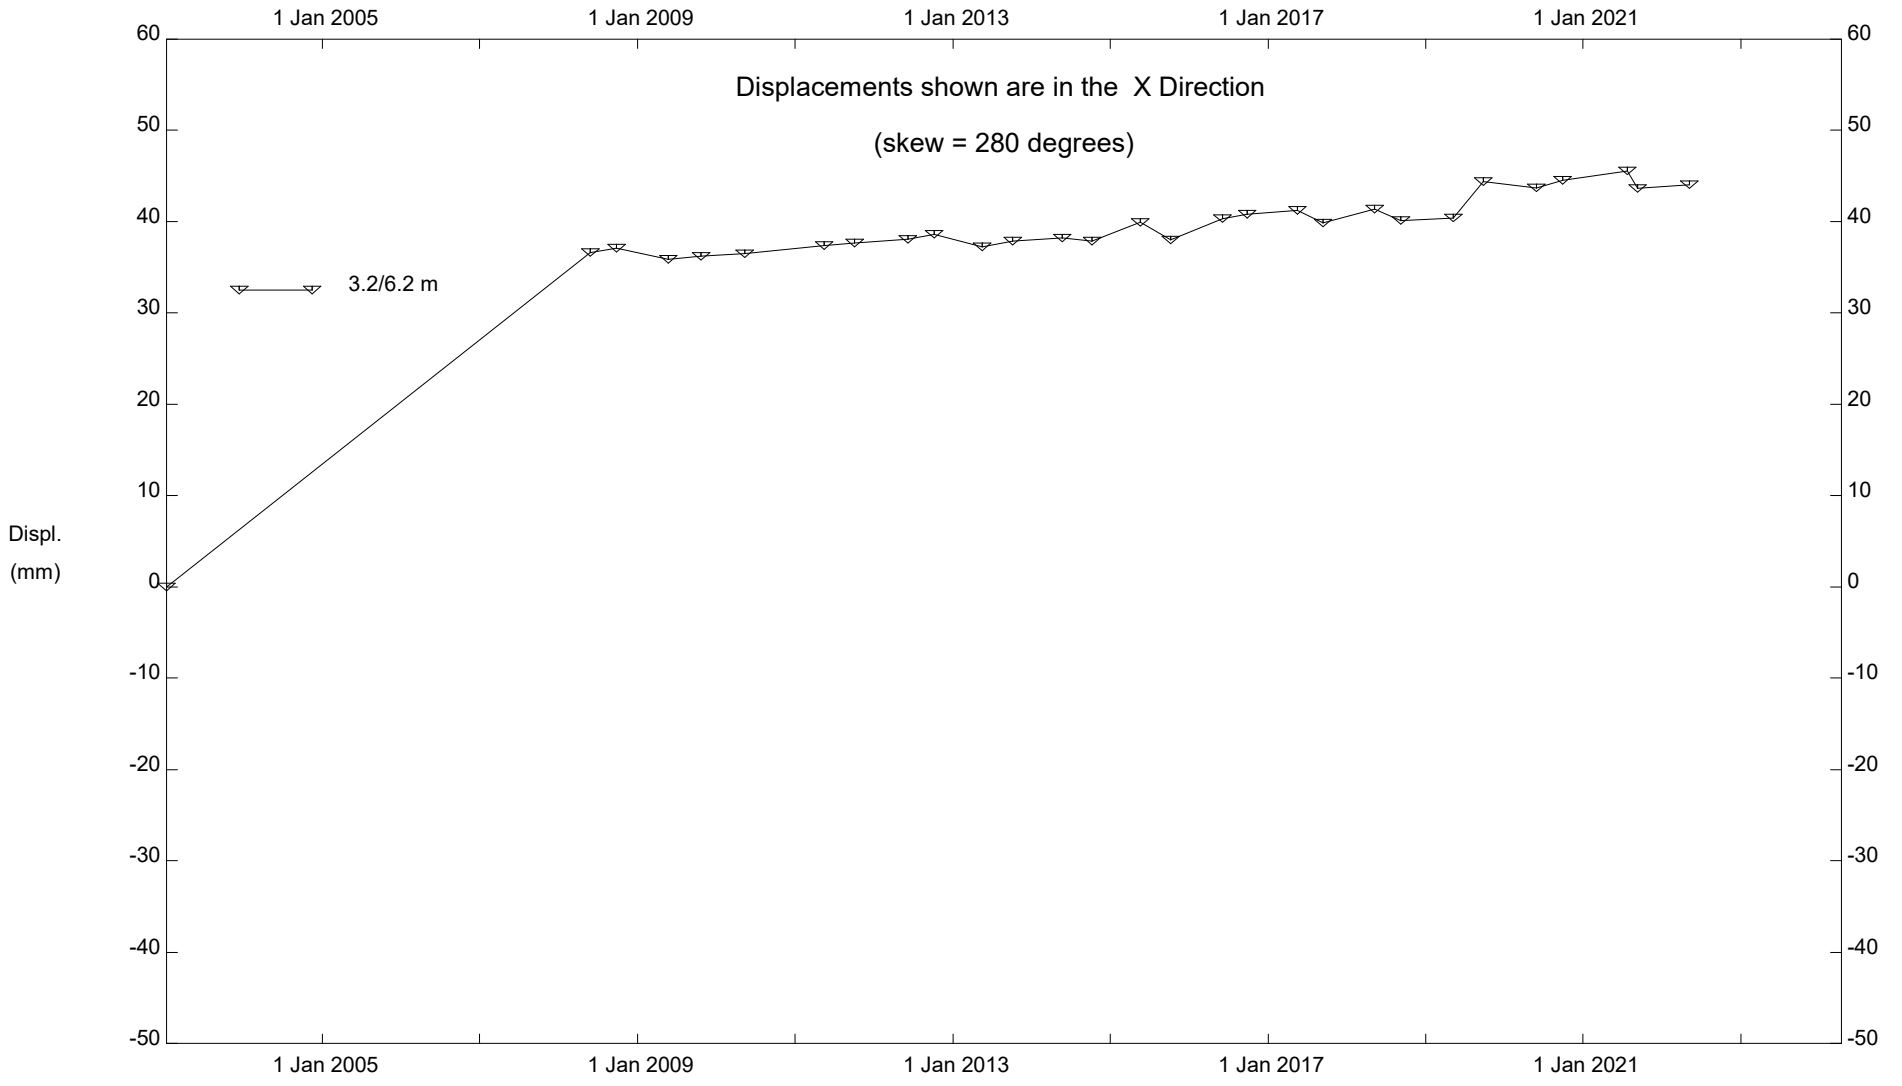
NC067, Inclinometer SI-12

SI-12 has a zone of movement between 3.2 m and 6.2 m and shows creep at a rate of about 1 mm/yr since 2008 with a total cumulative movement of 44 mm.

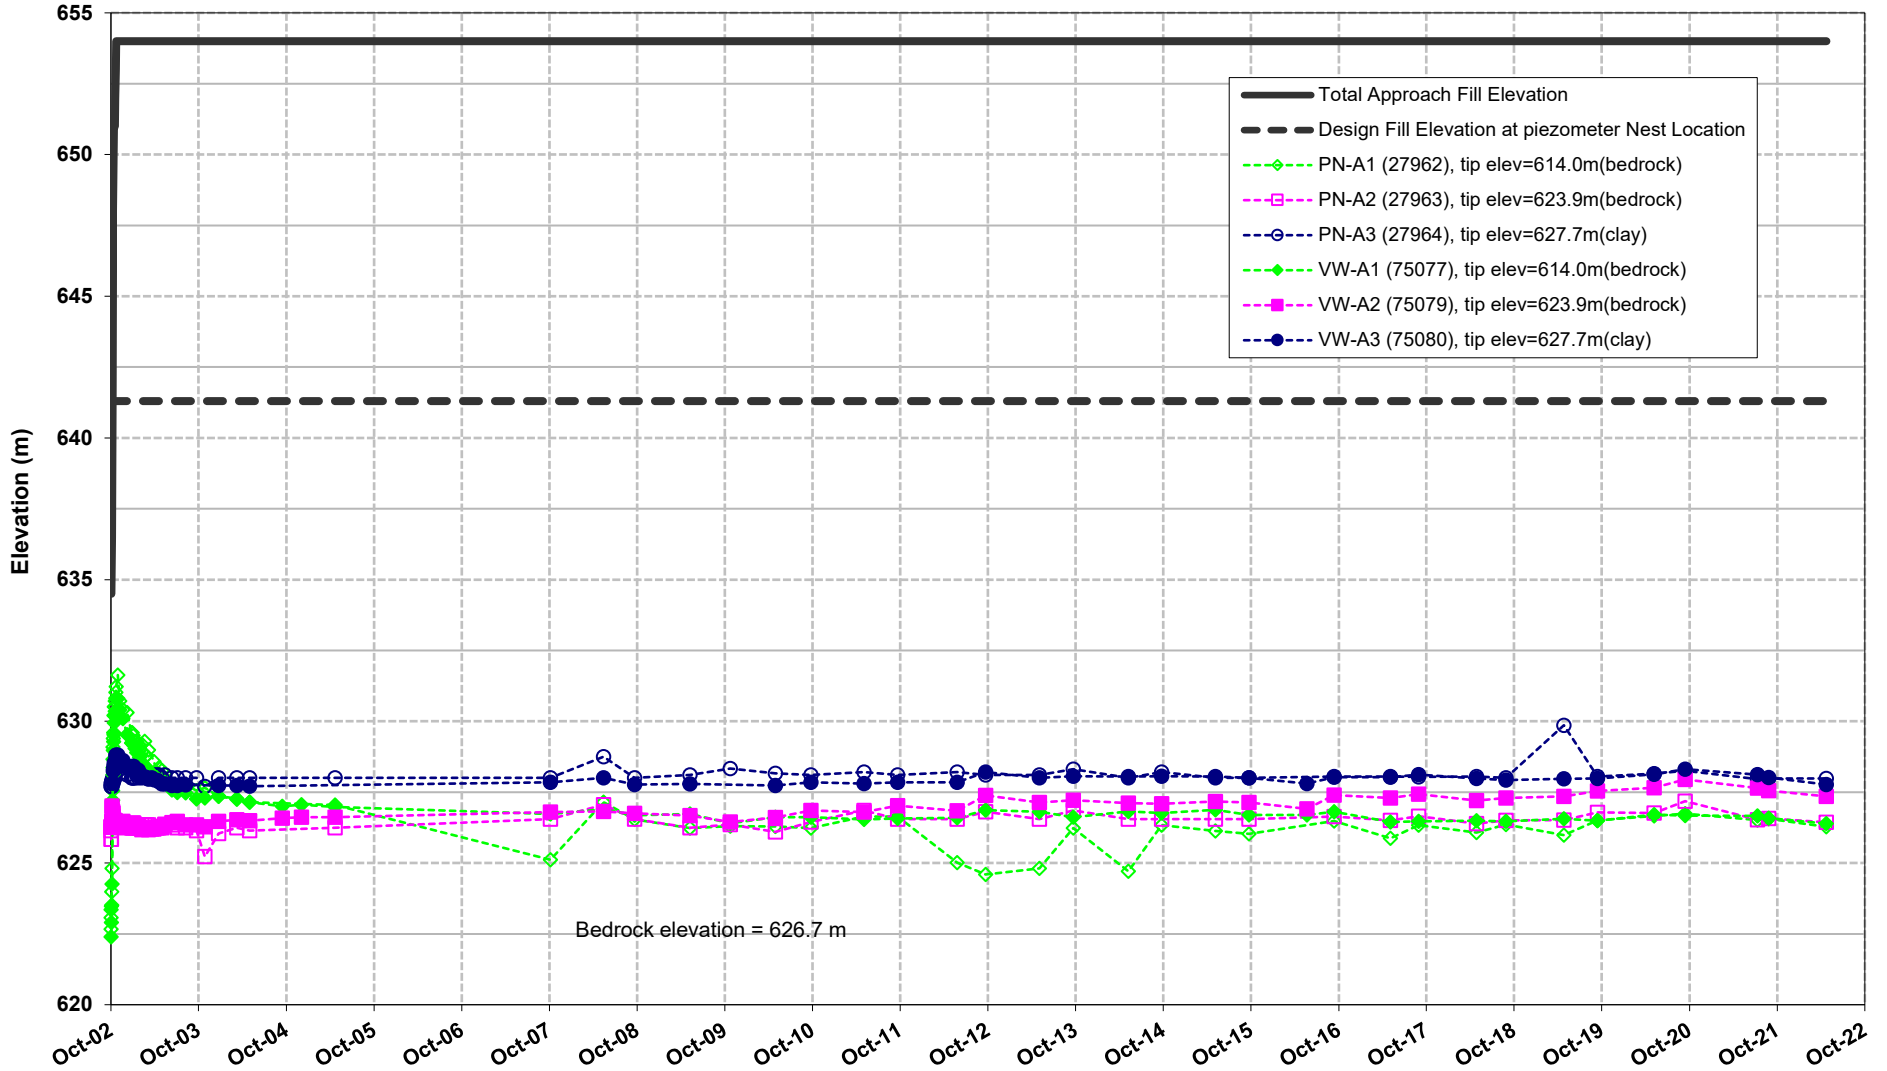
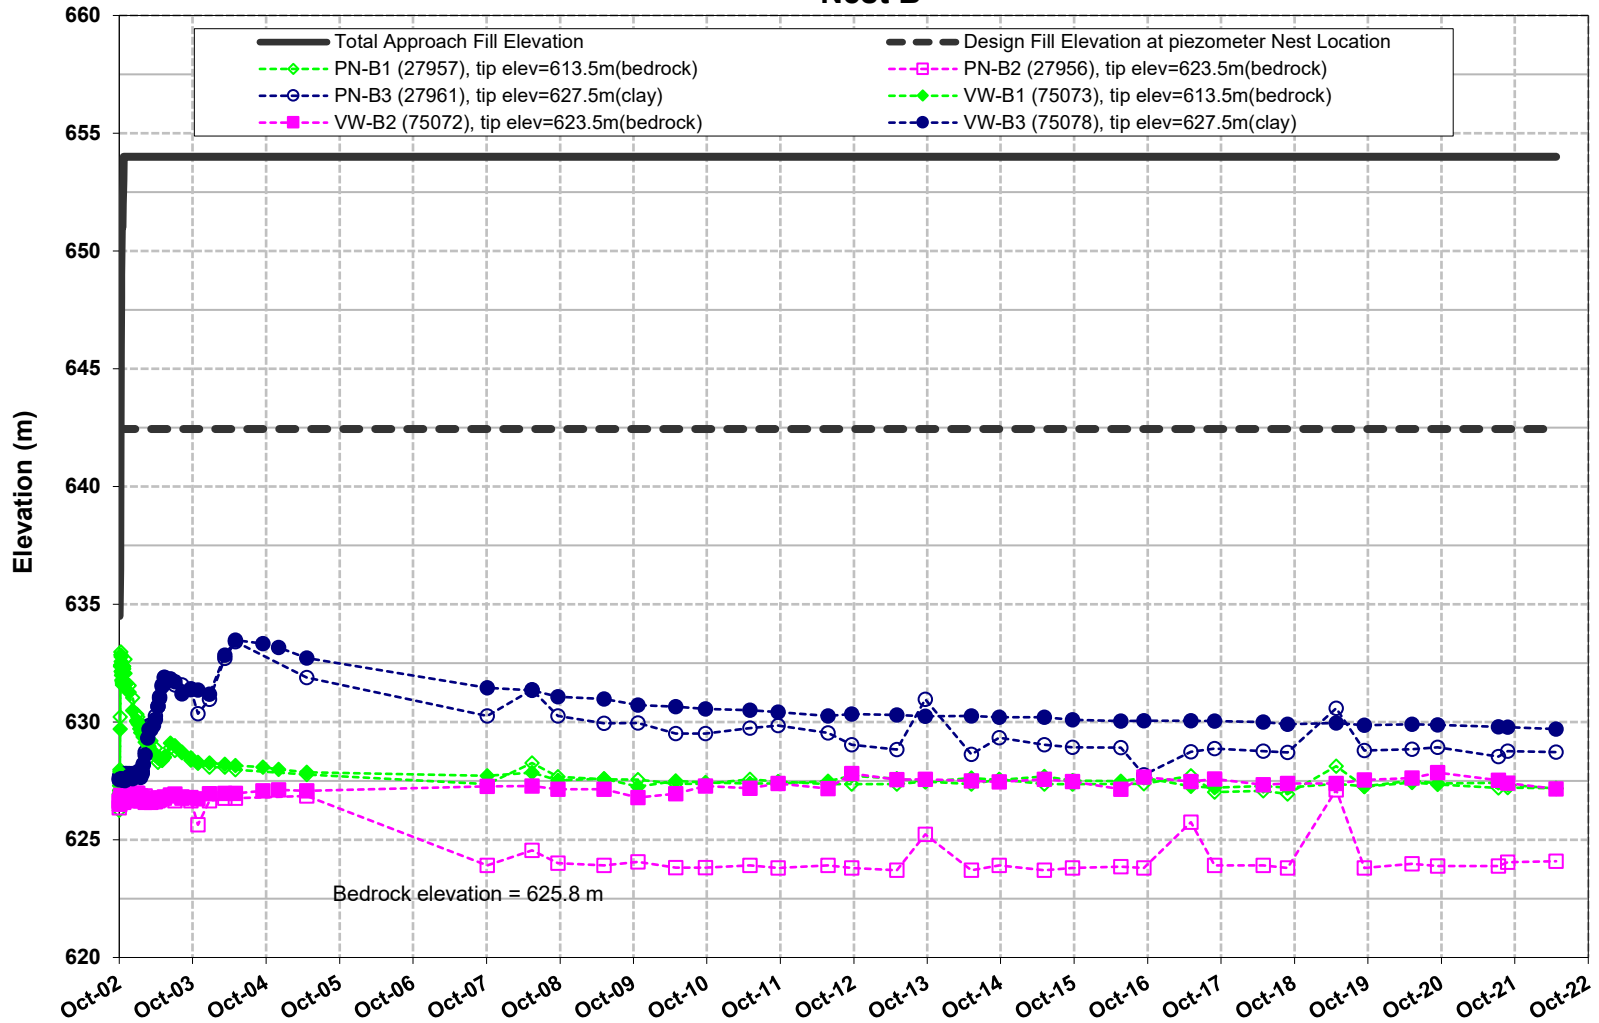
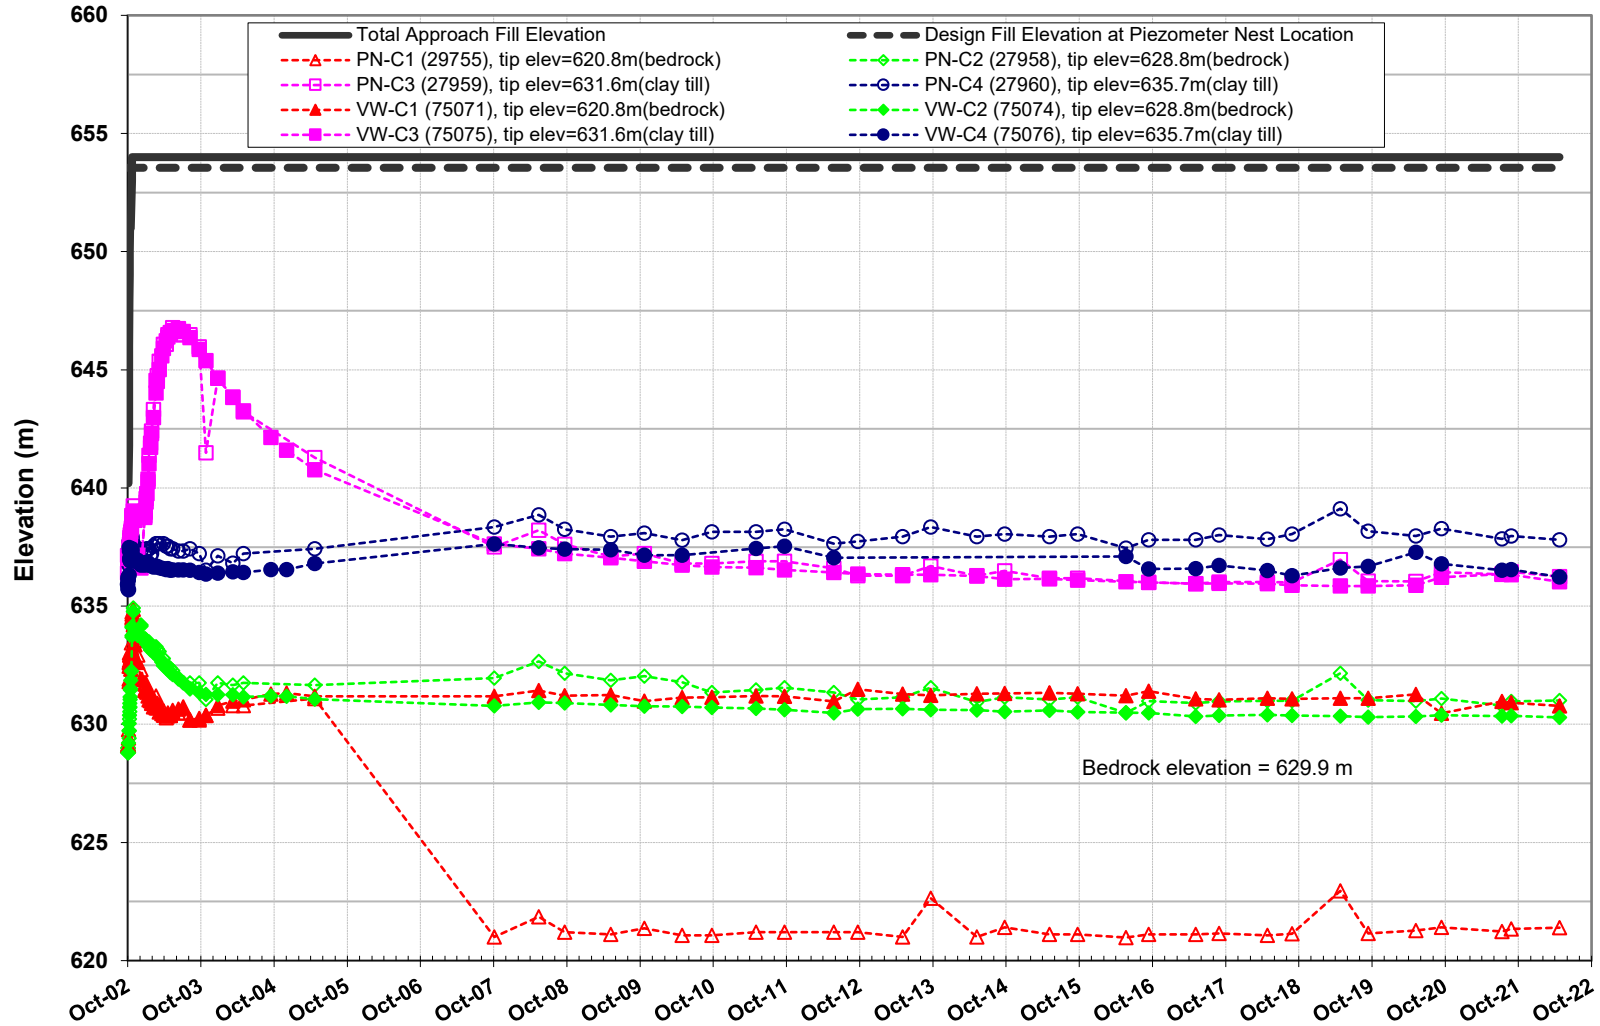
In general, the PNs in the west abutment showed piezometric level difference between 0.3 m decrease and 0.1 m increase compared to Fall 2021 readings.
